Location of spill: Dolores AIL Federal #3

Environmental Site Remediation Work Plan

County:	Eddy	Incident ID:	Unknown
Landowner:	Federal	Location:	32.393634, -103.742007
Client:	EOG Resources, Inc.	Site Location:	Dolores AIL Federal #003
Date:	February 22, 2025	Project #:	25A-00478
Client Contact:	Chase Settle	Phone #:	575.703.6537
Vertex PM:	Chance Dixon	Phone #:	575.988.1472

Objective

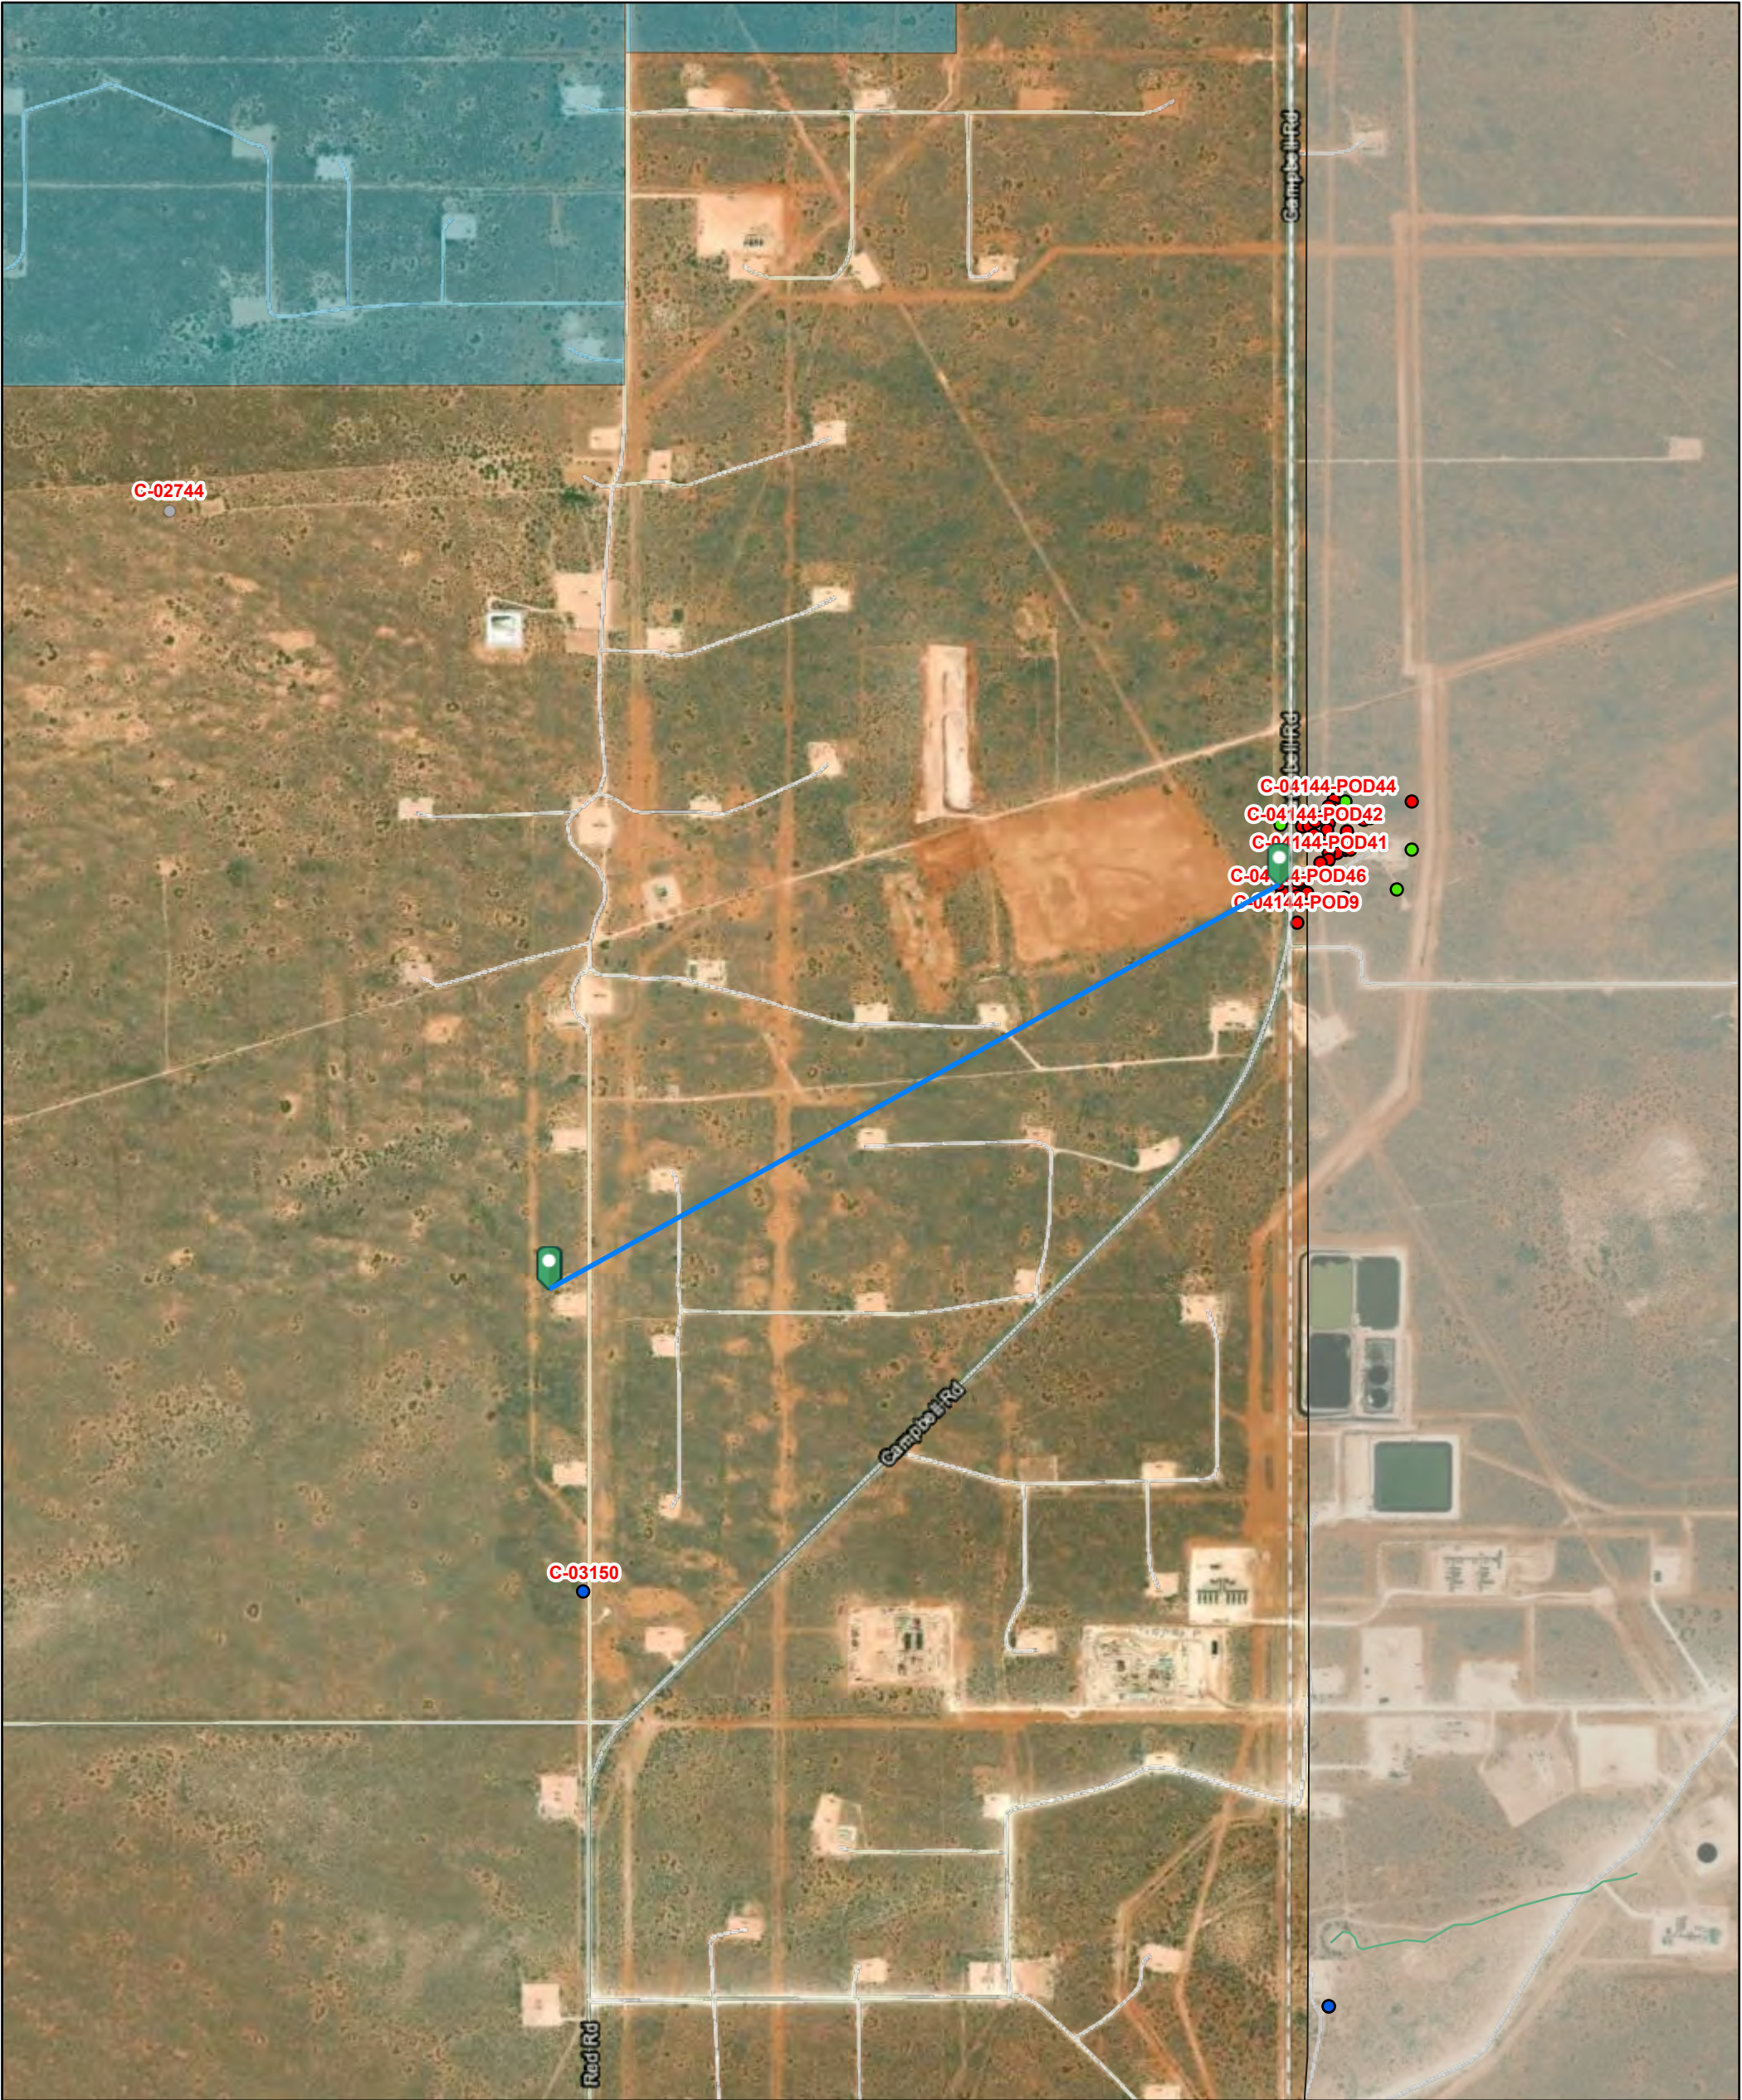
Dolores AIL Federal #3 - C-4144 POD 13

Comments : 12:30 (CT) Boring terminated at 105' with no presence of groundwater or moisture.

9:13 (CT) 03/07/2022 no presence of groundwater was detected

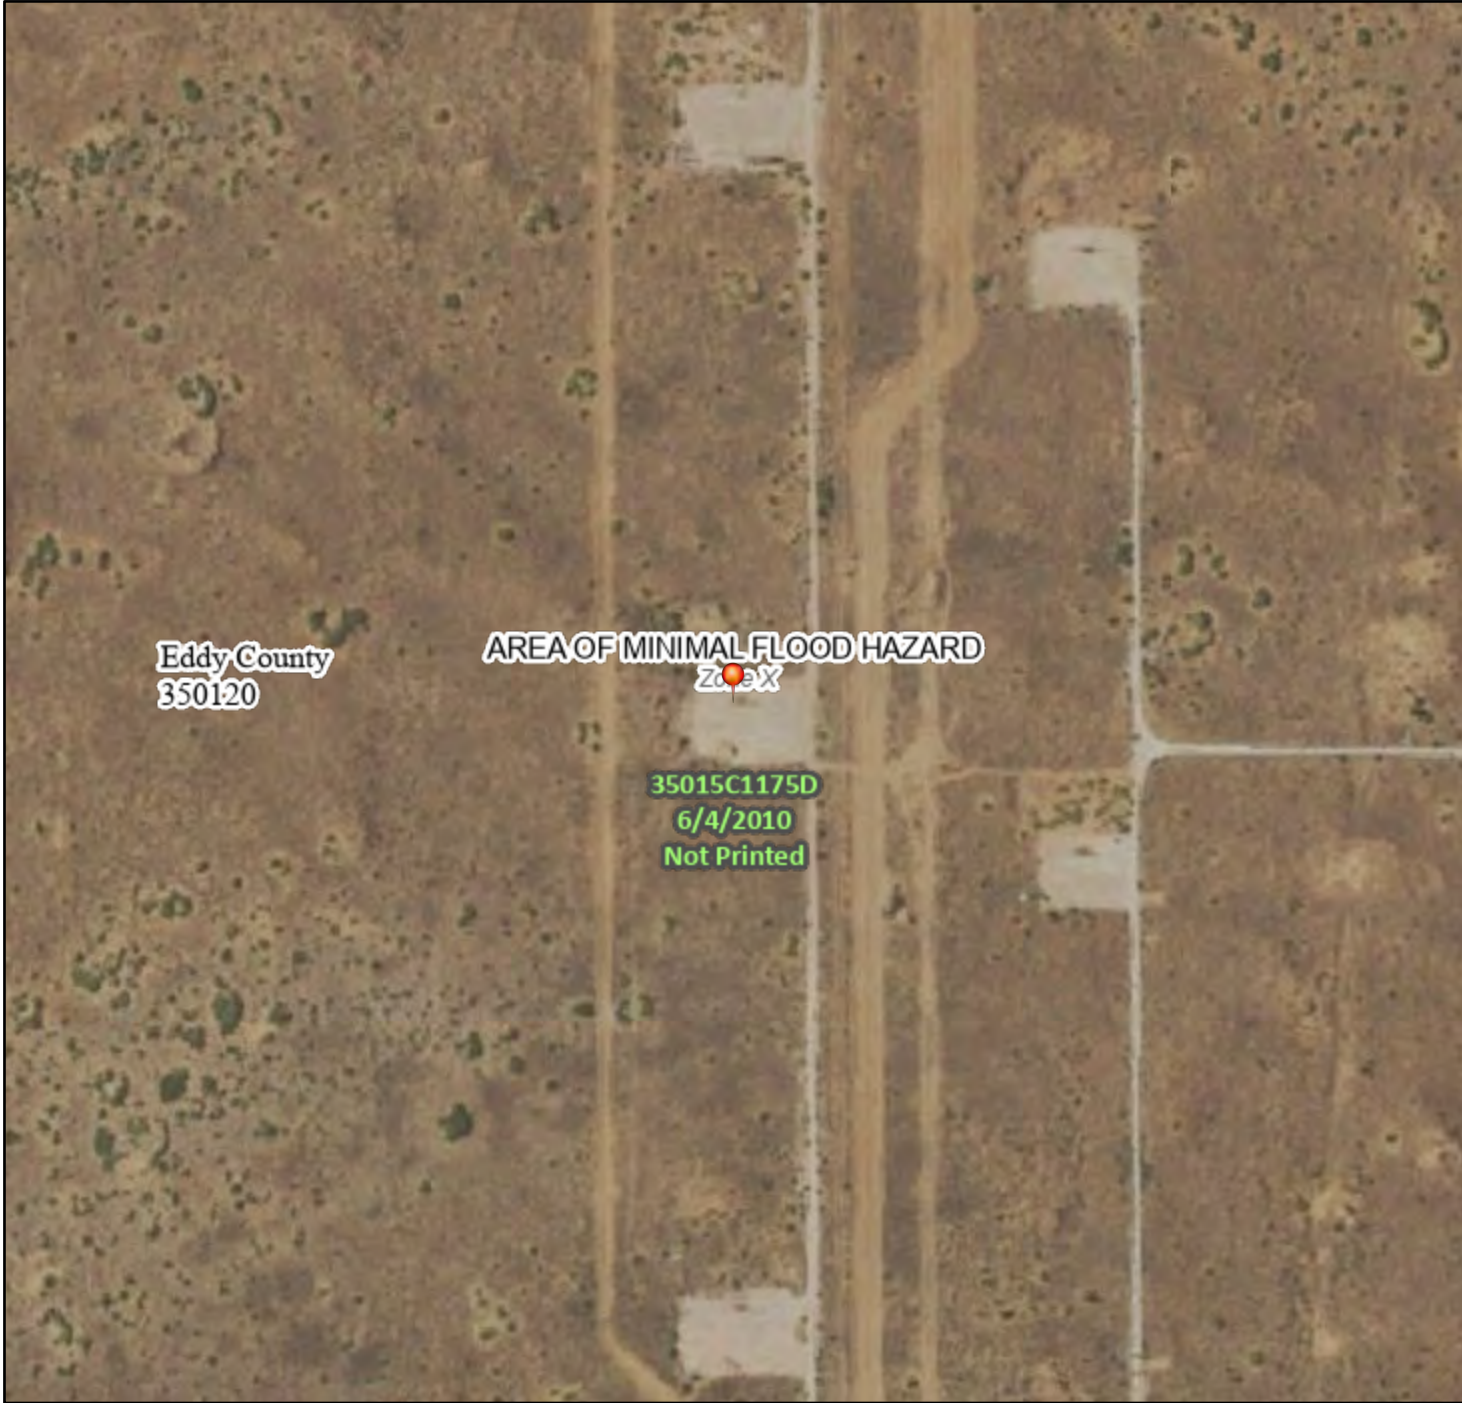
National Flood Hazard Layer FIRMette

The flood hazard information is derived directly from the authoritative NFHL web services provided by FEMA. This map was exported on 1/27/2025 at 11:23 PM and does not reflect changes or amendments subsequent to this date and time. The NFHL and effective information may change or become superseded by new data over time.

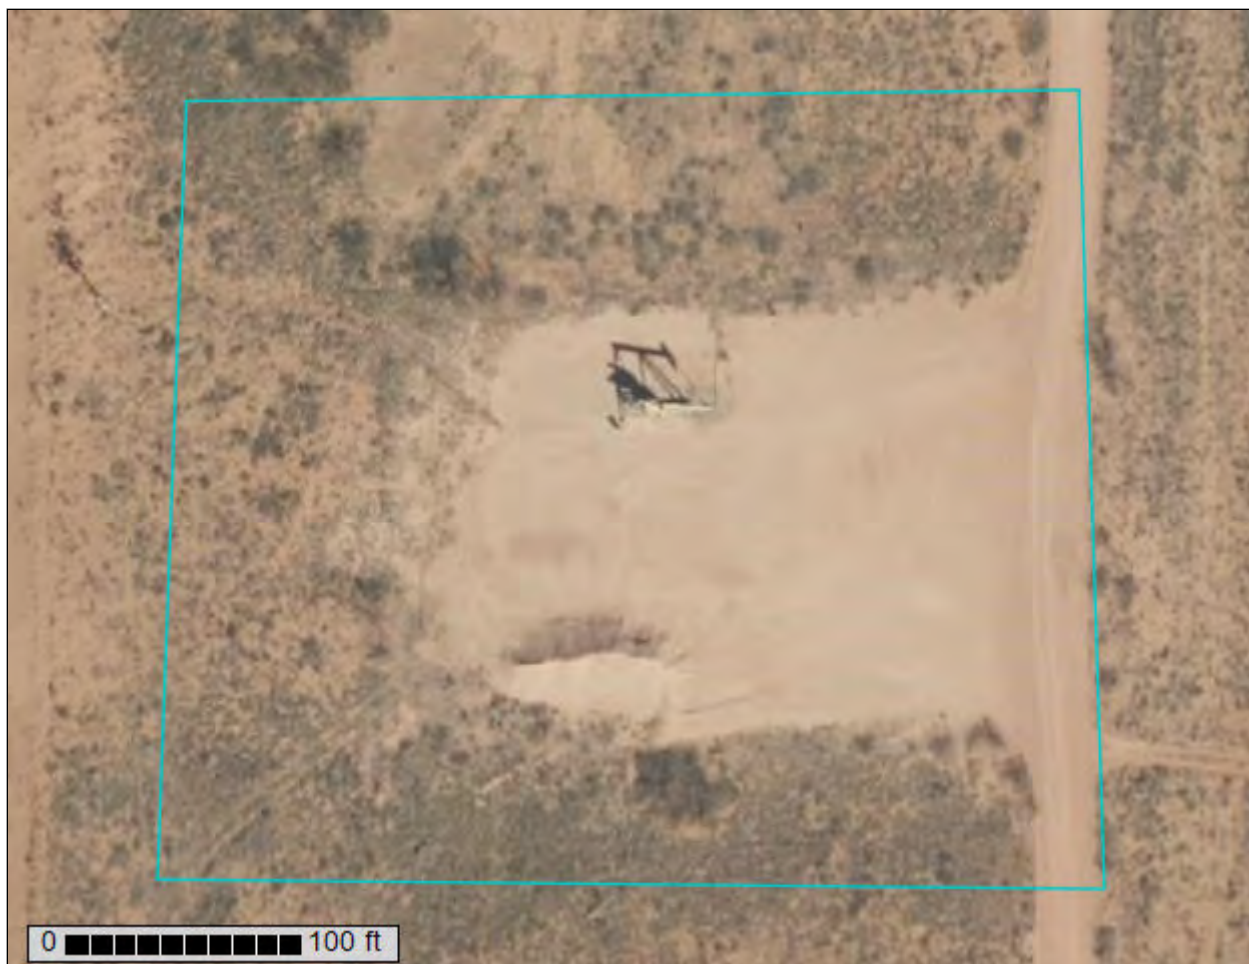
Custom Soil Resource Report for Eddy Area, New Mexico

A map unit delineation on a soil map represents an area dominated by one or more major kinds of soil or miscellaneous areas. A map unit is identified and named according to the taxonomic classification of the dominant soils. Within a taxonomic class there are precisely defined limits for the properties of the soils. On the landscape, however, the soils are natural phenomena, and they have the characteristic variability of all natural phenomena. Thus, the range of some observed properties may extend beyond the limits defined for a taxonomic class. Areas of soils of a single taxonomic class rarely, if ever, can be mapped without including areas of other taxonomic classes. Consequently, every map unit is made up of the soils or miscellaneous areas for which it is named and some minor components that belong to taxonomic classes other than those of the major soils.
