## NM-35 LINE LEAK

### Remediation Action Plan

NMOCD Incident No. nAPP2413552773  
UL "E", Sec. 4, T20S, R38E  
32.604361°, -103.15911°  
Lea County, New Mexico

May 22, 2025

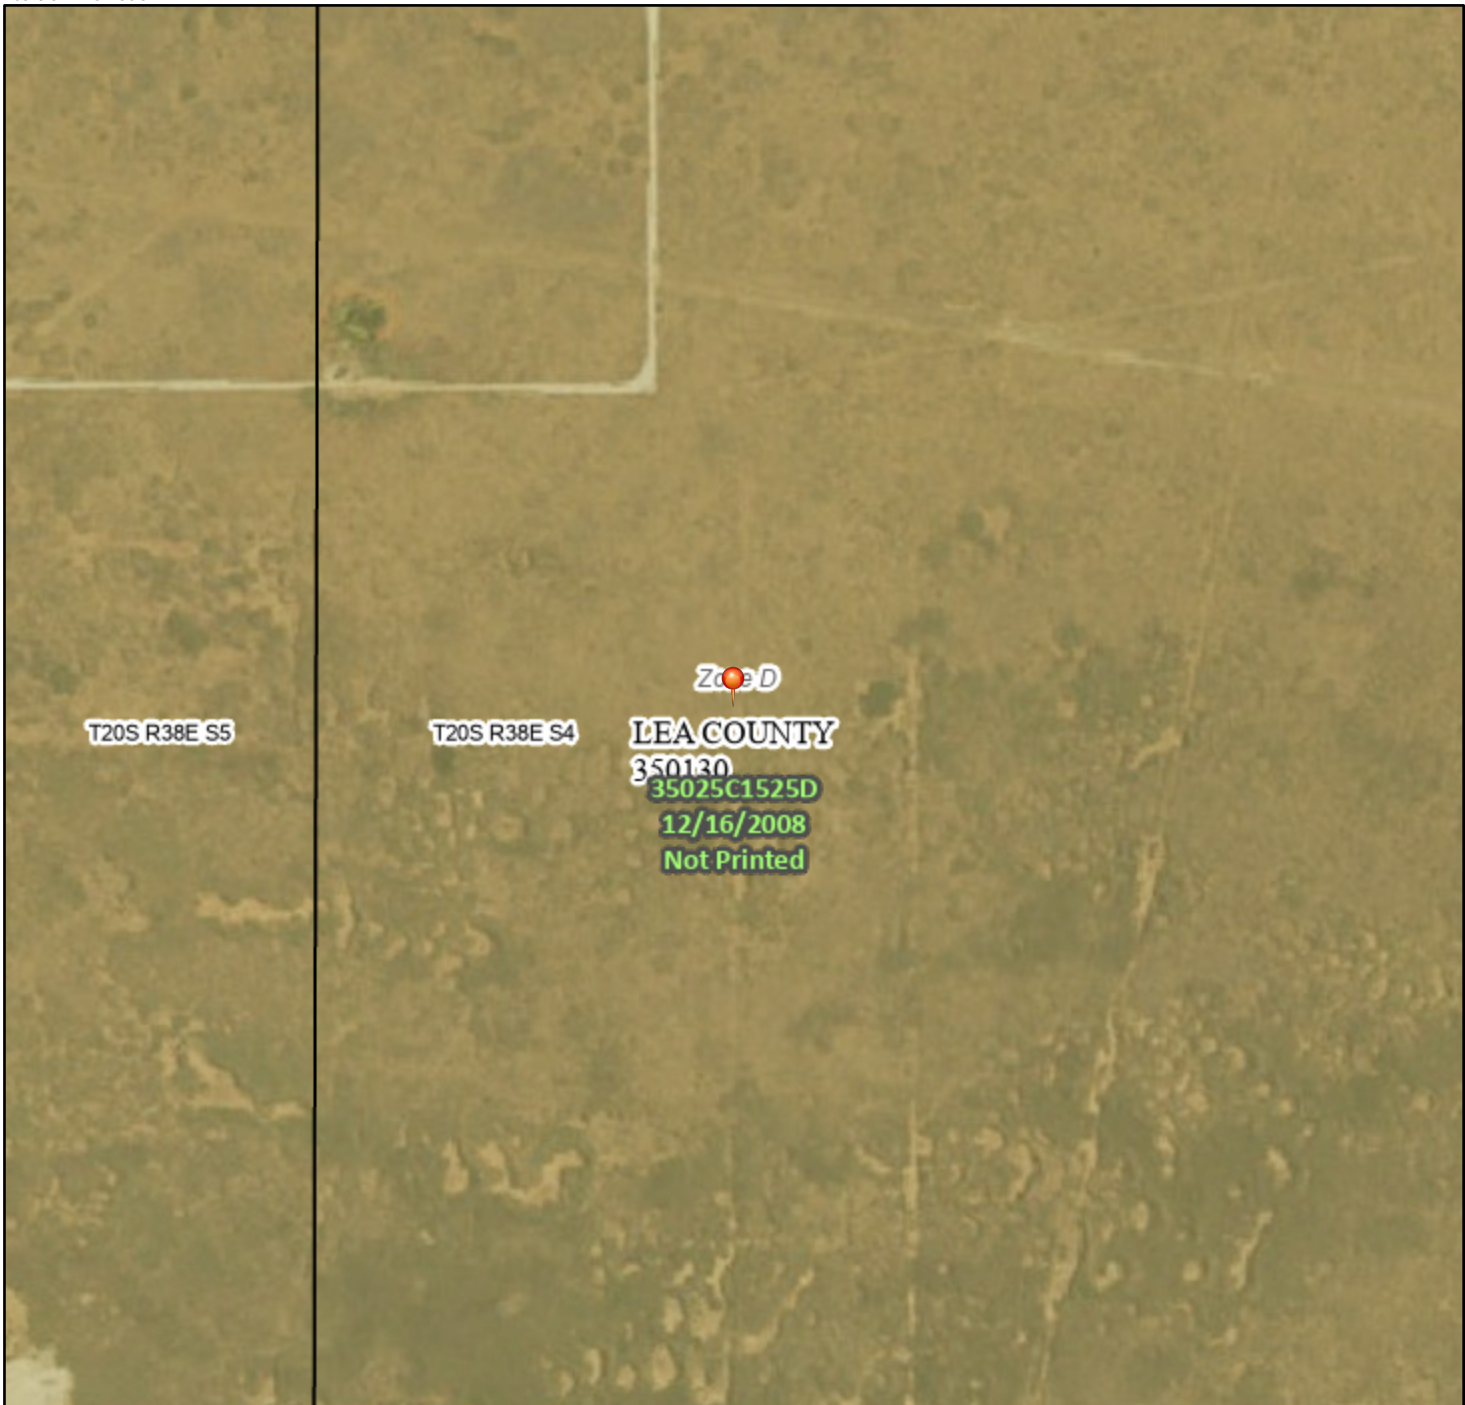
# National Flood Hazard Layer FIRMMette

Review of flood map data published by the Federal Emergency Management Agency (FEMA) indicates the site is not located within a 100-year floodplain. A copy of the FEMA FIRMete Map can be found attached as Figure 4.
