LEMANS 2419 ST COM 304H

nAPP2506641719

PREPARED BY SAPEC-ECO, LLC.

RE: **Remediation Closure Report**  
**Lemans 2419 St Com 304H**  
**API # 30-015-49939**  
**GPS: Latitude 32.55525 Longitude -103.345217 NAD83**  
**ULSTR – E – 24 – 20S – 26E Eddy County, NM**  
**NMOCD Incident ID nAPP2506641719**

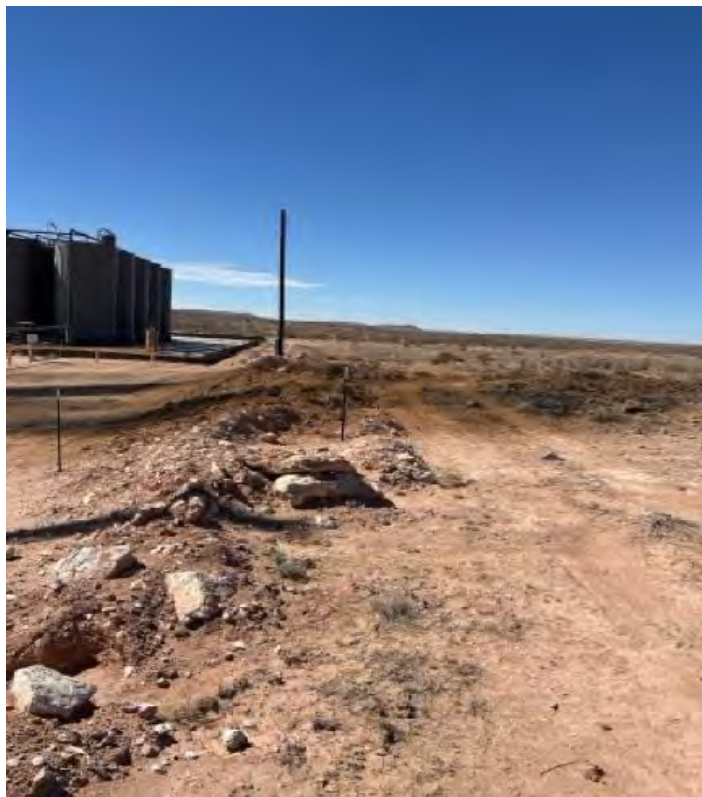
**nAPP2506641719:** On February 21, 2025, an unknown equipment failure occurred causing a release of approximately 3.6 barrels (bbls) of crude oil. The fluid was released out of the flare which resulted in a fire. Approximately 0 bbls of fluid were recovered as the fire consumed them and eventually put itself out.

Initial Spill picture, NE of flare looking W

On March 21, 2025, Wild West Services LLC mobilized personnel and equipment to the site to begin excavating the release area. The total area of the excavation measured approximately 1,500 square feet, on and off the pad, and was excavated to a depth of approximately 6" bgs. The total amount of soil removed was approximately 20 cubic yards.

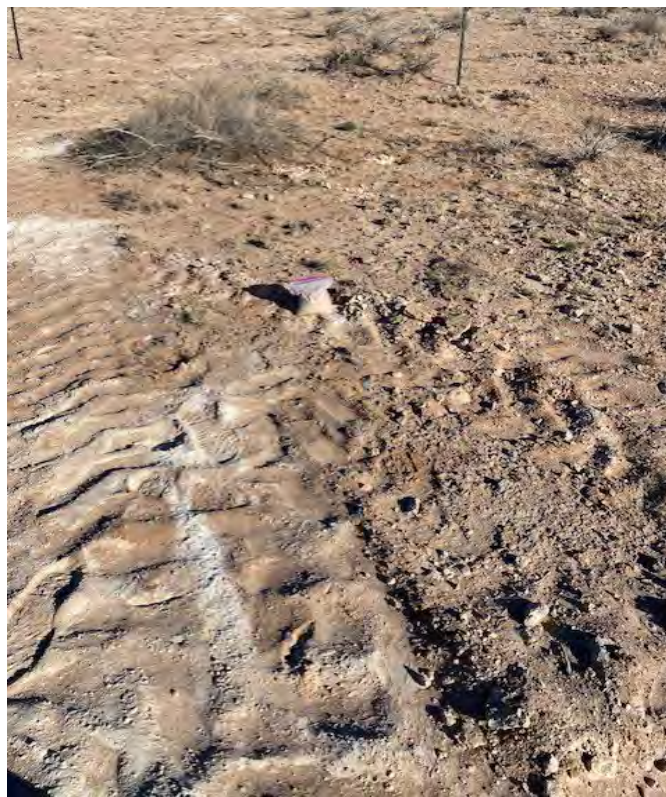
Confirmation Sampling pad section looking E

On March 26, 2025, after submitting a 48-hour notification to the NMOCD for a confirmation sampling event, Saptec personnel mobilized to the site to collect the confirmation samples. Forty (40) subsamples were collected from the base of the excavation to form eight (8) 5-point composite samples. Twenty (20) subsamples were collected from the walls of the excavation to form four (4) 5-point composite samples. These samples were collected from a depth 6" bgs. A total of twelve (12) composite samples were immediately placed in a cooler with ice, then prepared and delivered to Envirotech Analytical Laboratories for official analysis of all constituents listed in Table 1 19.15.29.12 NMAC. A Confirmation Sample Map can be referenced in Figure 1. The laboratory results of this sampling event can be seen in the Data Table in Figure 2. A complete Laboratory Report can be found in Appendix E.

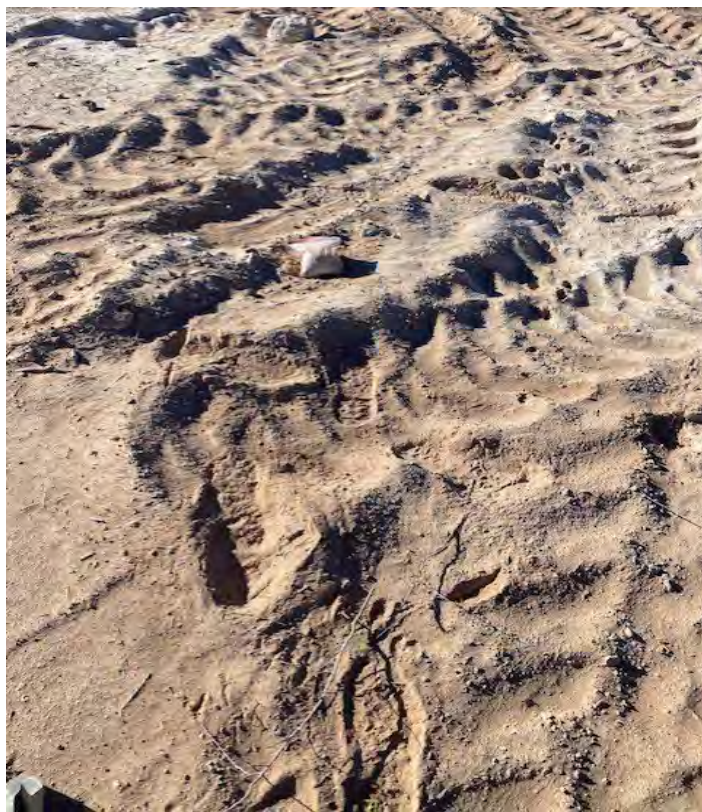
Confirmation Sampling pad section

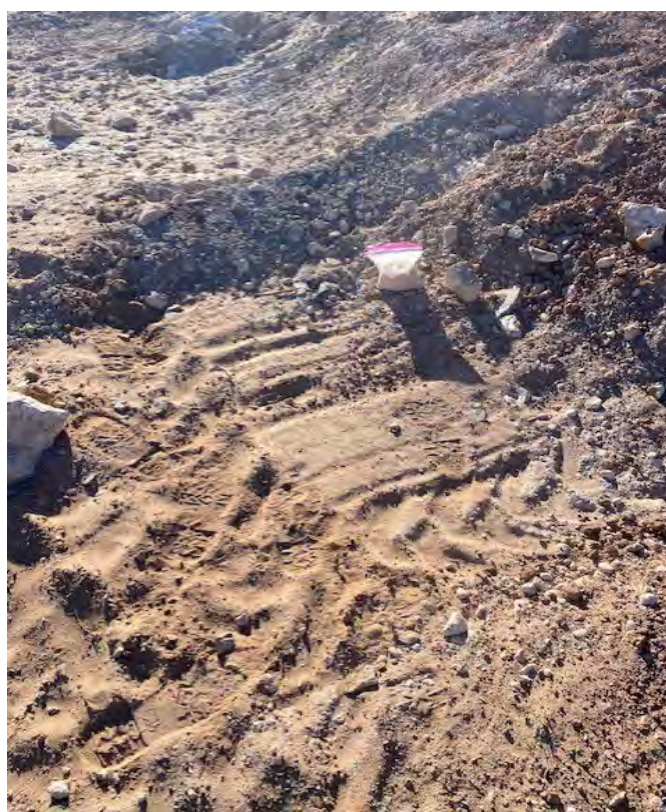
Confirmation sampling section at berm

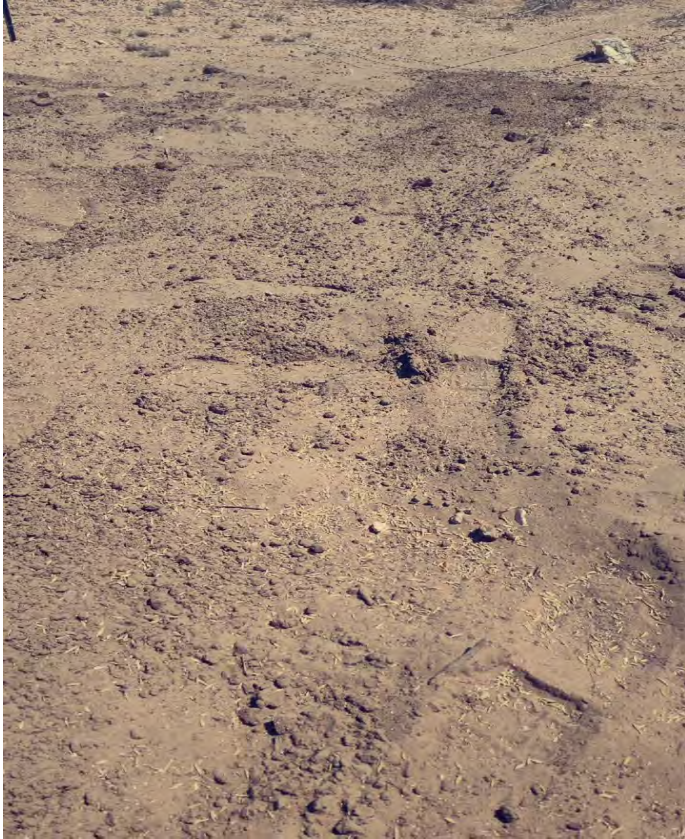
Pasture section with topsoil after seeding

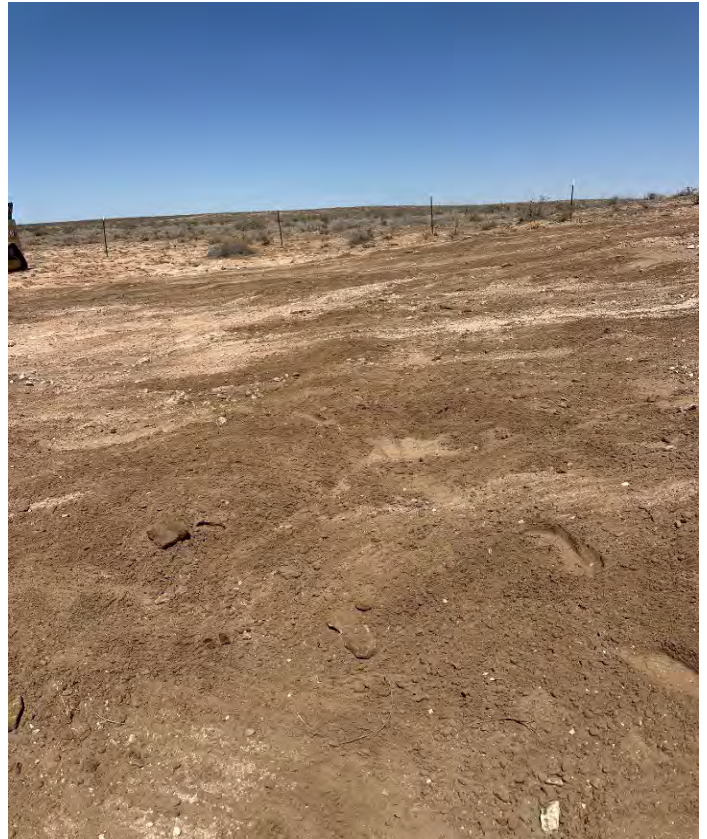
Pasture section after seeding looking N

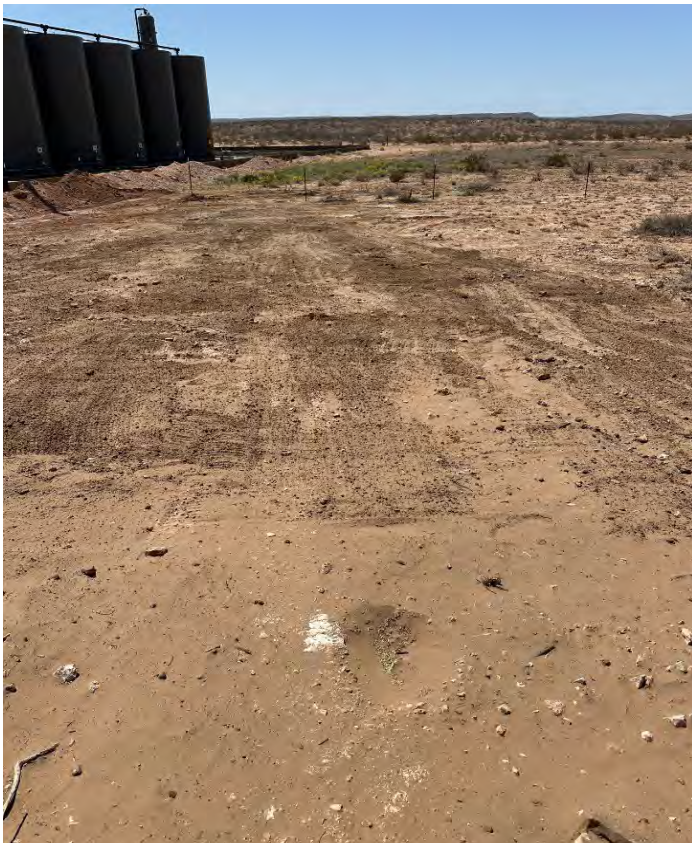
Pasture section after seeding looking W

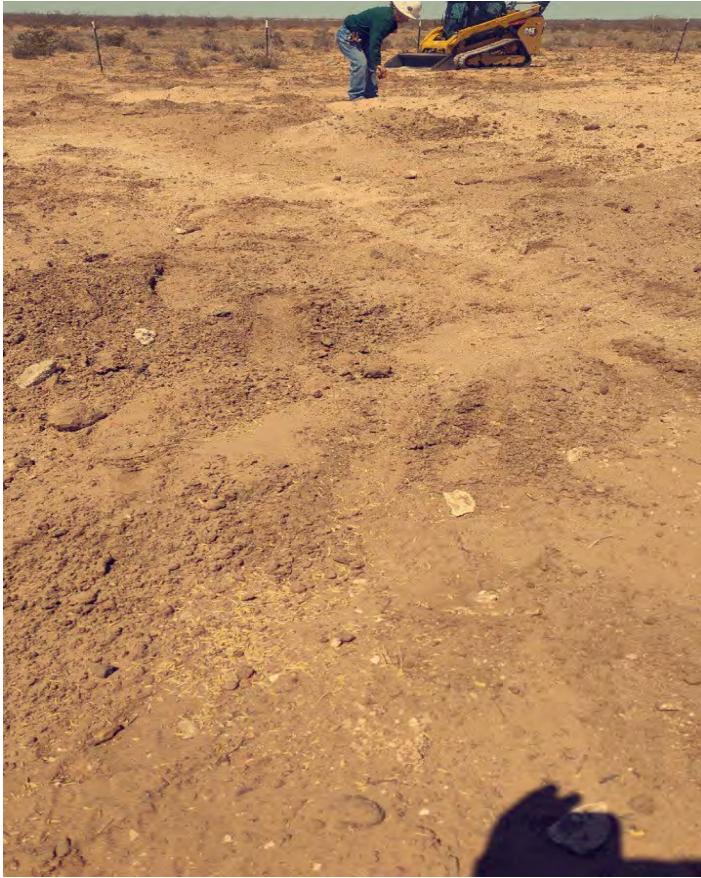
Pasture section during reseeding looking NW

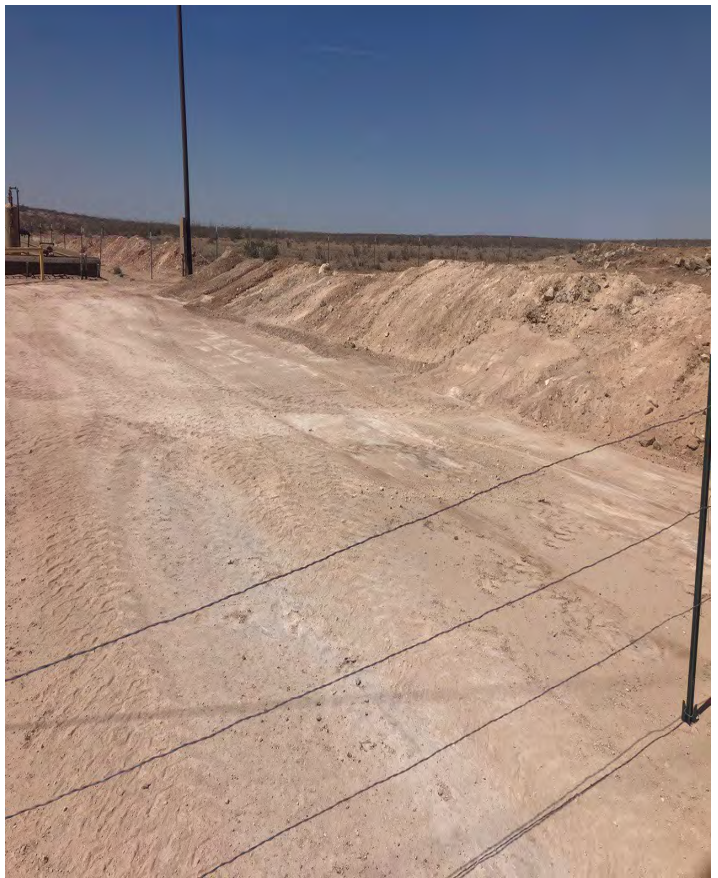
Pad section after backfill & repacking looking W

On April 7, 2025, Wild West personnel returned to the site to backfill the excavation with clean, like material from the nearest available caliche pit location.

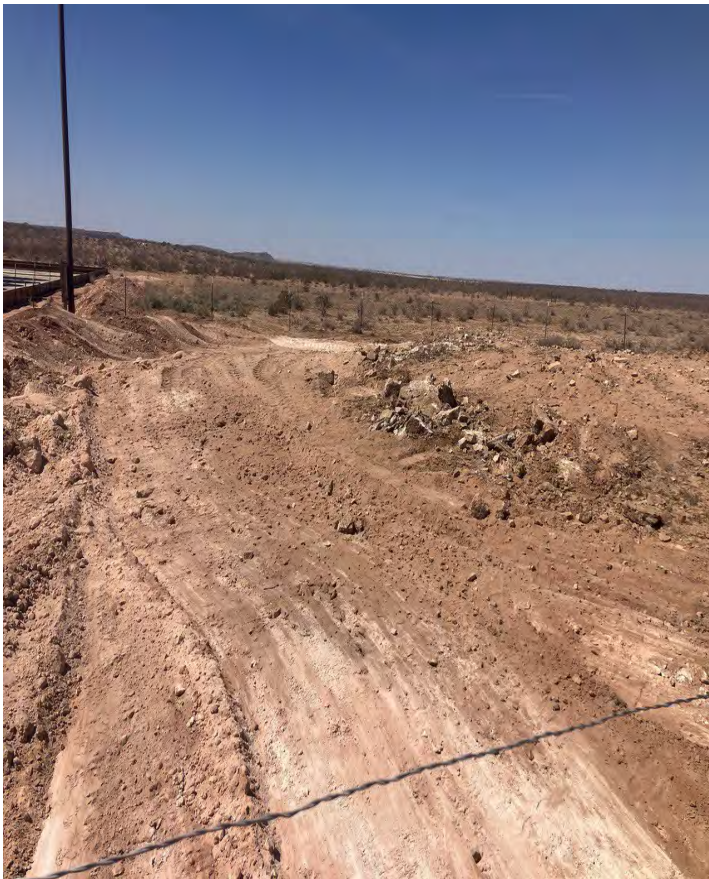
Pasture section during scrape looking W

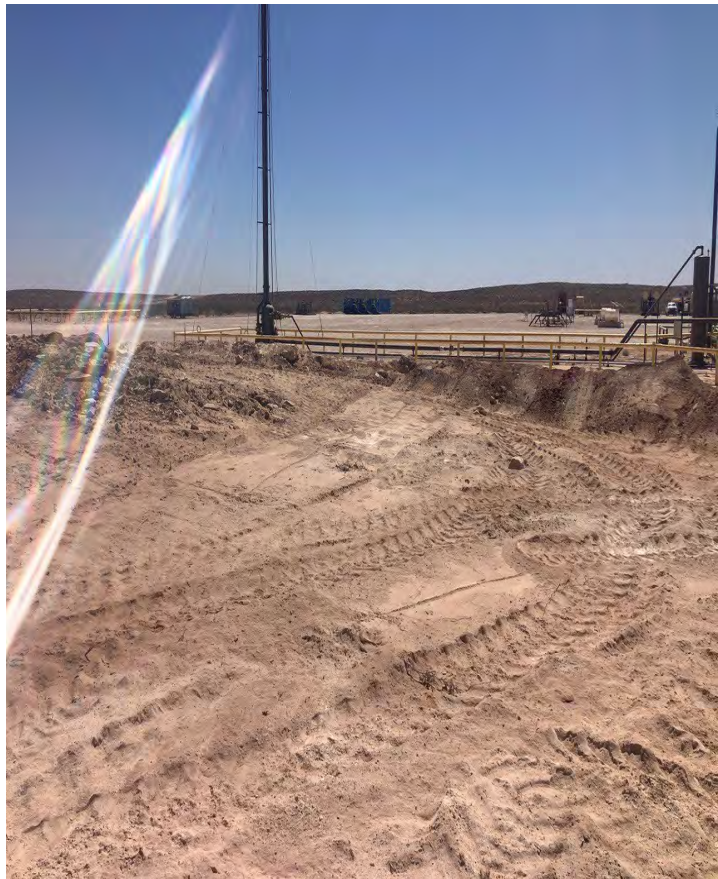
Pasture section during scrape looking S
