Closure Report
Cutbow West CTB 1 (06.06.2025)
Incident ID: NAPP2516177828
Lea County, New Mexico
Unit N, Sec 25, T19S, R32E
32.626464, -103.721778

Crude Oil Release
Point of Release: Flare Fire
Release Date: 06.06.2025
Volume Released: 0.4 Barrels of Crude Oil
Volume Recovered: 0.0 Barrels of Crude Oil

Re: **Closure Report**
Cutbow West CTB 1 (06.06.2025)
Incident ID: NAPP2516177828
Coterra Energy Operating Co.
Site Location: Unit N, S25, T19S, R32E
32.626464, -103.721778
Lea County, New Mexico

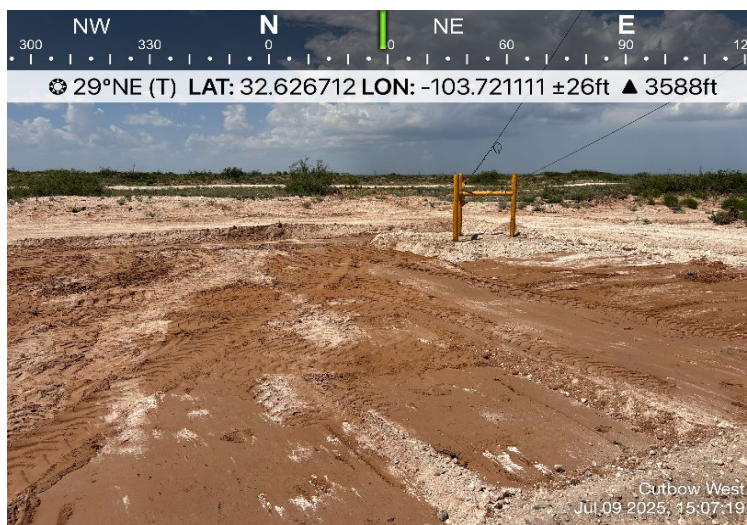
Photograph No. 3

View NorthWest, Area of CS-1 through CS-9

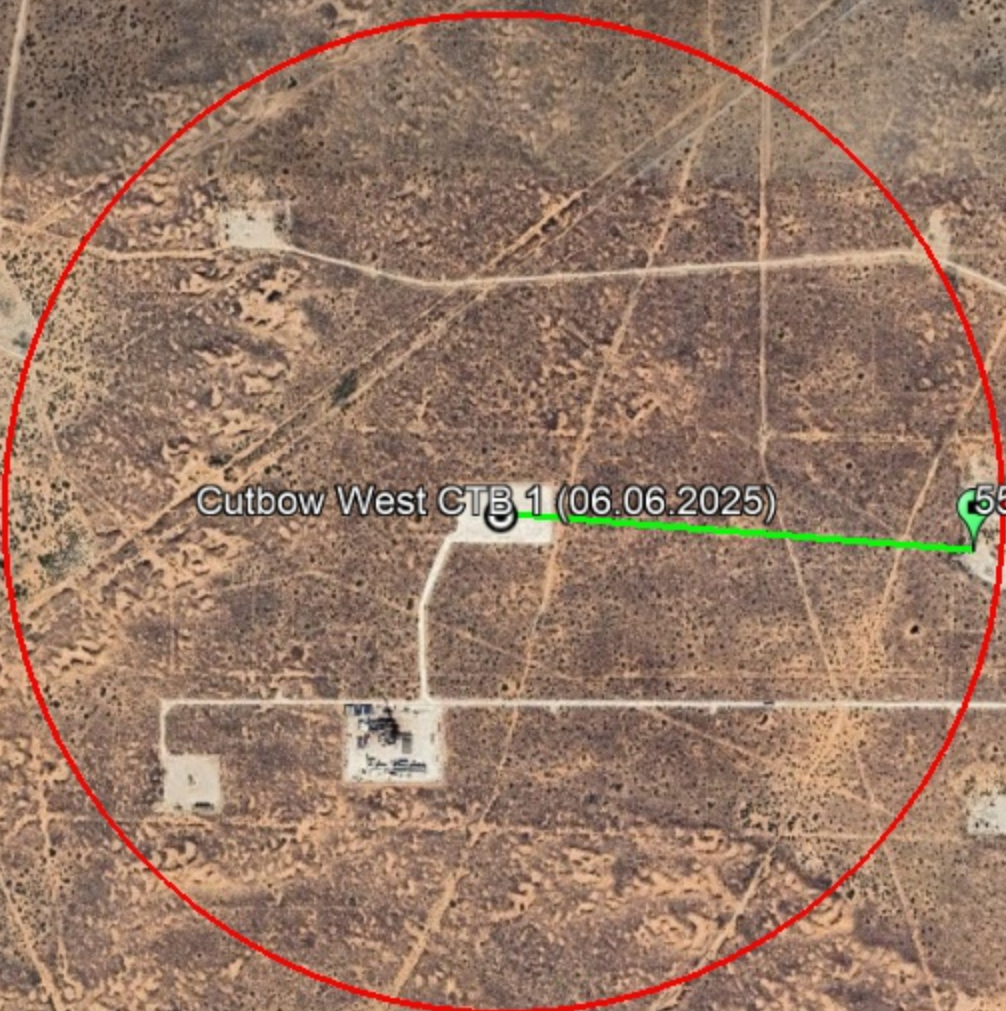
Nearest water well

- 0.48 Miles
- 0.50 Mile Radius
- Cutbow West CTB 1 (06.06.2025)
- Groundwater Determination Bore

55' GWDB - Drilled 2025

The site is located within a low karst area. Based on a review of the New Mexico Office of State Engineers and USGS databases, there are no known water sources within a 0.50-mile radius of the location. The nearest Groundwater Determination Bore (GWDB) is located approximately 0.48 miles East of the site in S25, T19S, 32E (32.625917°, -103.713639°) and was drilled in 2024. The GWDB was drilled to 55 feet below ground surface (ft bgs) and did not have evidence of groundwater. A copy of the associated well log is attached in Appendix D.
