**Re: Sampling Plan  
James Ranch Unit #10 Battery  
Incident Numbers NAB1521257588, NAB1535754357, and NAB1904653072  
Eddy County, New Mexico**

Ensolum, LLC (Ensolum), on behalf of XTO Energy, Inc. (XTO), presents this *Sampling Plan* proposing confirmation soil sampling activities following the utilization of a solar soil vapor extraction (SVE) system at the James Ranch Unit #10 Battery (Site). The SVE system has been in operation since May 27, 2022, to remediate residual subsurface hydrocarbon impacts to soil at the Site. The following *Sampling Plan* proposes to complete confirmation soil sampling activities via drilling rig.

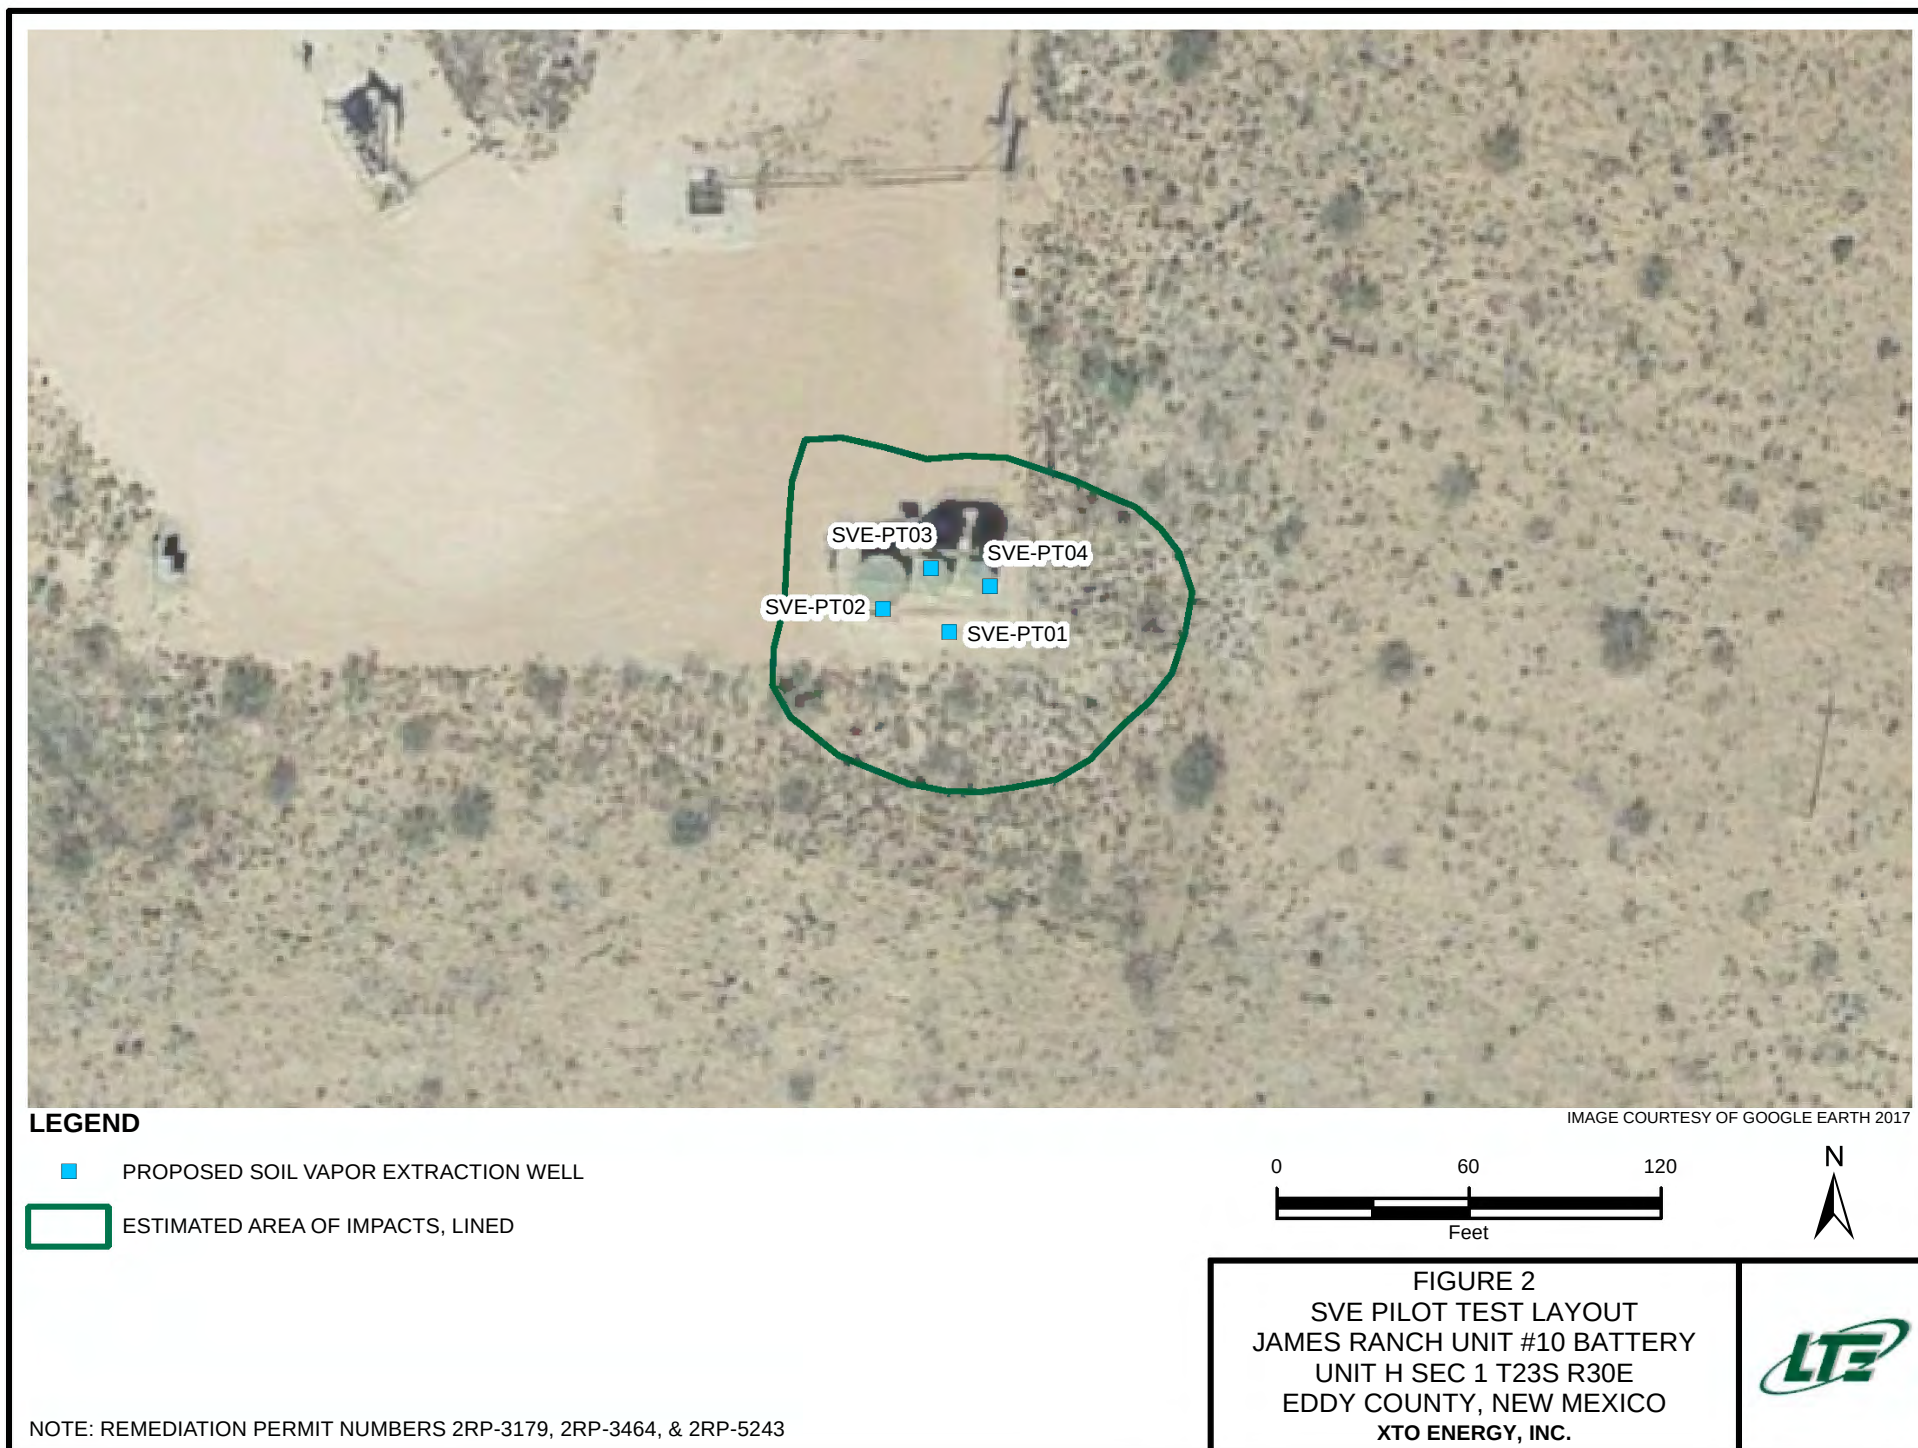
Four SVE wells (SVE-PT-01 through SVE-PT-04) were installed prior to testing in the locations presented on Figure 2. During the advancement of each SVE well, continuous soil sampling was conducted, which included describing the lithology based on the Unified Soil Classification System (USCS) as specified in American Society for Testing and Materials (ASTM) D2488, observations of staining and odors, and field screening of volatile aromatic hydrocarbons and chloride utilizing a calibrated photo-ionization detector (PID) and Hach® chloride QuanTab® test strips, respectively. Soil boring logs were completed at the time of drilling and are provided with the construction diagrams of the SVE wells as Attachment 2.

Vacuum was applied to two of the SVE wells (SVE-PT-01 and SVE-PT-04), while the other two SVE wells were utilized as observation wells (SVE-PT-02 and SVE-PT-03). SVE wells SVE-PT-02 and SVE-PT-03 will ultimately be utilized for full-scale SVE design. The SVE wells were screened across different lithologies observed in the subsurface to test applied vacuum responses and influence within those lithologies.

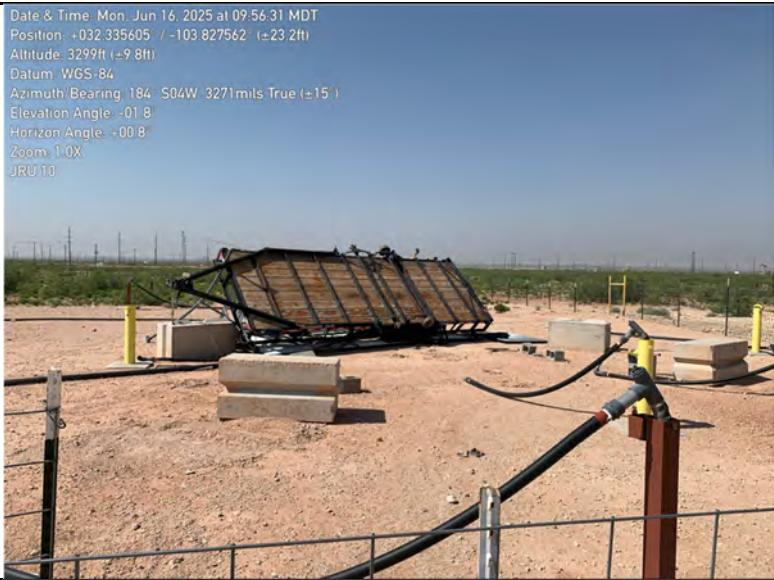
| <b>Photograph 1</b><br><br>SVE System Post-Storm<br>June 16, 2025 at 9:56 AM | <p>Date &amp; Time: Mon, Jun 16, 2025 at 09:56:31 MDT<br/>Position: +032.335605° / -103.827562° (±23.2ft)<br/>Altitude: 3299ft (±9.8ft)<br/>Datum: WGS-84<br/>Azimuth Bearing: 184° S04W 3271mils True (±15°)<br/>Elevation Angle: -01.8°<br/>Horizon Angle: +00.8°<br/>Zoom: 1.0X<br/>JRU 10</p> |

On June 16, 2025, an O&M technician was driving by the Site and observed the SVE system disconnected from the anchors and flipped upside down, landing on the faces of the solar panels, likely due to recent high wind events. Upon further inspection, it was determined the existing system would no longer be operational without significant repairs and/or modifications to prevent similar incidents from occurring in the future. The SVE system was removed from the Site for storage at a nearby XTO yard. Photographs of the SVE system post-wind event are provided as Appendix B.

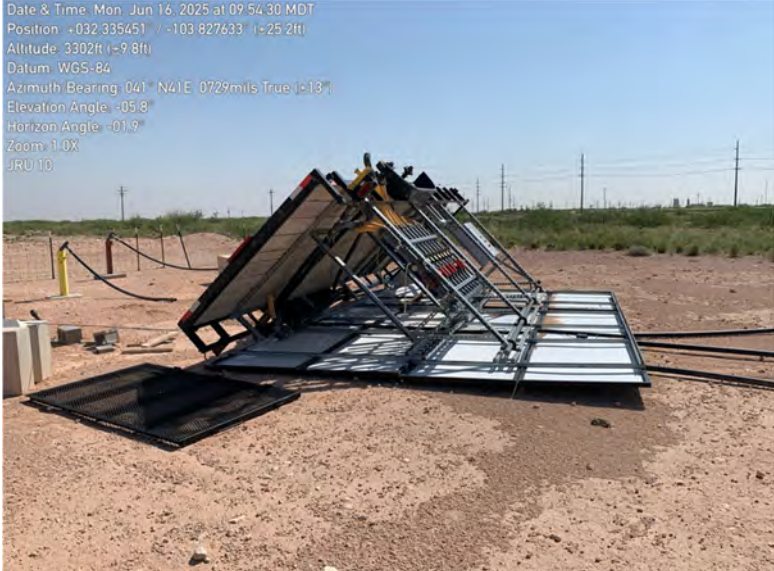
| <b>Photograph 2</b><br><br>SVE System Post-Storm<br>June 16, 2025 at 9:54 AM | <p>Date &amp; Time: Mon, Jun 16, 2025 at 09:54:30 MDT<br/>Position: +032.335451° / -103.827633° (±25.2ft)<br/>Altitude: 3302ft (±9.8ft)<br/>Datum: WGS-84<br/>Azimuth Bearing: 041° N41E 0729mils True (±13°)<br/>Elevation Angle: -05.8°<br/>Horizon Angle: -07.9°<br/>Zoom: 1.0X<br/>JRU 10</p> |
