Closure Report

BTA Oil Producers, LLC

Maxus West Tank Battery

Incident ID: nAPP2204058713

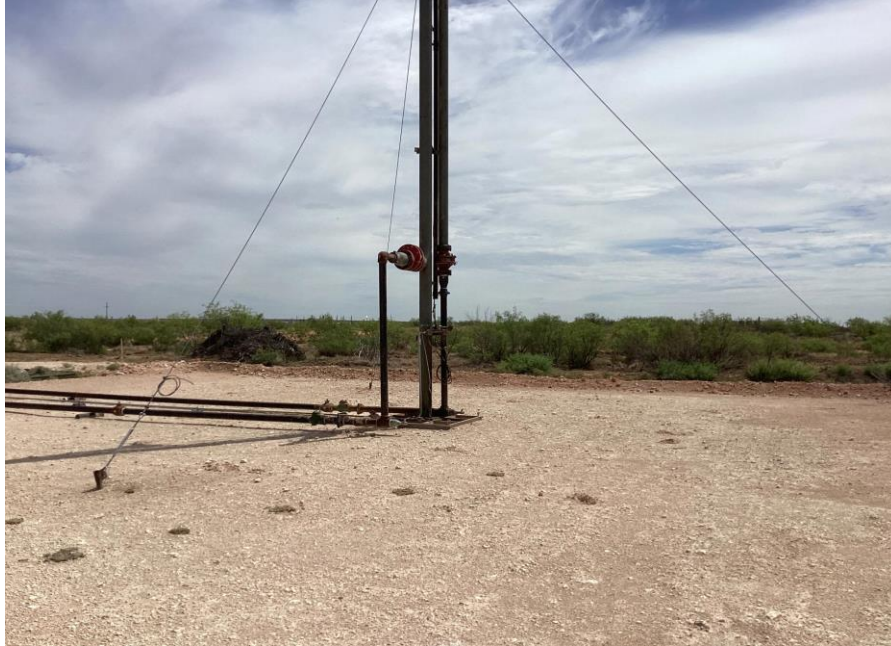
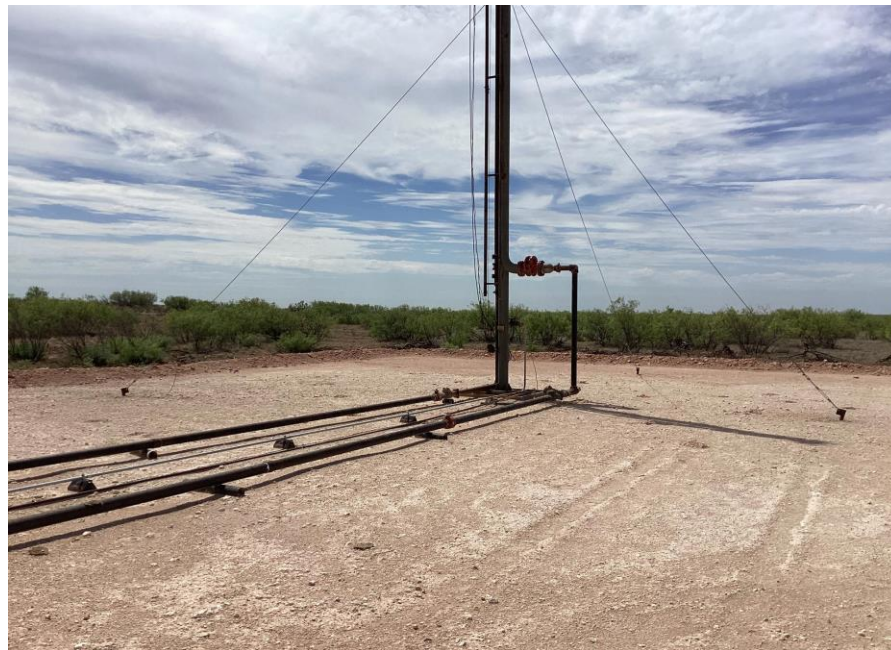
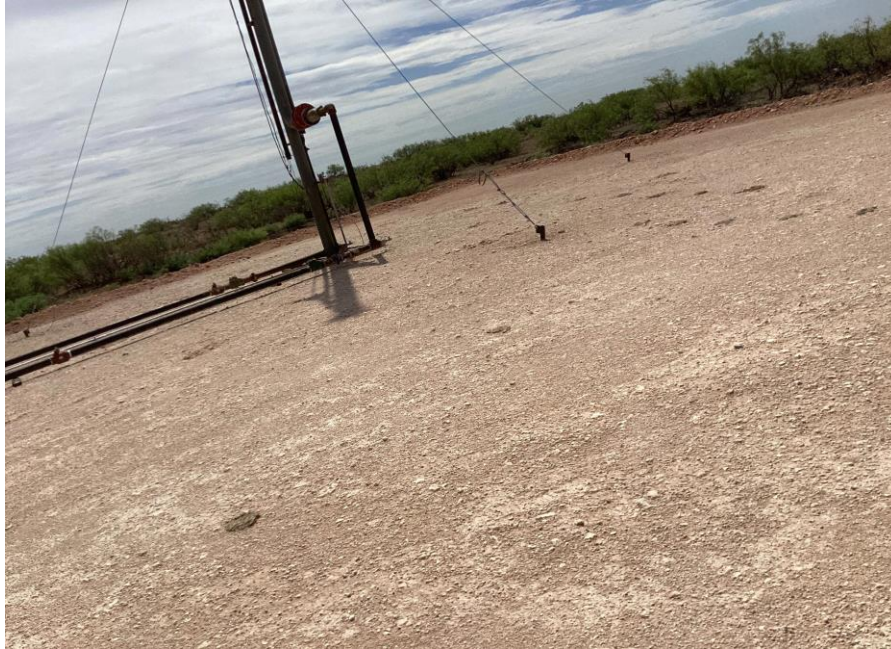
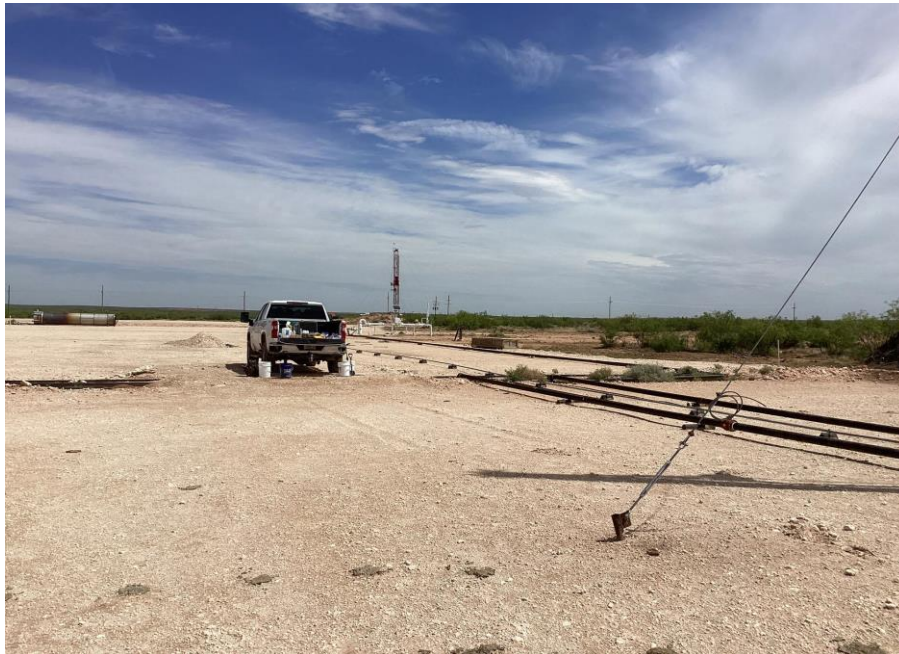
Photographic Log

On Monday June 26th, Charger Services conducted an initial site assessment. During a second site assessment, on Tuesday August 8th, four 5pt. composite samples were collected at 0-6 inches and sent to Eurofins Lab in Midland Texas for confirmation testing.
