## **SITE RECLAMATION REPORT**

**3PD TO BLACK BUCK METER LAY FLAT LINE  
32.157556, -104.142566  
UNIT J, SECTION 01, T25S-R27E  
NMSLO LEASE ID# V057690001  
EDDY COUNY, NEW MEXICO  
INCIDENT # NAPP2514235896**

**RANGER REFERENCE #5375**

**AUGUST 27, 2025**

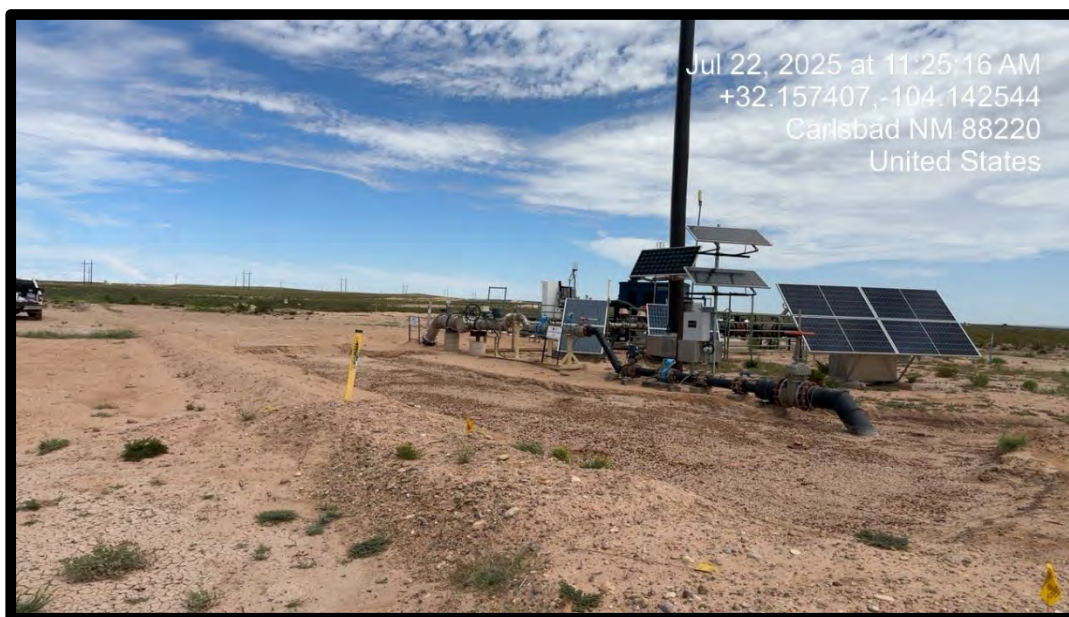
**PHOTOGRAPH NO. 1 – A view of the impact/remediation area upon completion. The view is towards the north.**

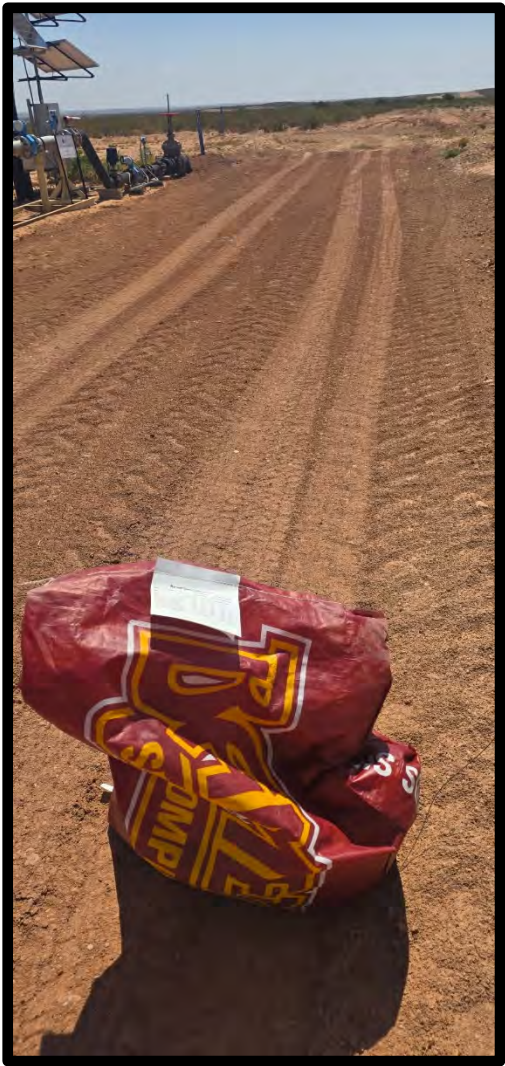
PHOTOGRAPH NO. 3 – A view of the site during the seeding activities. The view is towards the southeast.

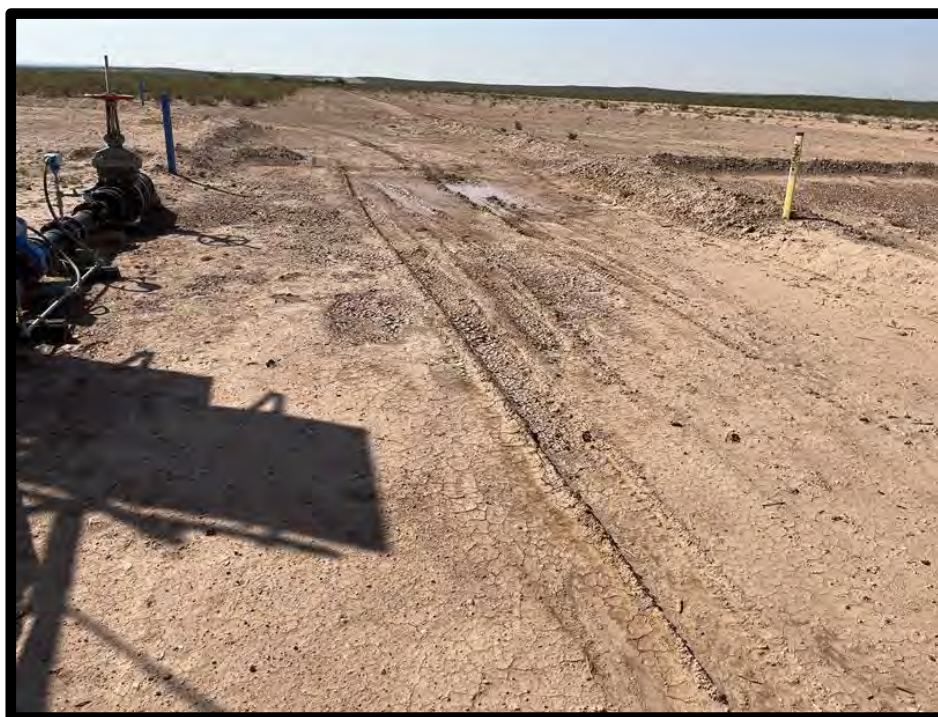
**PHOTOGRAPH NO. 1 – A view of the release area during an initial inspection. The view is towards the southeast.**

(Approximate GPS Coordinates: 32.157428, -104.142583)

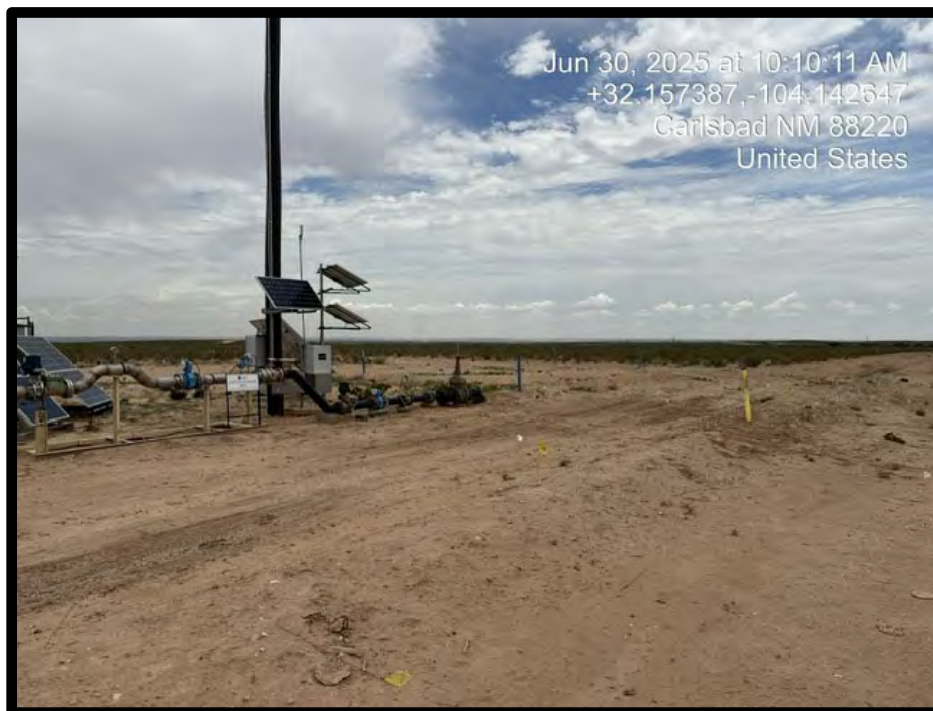
**PHOTOGRAPH NO. 2 – A view of the Site during the June 30, 2025 site assessment activities. The view is towards the northeast.**

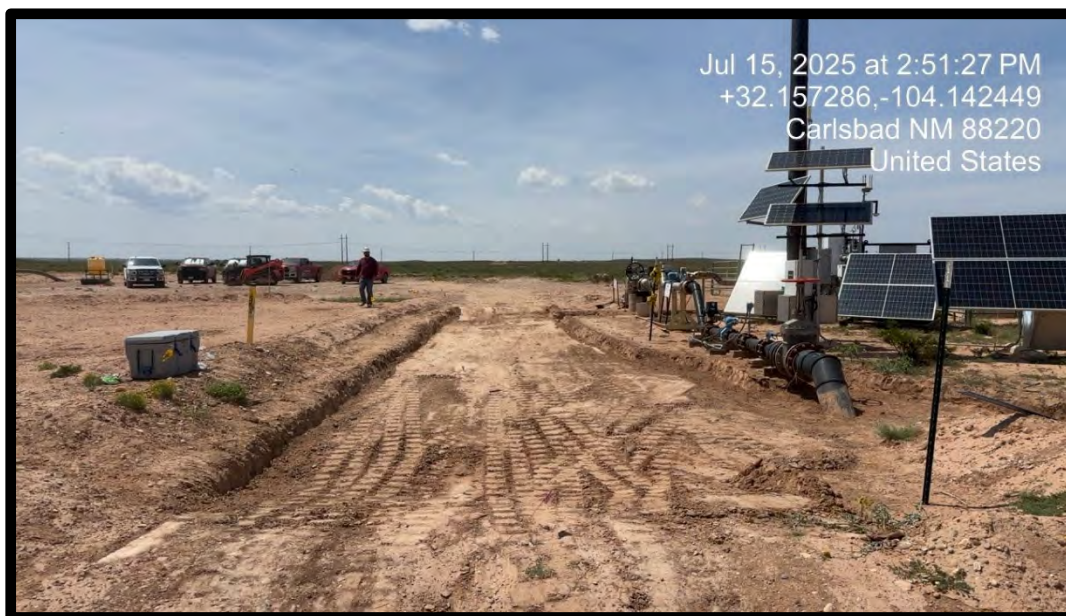
**PHOTOGRAPH NO. 3 – A view of the Site during the remediation process. The view is towards the northwest.**

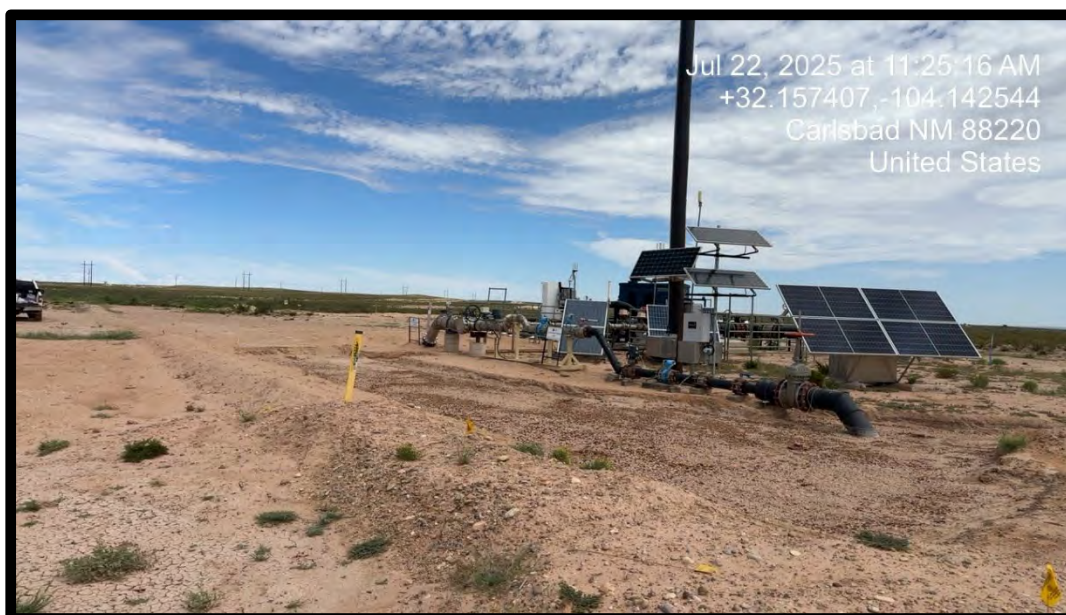
**PHOTOGRAPH NO. 4 – An additional view of the Site upon completion. The view is towards the north.**

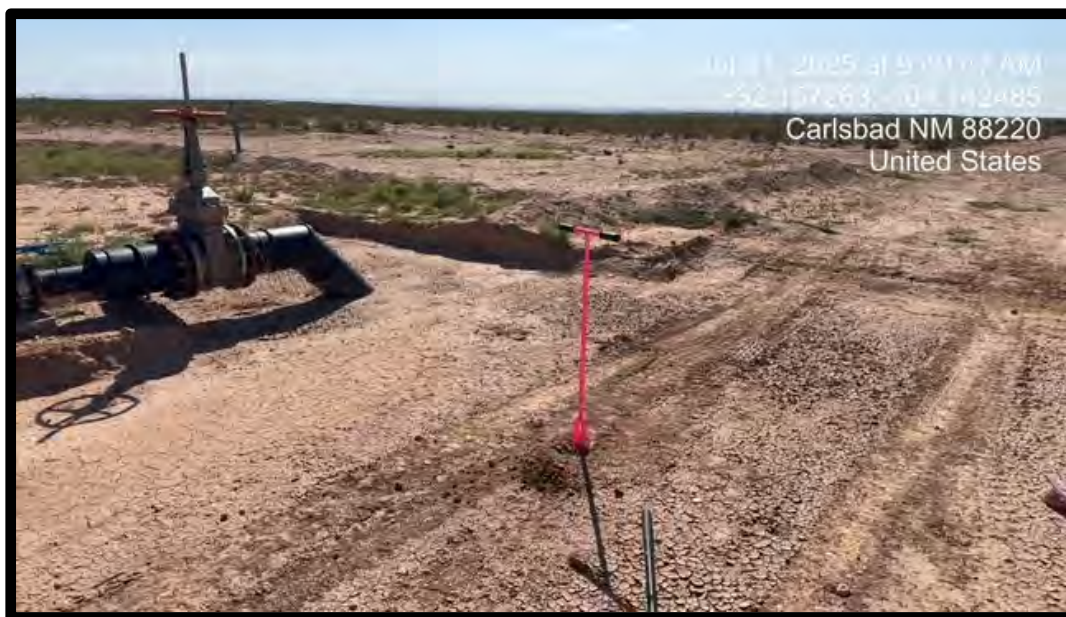
**PHOTOGRAPH NO. 5 – A view of the additional assessment sampling activities on July 31, 2025. The view is towards the southeast.**
