VACUUM ABO UNIT #010

nJXK1519752626

PREPARED BY SAPEC-ECO, LLC.
PREPARED FOR MAVERICK PERMIAN, LLC.

Proposed Sampling and Remediation Work Plan

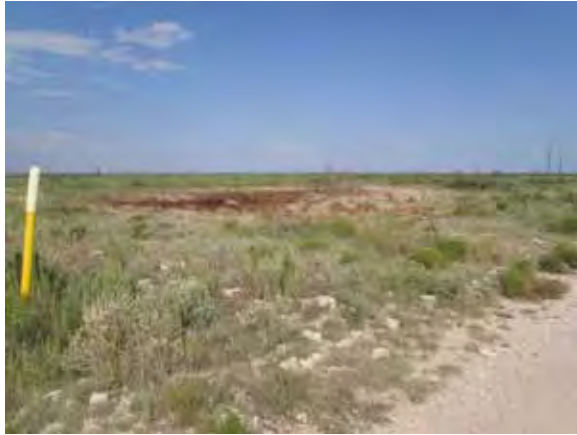
On July 30, 2015, Basin Environmental Service Technologies (Basin) personnel were on site to assess the release. The release was mapped and photographed.

Initial release facing west 7/30/15

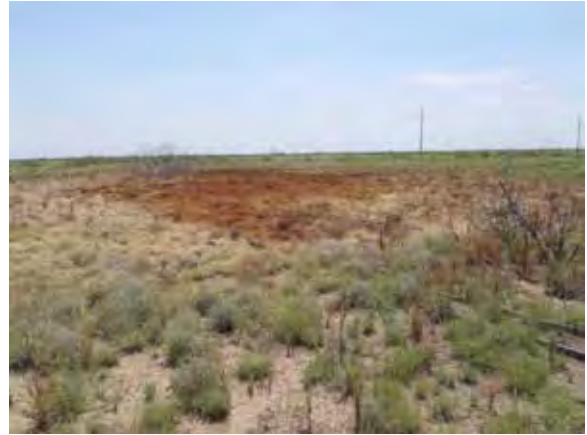
Initial release facing east 7/30/15

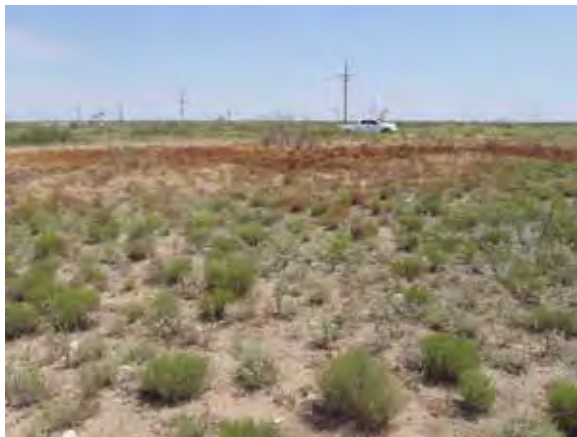
Initial release facing north 7/30/15

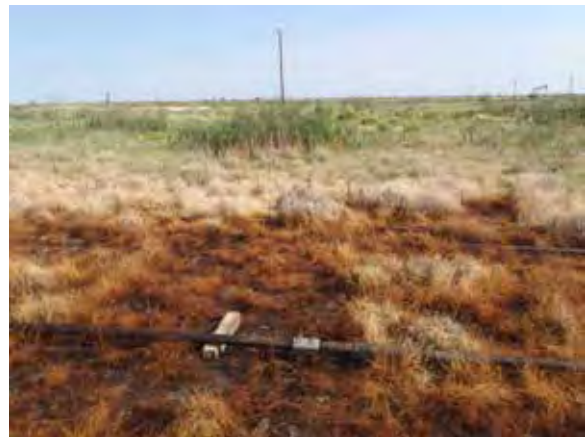
Initial release facing north west 7/30/15

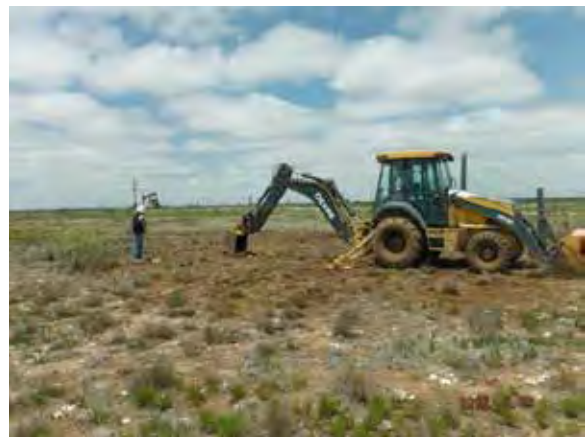
On May 19, 2016, Basin personnel returned to the Site and installed two (2) vertical sample points within the release area. Samples were collected from various depths ranging from surface to 3 feet bgs. The samples were field tested for chlorides and for organic vapors with a PID meter. Representative samples were sent to Cardinal Laboratories for official analysis. Basin completed a Corrective Action Plan that was submitted to the NMOCD on May 23, 2016. The plan was approved by the NMOCD the same day. This plan can be found in the Incident Files link on the OCD Permitting page for this incident. It is also included for reference as Appendix E.

Excavating vertical 2 facing north west 5/19/16
