**Re: Deferral Request  
BEU DI 29 Pad  
Incident Number nAPP2434828618  
Lea County, New Mexico**

Ensolum, LLC (Ensolum), on behalf of XTO Energy, Inc. (XTO), has prepared the following *Deferral Request* for the BEU DI 29 Pad (Site). This *Deferral Request* includes the additional information requested in a denial by the New Mexico Oil Conservation Division (NMOCD) of a previously submitted Deferral Request, submitted on March 10, 2025. In the denial, NMOCD expressed concern that the potential medium potential karst designation of the Site posed an imminent risk to groundwater. As such, NMOCD requested a karst survey and an evaluation of the soil type and review of safe excavation distances. XTO is providing the additional information requested by NMOCD and, after evaluation of that information, requesting no further action for Incident Number nAPP2434828618.

XTO Energy, Inc  
Deferral Request  
BEU DI 29 Pad

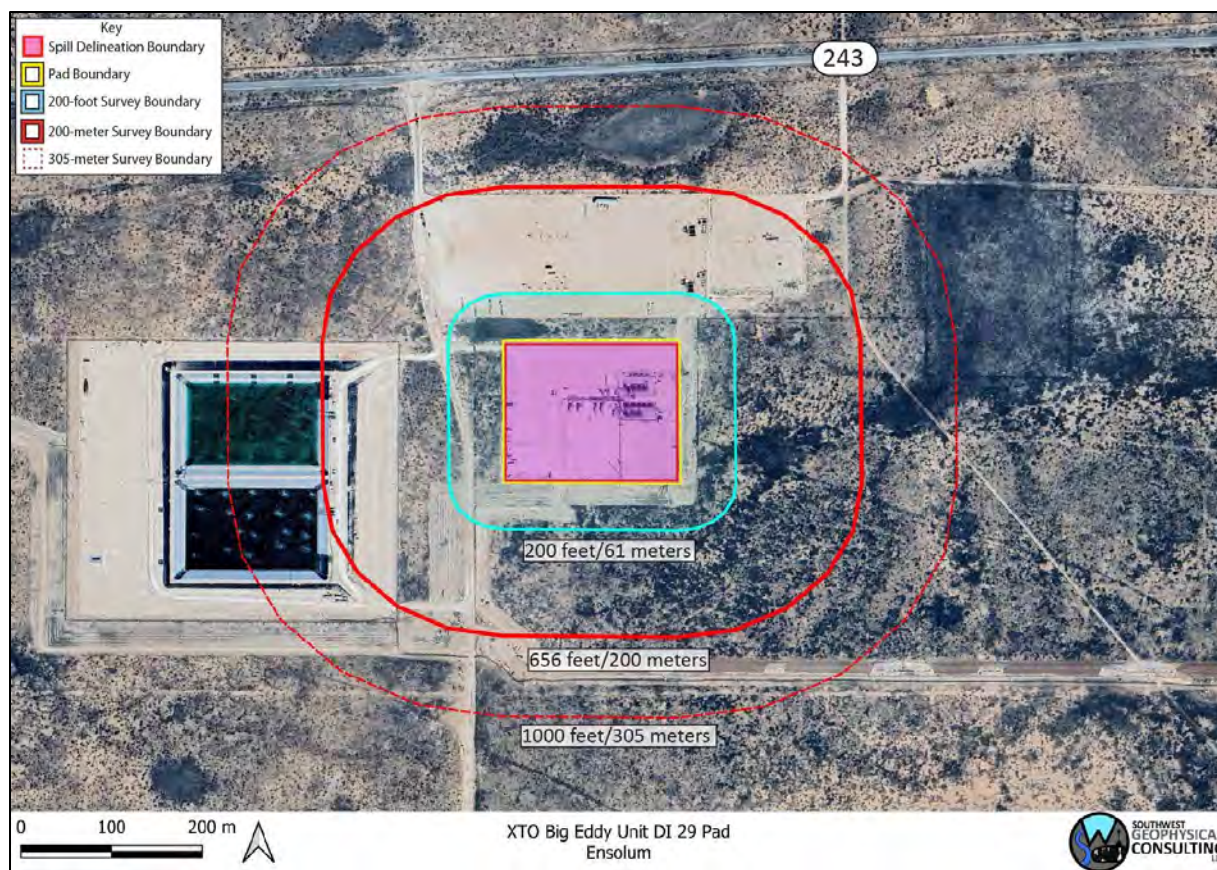
Surface karst surveys are conducted by sUAS at low elevation within 200 meters of the spill delineation boundary<sup>[3]</sup> (**Figure 4**) following a preplanned raster pattern flightpath designed for the purpose of generating at least 75% imagery overlap. The collected high-resolution, georeferenced imagery is stitched together to develop orthomosaic imagery which is further developed into a digital elevation model (DEM); the DEM is then processed into a local relief model (LRM) (**Figure 6**). This LRM is color coded to enhance differences in elevation of as little as five centimeters. The orthoimagery, DEM, and LRM are uploaded to a server where they are analyzed by an experienced karst geologist. Finally, the data is reviewed by a senior karst geologist for quality assurance and downloaded into a table for inclusion in a written report<sup>[15]</sup>.

Figure 4: Surface survey overview. Background image credit: Google Earth. Image date: April 2, 2023. Datum: WGS-84.

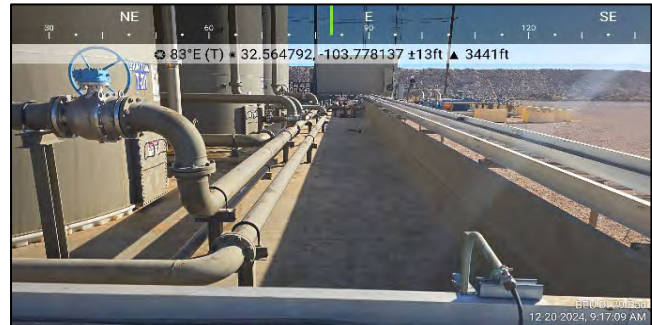
Photograph: 2  
Description: Liner inspection activities  
View: East

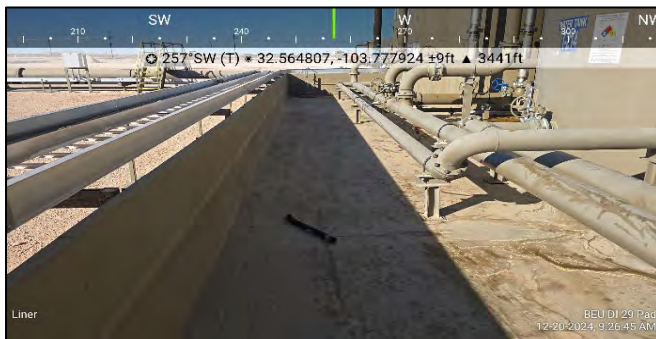
Photograph: 3  
Description: Liner inspection activities  
View: West

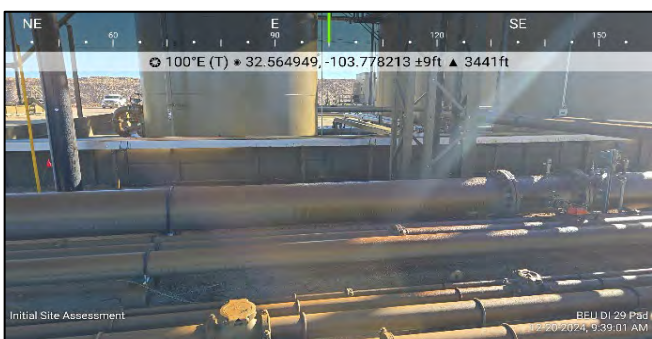
Photograph: 4  
Description: Overspray area  
View: East

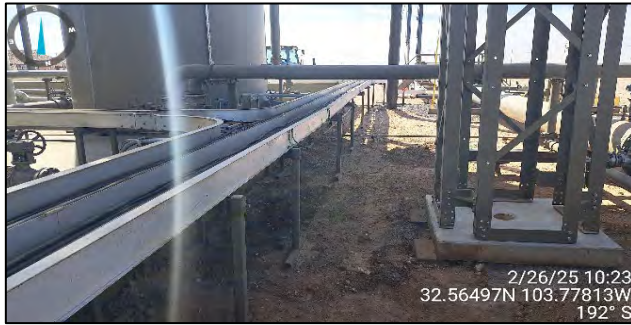
Photograph: 5                      Date: 2/26/2025  
Description: Surface scrape and delineation activities  
View: South

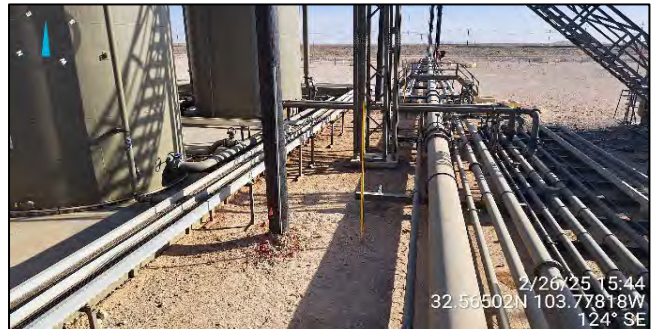
Photograph: 6                      Date: 2/26/2025  
Description: Surface scrape and delineation activities  
View: Southeast

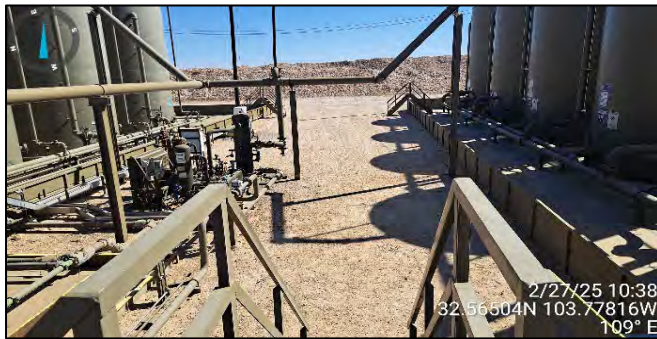
Photograph: 7                      Date: 2/27/2025  
Description: Surface scrape and delineation activities  
View: East
