RE: Site Assessment – Liner Inspection Summary
Newman Cosmo Battery
Incident No. nAPP2522026499
Tasman Project No. 8999
UL “G”, Sec. 33, Township 24 South, Range 35 East, Lea County, New Mexico

Site Location & Groundwater
Map

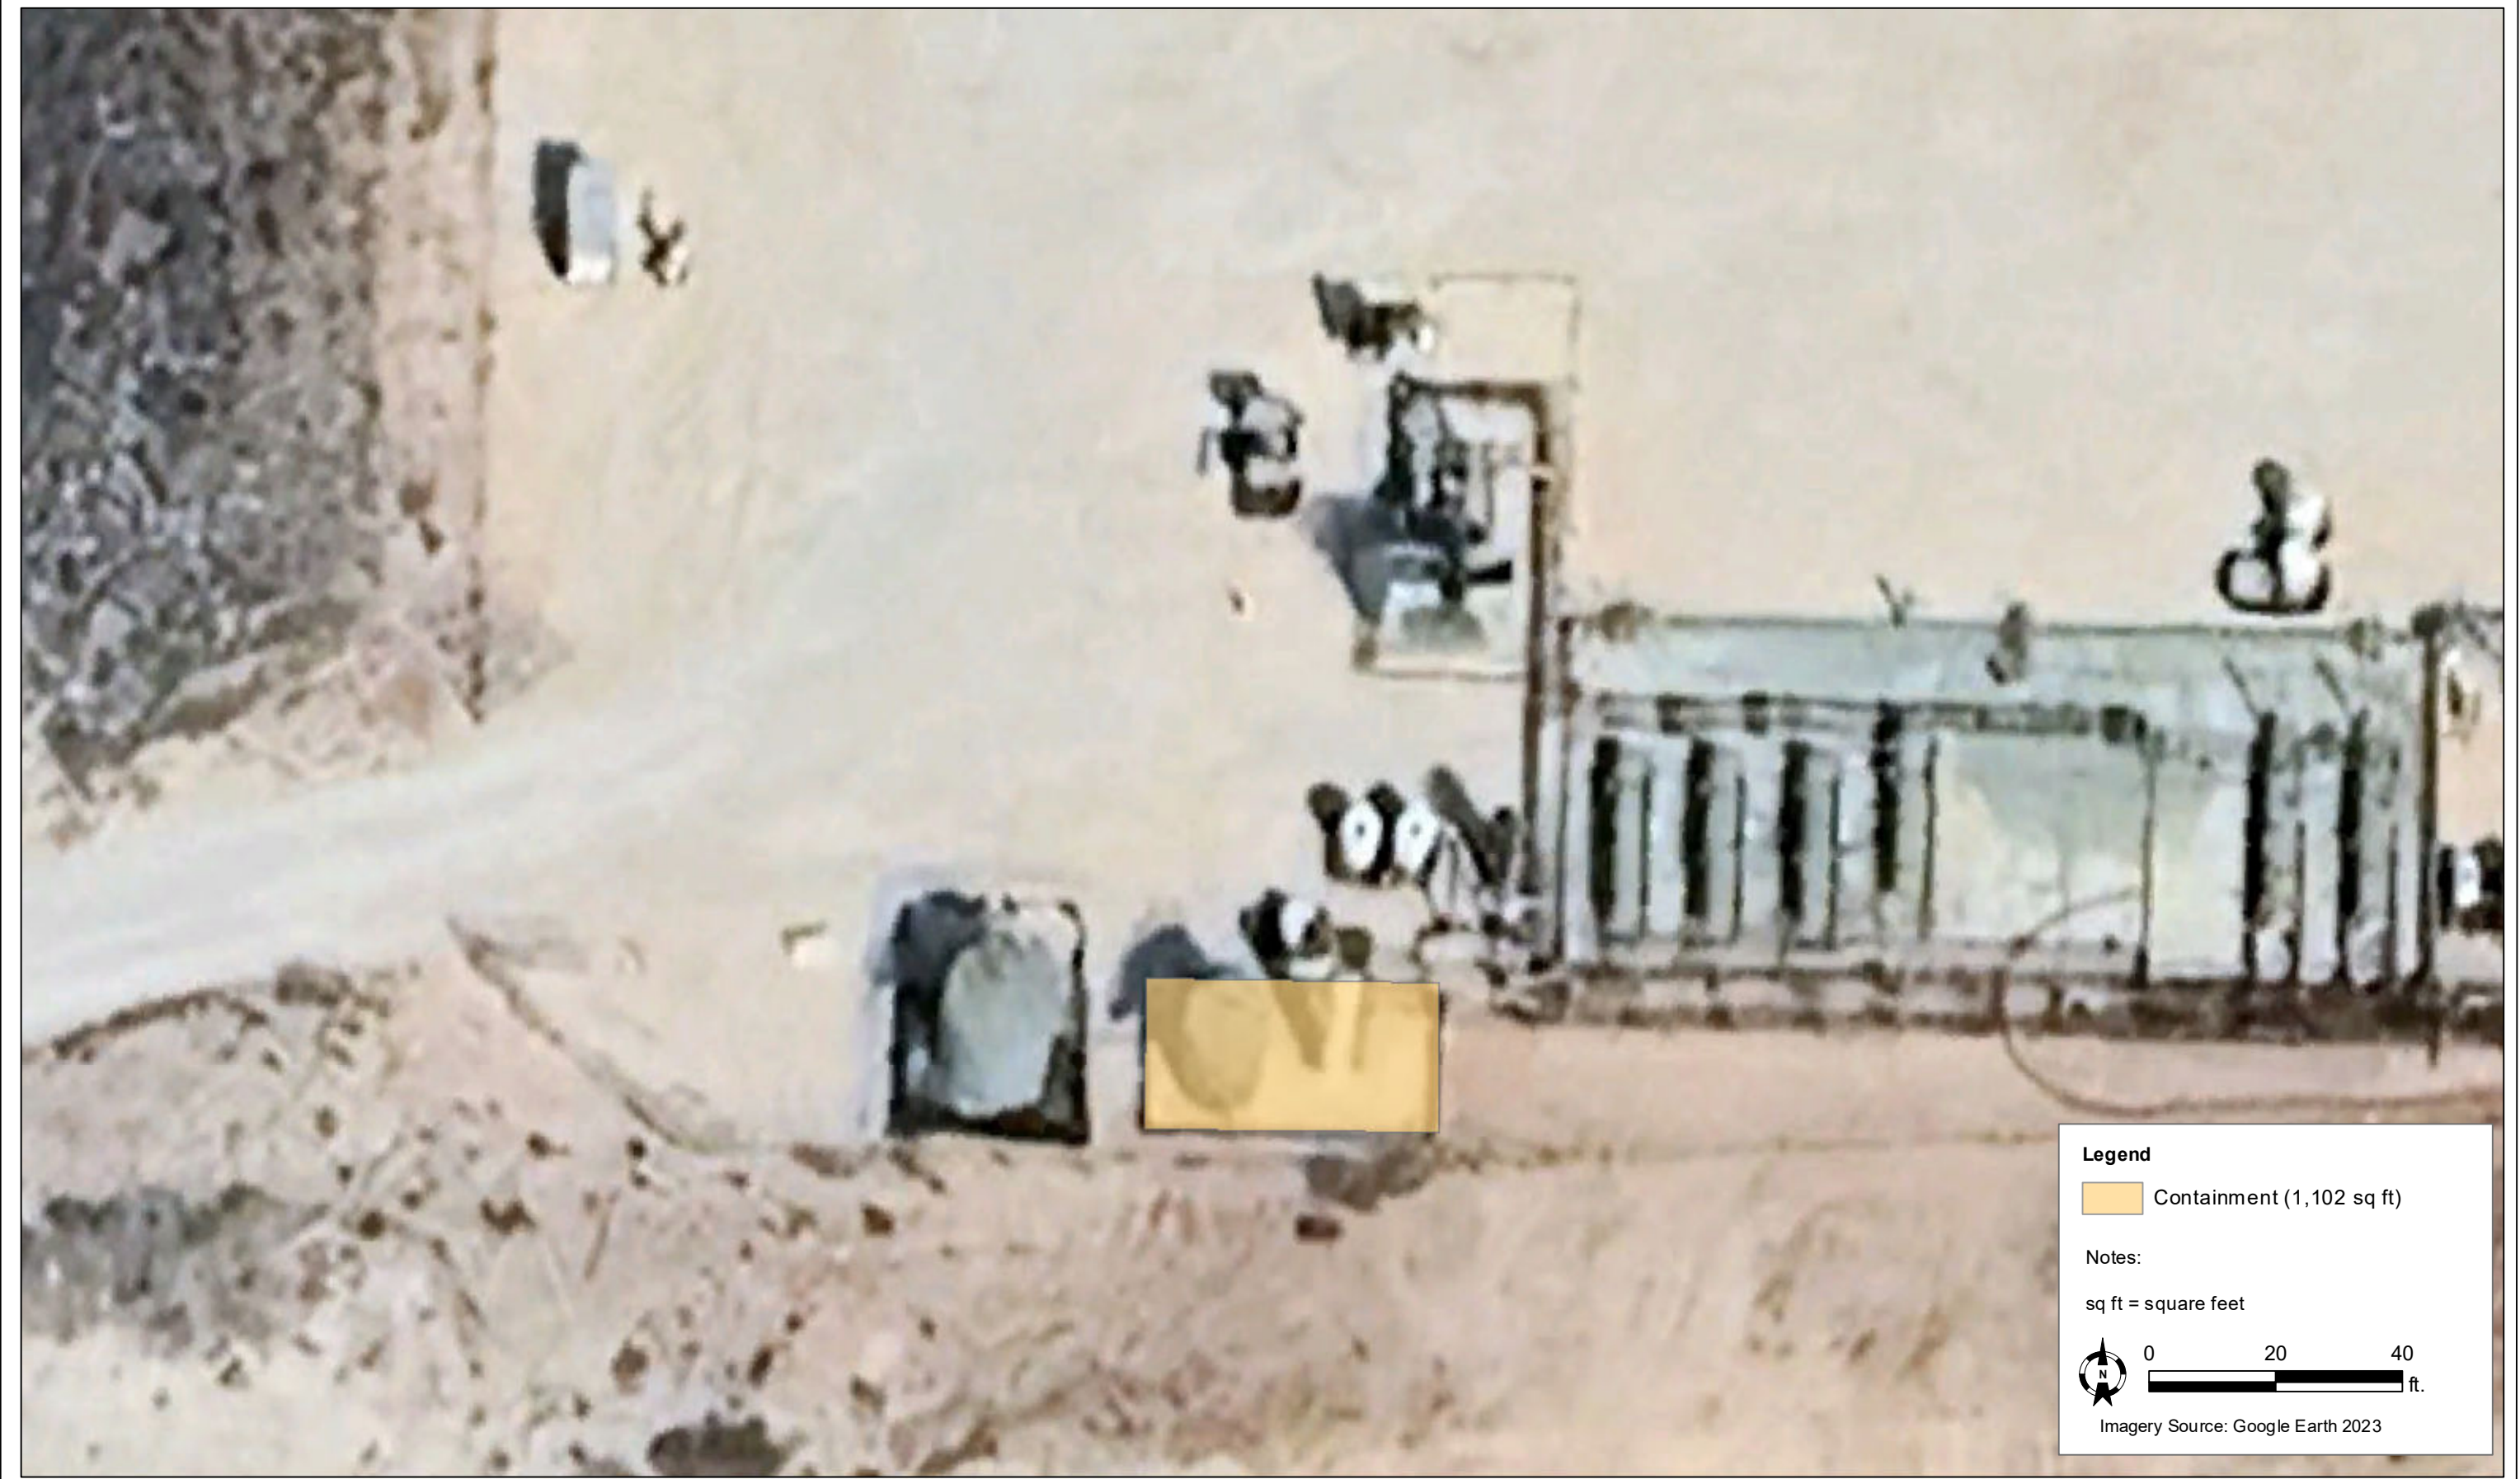
Figure 5

On August 13, 2025, Tasman personnel conducted site evaluation of the release extent based on the information provided on Form C-141. A site assessment and liner inspection were conducted of the lined containment. Assessment and observation of the site confirmed no visible staining or releases outside of the lined containment. During inspection of the liner, no visible tears or other damage were observed. Photographic documentation from the liner inspection is provided in Appendix B, and overview of the containment in figure 5.

Site Overview Map

Based on the information provided herein, the release was entirely contained within the lined containment, and the liner integrity is sound. Tasman recommends that no further action be taken regarding the release of produced water at the site.
