Incident Number: nAPP2517841727

## Release Assessment and Closure

Big Eddy Unit DI 9 Tank Battery

ExxonMobil Upstream Company

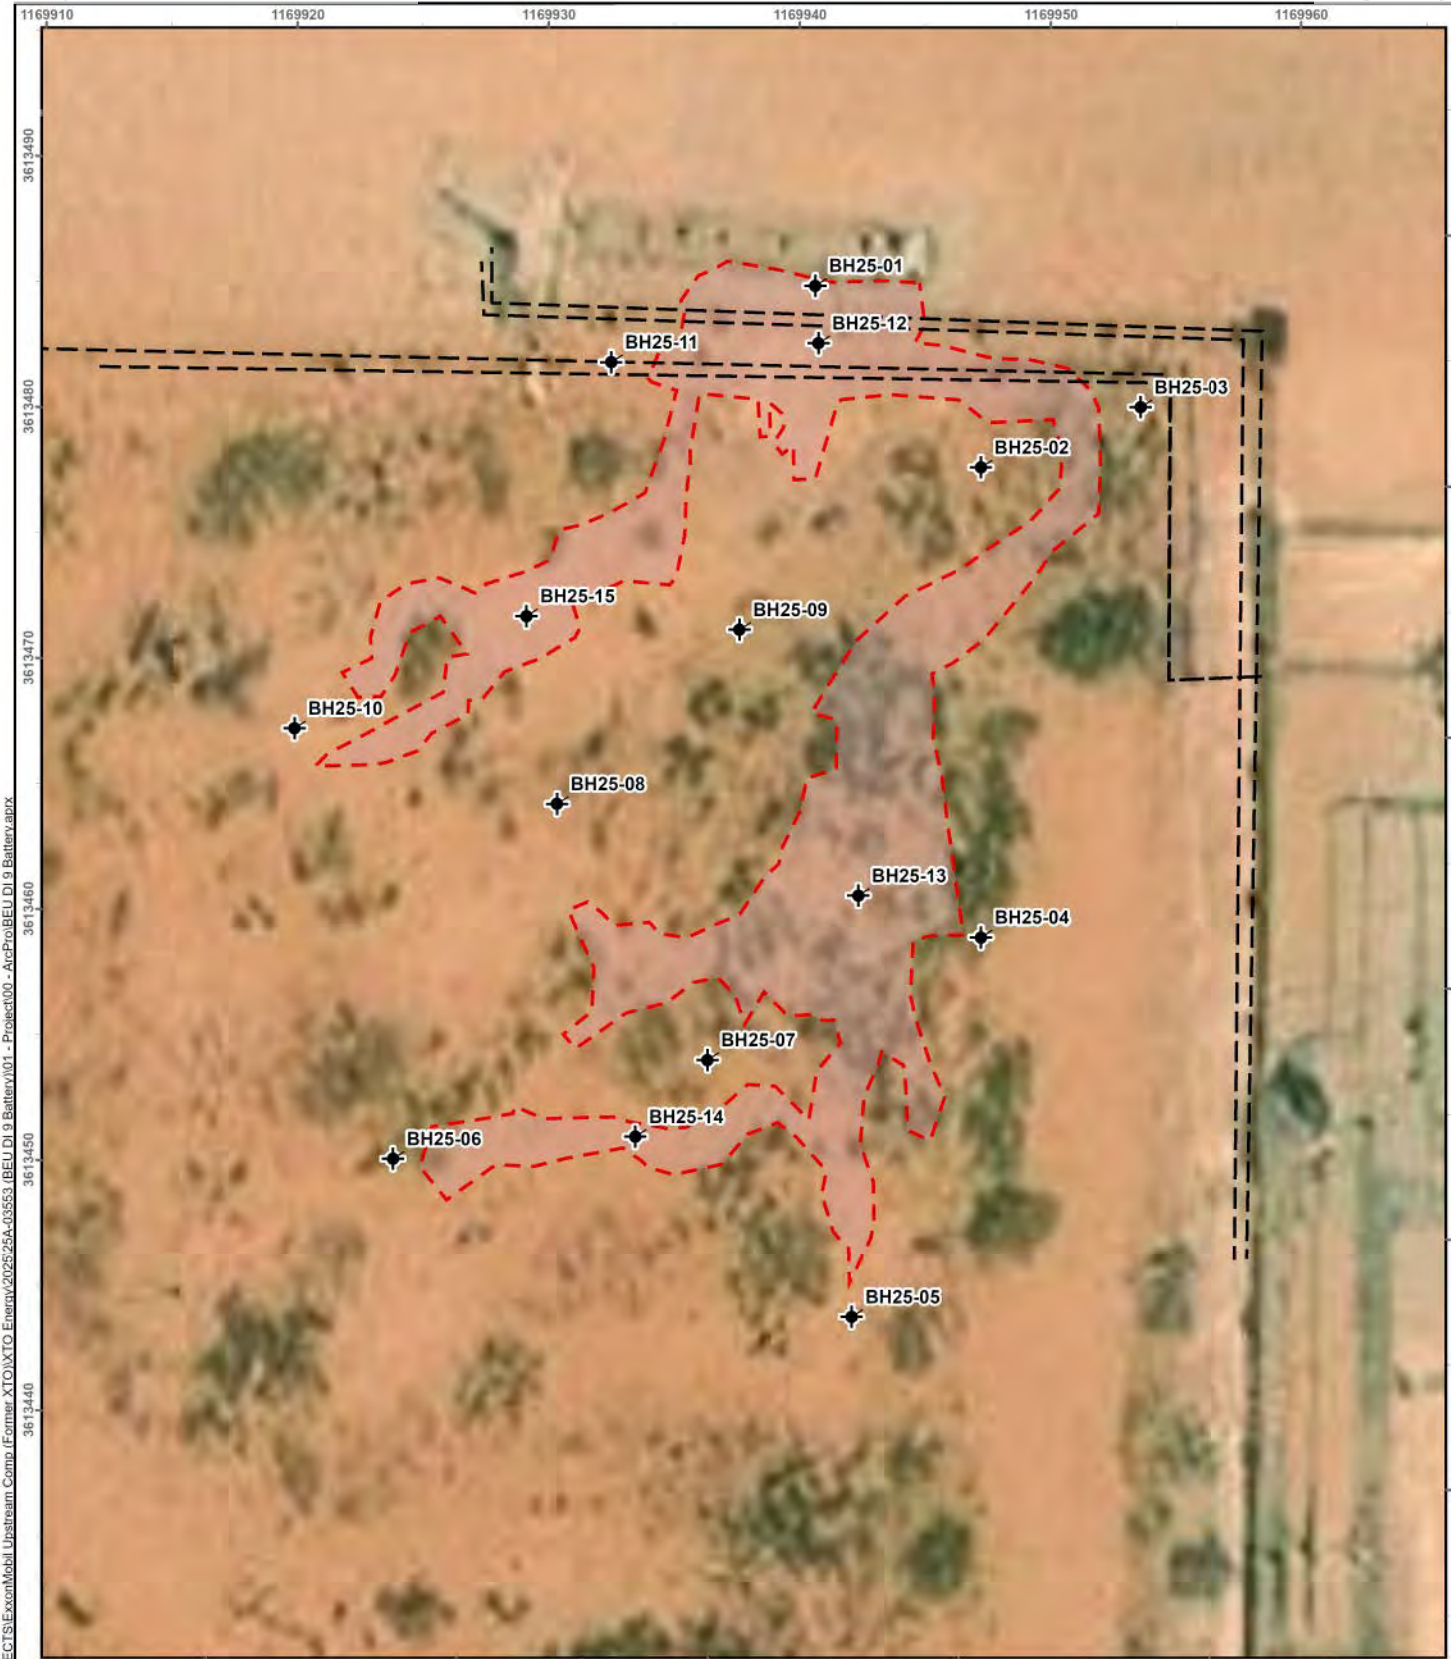
- ✦ Borehole
- Pipeline (Aboveground)
- Release Extent (~3,327 sq.ft. | 852 ft.)

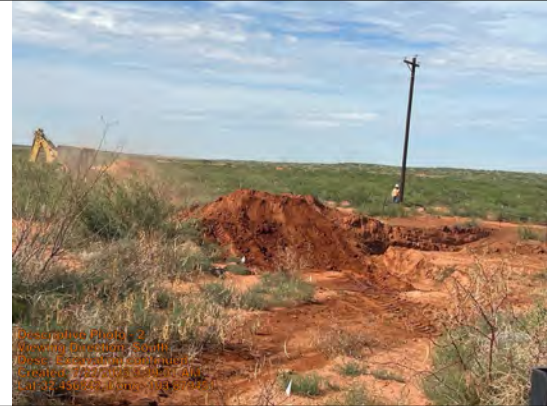
Contaminated material placed on plastic liner

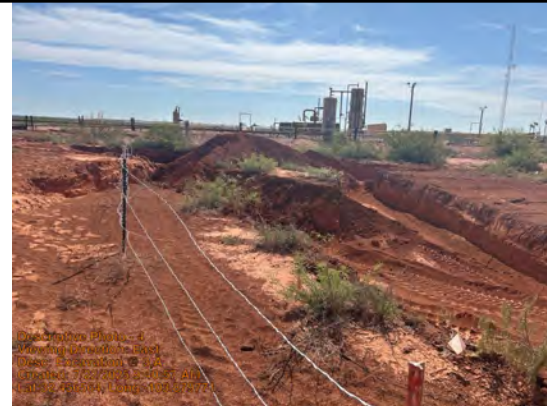
Hydrovacing continued @ 3'

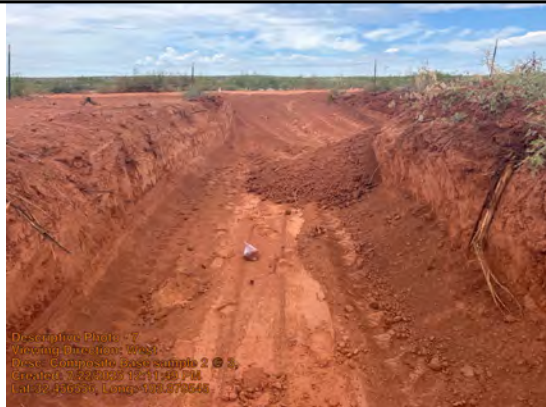
Composite Base sample 1 @ 3'

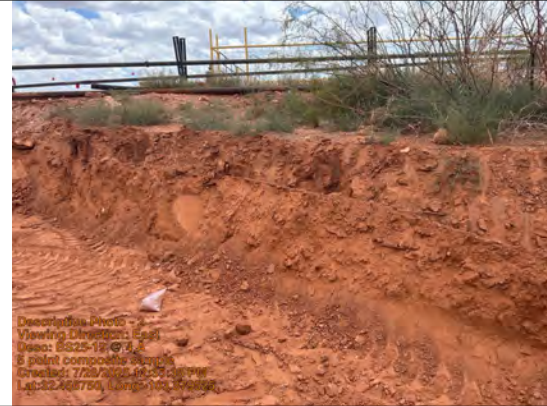
BS25-18 @ 4'  
5 point composite sample

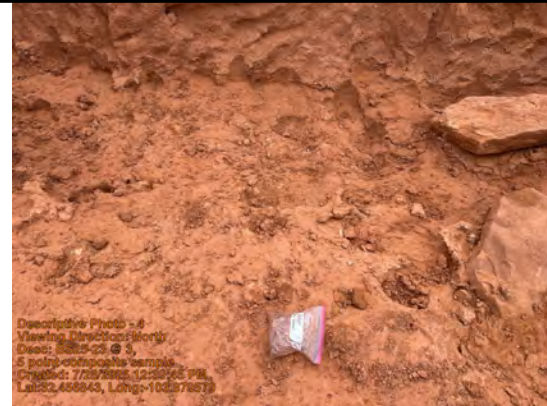
BS25-22 @ 3'  
5 point composite sample

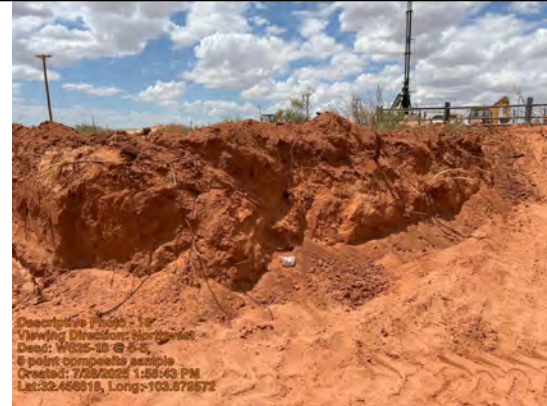
WS25-09 @ 0-5'  
5 point composite sample

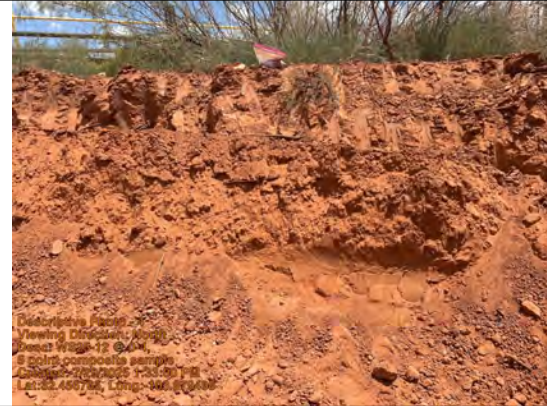
WS25-11 @ 0-4'  
5 point composite sample

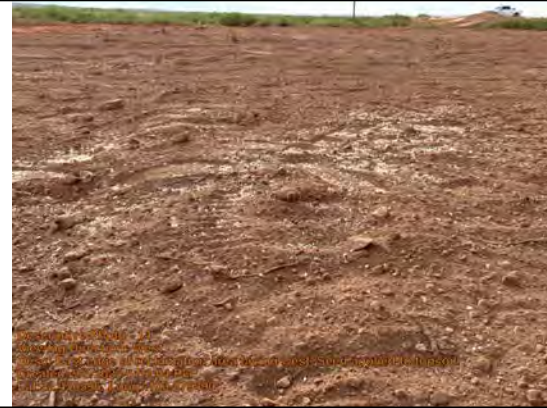
East edge of reclamation area facing west.  
Seed applied to topsoil.

Surface reclamation included determination of background topsoil depth as site conditions are required to meet pre-existing conditions. Reclamation of the location was completed after backfilling operations. Clean, locally sourced topsoil and caliche was imported to the site to backfill the excavation. The pasture areas were fenced with a 4-strand barbed wire fence.
