**Re: Site Assessment and Closure Report**  
**Newcastle 6 Fed Com TB**  
**GPS: Latitude 32.85883 Longitude -104.01932**  
**UL "M", Sec. 06, T17S, R30E**  
**Eddy County, NM**  
**NMOCD Ref. No. NAPP2514029296**

Paragon Environmental, LLC (Paragon) has been contracted by Spur Energy Partners (Spur) to perform a spill assessment, conduct remediation activities, and prepare a closure report for the Newcastle 6 Fed Com TB (Newcastle) release site. Details of the release are summarized below:

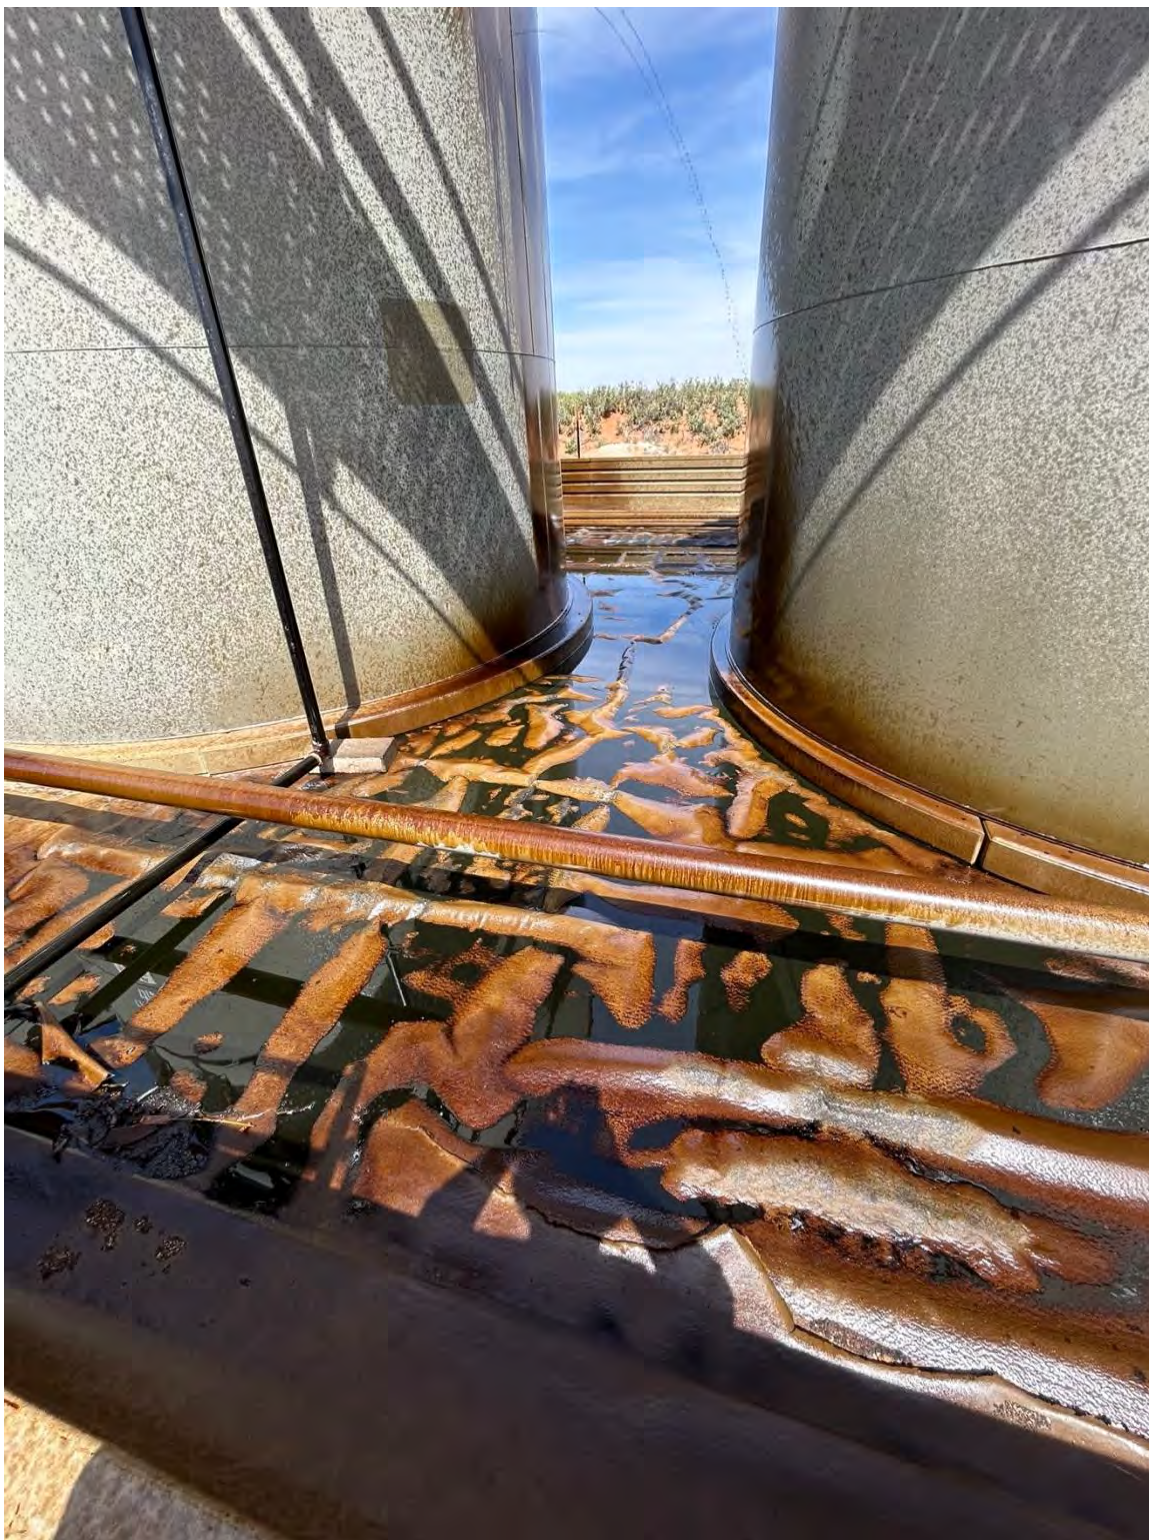
**Photographic Documentation  
Initial Pics**

| Release Details | | | |
|---|---|---|---|
| Corrosion of a tank weld caused oil to spill into the lined containment. | | | |

On May 19, 2025, Paragon visited the Newcastle and conducted an initial site assessment. During the initial site assessment, the liner and the surrounding location were visually inspected, and it was determined that the release had not breached the lined containment, and the liner's integrity was still intact.

The stained area measured approximately 680 s/f. We used a hand crew to spray the area with degreaser, followed by heated water to power wash the liner clean. A vac truck was on site, sucking up the fluids as the crew sprayed the liner down and used a squeegee to move the fluids to the vac truck.

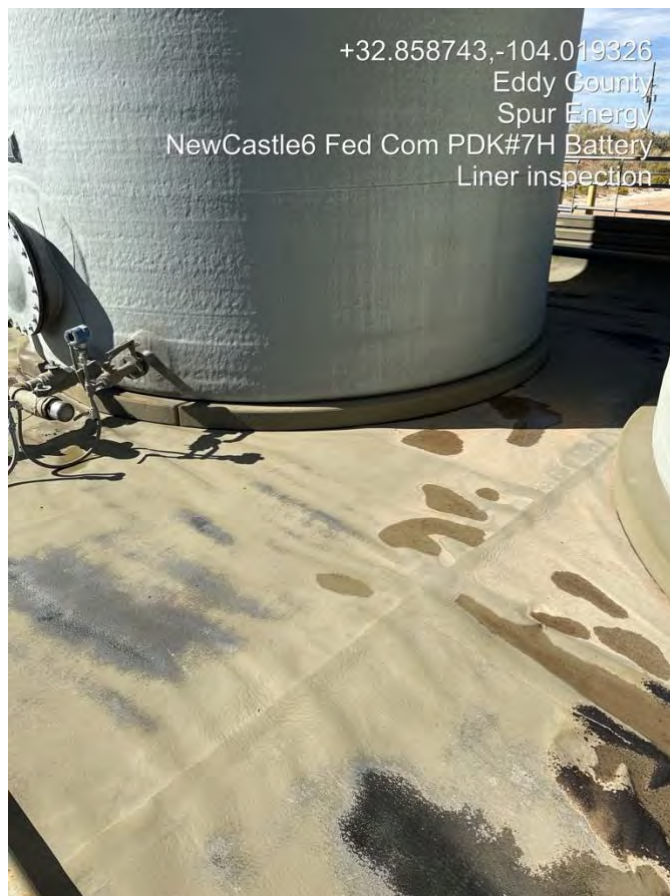
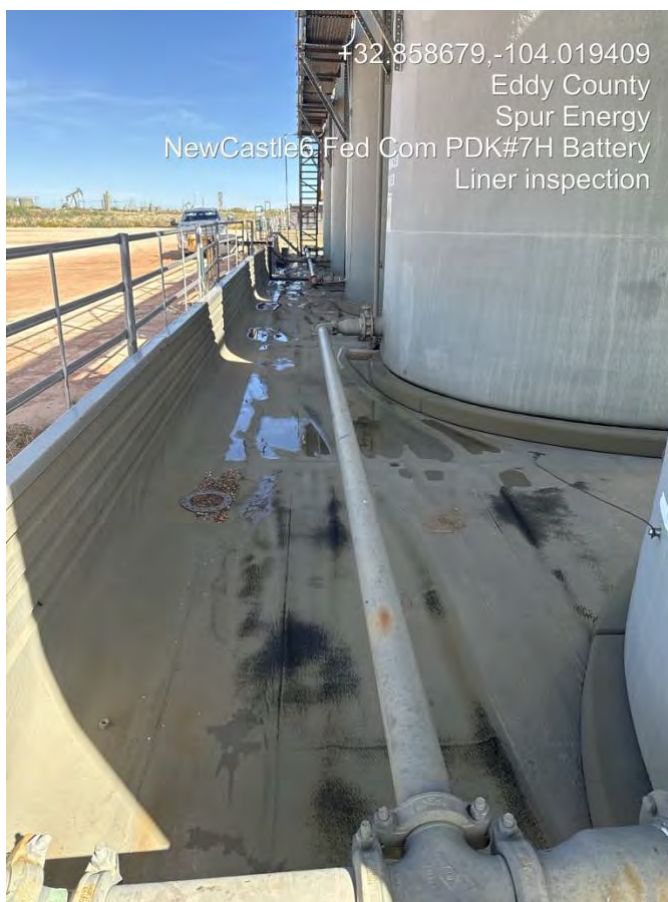
### Completed and Liner Inspection

| Visualization | Yes | No | Comments |
|---|---|---|---|
| Is there a tear in the liner? | | x | |
| Are there holes in the liner? | | x | |
| Is the liner retaining any fluids? | | x | |
| Does the liner have integrity to contain a leak? | x | | |

| Summarize any additional remediation activities not included by answers (above) | THE LINED CONTAINMENT WAS POWERWASHED AND INSPECTED AND FOUND TO HAVE THE ABILITY TO CONTAIN FLUIDS |
