RE: **Release Investigation and Remediation Action Report and Plan**  
PLU South Pond  
Unit J, Section 27, Township 25S, Range 30E  
32.097728°, -103.865422°  
Eddy County, New Mexico  
Terracon Project No. KH247047

Remediation Action Report  
PLU South Pond | Eddy County, New Mexico  
September 22, 2025 | Terracon Project No. KH247047

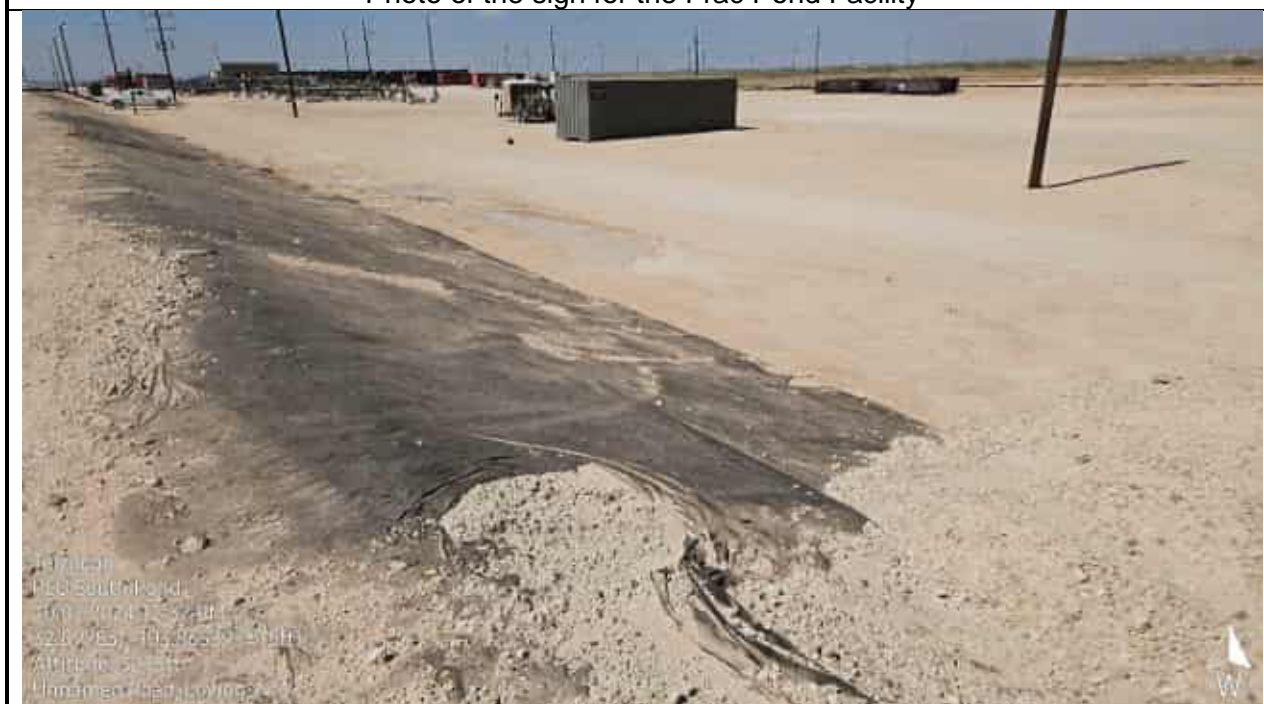
View of the release facing west from the top of the pond berm

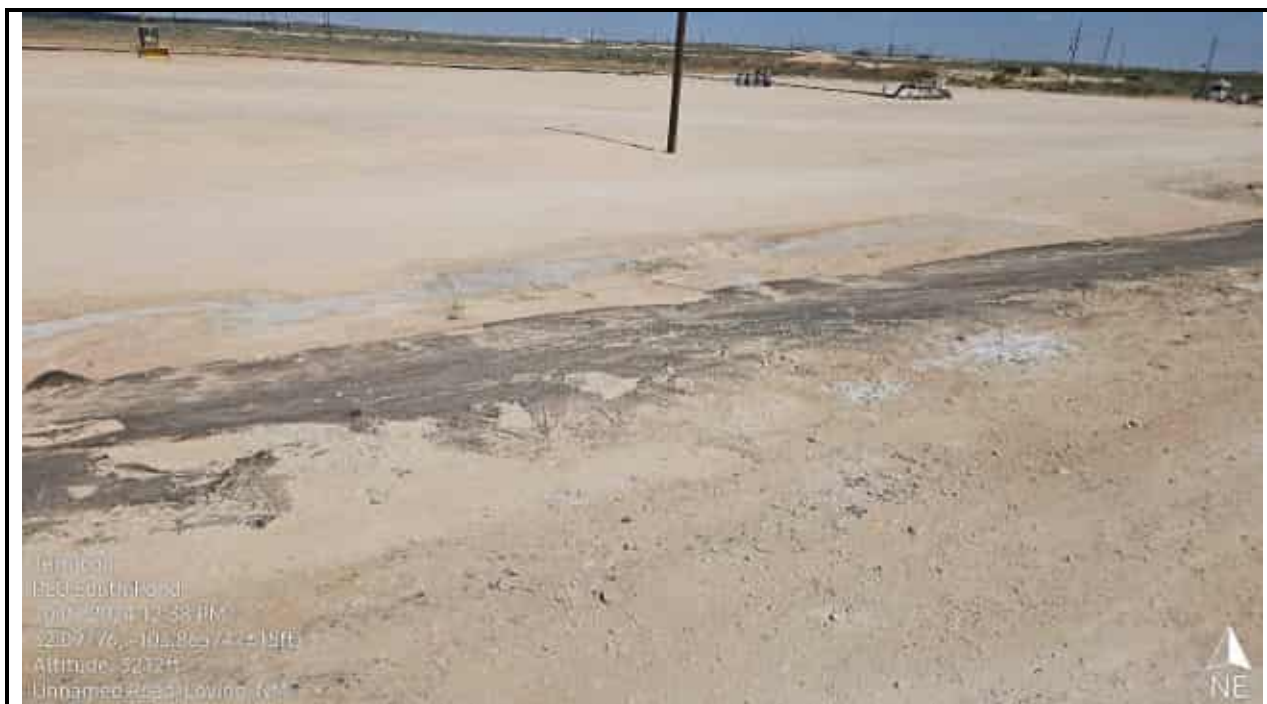
View of the release facing northeast from the top of the pond berm

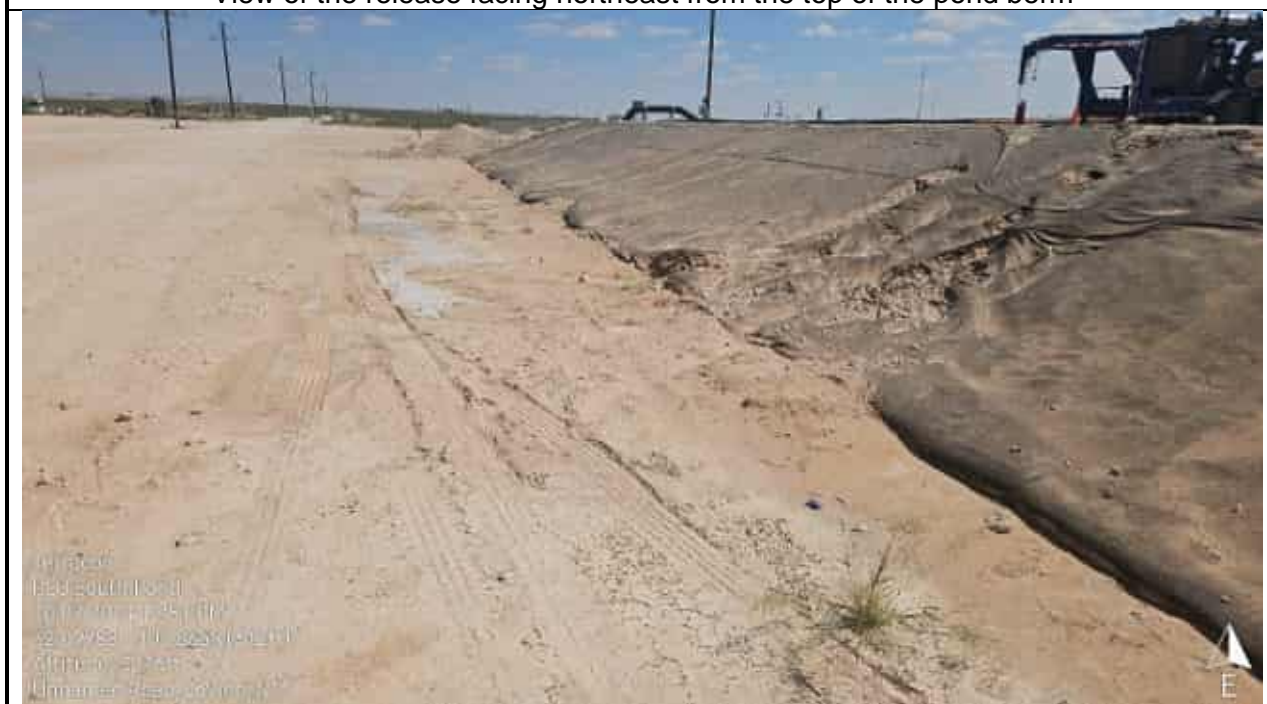
View of the release facing east

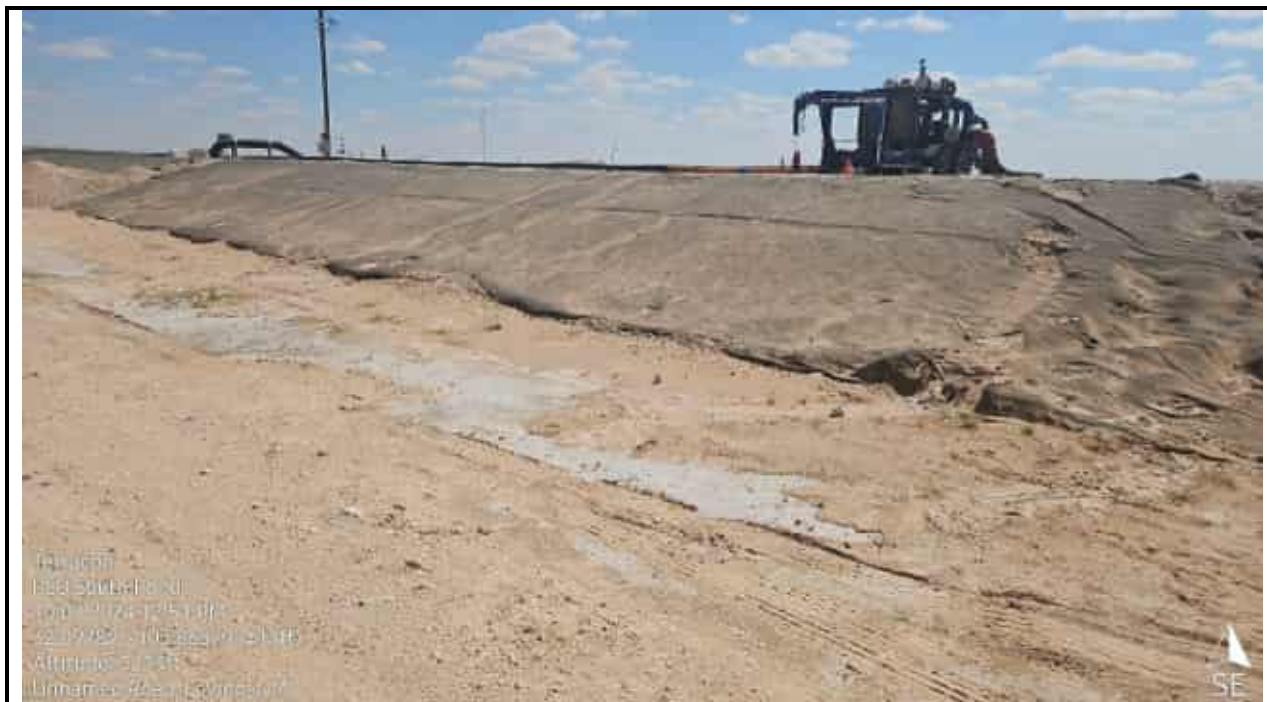
View of the release facing southeast

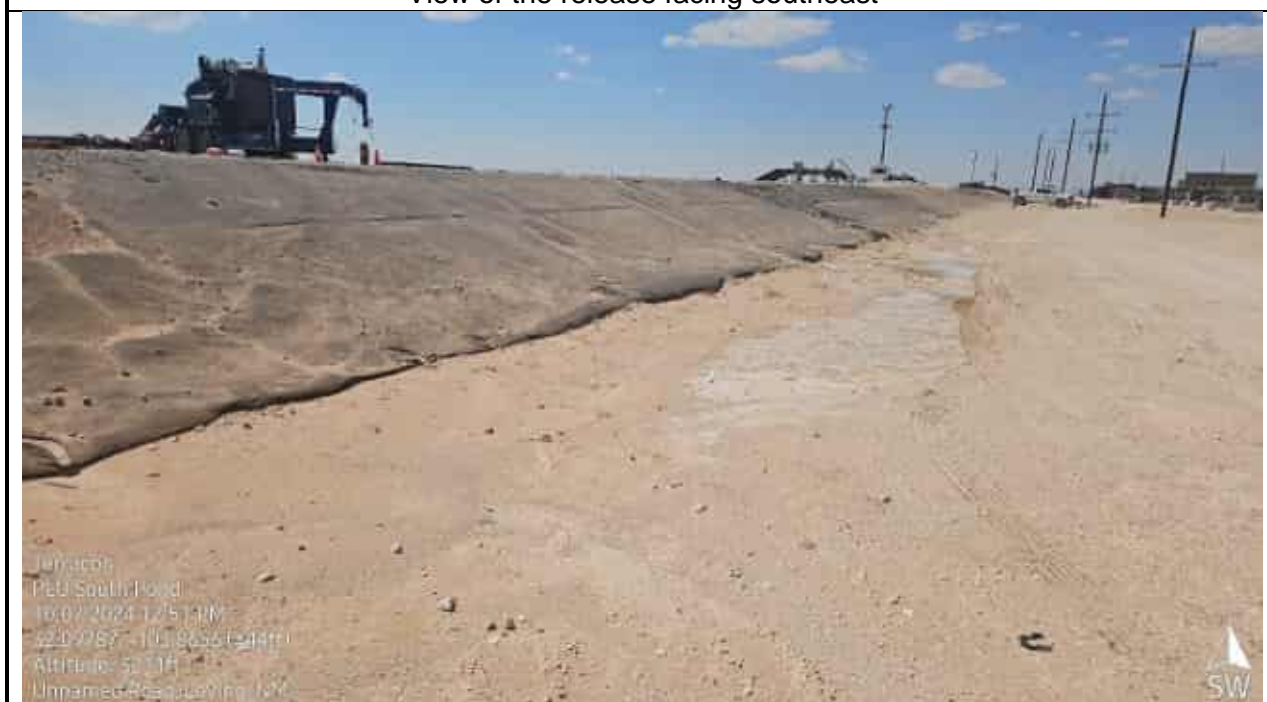
View of the release facing southwest

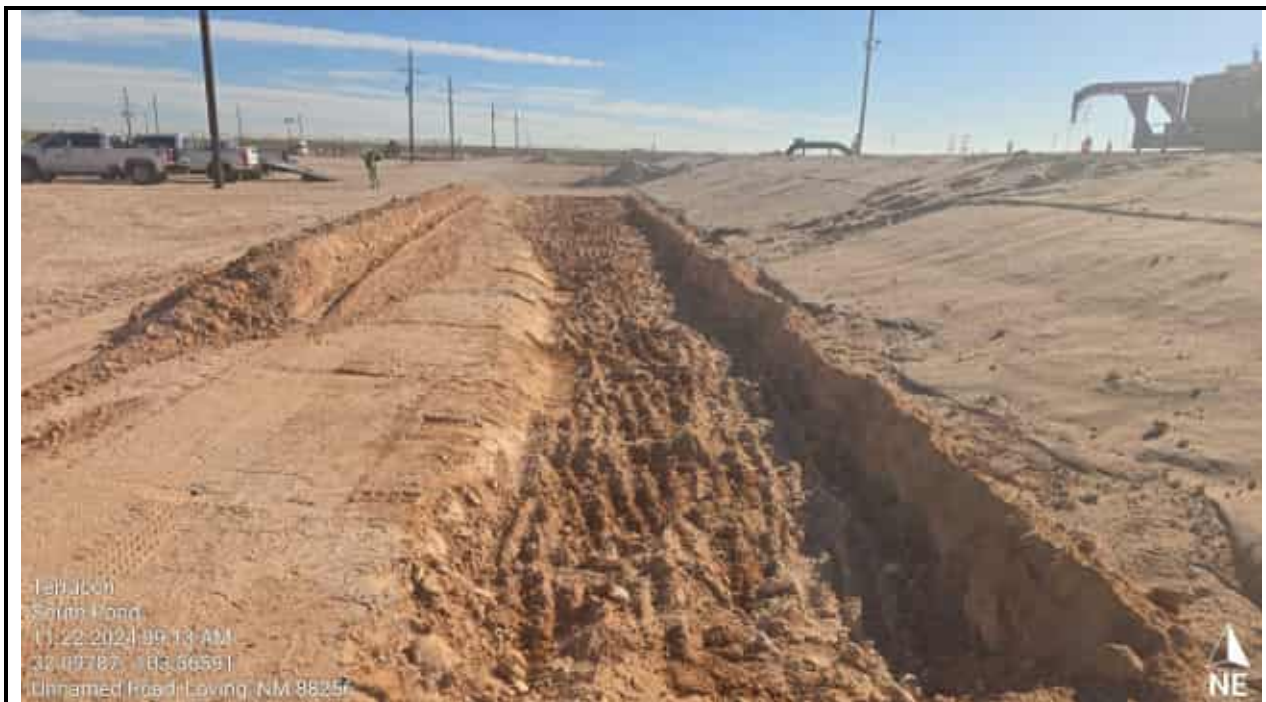
View of the excavated area where the release was facing northeast

A total of approximately 72 cubic yards (cu. yds.) of loose soil were excavated during remedial activities and 72 cu. yds. of that total came from the reclamation zone, being from surface to four feet below grade surface. Excavated material was stockpiled on-site atop a polyethylene liner pending disposal under an approved Form C-138. The excavated material was disposed of at R360 Red Bluff Facility. Soil disposal waste manifests are available upon request. Confirmation analytical results for Chlorides/BTEX/TPH are included in Appendix B, Table 2 and 3, respectively. Photographs of the project site are included in Appendix E. The analytical reports and Chain of Custody (COC) are included in Appendix F.
