Remediation Summary & Soil Closure Request

Mewbourne Oil Company Judge 3-4 Battery SWD Line

Eddy County, New Mexico
Unit Letter "I", Section 3, Township 20 South, Range 29 East
Latitude 32.6008946° North, Longitude 104.0573129° West
NMOCD Reference No. nAPP2517842157

September 11, 2025

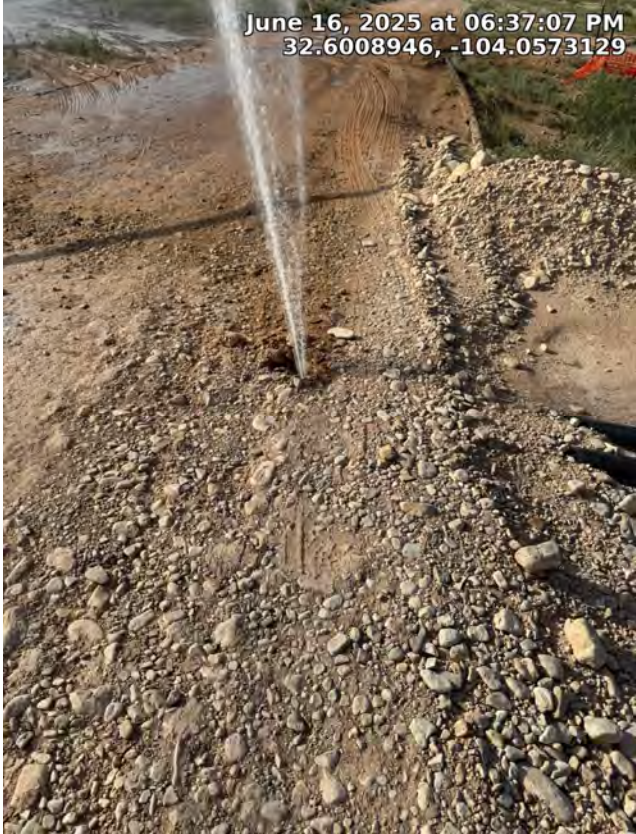
Photo Number: 1

Photo Direction: North	
Photo Description: Release point.

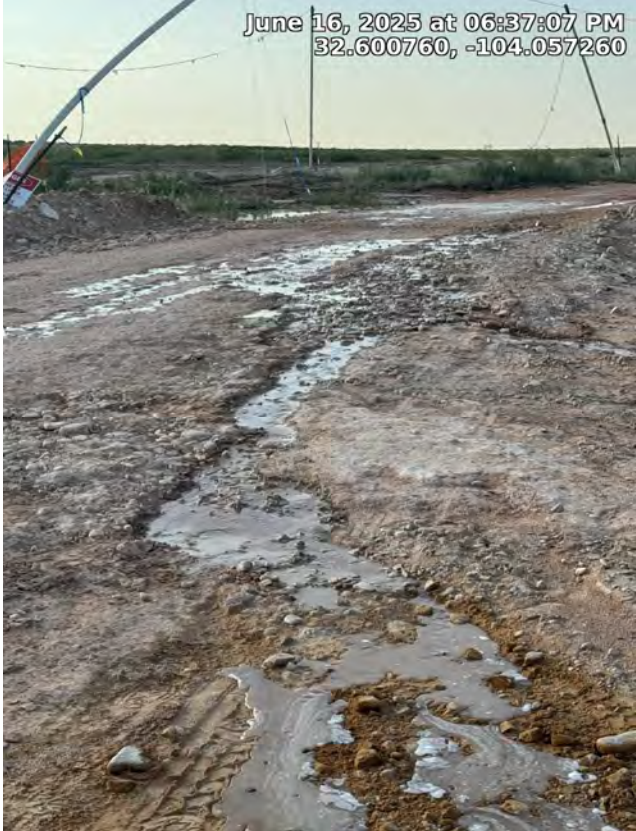
Photo Number: 2

Photo Direction: North-Northwest	
Photo Description: View of the affected area.

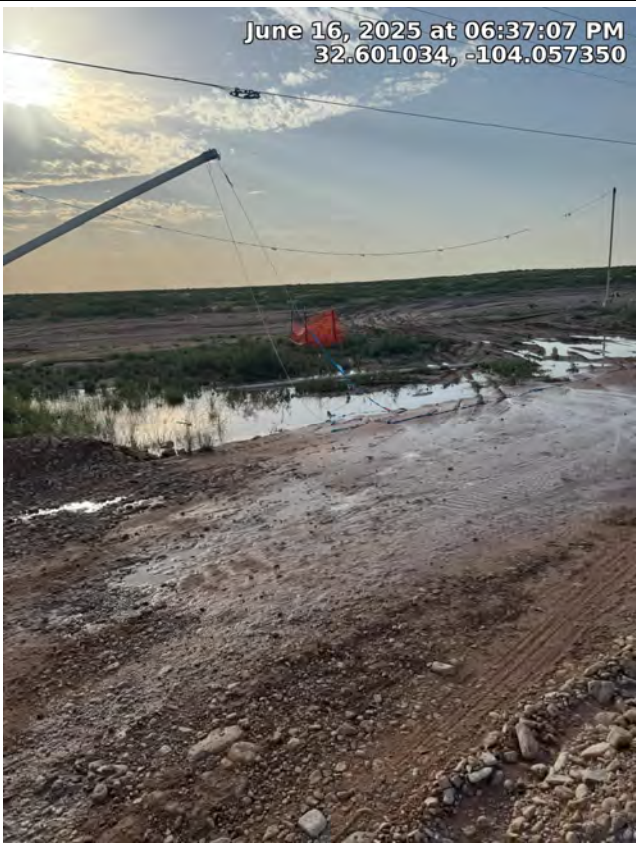
Photo Number: 3

<p>June 16, 2025 at 06:37:07 PM 32.601034, -104.057350</p>
Photo Direction: Northwest	
Photo Description: View of the affected area.

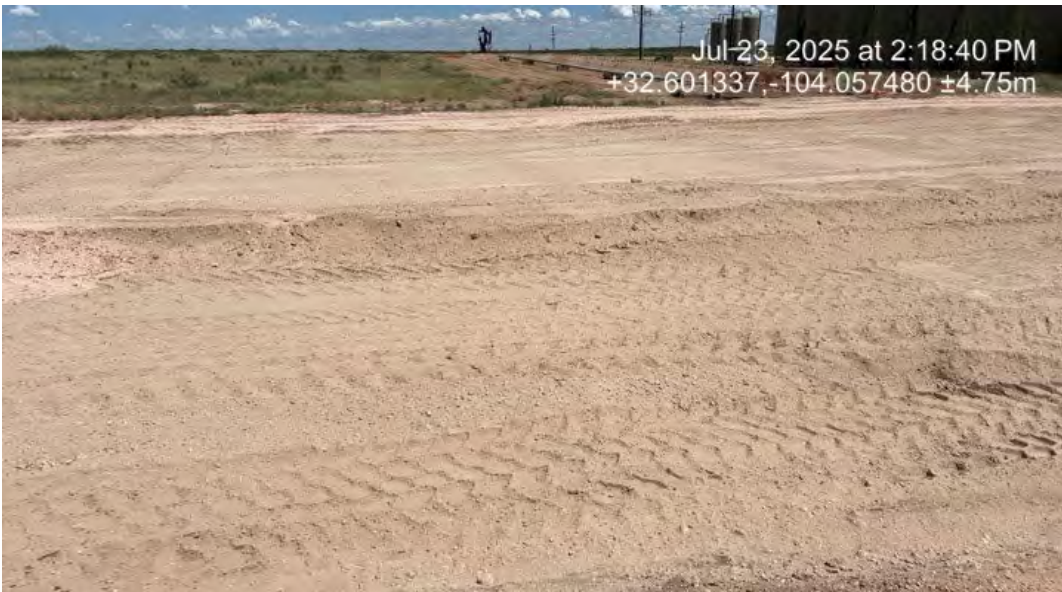
Photo Number: 14

Photo Direction: East	
Photo Description: View of the remediated area following backfilling and regrading.

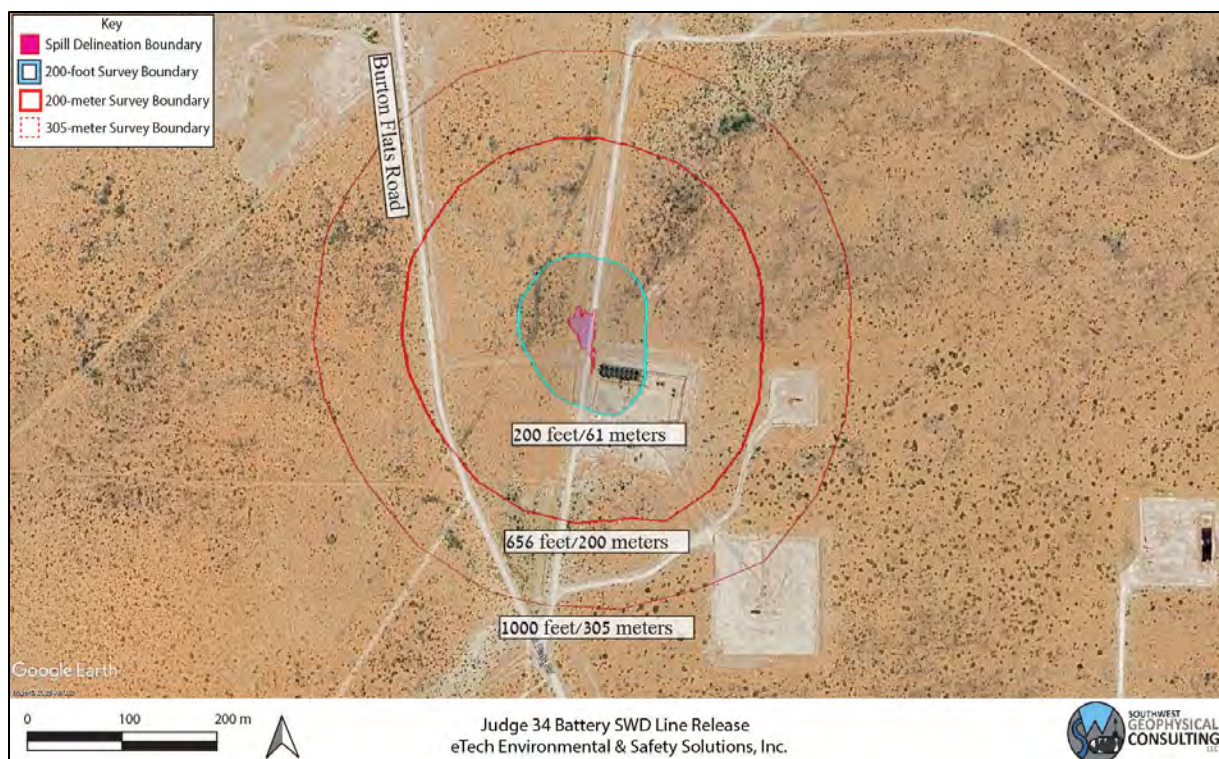
Figure 4: Surface survey overview. Background image credit: Google Earth. Image date: July 13, 2024. Datum: WGS-84.

Surface karst surveys are conducted by sUAS at low elevation within 200 meters of the spill delineation boundary^[4] (**Figure 4**) following a preplanned raster pattern flightpath designed for the purpose of generating at least 75% imagery overlap. The collected high-resolution, georeferenced imagery is stitched together to develop orthomosaic imagery which is further developed into a digital elevation model (DEM); the DEM is then processed into a local relief model (LRM) (**Figure 6**). This LRM is color coded to enhance differences in elevation of as little as five centimeters. The orthoimagery, DEM, and LRM are uploaded to a server where they are analyzed by an experienced karst geologist. Finally, the data is reviewed by a senior karst geologist for quality assurance and downloaded into a table for inclusion in a written report^[16].

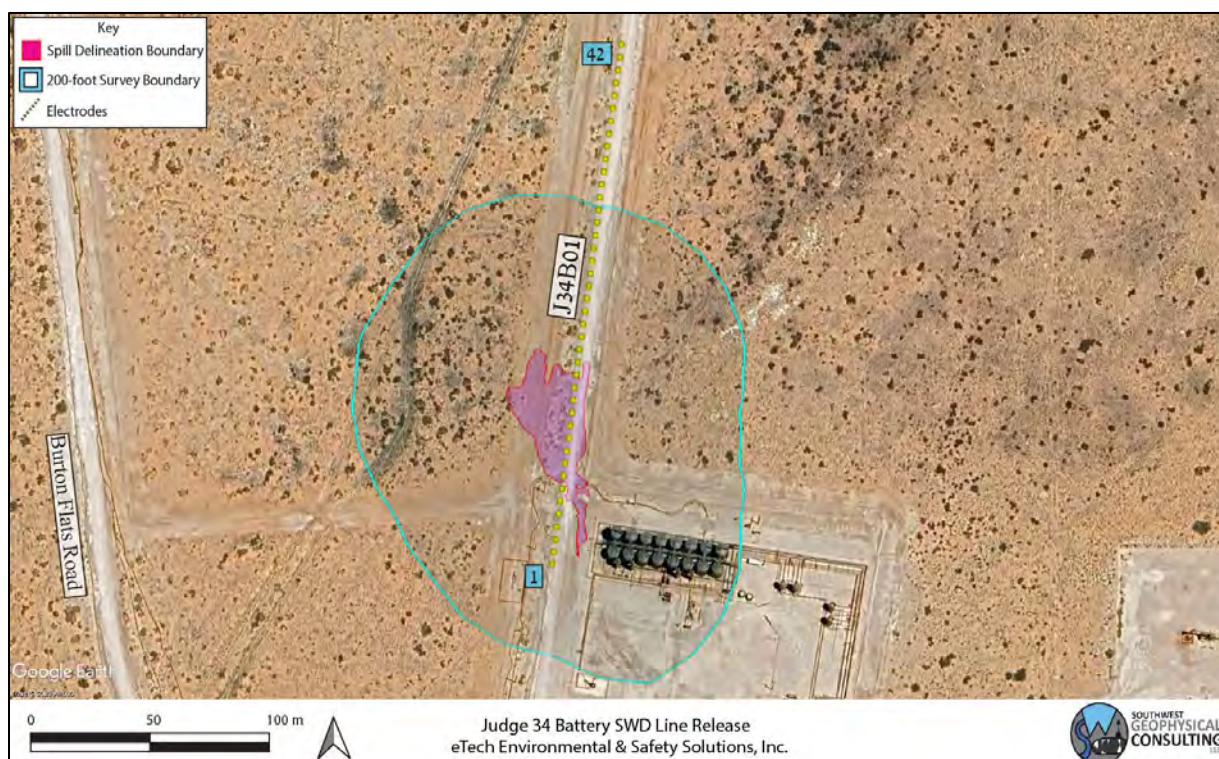
Figure 5: Geophysical survey overview. One survey line was conducted with 42 electrodes each at 5-meter spacing (yellow dots denoted with blue numbers). Background image credit: Google Earth. Image date: July 13, 2024. Image datum: WGS-84.

For this survey, a Guideline Geo Terrameter LS 2 and a 42-electrode array of 40-centimeter-long electrodes were used to image the subsurface. This survey consisted of one resistivity line in a dipole-dipole configuration laid out south to north. This line consisted of 42 electrodes at 5-meter spacing, resulting in a 205-meter-long array (**Figure 5, Table 1**). A preconfigured protocol file was used to run the data collection (DipoleDipole3x14). This electrode configuration provided a depth of investigation of 41 meters (135 feet) and a resolution of 2.5 to 3.0 meters (8.2 to 9.8 feet) within the first 5 to 8 meters (16 to 26 feet) from the surface. A Leica GS18 GPS was used to record electrode locations and elevations.
