**Closure Report
9418 JV-P Vaca Draw Battery
Lea County, New Mexico
Unit A, Sec 10, T25S, R33E
32.1518059°, -103.563446°**

**Incident ID: nkJ1518155255
Crude Oil Release
Point of Release: Equipment Failure on Dump Valve
Release Date: 06.20.2015
Volume Released: 45 Barrels of Crude Oil
Volume Recovered: 40 Barrels of Crude Oil**

**Incident ID: nJXK1611133725
Crude Oil Release
Point of Release: Gasket on Separator Failed
Release Date: 04.03.2016
Volume Released: 34 Barrels of Crude Oil
Volume Recovered: 30 Barrels of Crude Oil**

**Prepared for:
BTA Oil Producers, LLC
104 South Pecos Street
Midland, Texas 79701**

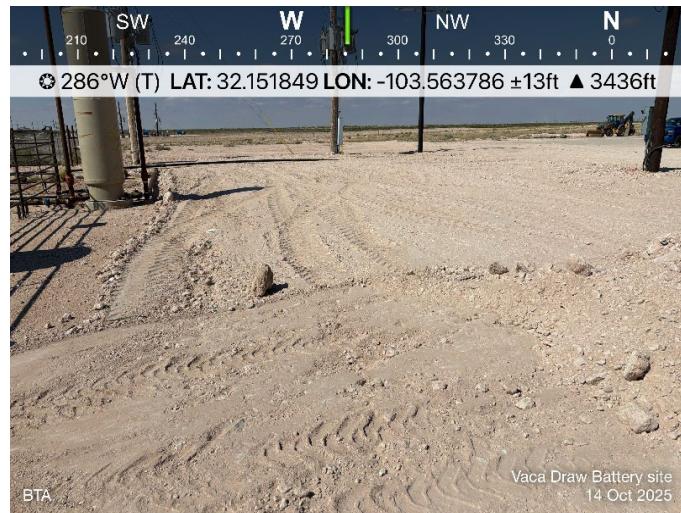
Photograph No. 1**Facility:** 9418 JV-P Vaca Draw Battery**County:** Lea County, New Mexico**Description:**

View West, 0.5' scraped area of concern CS-1 through CS-42

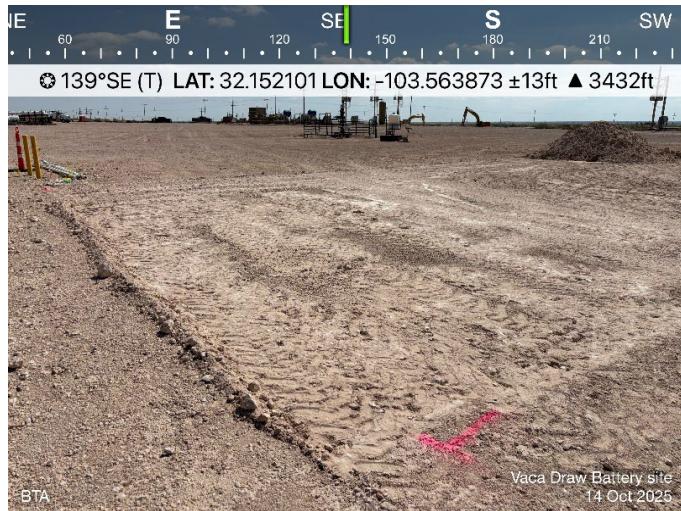
**Photograph No. 2****Facility:** 9418 JV-P Vaca Draw Battery**County:** Lea County, New Mexico**Description:**

View Southeast, 0.5' scraped area of concern CS-1 through CS-42

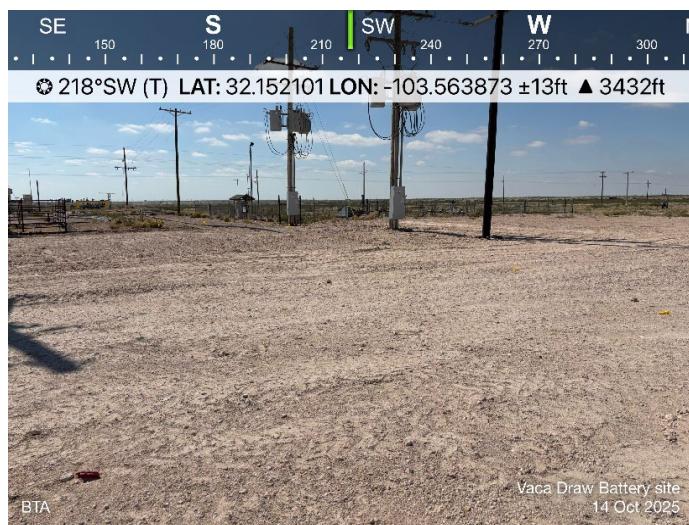
**Photograph No. 3****Facility:** 9418 JV-P Vaca Draw Battery**County:** Lea County, New Mexico**Description:**

View Southwest, 0.5' scraped area of concern CS-1 through CS-42

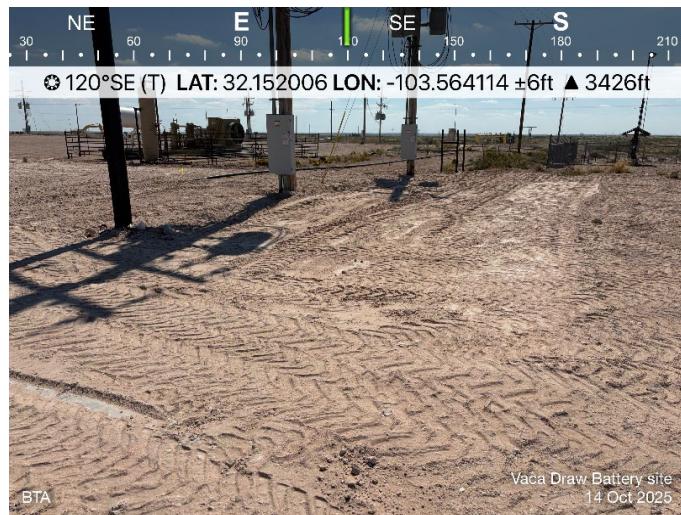
Photograph No. 4**Facility:** 9418 JV-P Vaca Draw Battery**County:** Lea County, New Mexico**Description:**

View Southeast, 0.5' scraped area of concern CS-1 through CS-42

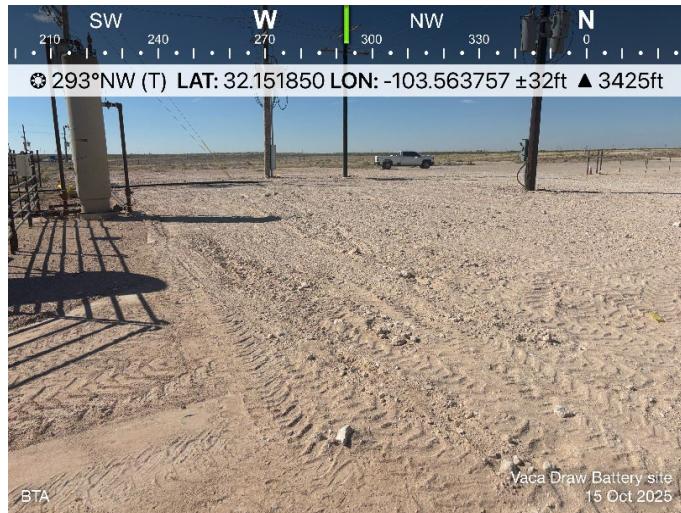
**Photograph No. 5****Facility:** 9418 JV-P Vaca Draw Battery**County:** Lea County, New Mexico**Description:**

View Northwest, Backfilled area of excavation

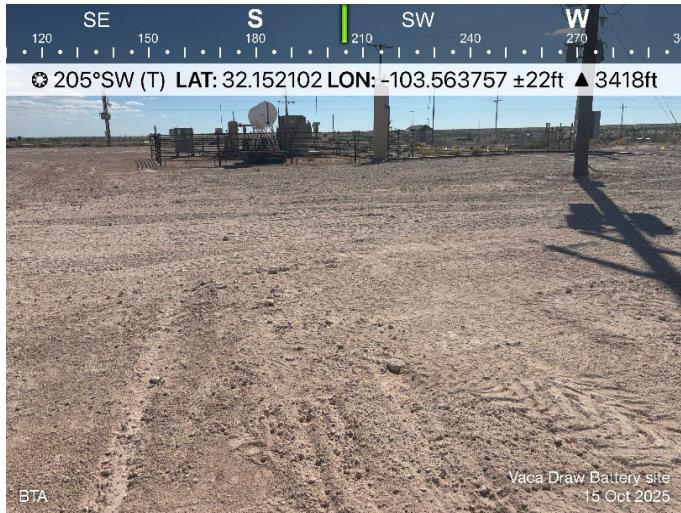
**Photograph No. 6****Facility:** 9418 JV-P Vaca Draw Battery**County:** Lea County, New Mexico**Description:**

View Southwest, Backfilled area of excavation

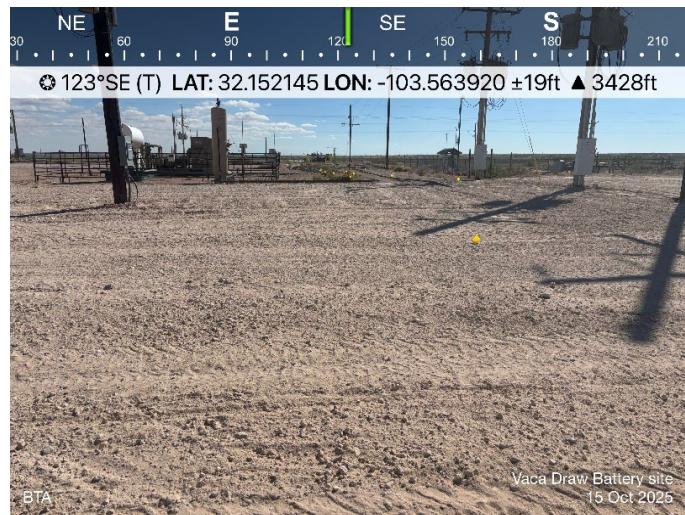
Photograph No. 7**Facility:** 9418 JV-P Vaca Draw Battery**County:** Lea County, New Mexico**Description:**

View Southeast, Backfilled area of excavation

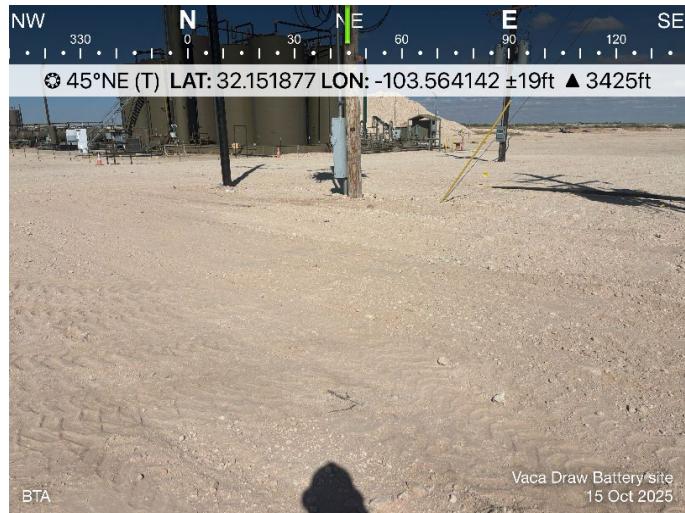
Photograph No. 8**Facility:** 9418 JV-P Vaca Draw Battery**County:** Lea County, New Mexico**Description:**

View Northeast, Backfilled area of excavation

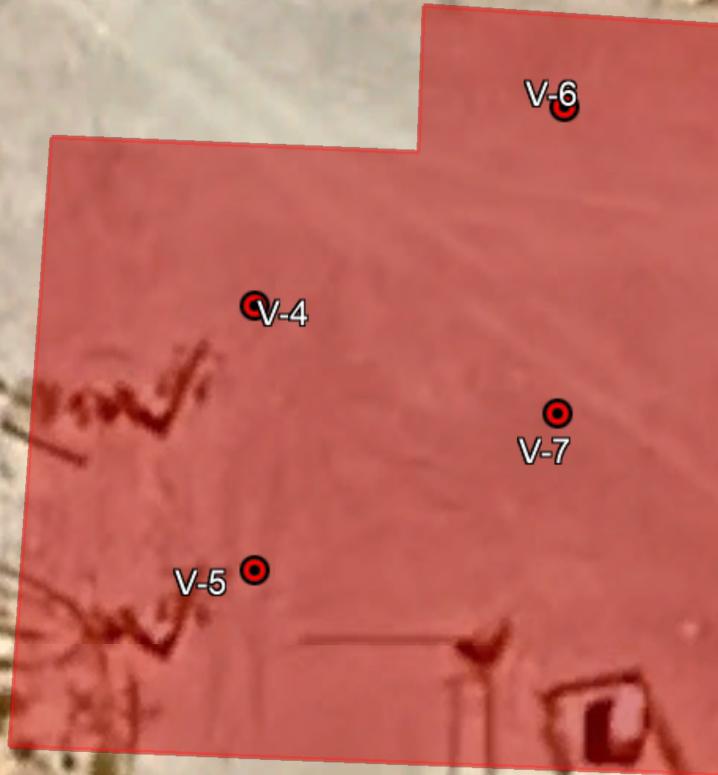
Proposed Excavation Map

- 0.5ft Excavation
- Delineation Sample Points

The areas of V-4 through V-7 were proposed to be excavated to a depth of 0.5' bgs. Following this site assessment and the creation of the 2025 remediation work plan, no documentation related to the remediation of this spill incident can be found.

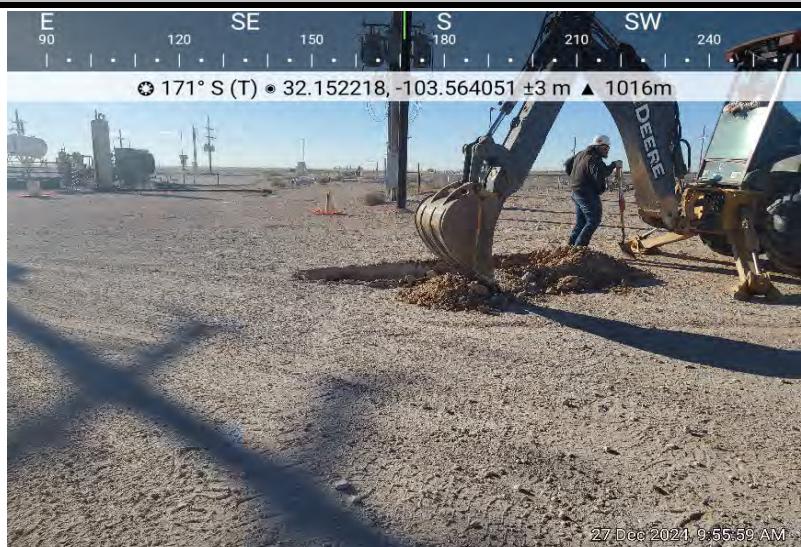
View of Initial Assessment Activities

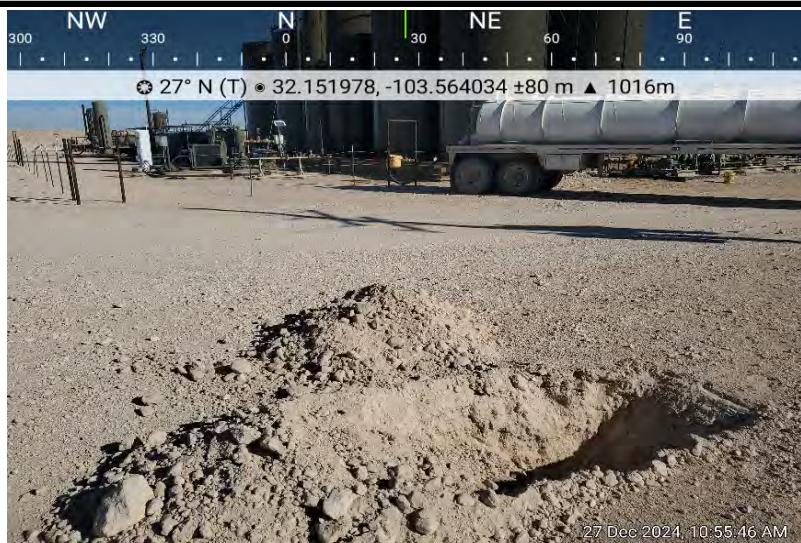
**Photograph No. 2**

View of Initial Assessment Activities

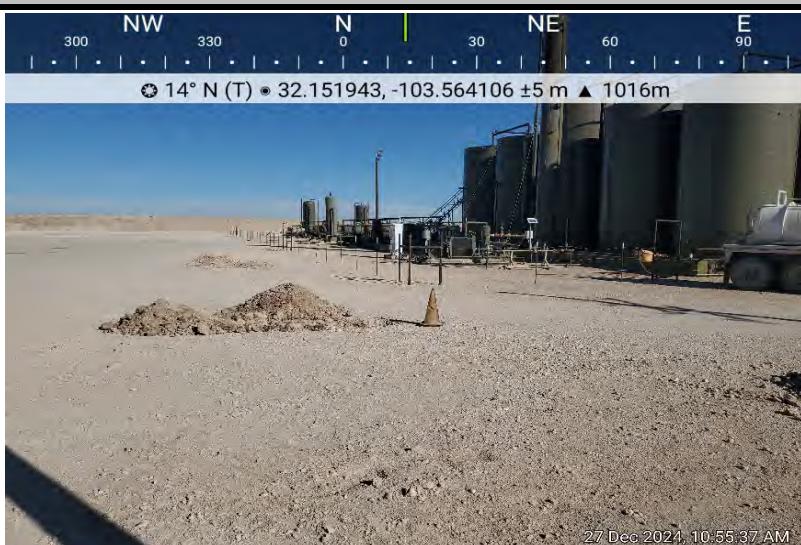
**Photograph No. 3**

View of Initial Assessment Activities

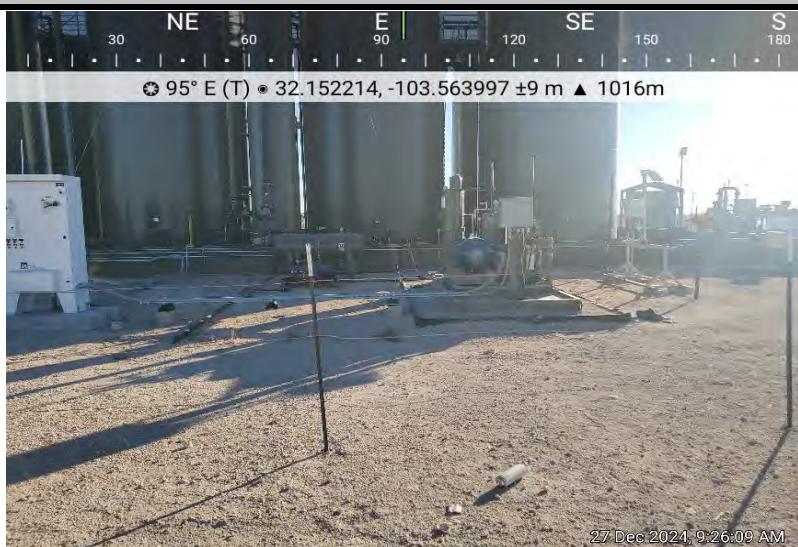
Photograph No. 4

View of Initial Assessment Activities

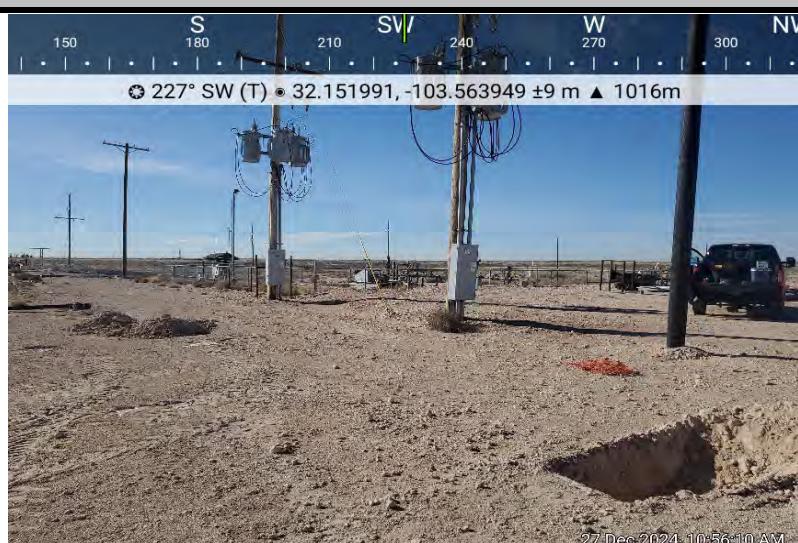
**Photograph No. 5**

View of Initial Assessment Activities

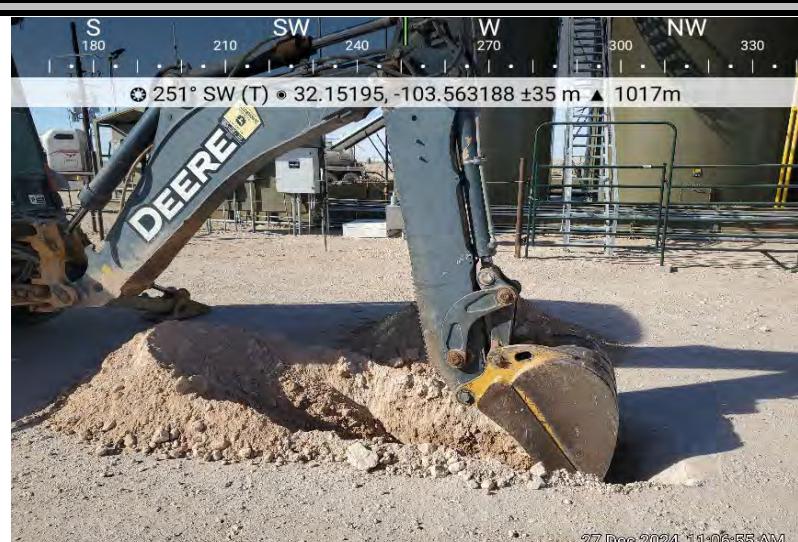
**Photograph No. 6**

View of Initial Assessment Activities
