Release Assessment and Deferral Request

Mesa Verde 7 Federal #002

Vertex File Number: 25A-01341

Devon Energy Production Company, LP

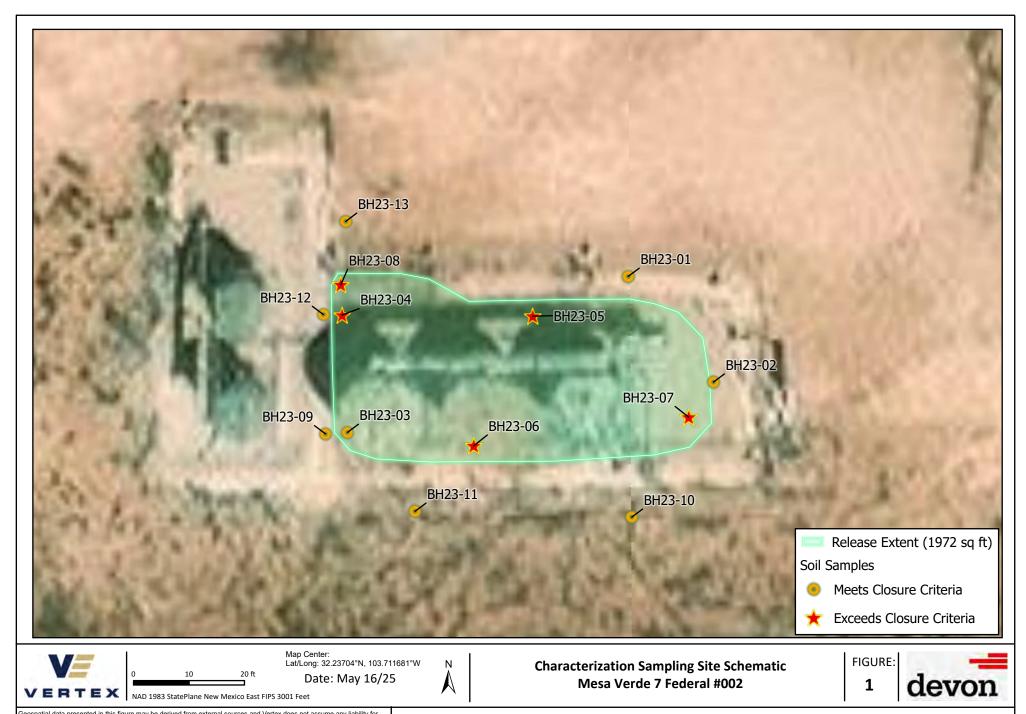
The site is located approximately 21.15 miles east of Malaga, New Mexico (Google Inc., 2025). The legal location for the site is Unit C, Section 07, Township 24 South and Range 32 East in Lea County, New Mexico. The release area is located on Bureau of Land Management property. An aerial photograph and site schematic are presented on Figure 1.
