Oil or Water Spill **TO SOIL** Volume Spreadsheet

Response to Comment 1: On 12 November 2025, SQE returned to the Robin LACT facility to conduct additional soil confirmation sampling in general accordance with the approved soil plan. An aerial image dated 19 August 2024 was obtained from ESRI Maxar, and the location of the Robin LACT facility where the additional soil confirmation sampling activities occurred is shown on the image below. The text boxes detail previously remediated areas labeled as CS-01 through CS-06, as well as the total depth of previously excavated material relative to feet below ground surface (ft bgs). The green dots represent sidewall soil aliquot locations and the pink dots are aliquots collected from the bottom of the excavation. The yellow dots located within the CS-03 and CS-04 remediated areas represent the approved confirmation sample locations (CS-03-CB and CS-04-CB).

Based on the remediation and restoration activities performed, as described above, the crude-oil release event has been appropriately addressed in accordance with NMAC §19.15.29, and no further actions are needed. With the following signature, I certify that, to the best of my ability a

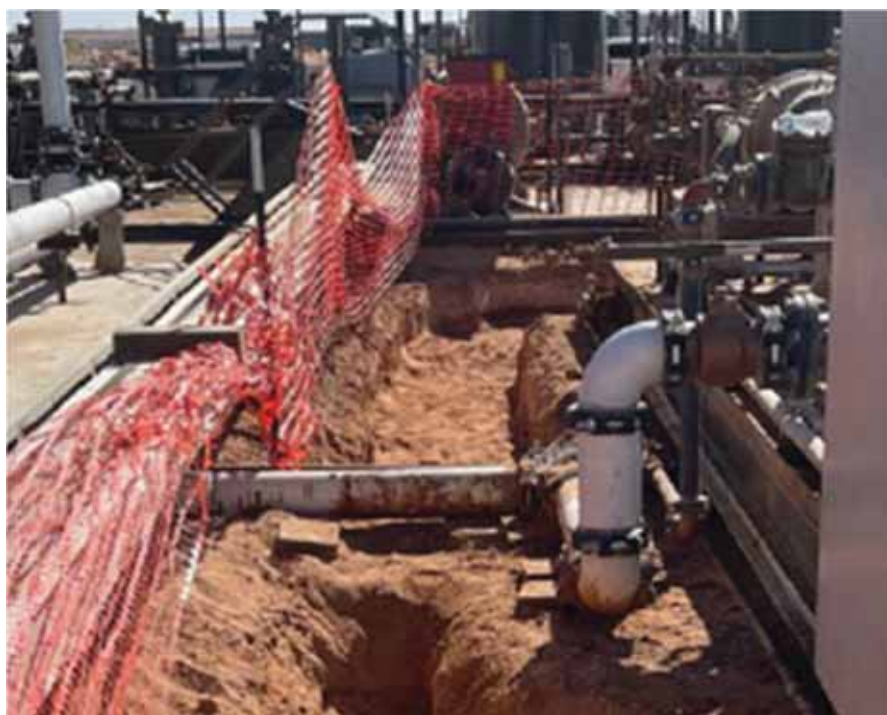
Due to pipes and other obstructions, all of CS-02 required manual excavation and use of hydro-excavation techniques. The portion of CS-02 that is shown in Photo 11 of the photolog is a very small portion of CS-02, where the excavation was a bit deeper around the pipe, this area may also have been used as a “sump” to allow efficient vacuuming of the soil slurry during hydro-excavation. The photo below shows the CS-02 area that was manually excavated (view looking south from CS-01). In this photo, the pipe is towards the right, behind the equipment. This area is also shown in Photo 10 of the photo log.

The overall excavation depth for this area was 1.5 ft although around the pipe, the excavation was a bit deeper.

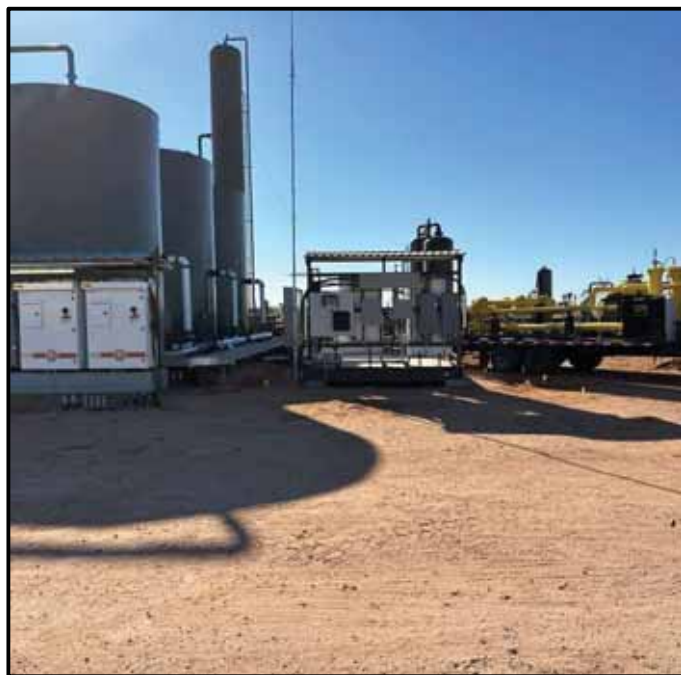
Photo 1. The north side of the LACT, after release and prior to remediation. Yellow pin flags outlining the extent of the release are visible.

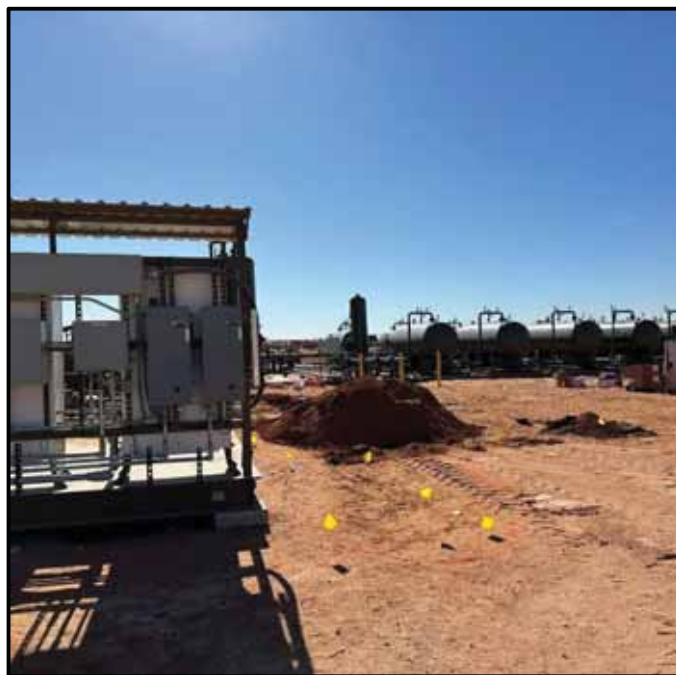
Photo 2. The northwest side (CS-06) of the LACT, after release and shortly after excavation commenced. Yellow pin flags and orange spray paint outlining the extent of the release are visible. No wet or discolored areas of soil were observed north of the LACT.

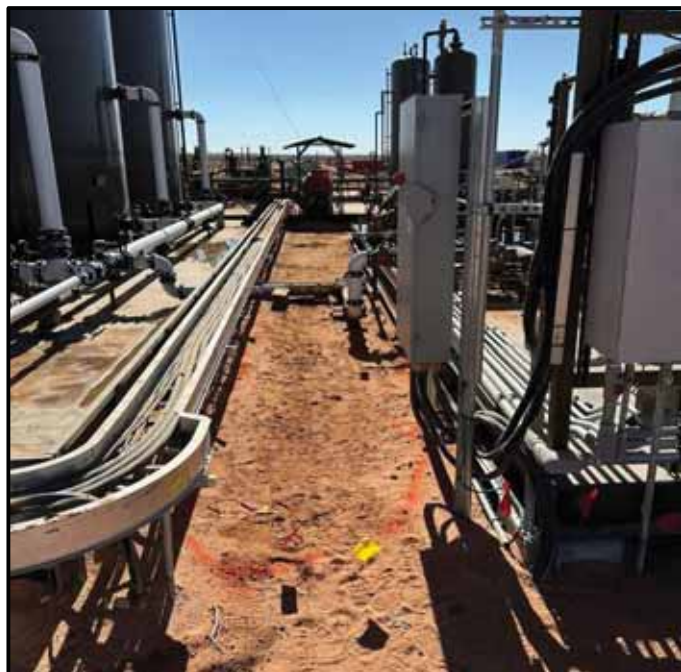
Photo 3. The northeast side (CS-01) of the LACT, after release and prior to remediation. Yellow pin flags and orange spray paint outlining the extent of the release are visible. No wet or discolored areas of soil were observed north of the LACT.

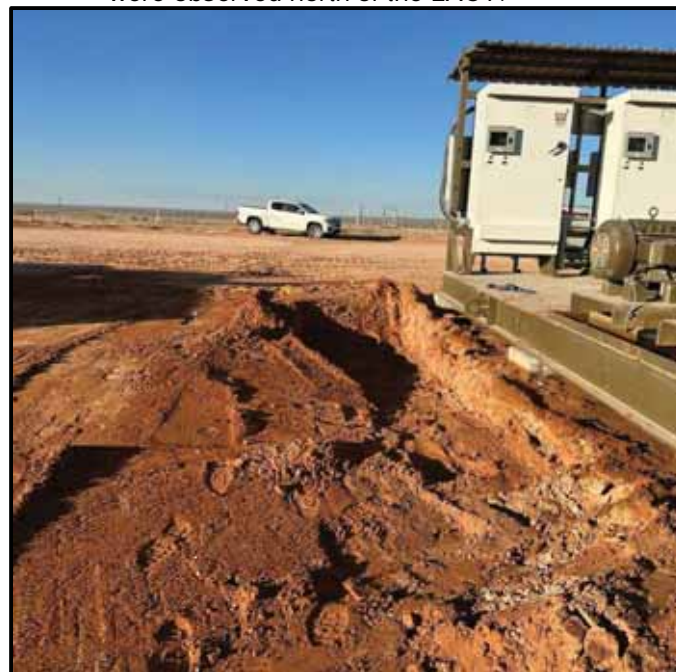
Photo 4. Excavating the extent of CS-06 during initial remediation activities. The excavation by backhoe was limited to a depth of 1.0 ft due to subsurface utilities.

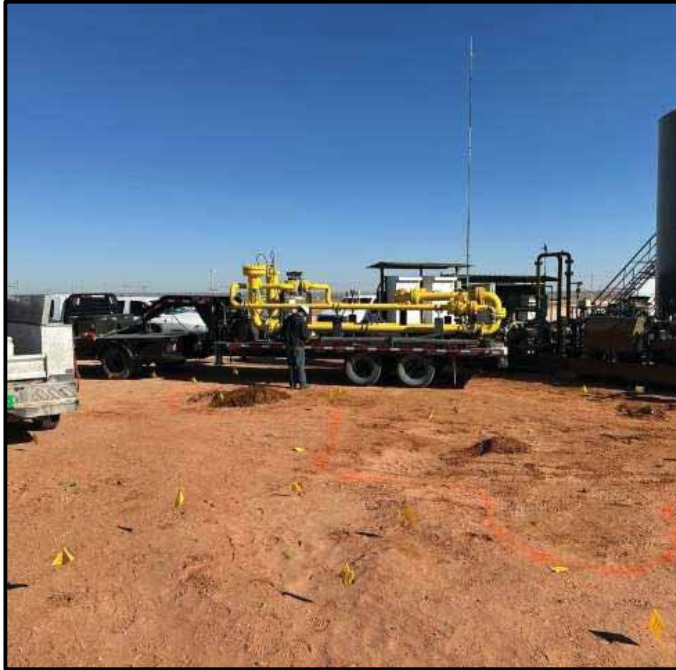
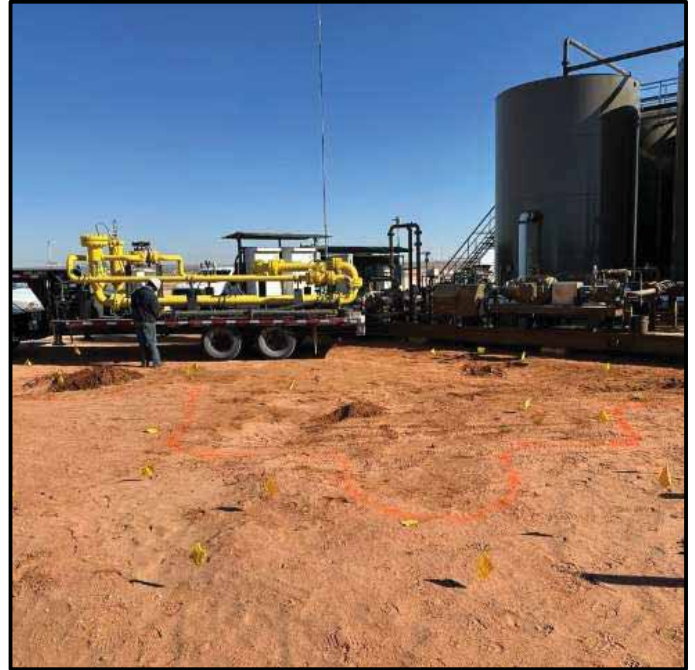
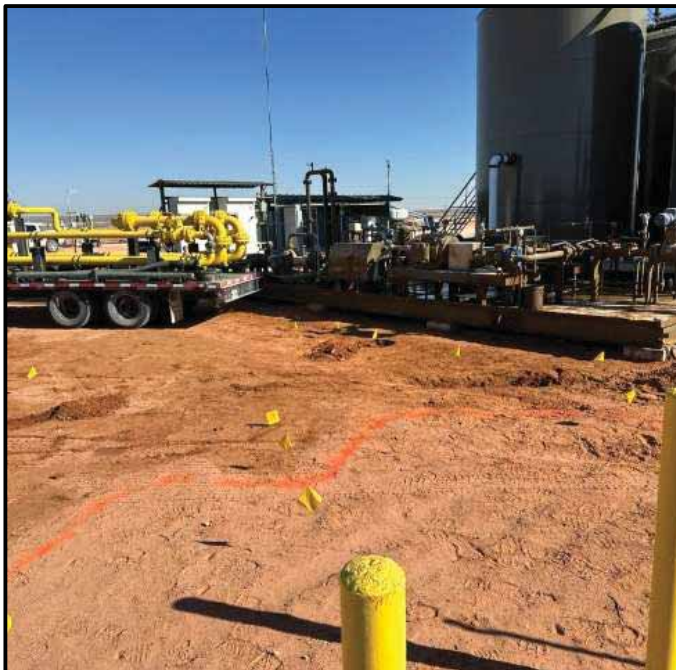
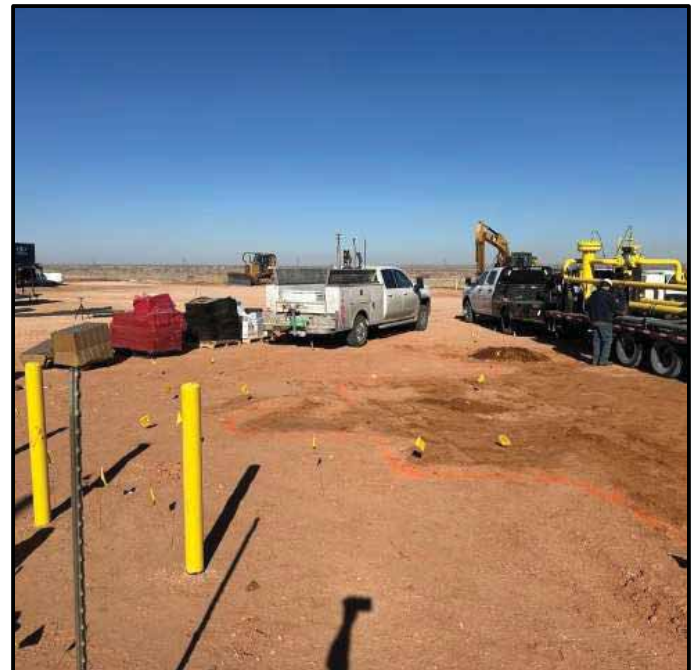
Photo 5. Orange spray paint used to demarcate the lateral extents (the perimeter) of impacted soil at the ground surface with an additional 1.0-ft capture zone.

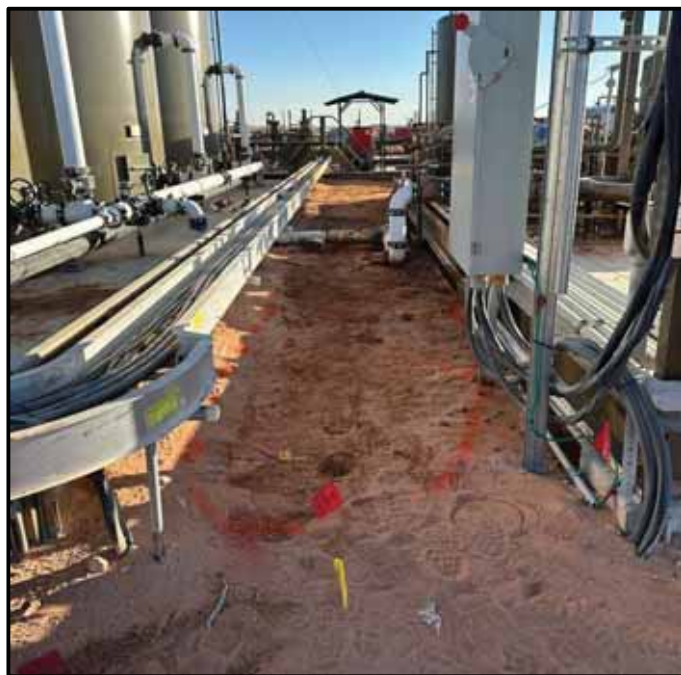
Photo 9. Collecting confirmation samples at the extent of CS-01 during initial remediation activities. No excavation was initially done at CS-01 due to the backhoe not being able to access the area.

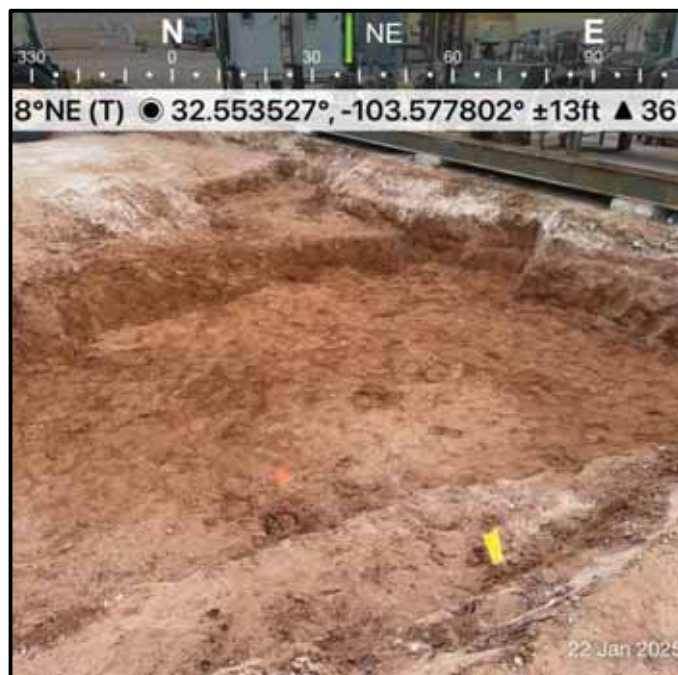
Photo 10. Excavation to a depth of 1.25 ft by hand and hydrovac methods at CS-06 until PID readings for the remaining soil indicated no or only minimal organic vapors were present.

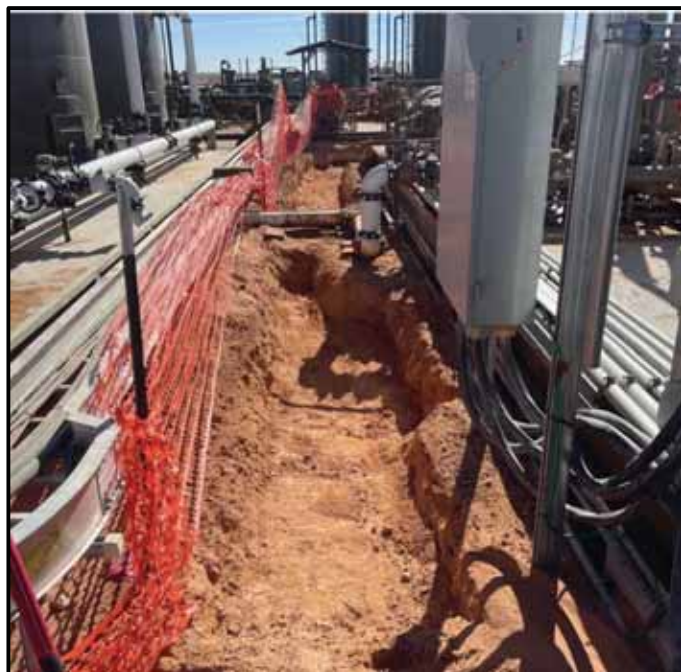
Photo 11. Excavation to a depth of 1.5 ft by hand and hydrovac methods at CS-01 until PID readings for the remaining soil indicated no or only minimal organic vapors were present.

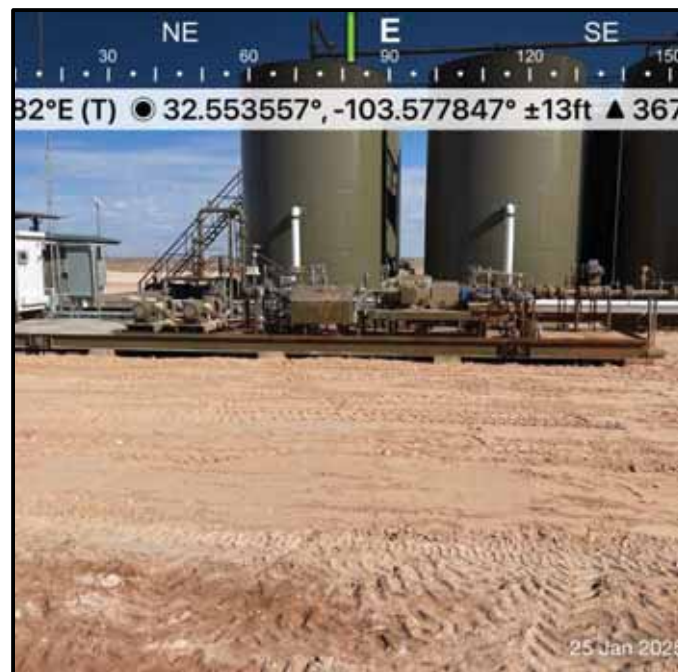
Photo 12. CS-06 following backfilling activities.

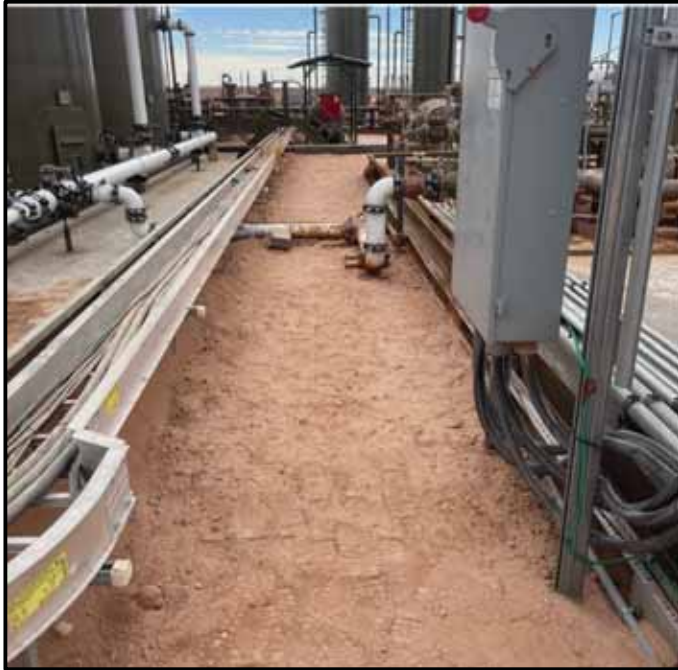
Photo 13. CS-01 following backfilling activities.

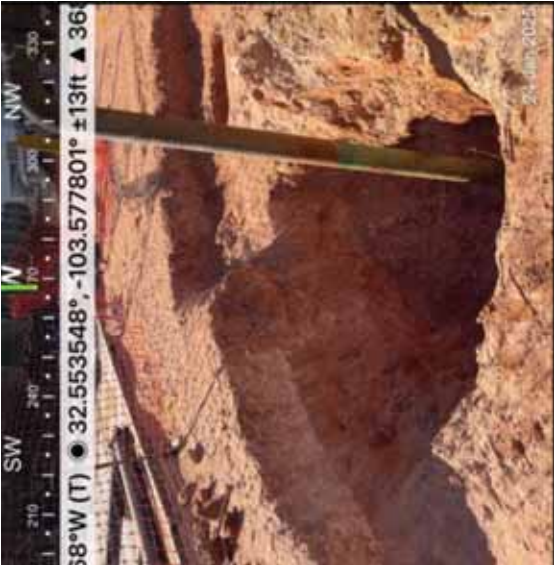
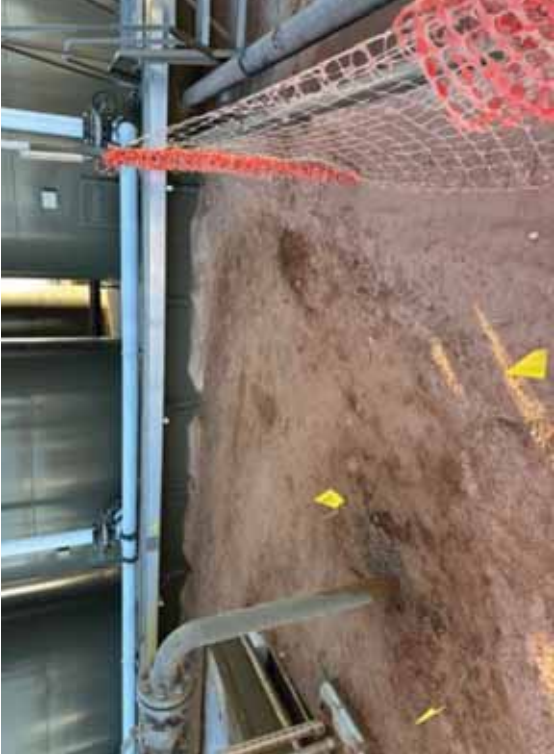
2. Referring to the 4/7/25 rejected closure report, Photo 11 showed area of CS-02 as much deeper than a 1.5' excavation. Explain. Photo 11 is a little misleading. For convenience, a copy of Photo 11 is shown below on the left (view towards the west). This photograph was taken in the area where a pipe was present. A "pre-remediation" photo is provided below on the right (view towards the east) which shows the same pipe.

Due to pipes and other obstructions, all of CS-02 require manual excavation and use of hydro-excavation techniques. The portion of CS-02 that is shown in Photo 11 of the photolog is a very small portion of CS-02, where the excavation was a bit deeper around the pipe, this area may also have been used as a "sump" to allow efficient vacuuming of the soil slurry during hydro-excavation. The photo below shows the CS-02 area that was manually excavated (view looking south from CS-01). In this photo, the pipe is towards the right, behind the equipment. This area is also shown in Photo 10 of the photo log.

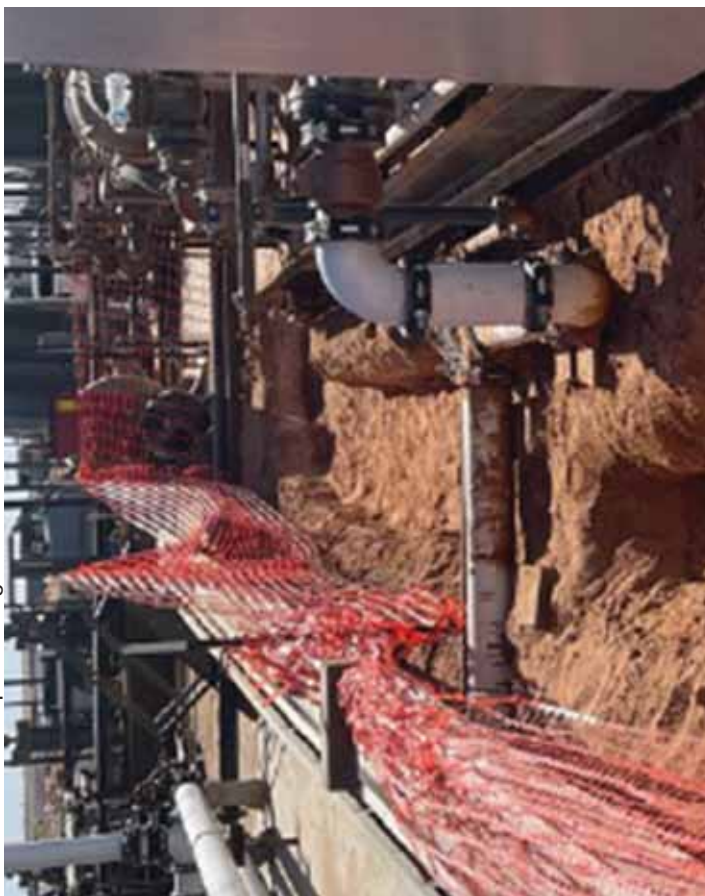
The overall excavation depth for this area was 1.5 ft although around the pipe, the excavation was a bit deeper.

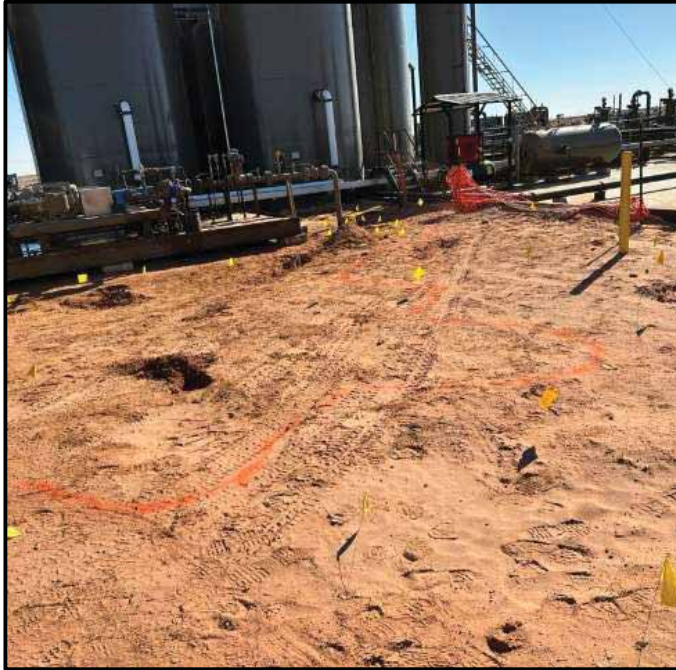
Photo 1. The visual extent of surface impacts outlined with orange spray paint at sub-areas CS-03 and CS-04; prior to remediation activities.

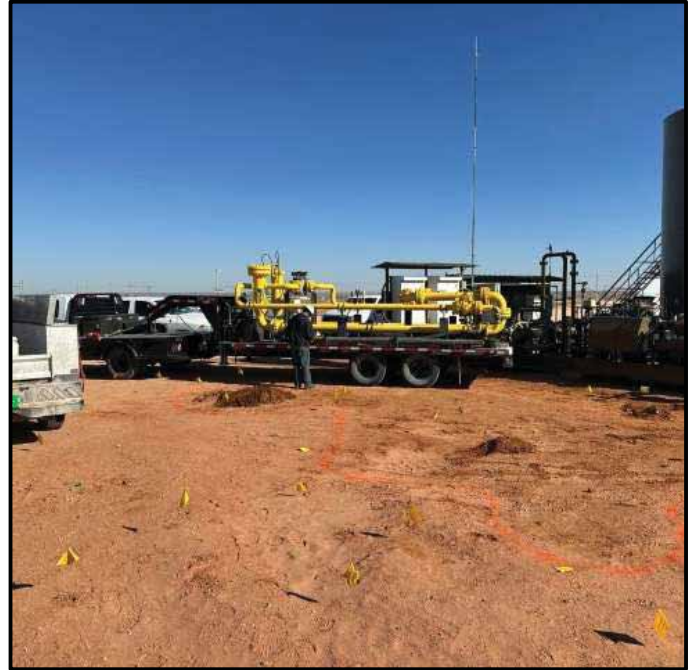
Photo 2. The visual extent of surface impacts outlined with orange spray paint at sub-areas CS-04 and CS-05; prior to remediation activities.

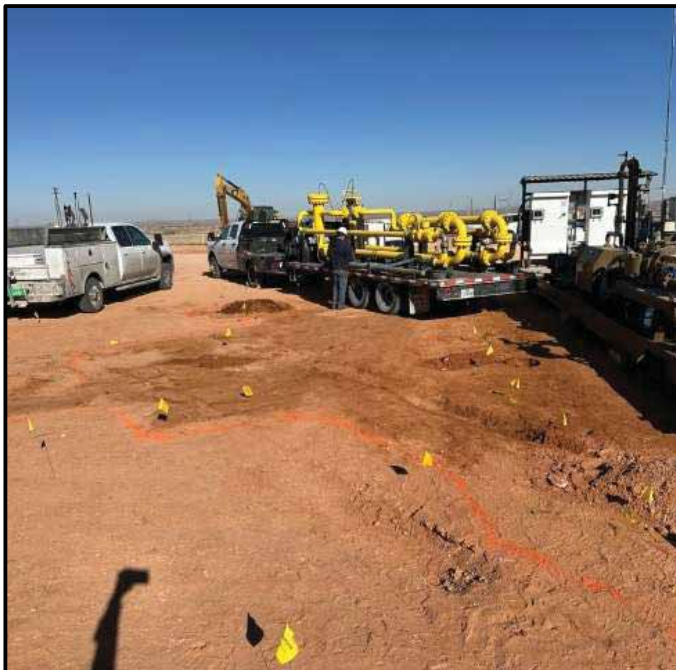
Photo 3. The visual extent of surface impacts outlined with orange spray paint at sub-areas CS-05 and CS-06; prior to remediation activities.

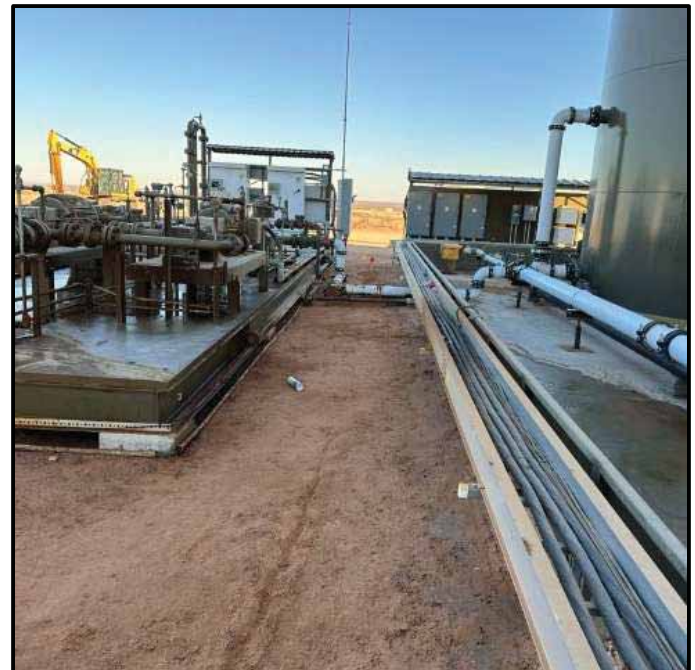
Photo 4. The visually impacted soil surface at sub-areas CS-01 and CS-02 prior to remediation activities.

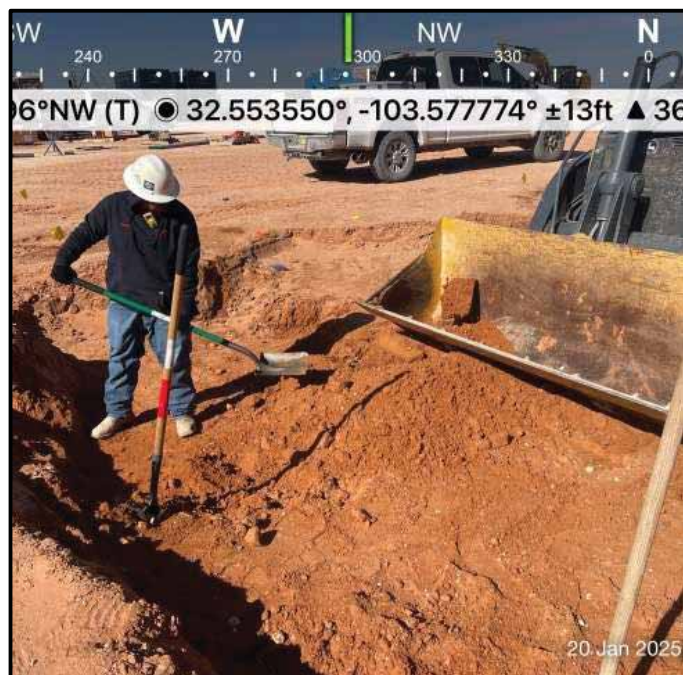
Photo 6. Hand-digging activities being performed at sub-area CS-06.

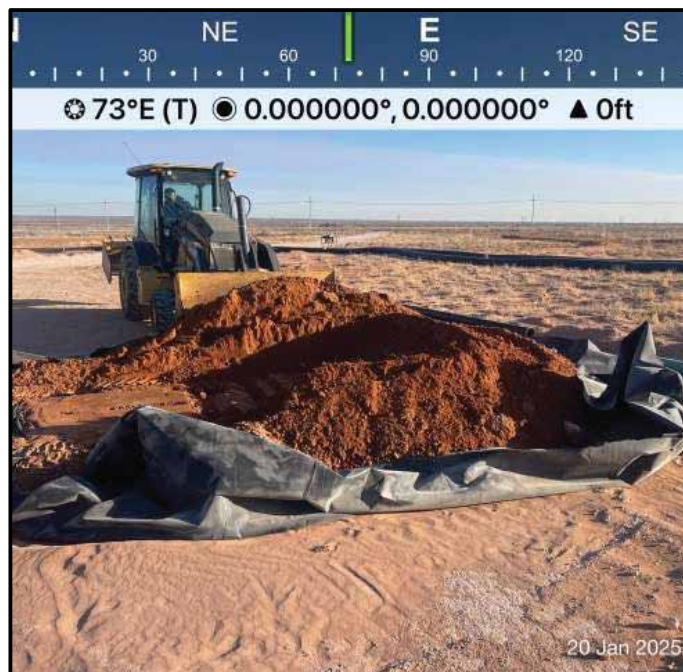
Photo 7. The temporary waste staging area where waste soil was deposited as remediation activities were being performed.

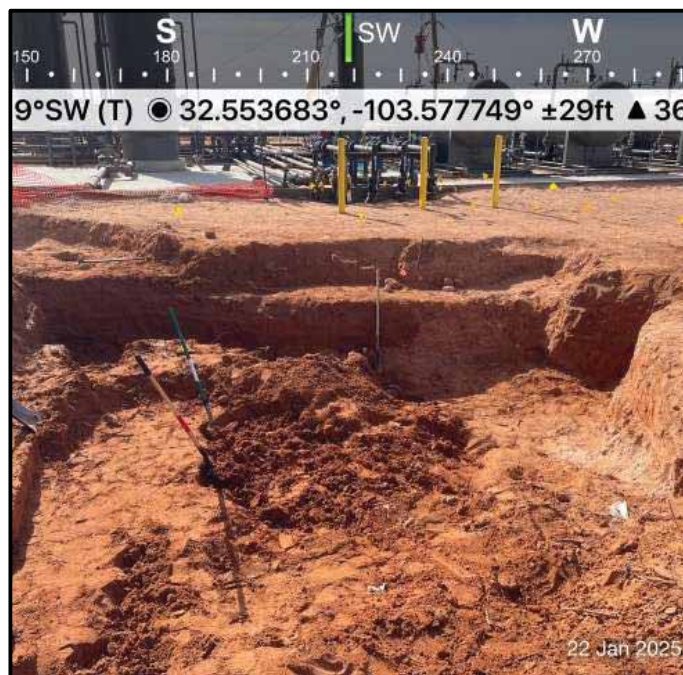
Photo 9. View of sub-areas CS-03 and CS-04 after remediation activities were performed and prior to backfilling (restoration) activities.

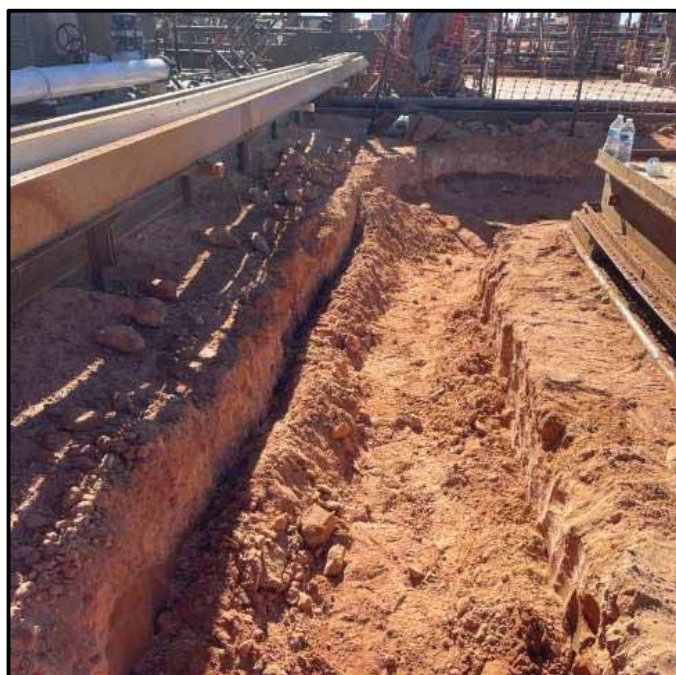
Photo 10. View of sub-areas CS-01 and CS-02 after remediation activities were performed and prior to backfilling (restoration) activities.

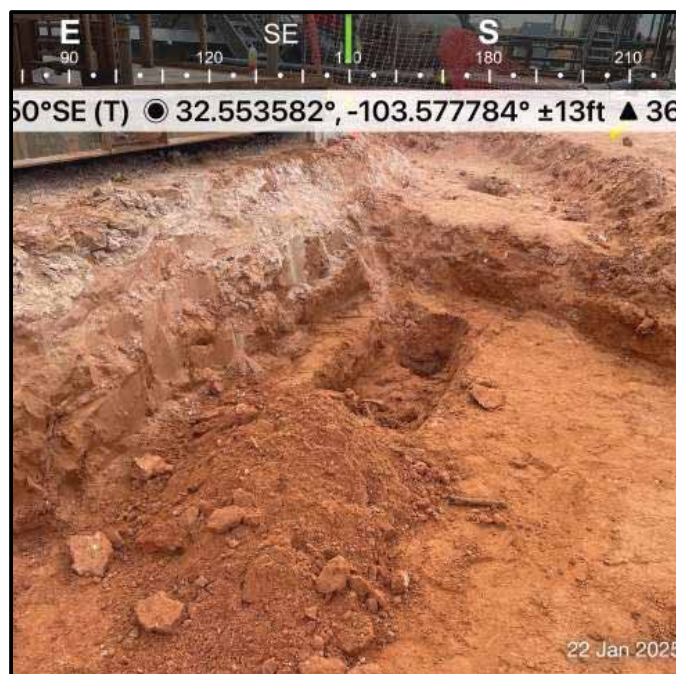
Photo 12. View of sub-area CS-03 after remediation activities were performed and prior to backfilling (restoration) activities.

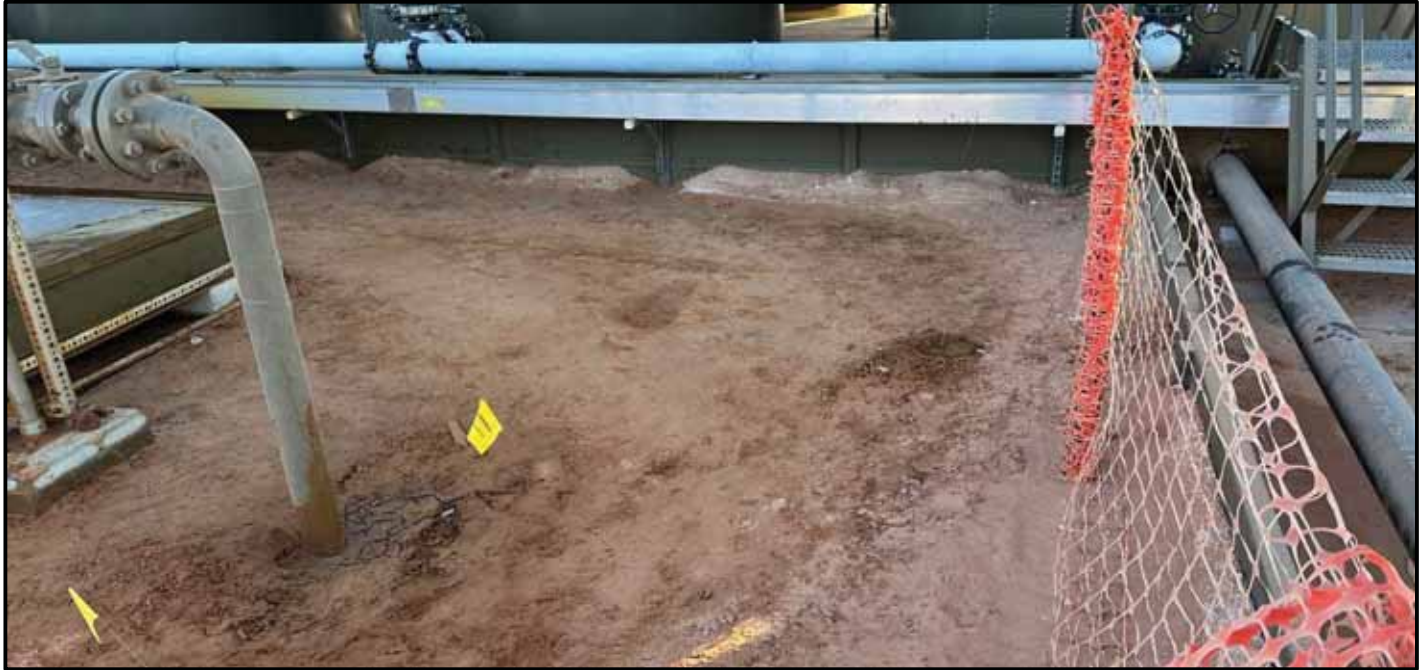
Photo 11a. This photograph is being submitted in response to Comment 2 of the 14 July 2025 OCD email. View looking east of sub-area CS-02 prior to remediation activities were performed. The pipe on the left side of the photograph is the same pipe shown on Photograph 11.

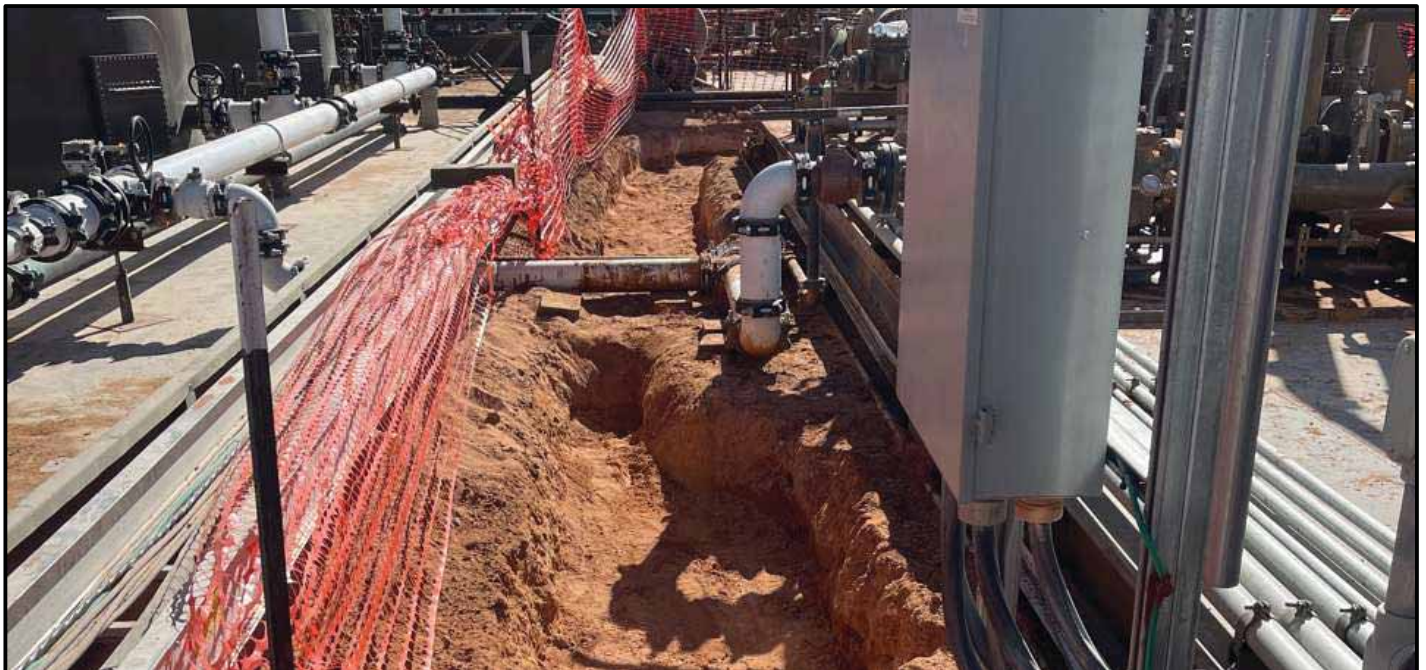
Photo 11b. This photograph is being submitted in response to Comment 2 of the 14 July 2025 OCD email. View looking south from CS-01 of the CS-02 area that was manually excavated.. The pipe in photograph 11 is towards the right of this photograph, behind the equipment.

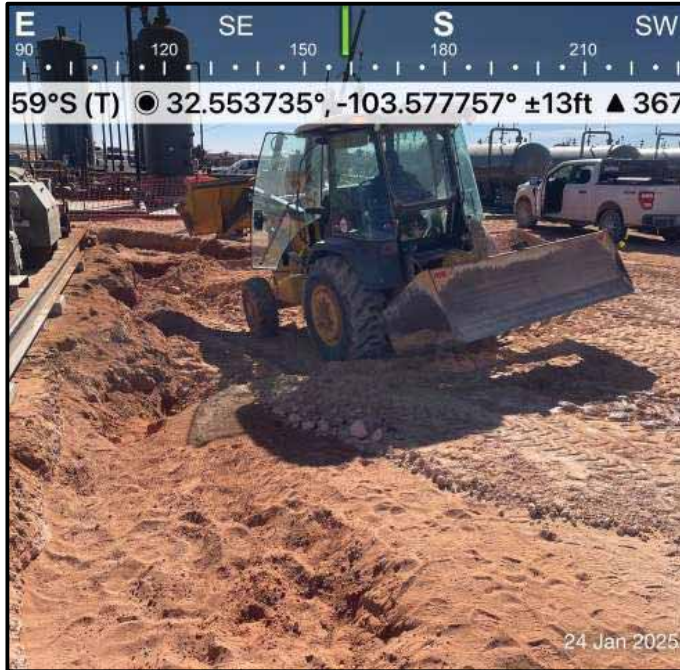
Photo 13. Backfilling the excavation in the general sub-areas of CS-03, CS-04, CS-05, and CS-06.

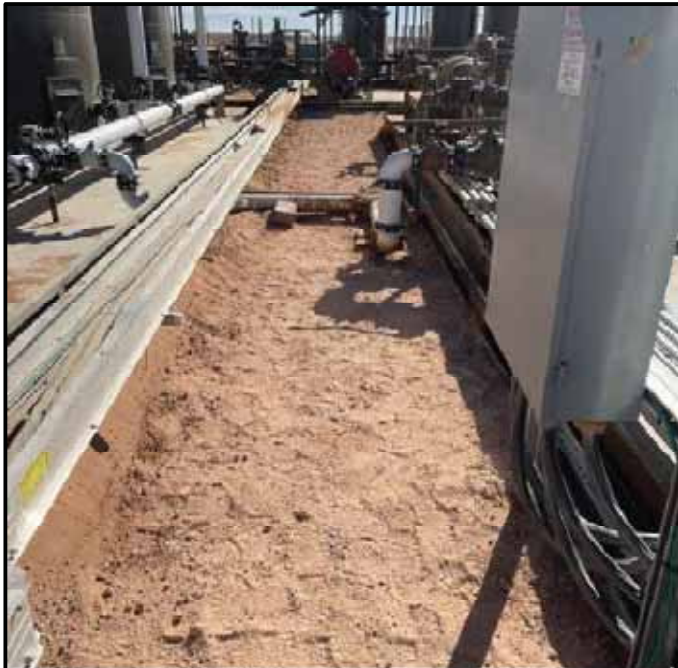
Photo 15. View of sub-area CS-01 at the conclusion of backfilling, watering, and compaction activities.

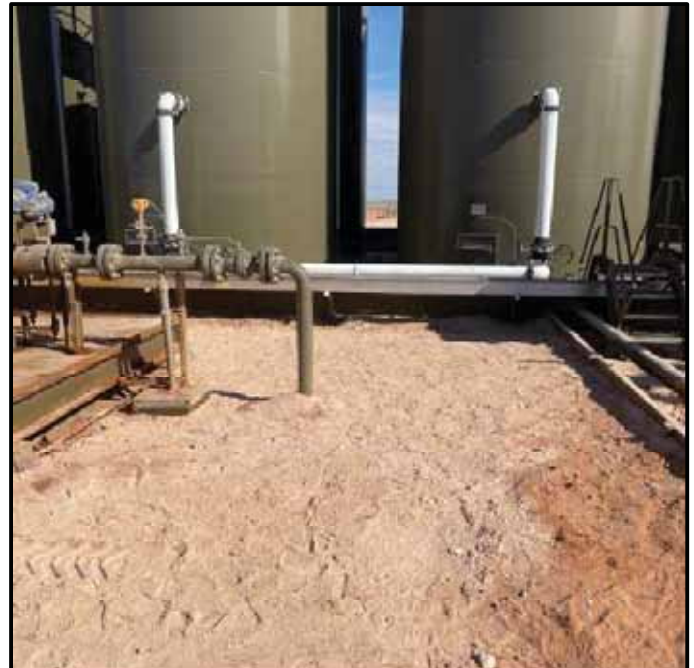
Photo 16. View of sub-area CS-02 at the conclusion of backfilling, watering, and compaction activities.

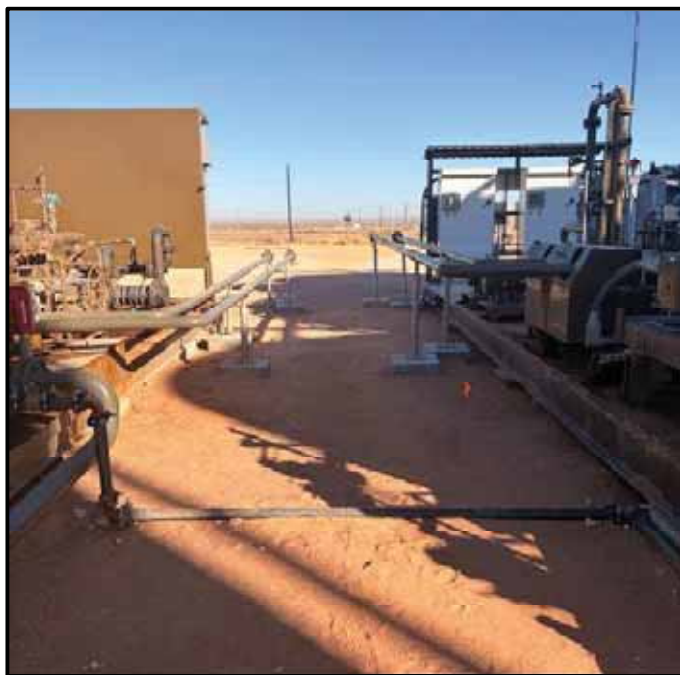
Photo 20. View of the CS-03-CB sample location area. The sample location is located at the red marker flag. This sample was collected in response to Comment 1 of the 14 July 2025 OCD email.

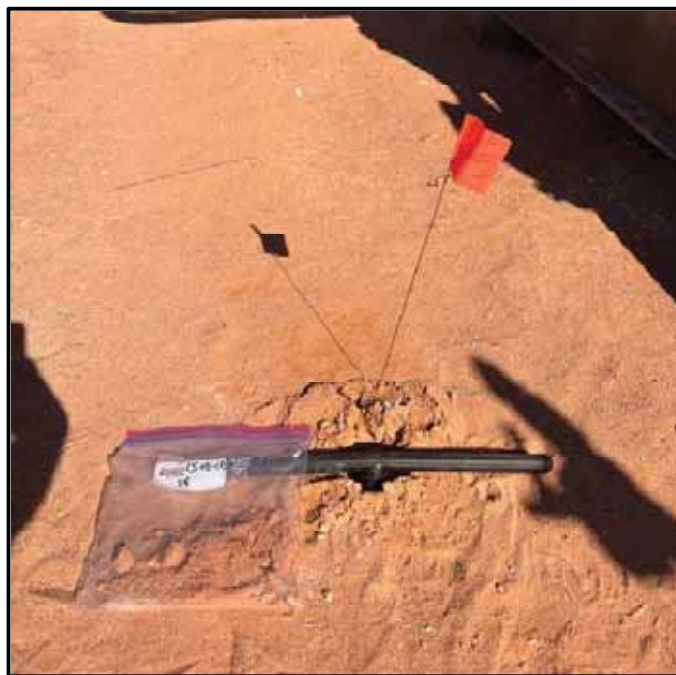
Photo 21. The CS-03-CB soil sample was collected via hand-auger from approximately four feet below ground surface (4 ft bgs).

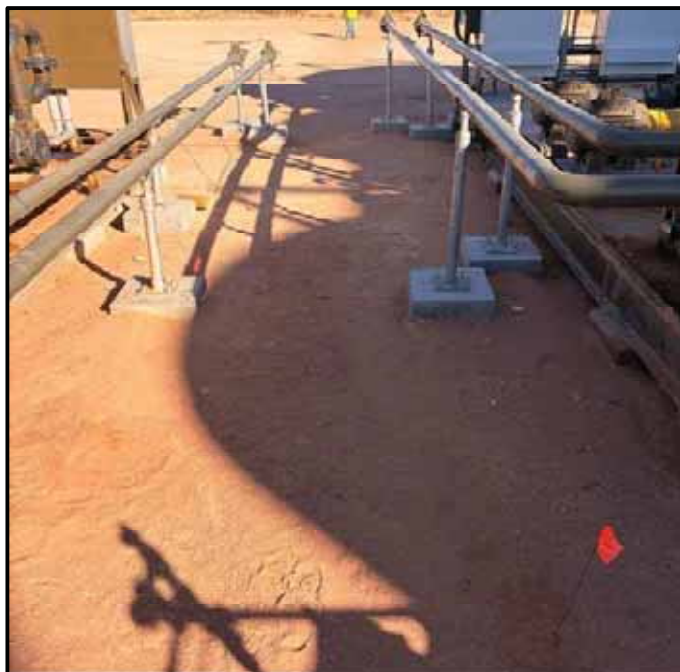
Photo 22. View of the CS-04-CB sample location area. The sample location is located at the red marker flag. This sample was collected in response to Comment 1 of the 14 July 2025

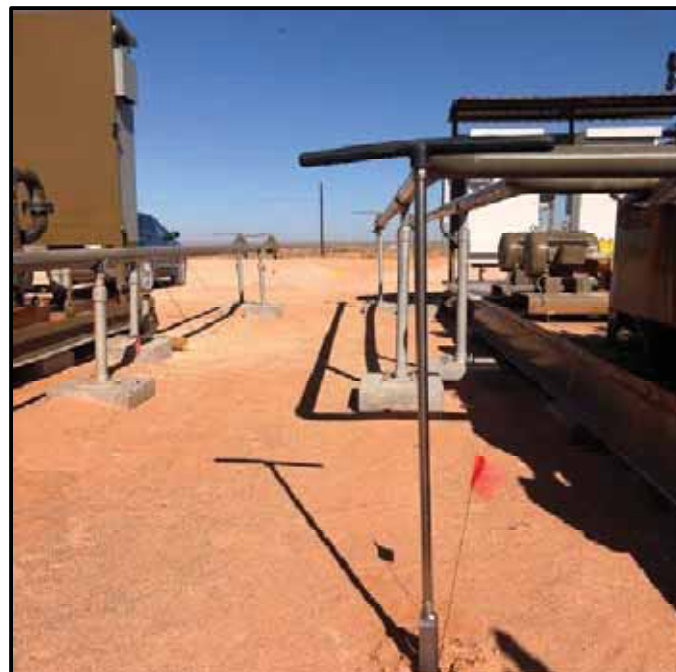
Photo 23. View of CS-04-CB sample location. The four foot hand-auger used to collect both CS-03-CB and CS-04-CB soil samples is shown in the foreground.

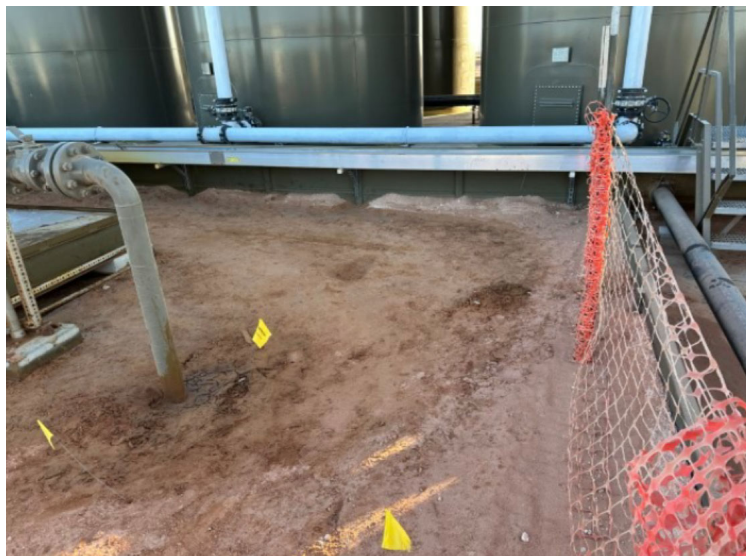
Photo 11 is a little misleading. For convenience, a copy of Photo 11 is shown below on the left (view towards the west). This photograph was taken in the area where a pipe was present. A “pre-remediation” photo is provided below on the right (view towards the east) which shows the same pipe.

Due to pipes and other obstructions, all of CS-02 require manual excavation and use of hydro-excavation techniques. The portion of CS-02 that is shown in Photo 11 of the photolog is a very small portion of CS-02, where the excavation was a bit deeper around the pipe, this area may also have been used as a “sump” to allow efficient vacuuming of the soil slurry during hydro-excavation. The photo below shows the CS-02 area that was manually excavated (view looking south from CS-01). In this photo, the pipe is towards the right, behind the equipment. This area is also shown in Photo 10 of the photo log.

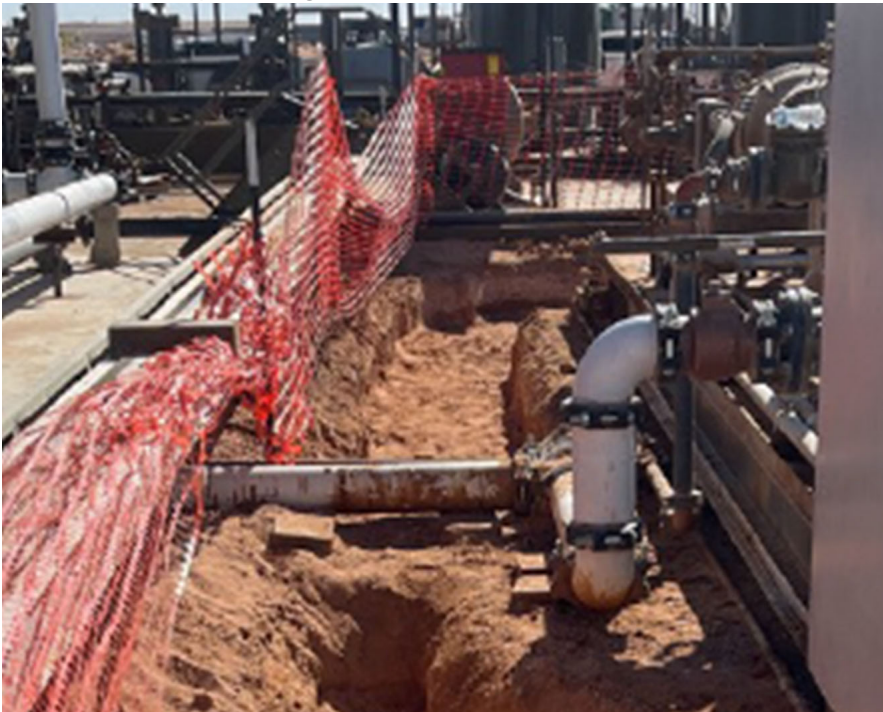
The overall excavation depth for this area was 1.5 ft although around the pipe, the excavation was a bit deeper.
