**Re: Remediation Work Plan  
Poker Lake Unit #153  
Incident Numbers nJMW1219345739, nJMW1228429248, nJMW1228428008,  
nJMW1231129593, and nHMP1441828179  
Eddy County, New Mexico**

Ensolum, LLC (Ensolum), on behalf of XTO Energy, Inc. (XTO), has prepared the following *Remediation Work Plan (Work Plan)* to propose sampling activities to address impacted soil identified at the Poker Lake Unit #153 (Site). On August 6, 2025, a *Closure Request Addendum (2025 Addendum)* was submitted to the New Mexico Oil Conservation Division (NMOCD) as a supplement to the July 26, 2021 *Closure Request Addendum (2021 Addendum)* and March 20, 2020 *Closure Request* detailing delineation activities at the Poker Lake Unit #153 (Site). The *2025 Addendum* was denied by the NMOCD on September 24, 2025. In the denial, NMOCD requested additional delineation sampling activities. The following *Work Plan* proposes additional soil sampling and potential remediation activities in support of requesting No Further Action (NFA) for Incident Numbers nJMW1219345739, nJMW1228429248, nJMW1228428008, nJMW1231129593, and nHMP1441828179.

XTO Energy, Inc.  
Remediation Work Plan  
Poker Lake Unit #153

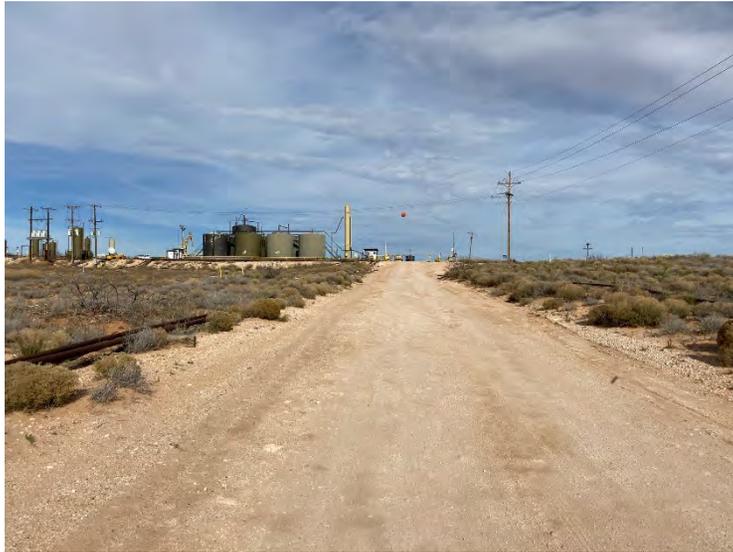
**Photograph 1:** View of lease road leading to pad – looking east.

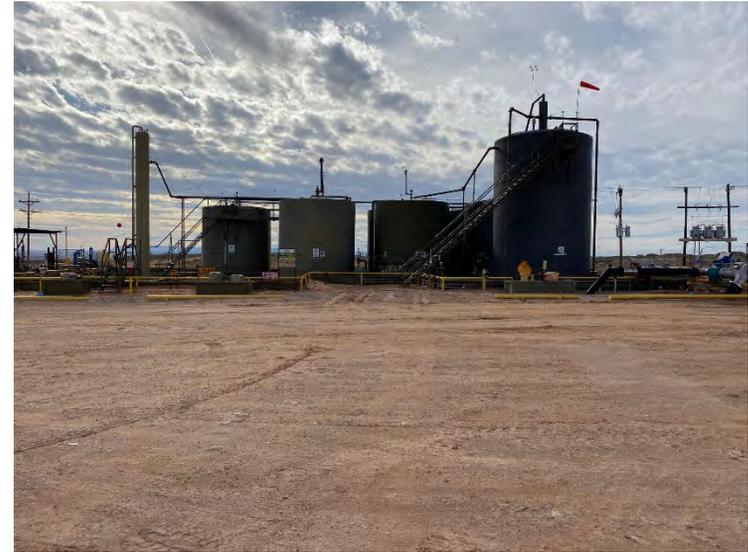
**Photograph 2:** View of pad and SWD tank battery – looking west

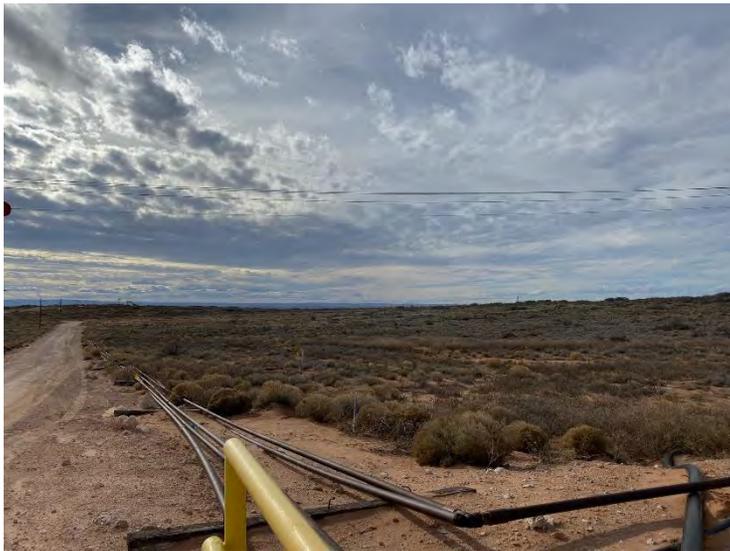
**Photograph 3:** View of well vegetated western pasture area.

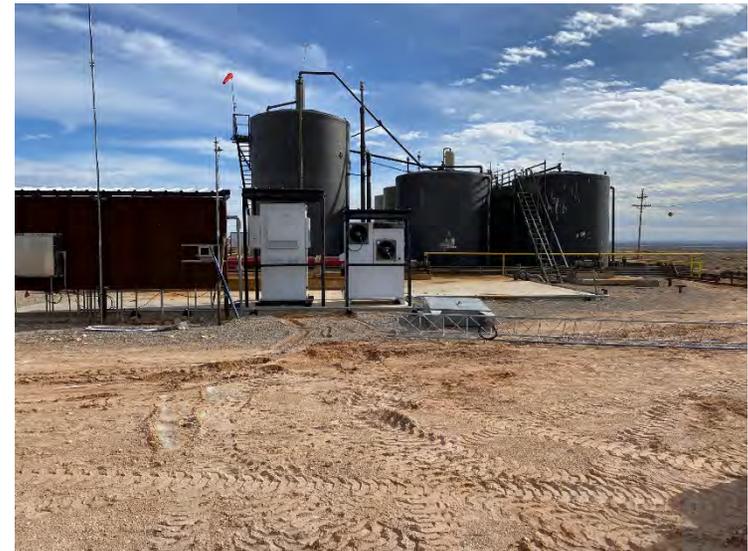
**Photograph 4:** View of pad and SWD tank battery – looking south.

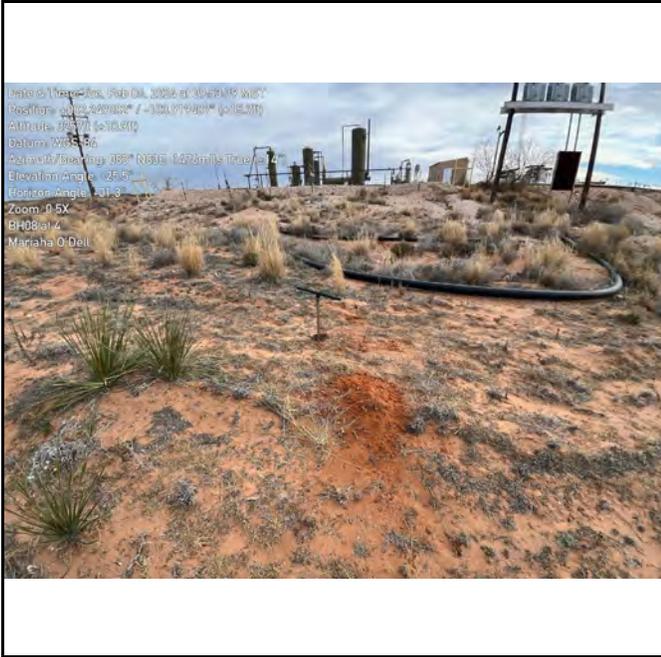
Photograph 1 Date: 02/06/2024  
Description: BH08  
View: East

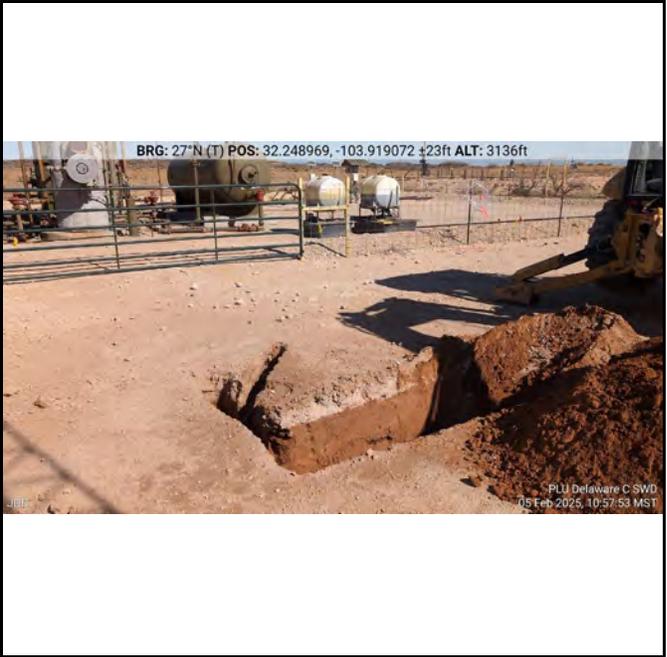
Photograph 2 Date: 02/05/2025  
Description: SS07  
View: North-northeast

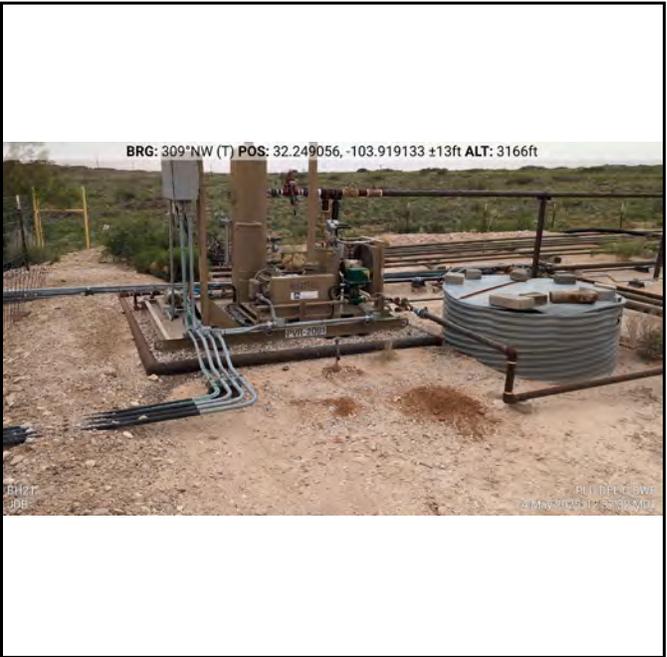
Photograph 4 Date: 05/14/2025  
Description: BH21  
View: Northwest
