Re: Closure Report

Thistle Unit 22 CTB 2 Unit 185H
Incident Number nAPP2519126637
Lea County, New Mexico

**Devon Energy Production Company, LP
Thistle Unit 22 CTB 2
Closure Report**

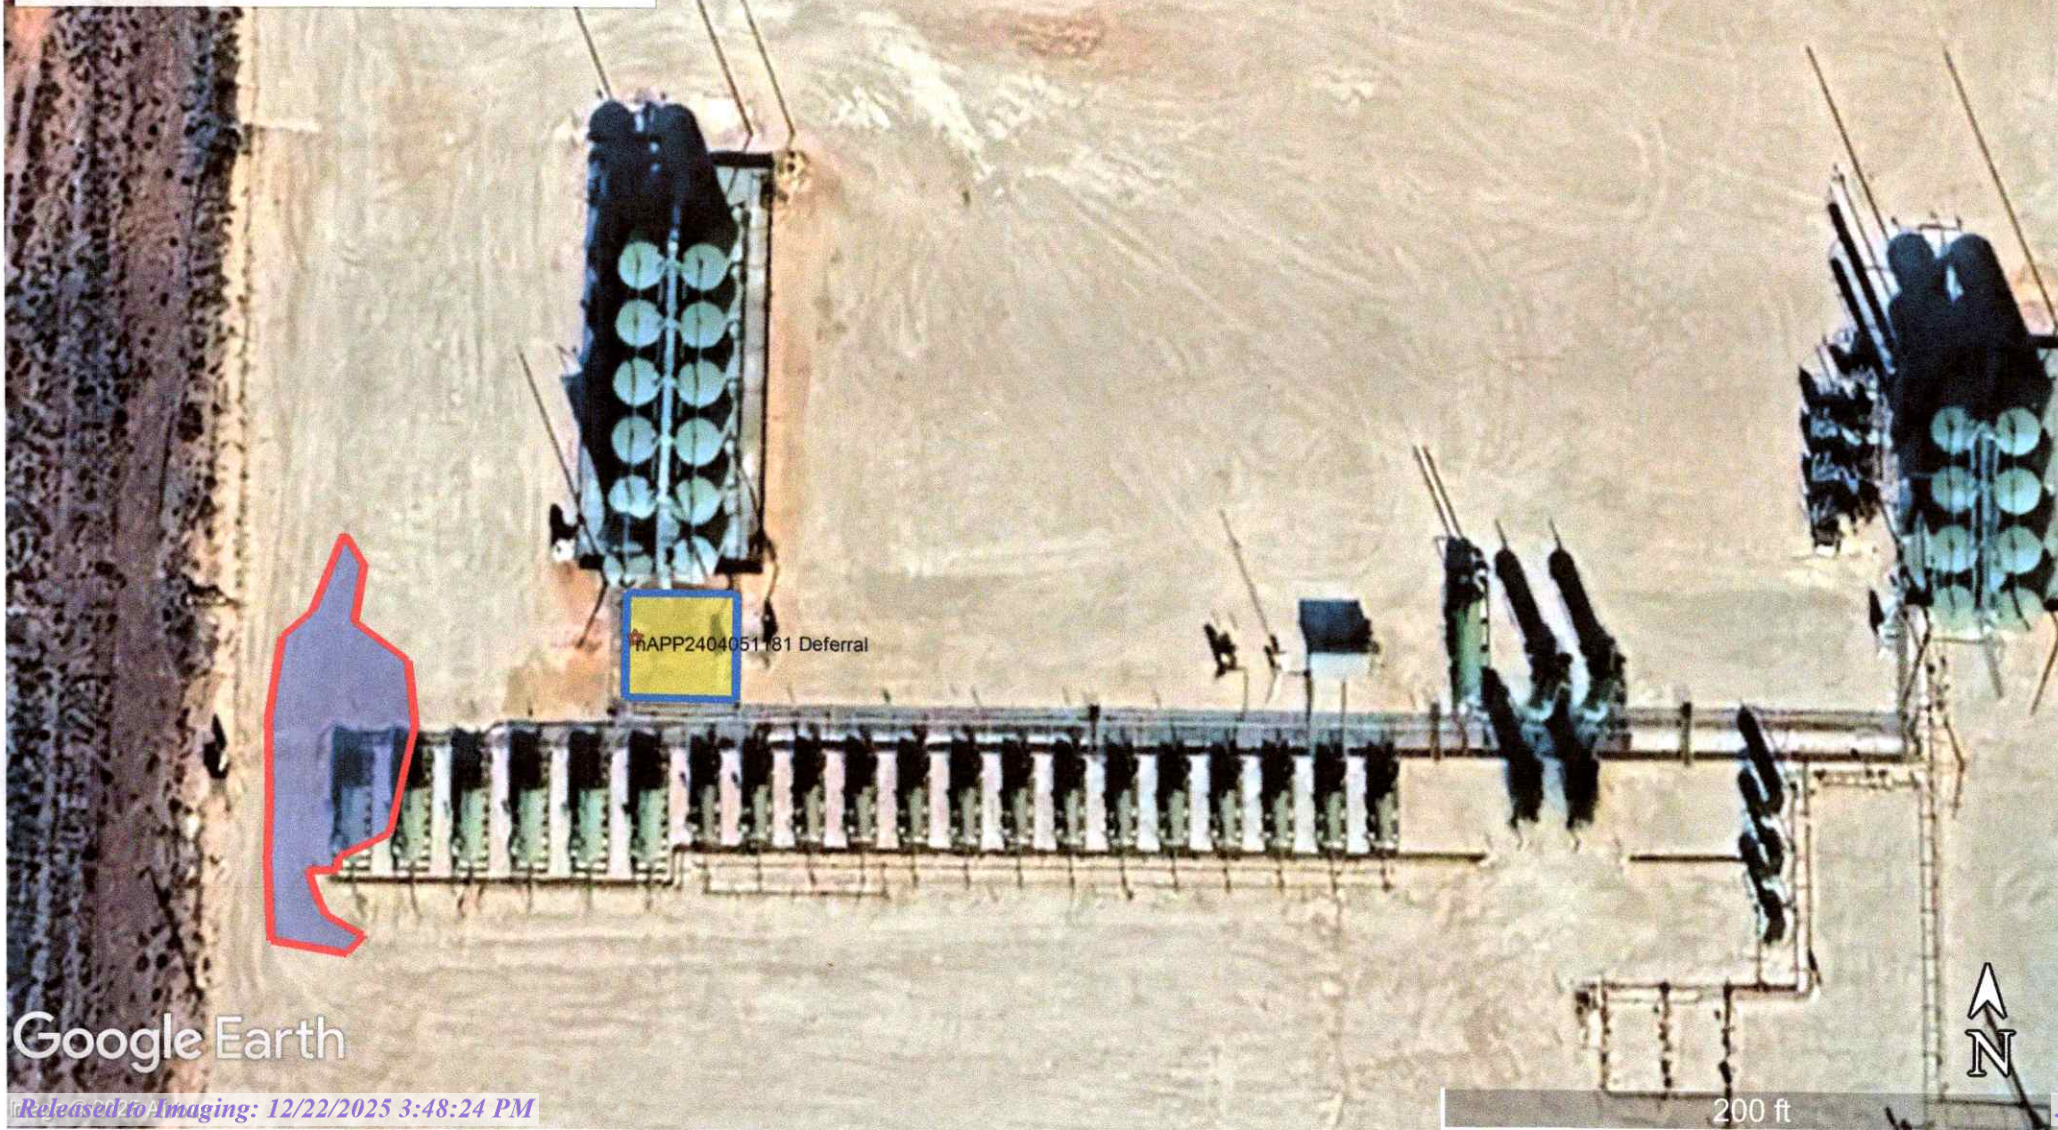
nAPP25119126637 Release Area

Incident C-141 received on 07/10/2025 for release on 07/09/2025. The cause of the release was reported as equipment failure: "Leak on 3-phase separator dump spool. Approximately 1BBL of produced water impacted the production pad. Produced Water | Released: 8 BBL | Recovered: 7 BBL | Lost: 1 BBL.

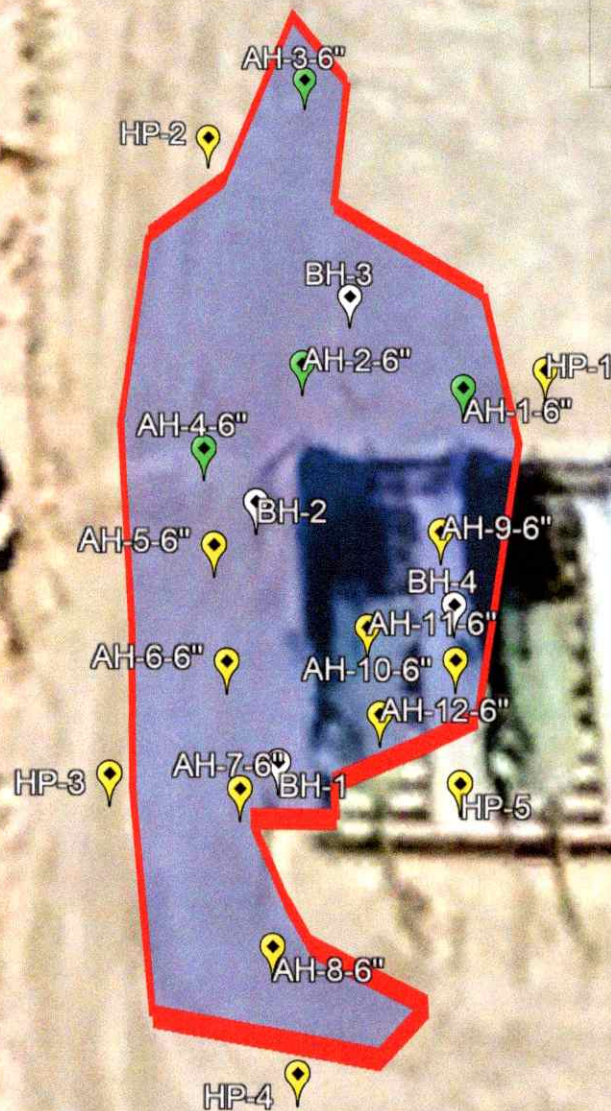
Delineation Sample Map

- AH-1 through AH-16
- HP1 through HP-12
- Release Area
- Release extension
- SS1 & SS2 (Under Separator)

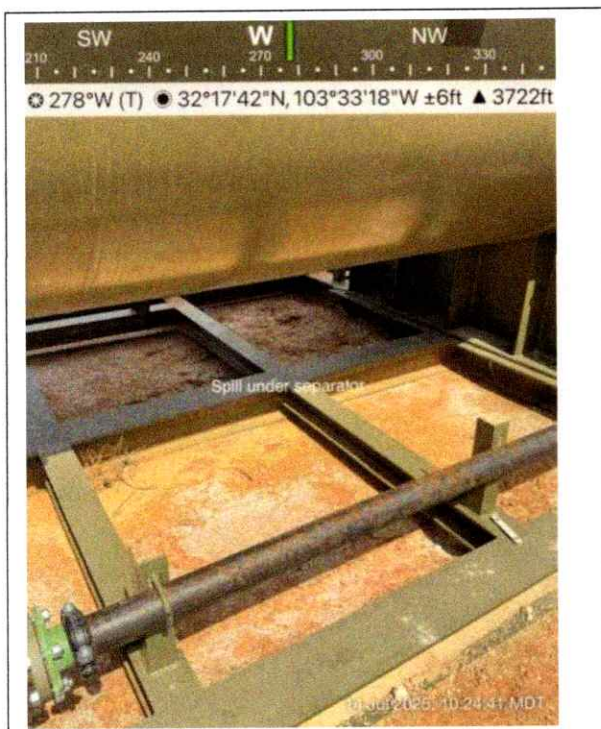
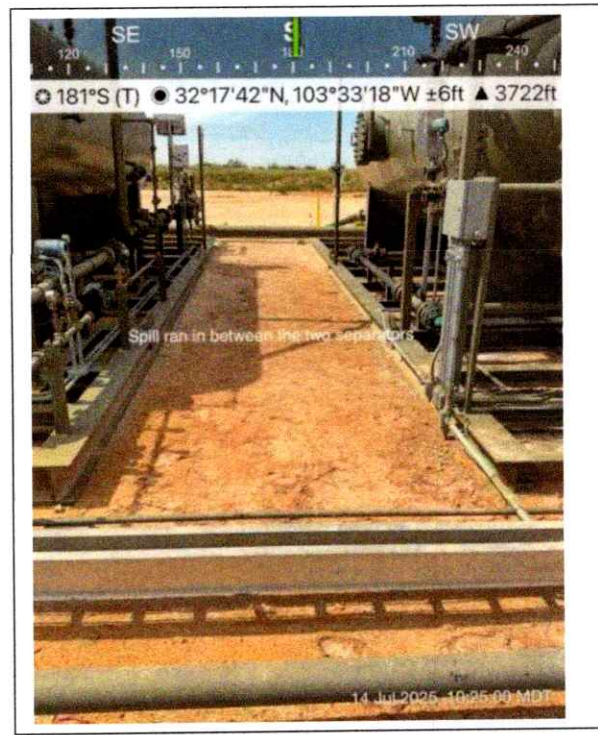
Thistle Unit 22 185 H

July 14, 2025

Excavation activities were conducted to depths ranging from approximately 0.5 inches to 2 feet below ground surface (bgs). Areas located beneath critical infrastructure were surface scraped to approximately 0.5 inches to remove observable staining to the maximum extent practicable.
