Operator: Coterra Energy Operating Co. 6001 Deauville Blvd Midland, TX 79706	OGRID: 215099
	Action Number: 526040
	Action Type: [NOTIFY] Notification Of Release (NOR)

Location of Release Source <i>Please answer all the questions in this group.</i>	
Site Name	Merchant Livestock 19 State 1 CTB
Date Release Discovered	11/12/2025
Surface Owner	State

Liner Integrity Certification

The following serves to verify that the affected liner has been inspected and found to be in serviceable condition in accordance with 19.15.29.11 A.(5)(a)(i-ii) of the New Mexico Administrative Code.

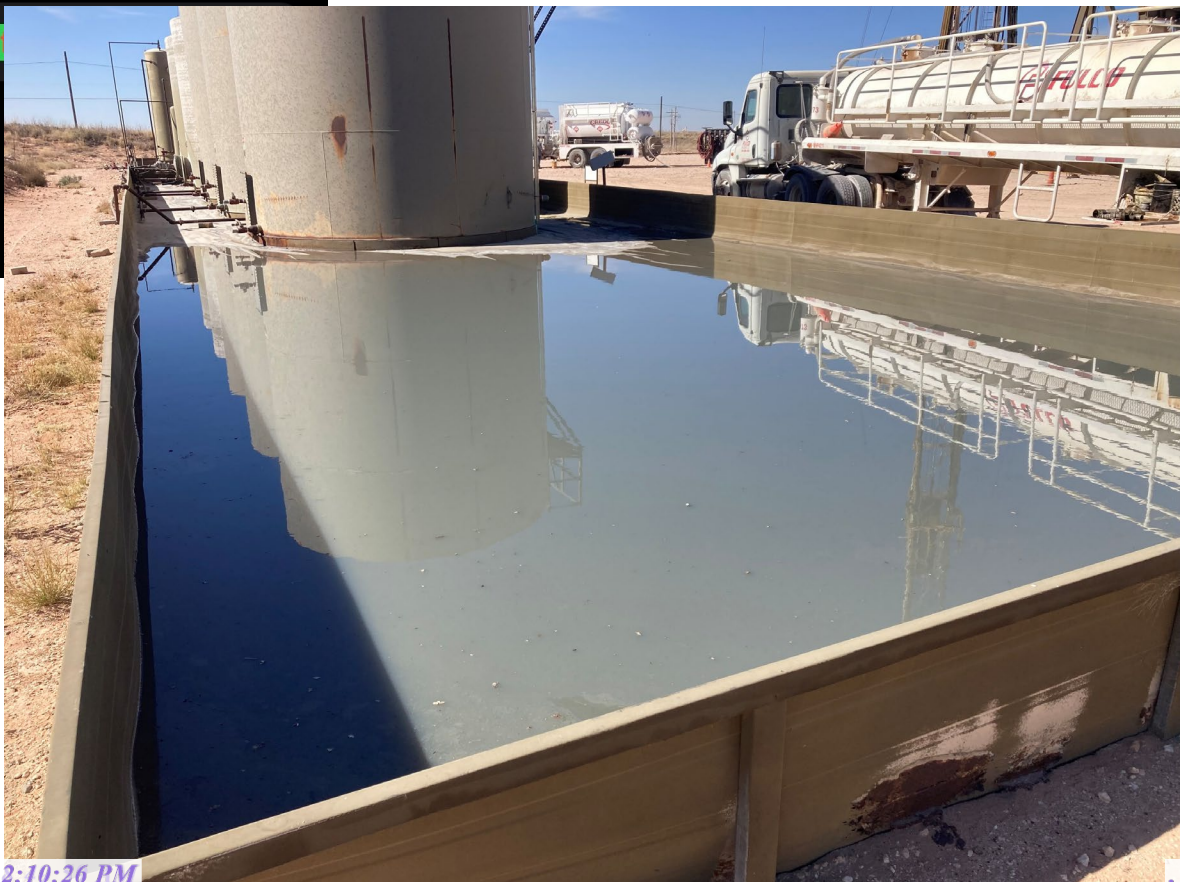
Standing Liquid Calculation

L(Ft)	W(Ft)	D(In)	Oil %
36	25.5	3	%

H2O Spill Total: 40.87 Bbls

Total Spilled: 40.87 Bbls

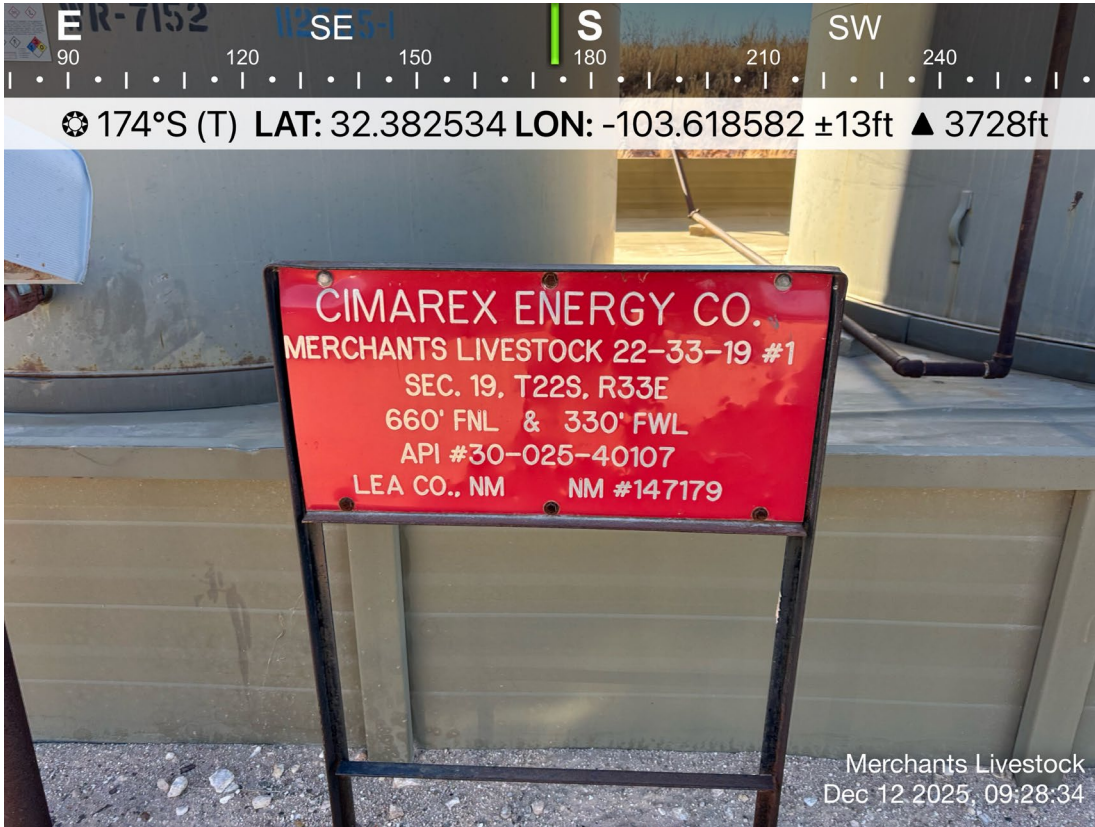
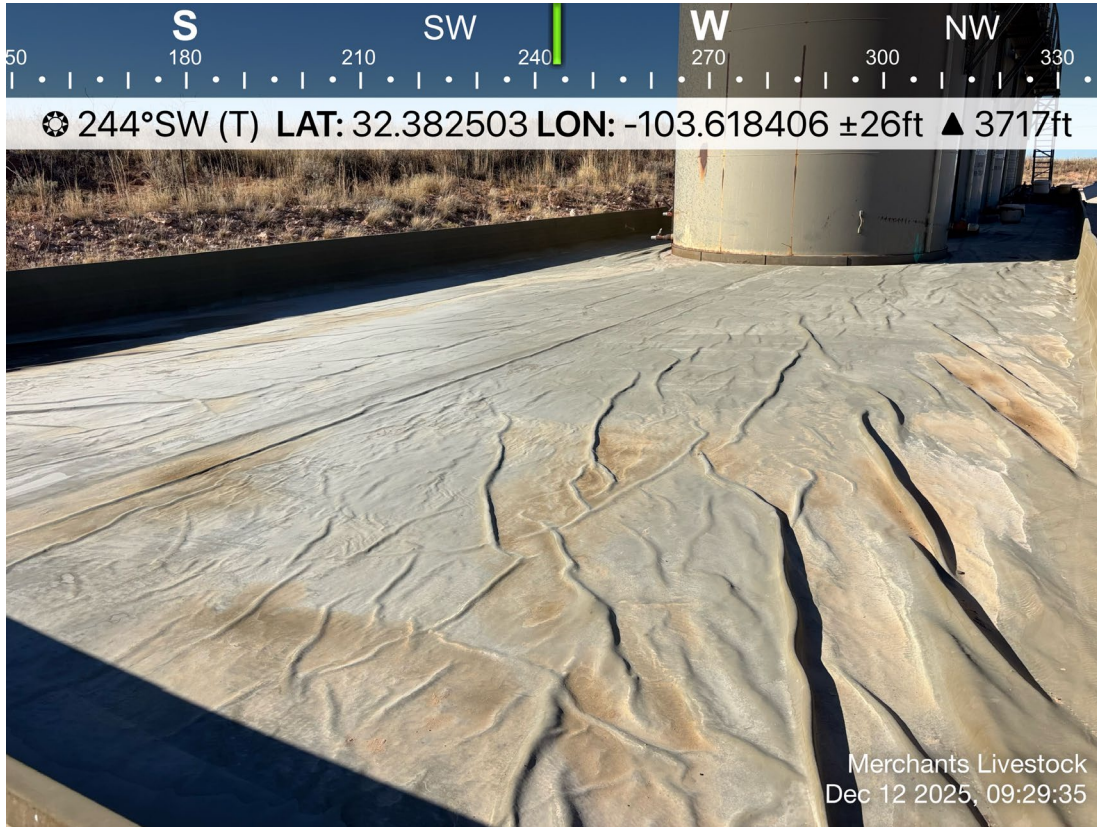
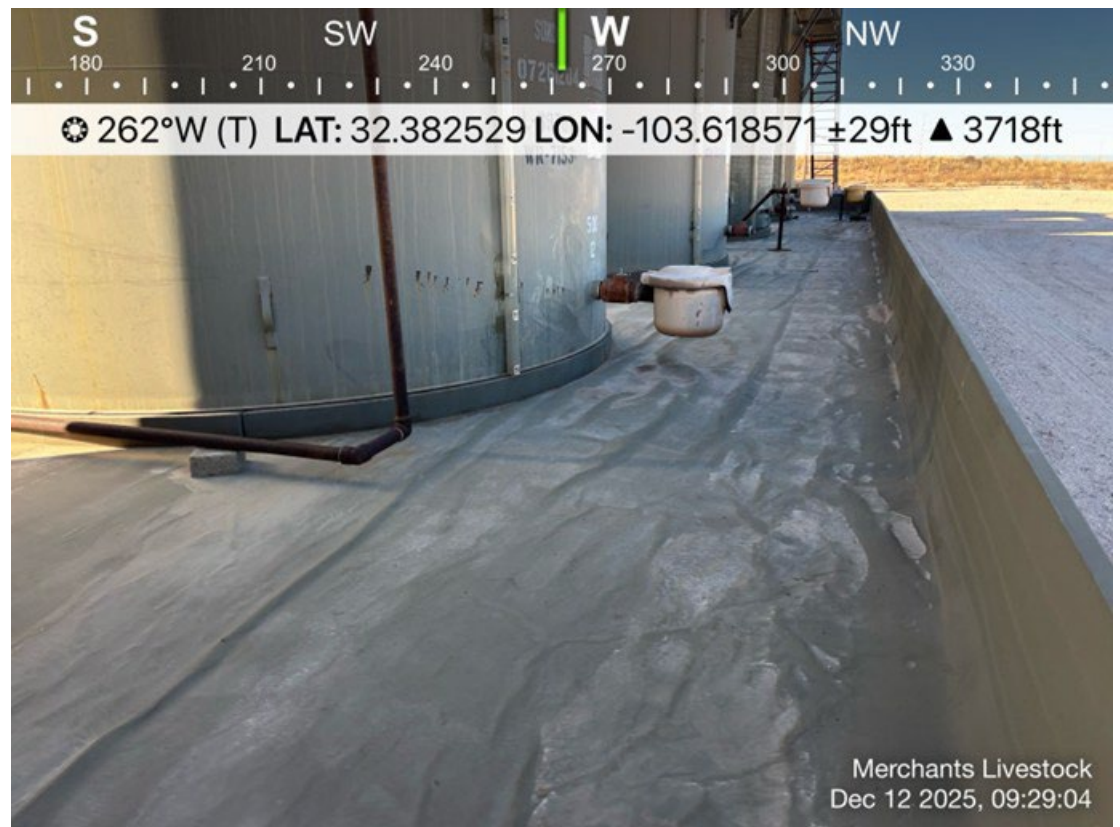
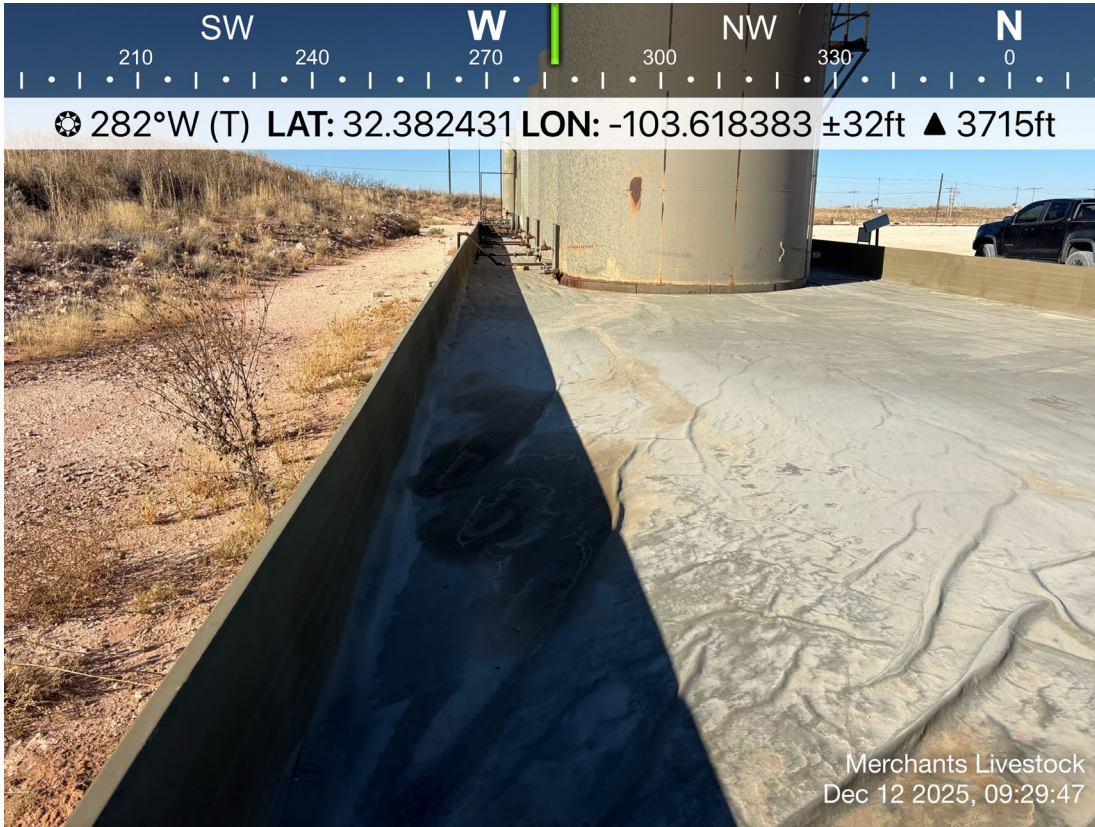
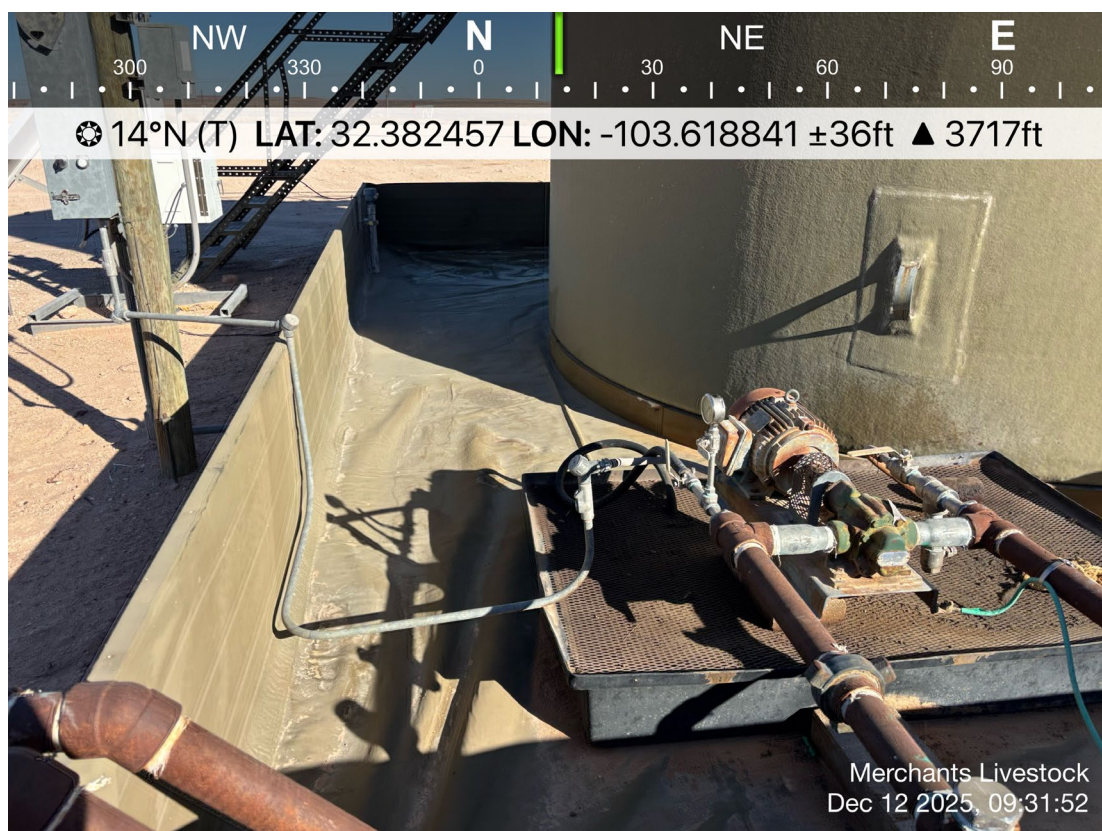
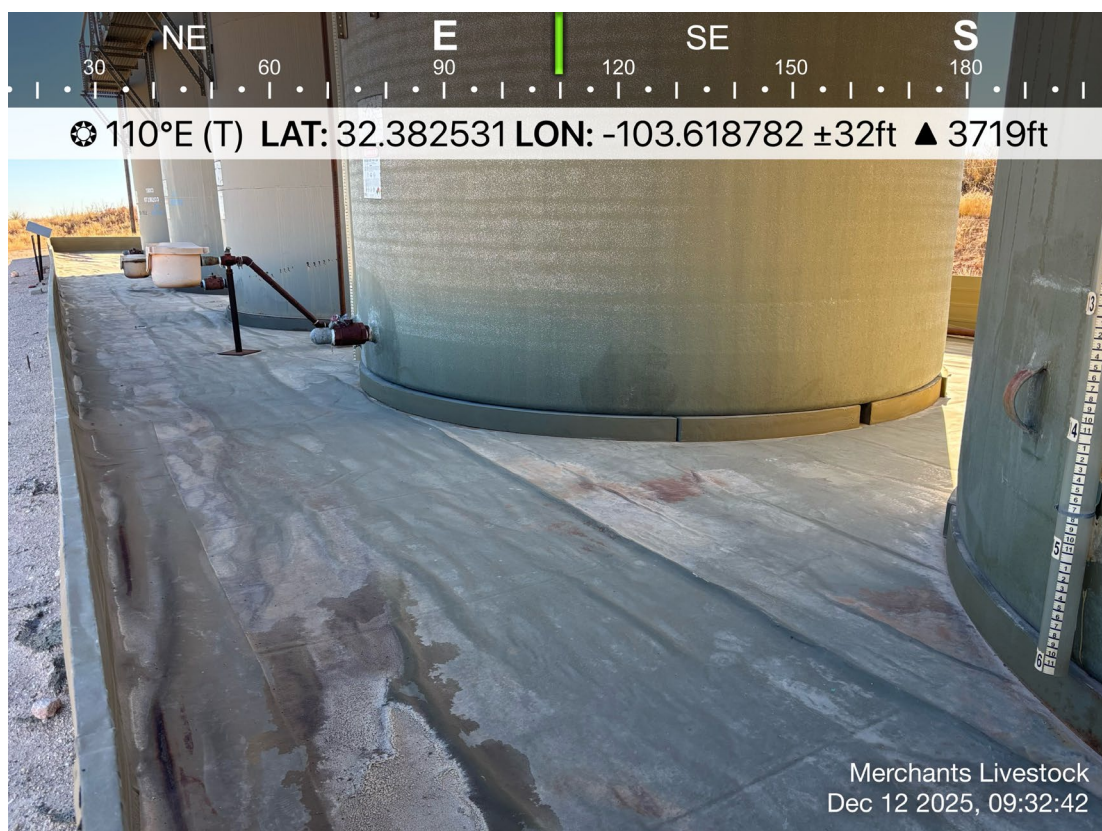
- ☒ Responsible Party has visually inspected the liner.
- ☒ Liner remains intact and was able to contain the leak in question.
- ☒ At least two business days' notice was given to the appropriate division district office before conducting the liner inspection.
- ☒ Photographs illustrating liner integrity are included.

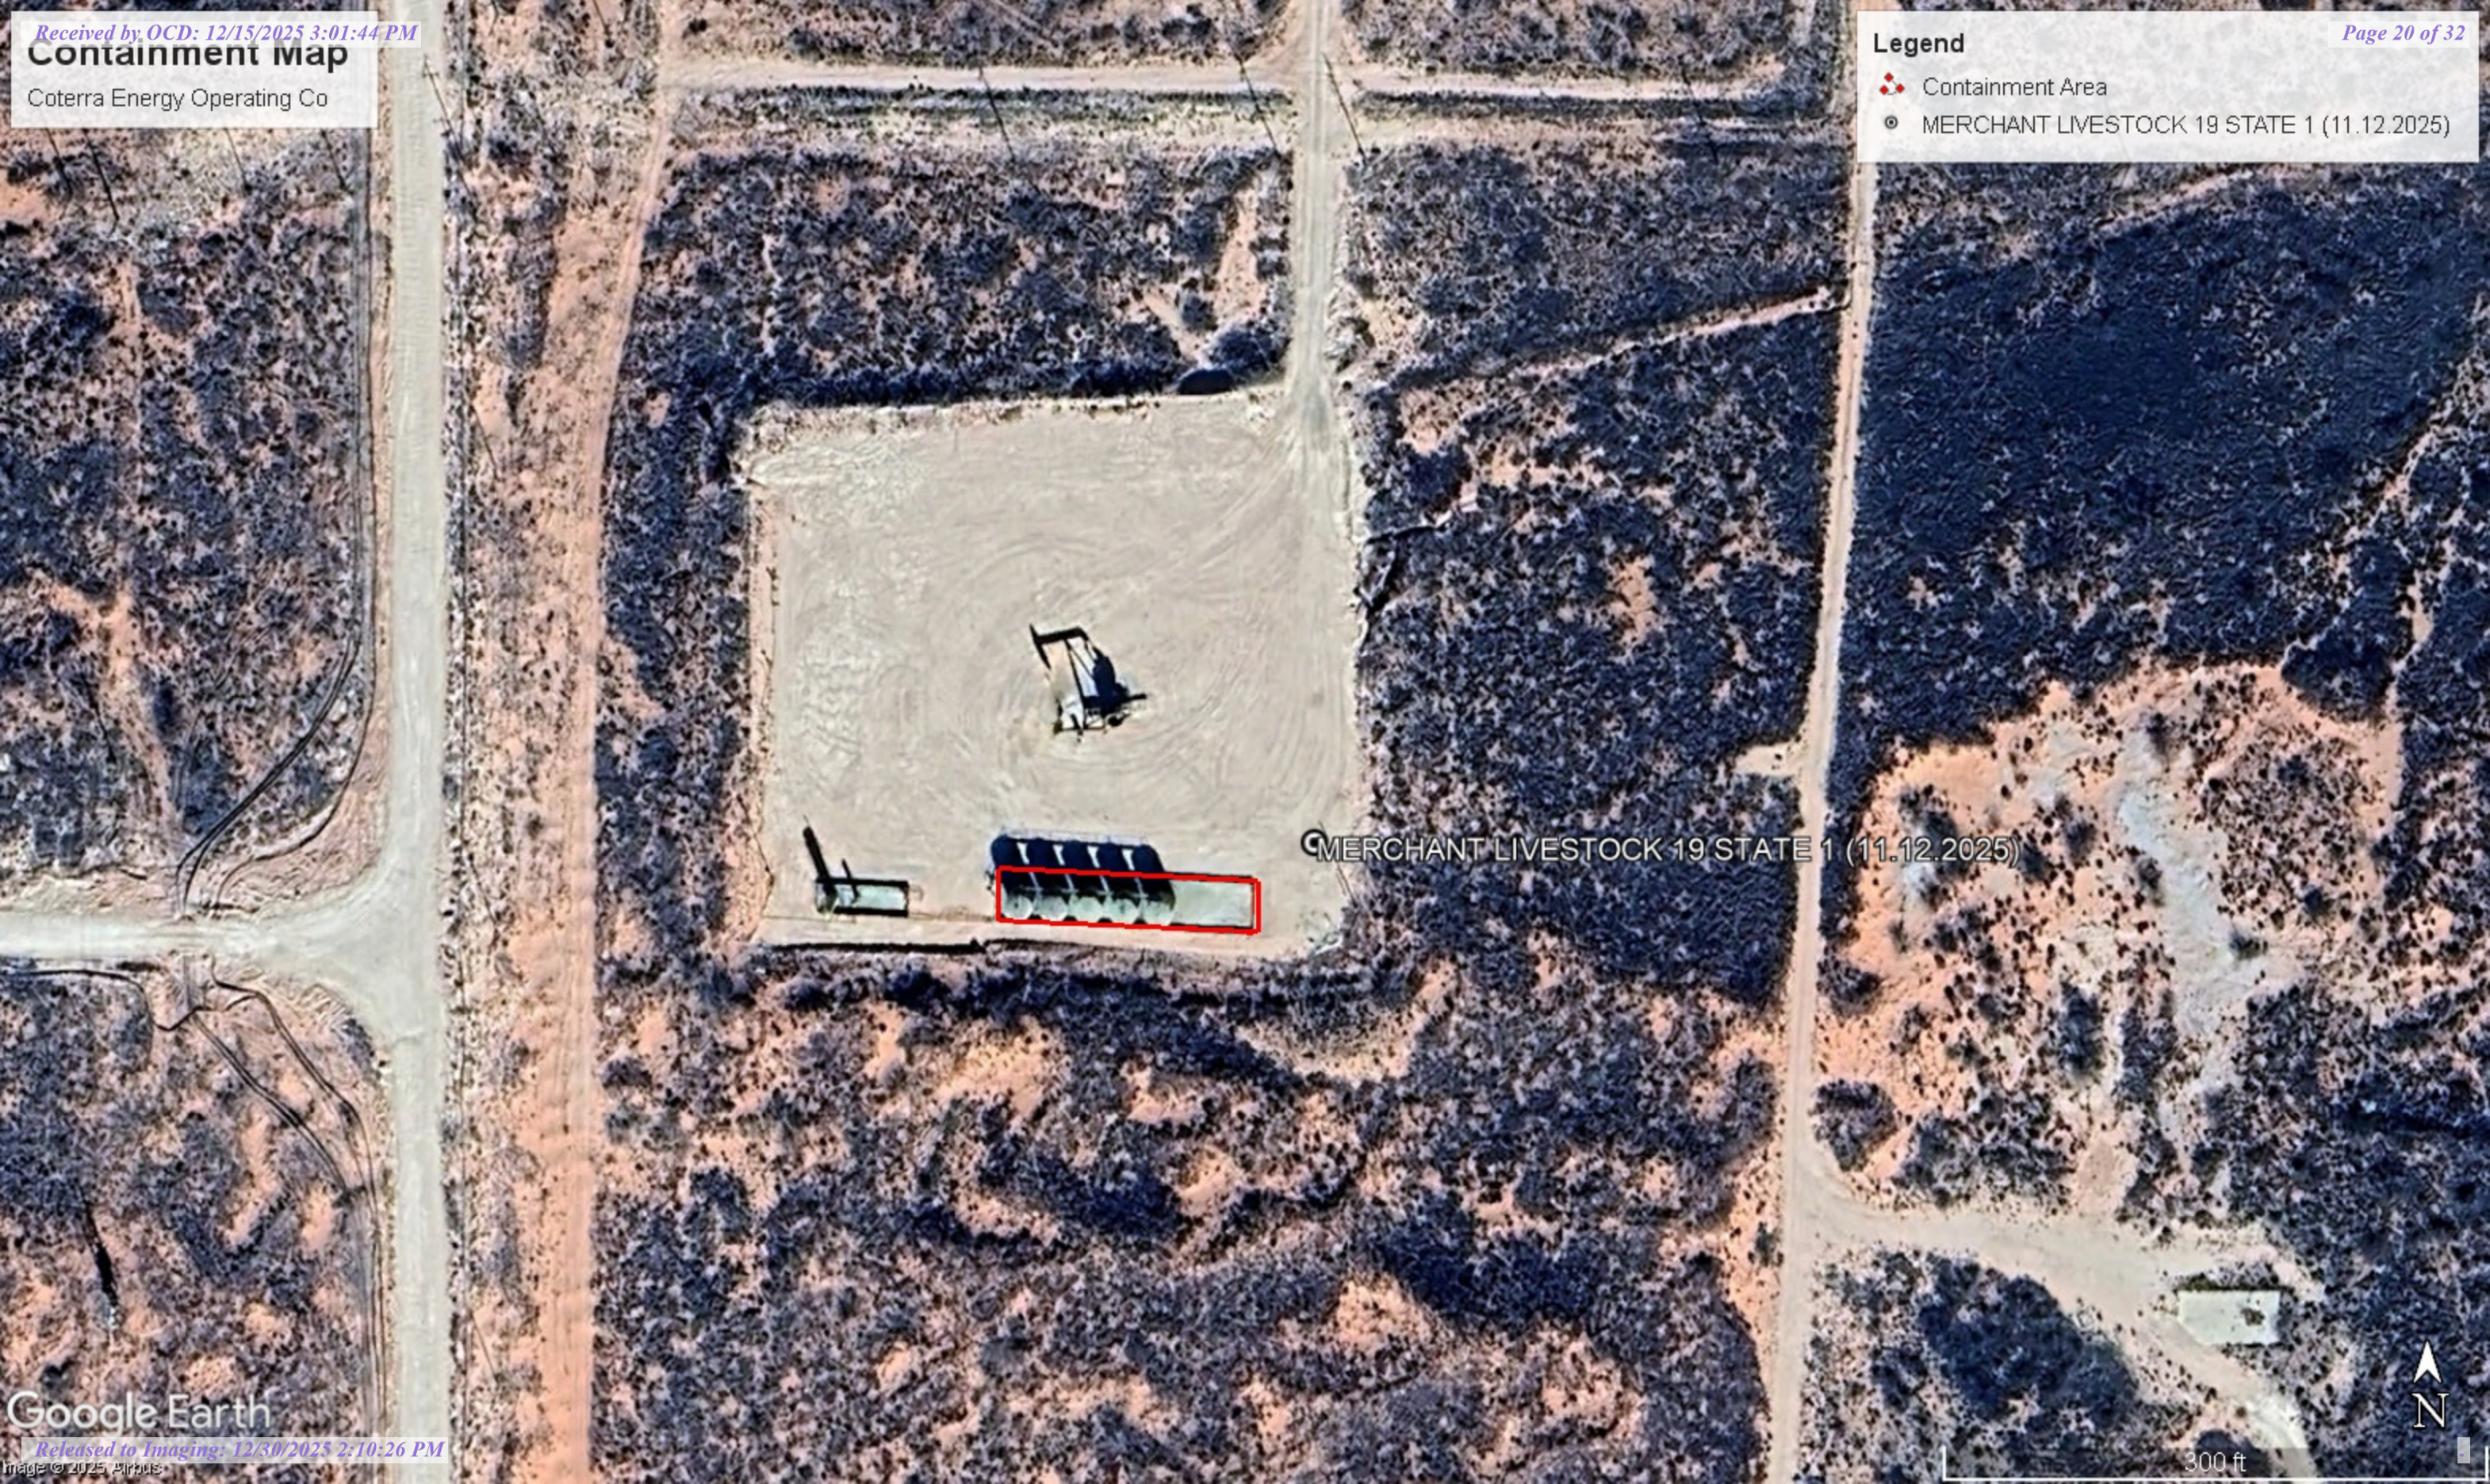
Containment map

Containment Area
-

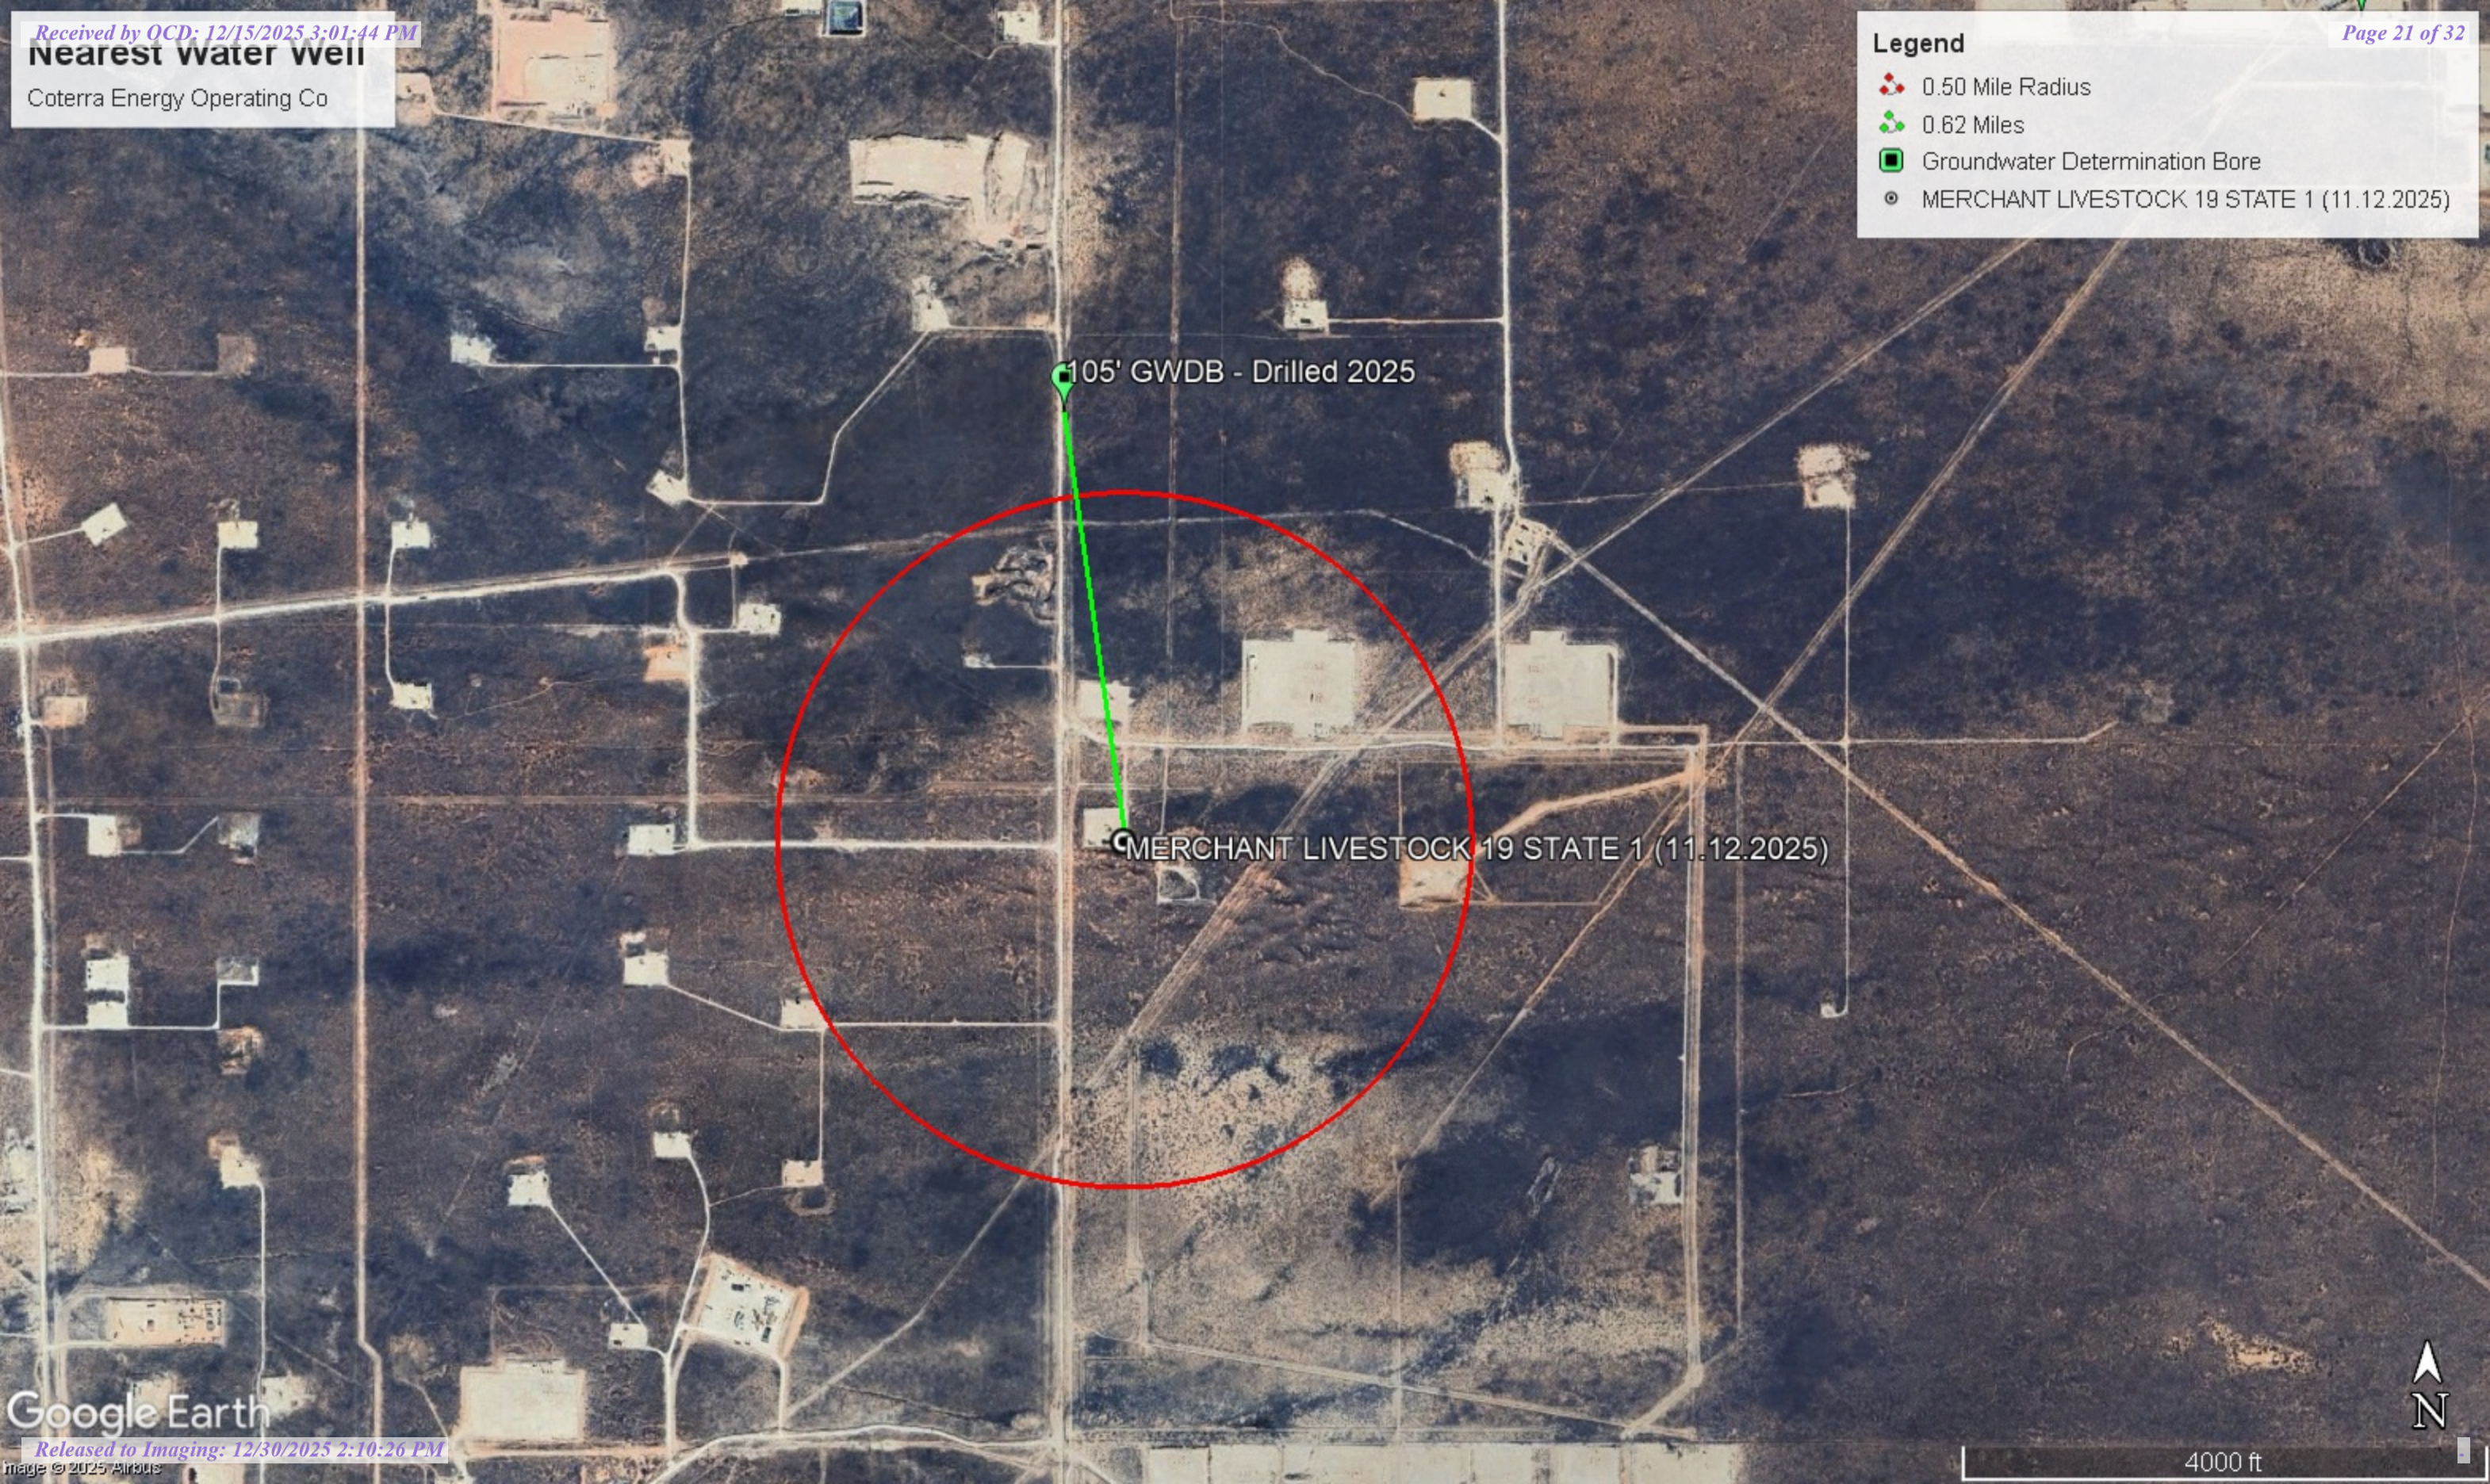
Nearest water well

- 0.50 Mile Radius
- 0.62 Miles
- Groundwater Determination Bore
- MERCHANT LIVESTOCK 19 STATE 1 (11.12.2025)

105' GWDB - Drilled 2025
