CLOSURE REPORT

Bisti 10E-1
Unit Letter F, S36 T27N R13W
San Juan County, New Mexico

New Mexico EMNRD OCD Incident ID No. NAPP2514846148

Ensolum Project No. 05A1226370

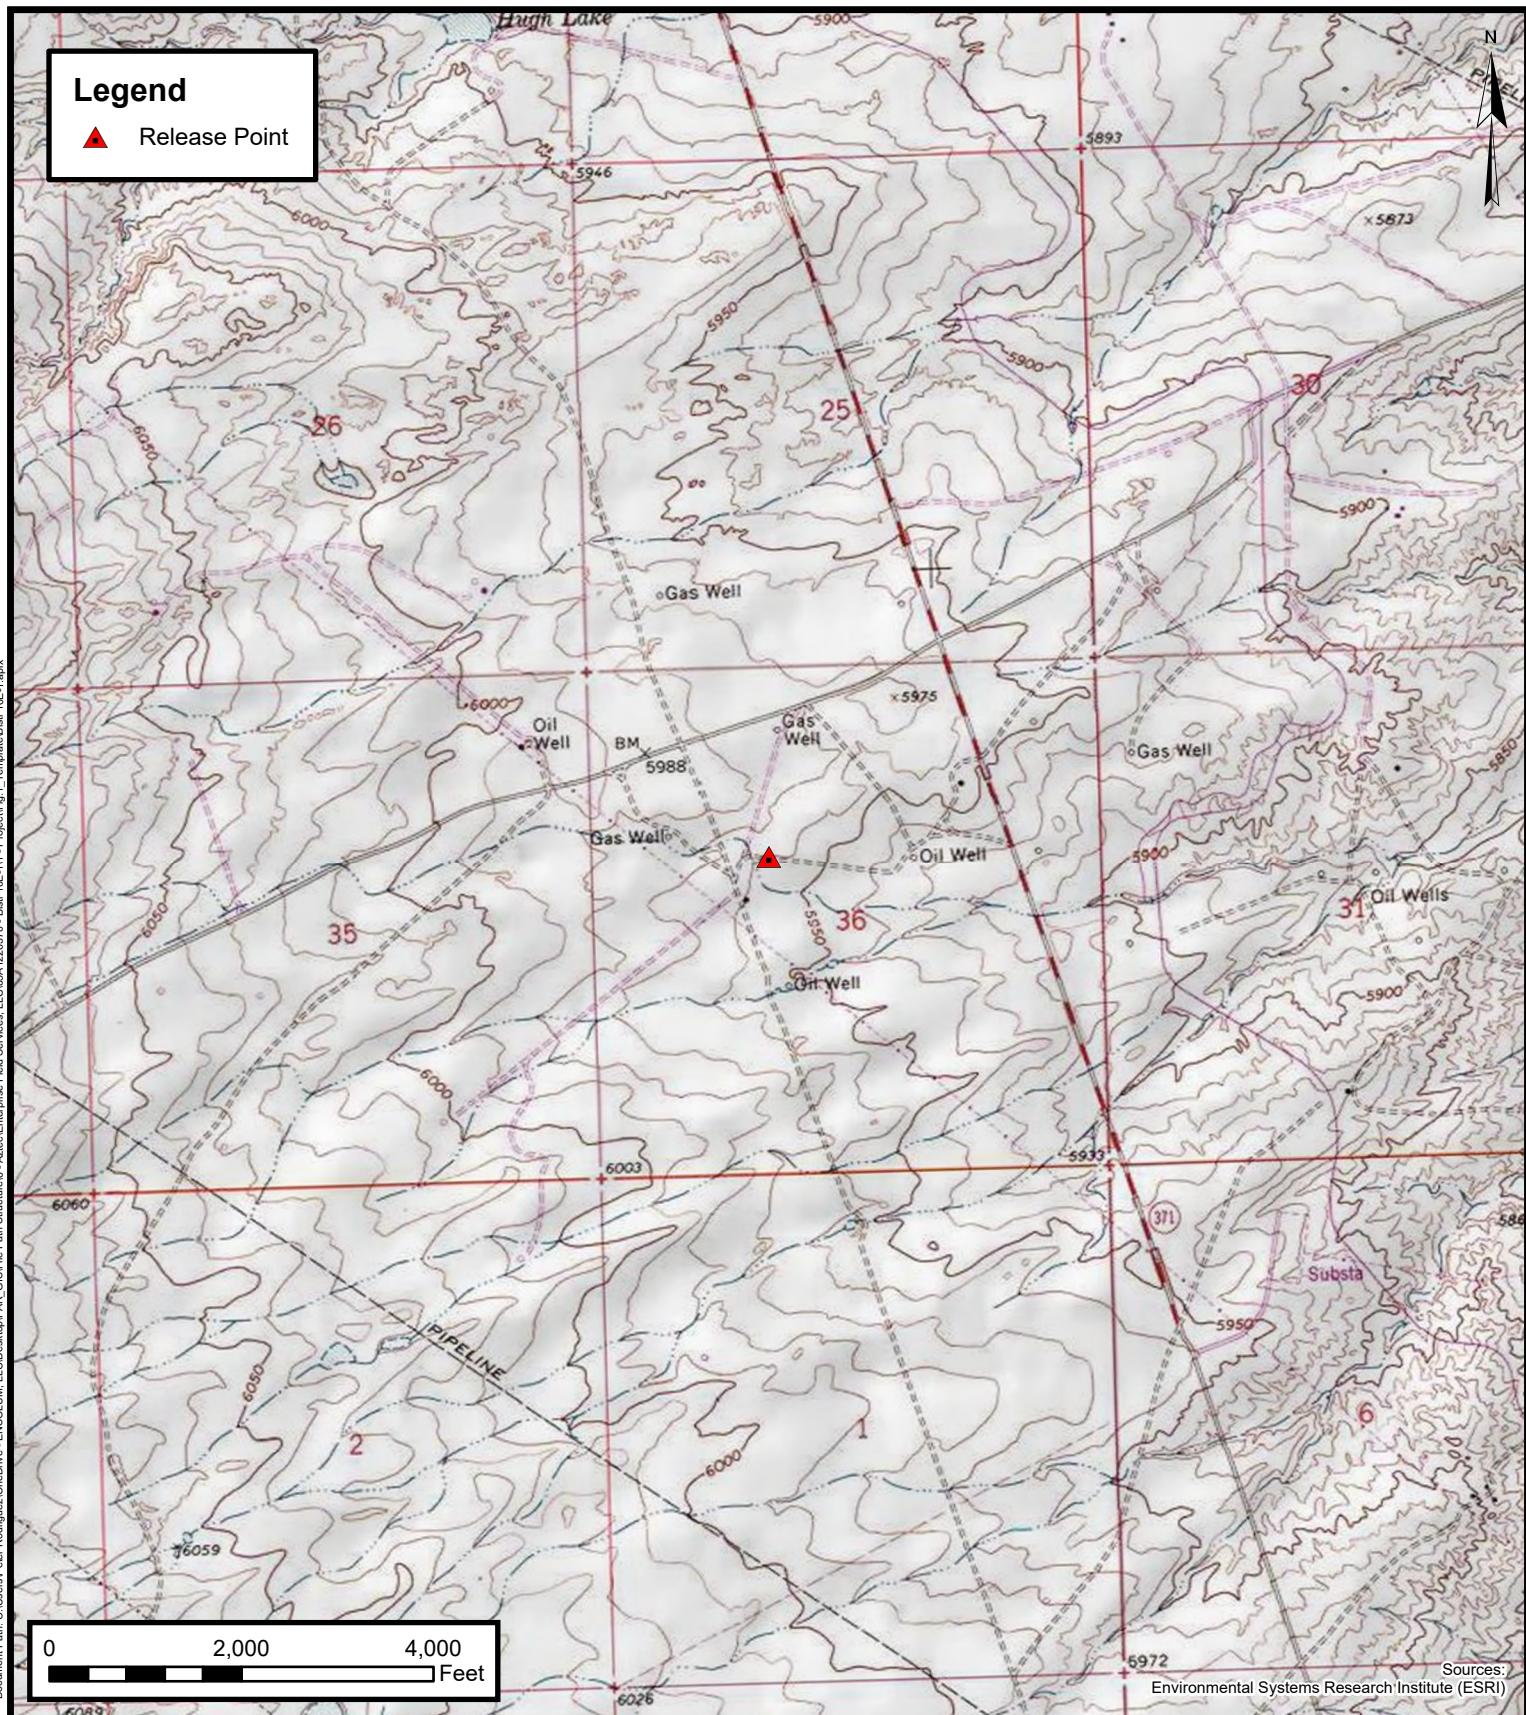
1

Topographic Map

A **Topographic Map** depicting the location of the Site is included as **Figure 1**, and a **Site Vicinity Map** is included as **Figure 2** in **Appendix A**.

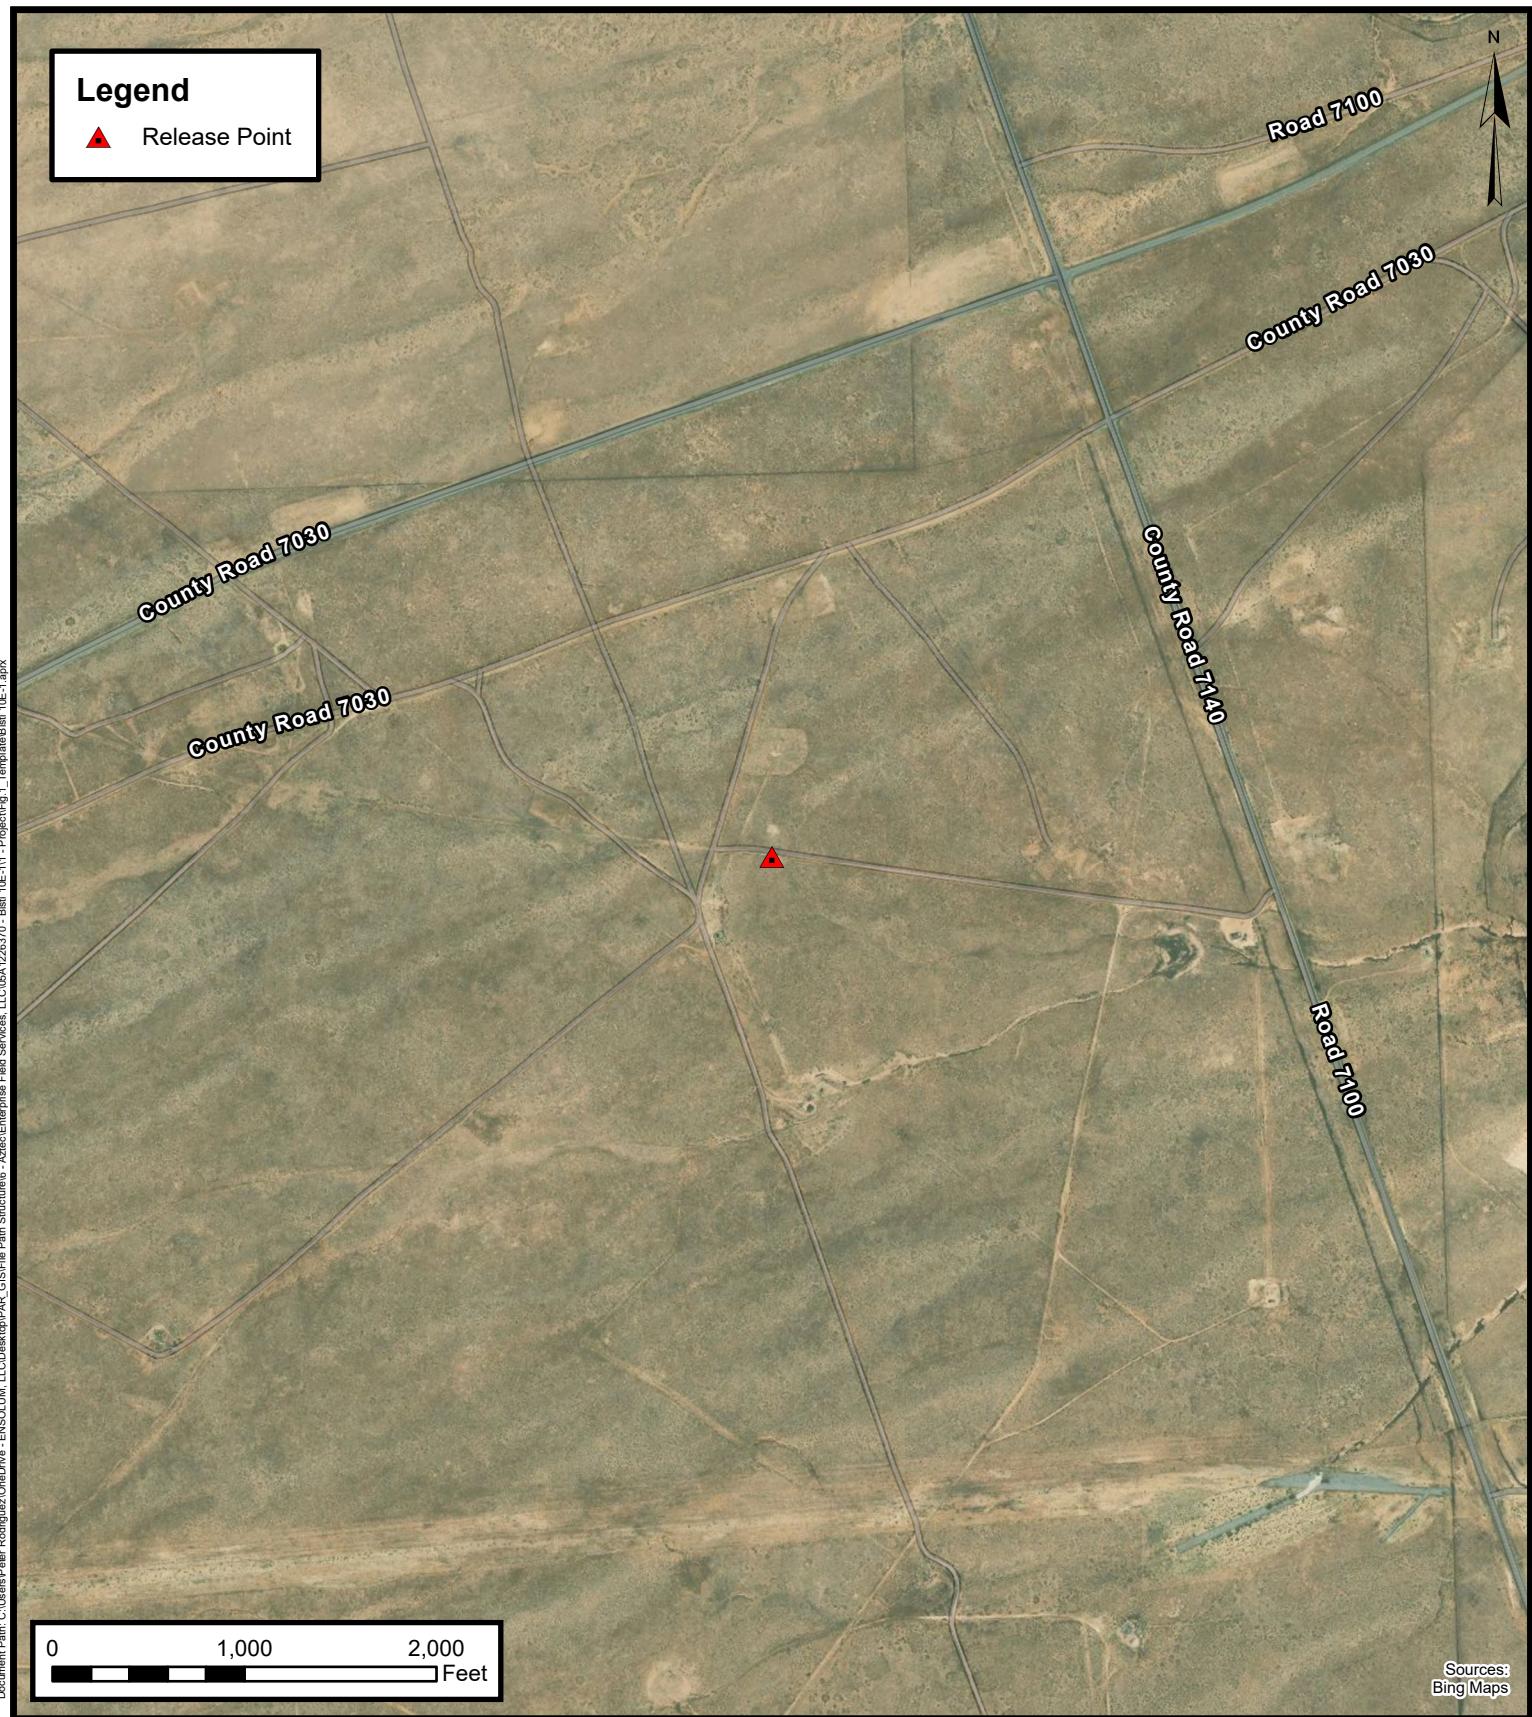
FIGURE
2

Site Vicinity Map

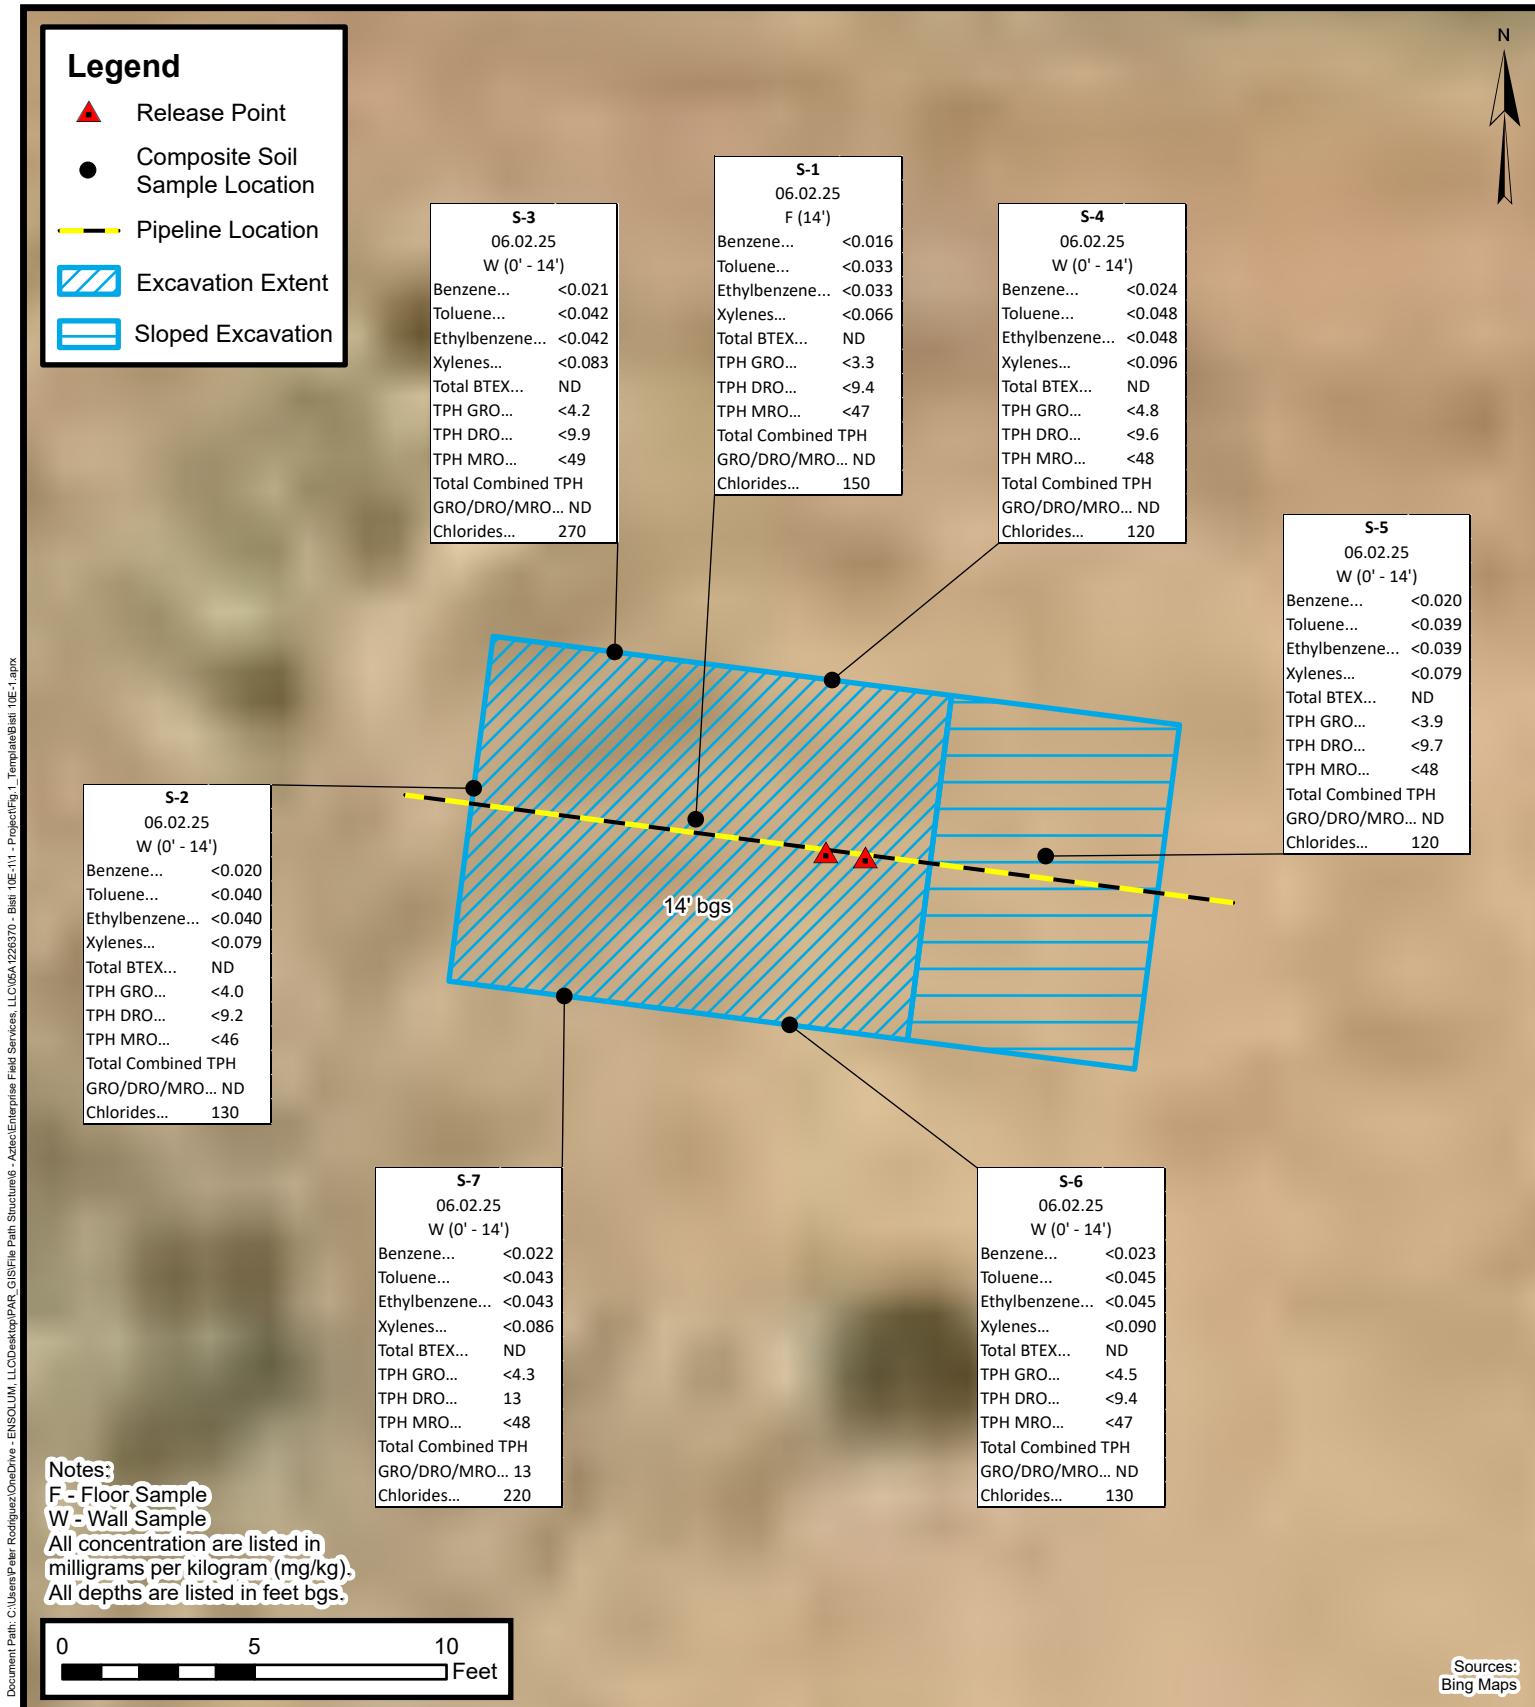
Figure 3 is a map that identifies approximate soil sample locations and depicts the approximate dimensions of the excavation with respect to the pipeline (**Appendix A**). Photographic documentation of the field activities is included in **Appendix D**.

Site Map with Soil Analytical Results

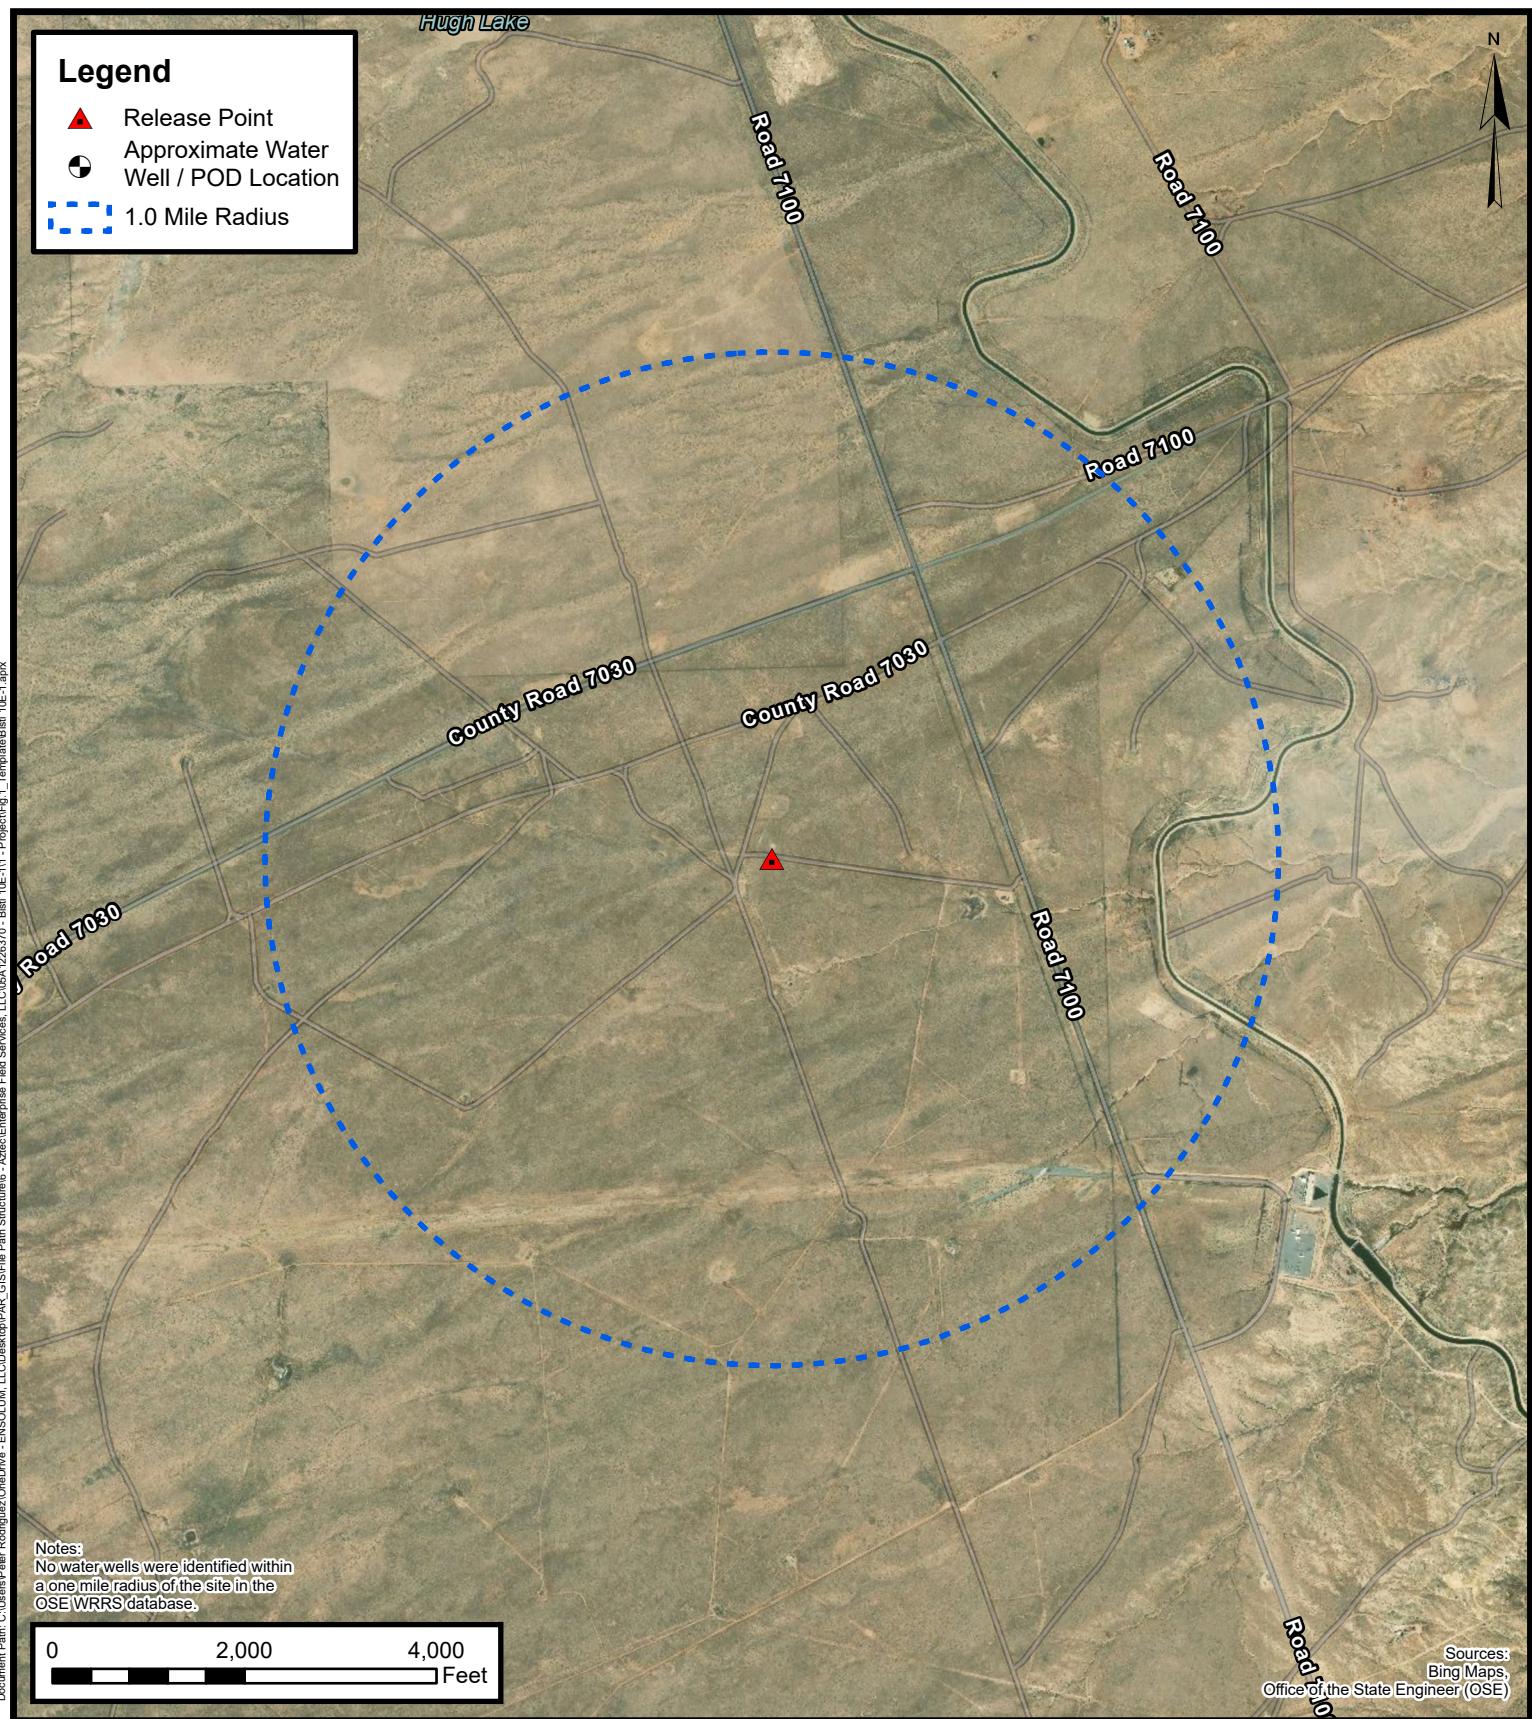
FIGURE A

- The NM Office of the State Engineer (OSE) tracks the usage and assignment of water rights and water well installations and records this information in the Water Rights Reporting System (WRRS) database. Water wells and other points of diversion (PODs) are each assigned POD numbers in the database (which is searchable and includes an interactive map). No PODs were identified in the same or adjacent Public Land Survey System (PLSS) sections (**Figure A, Appendix B**).

Notes:
No water wells were identified within a one mile radius of the site in the OSE WRSS database.

**1.0 Mile Radius Water Well /
POD Location Map**

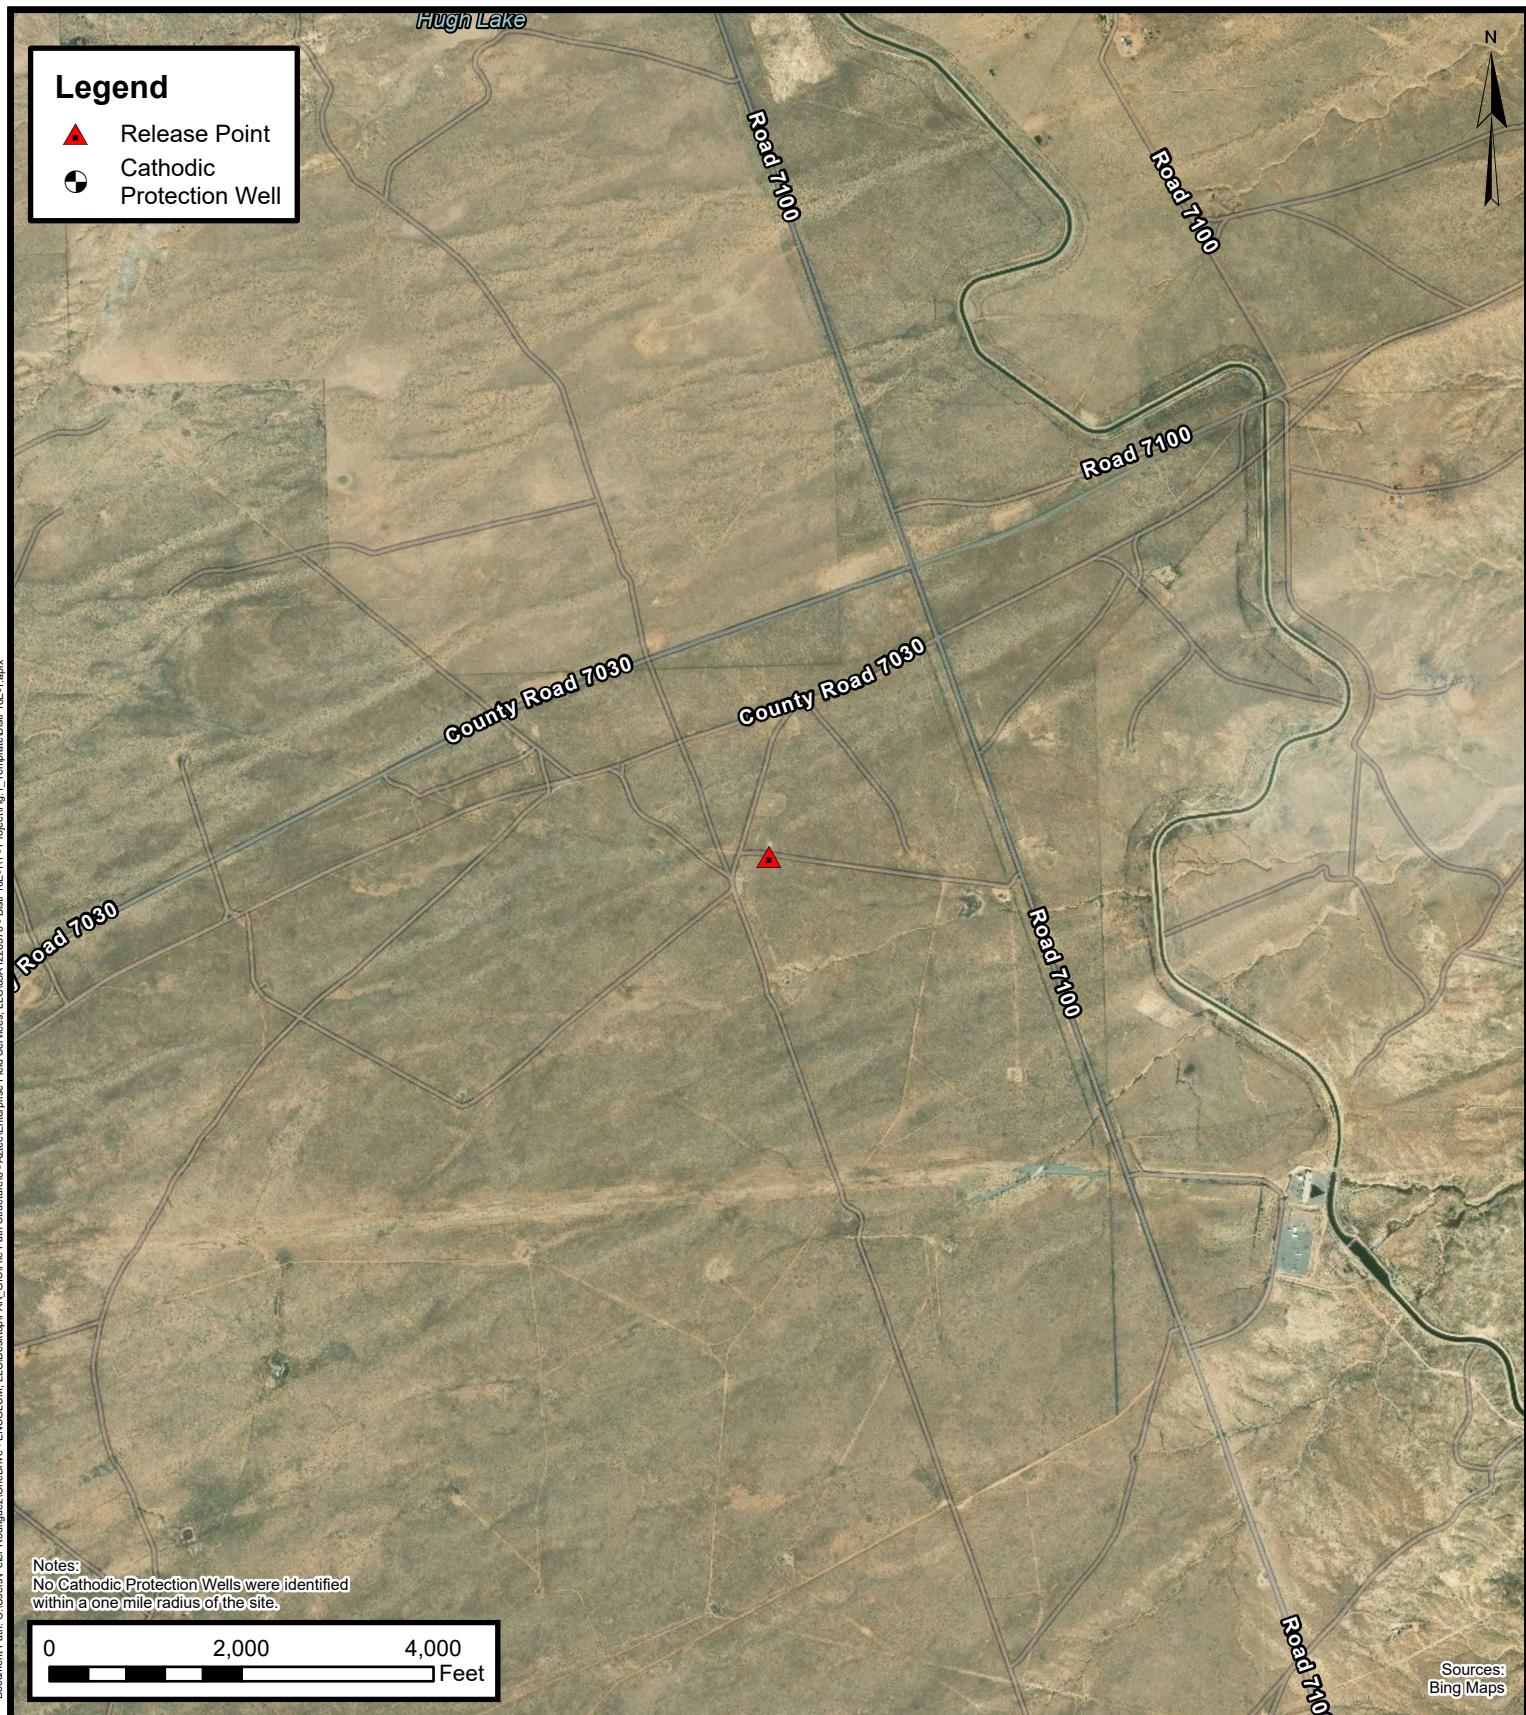
**FIGURE
B**

- No cathodic protection wells (CPWs) were identified in the NM EMNRD OCD imaging database in the same or adjacent PLSS sections (**Figure B, Appendix B**).

**Cathodic Protection Well
Recorded Depth to Water**
Enterprise Field Services, LLC
Bisti 10E-1
Project Number: 05A1226370

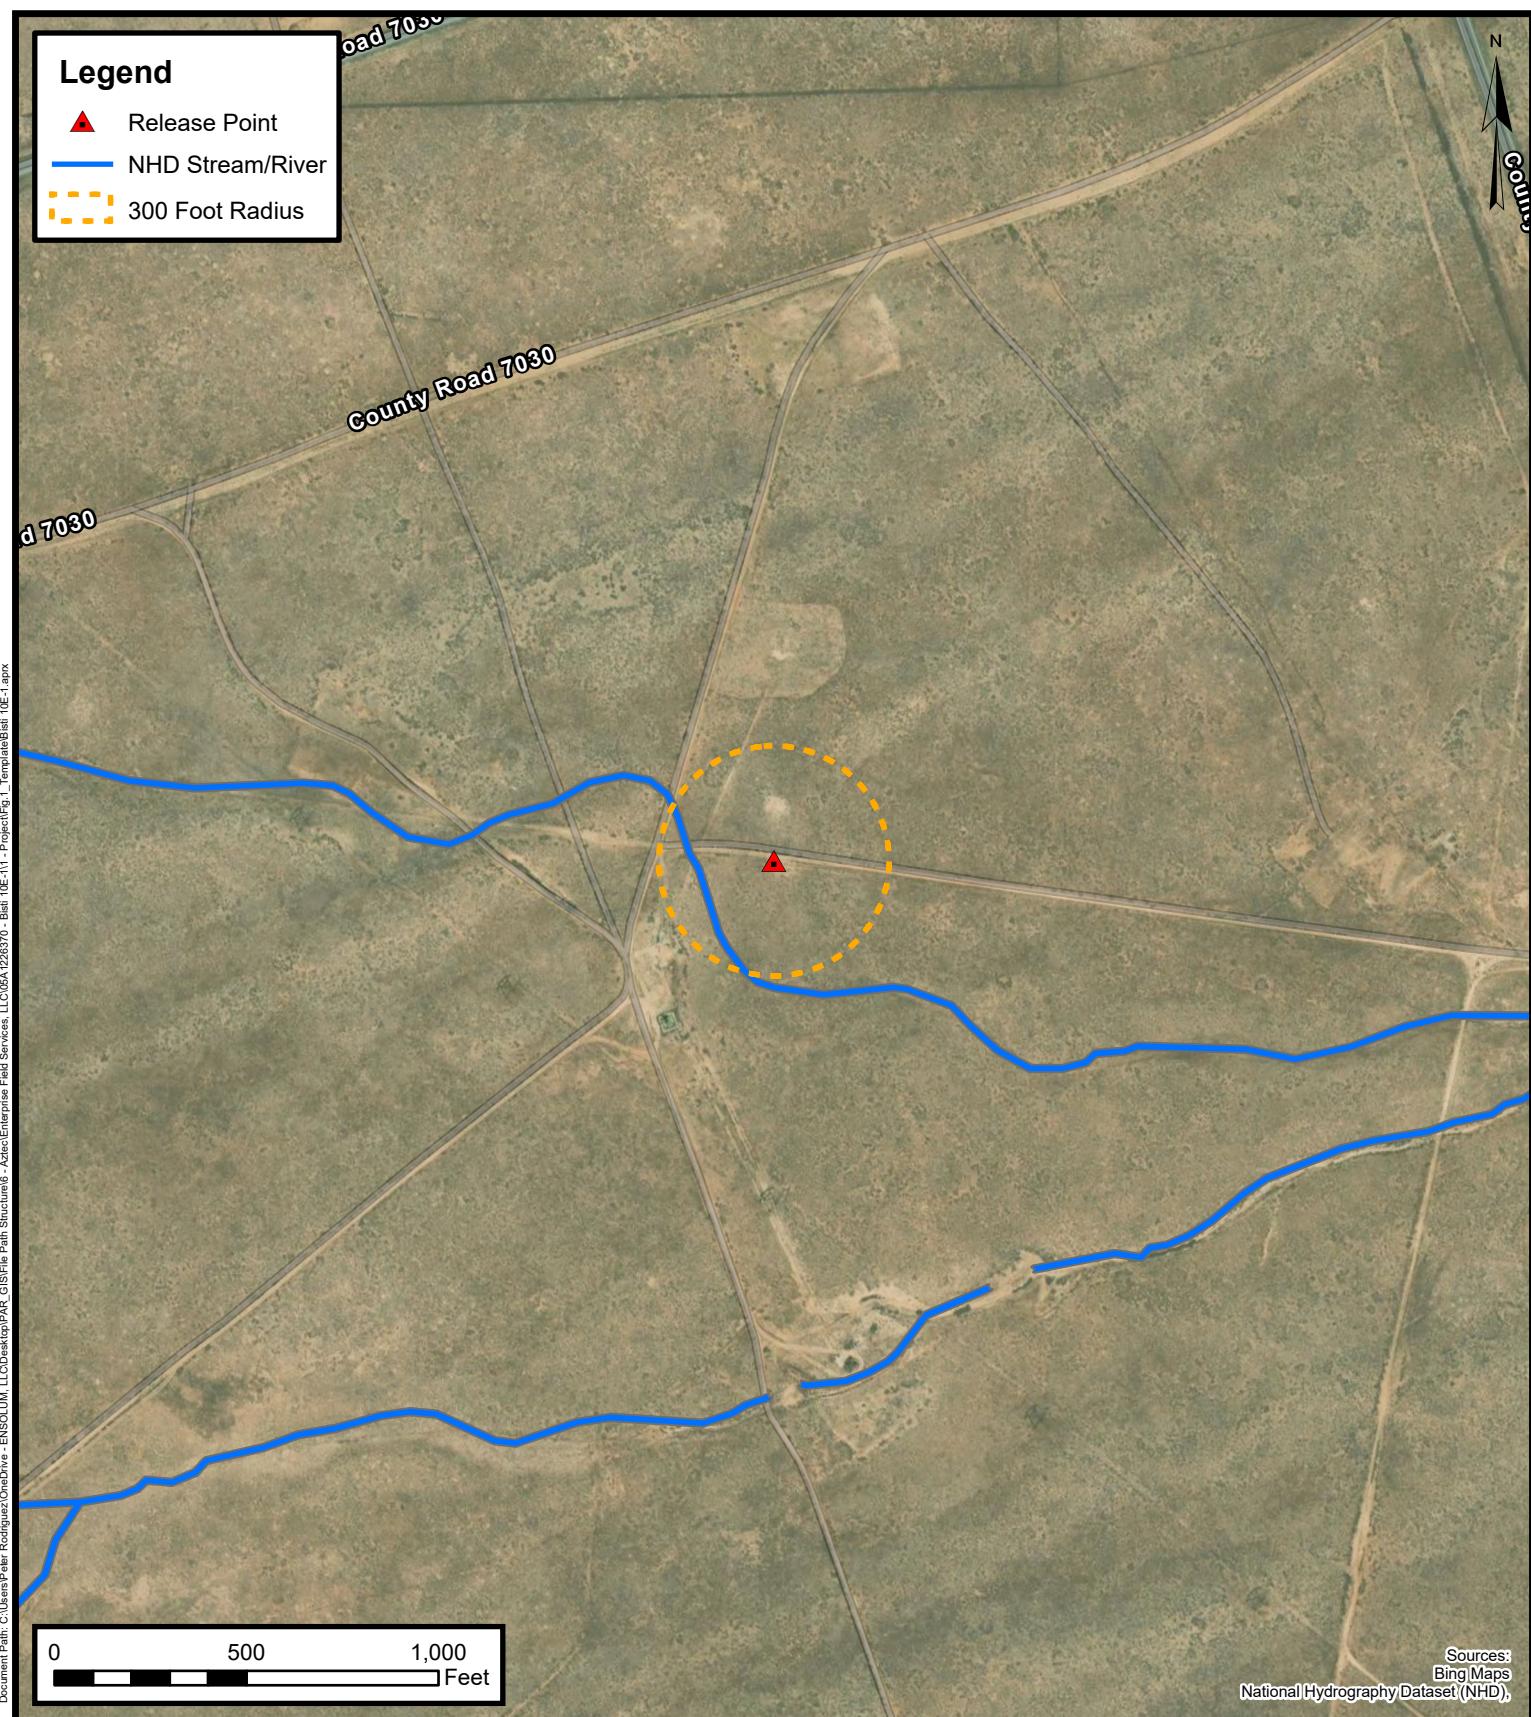
**FIGURE
C**

- The Site is located within 300 feet of a NM EMNRD OCD-defined continuously flowing watercourse or significant watercourse (**Figure C, Appendix B**). A “blue line” ephemeral wash is located is located approximately 190 feet west of the Site.

**300 Foot Radius Watercourse
and Drainage Identification**
Enterprise Field Services, LLC
Bisti 10E-1
Project Number: 05A1226370

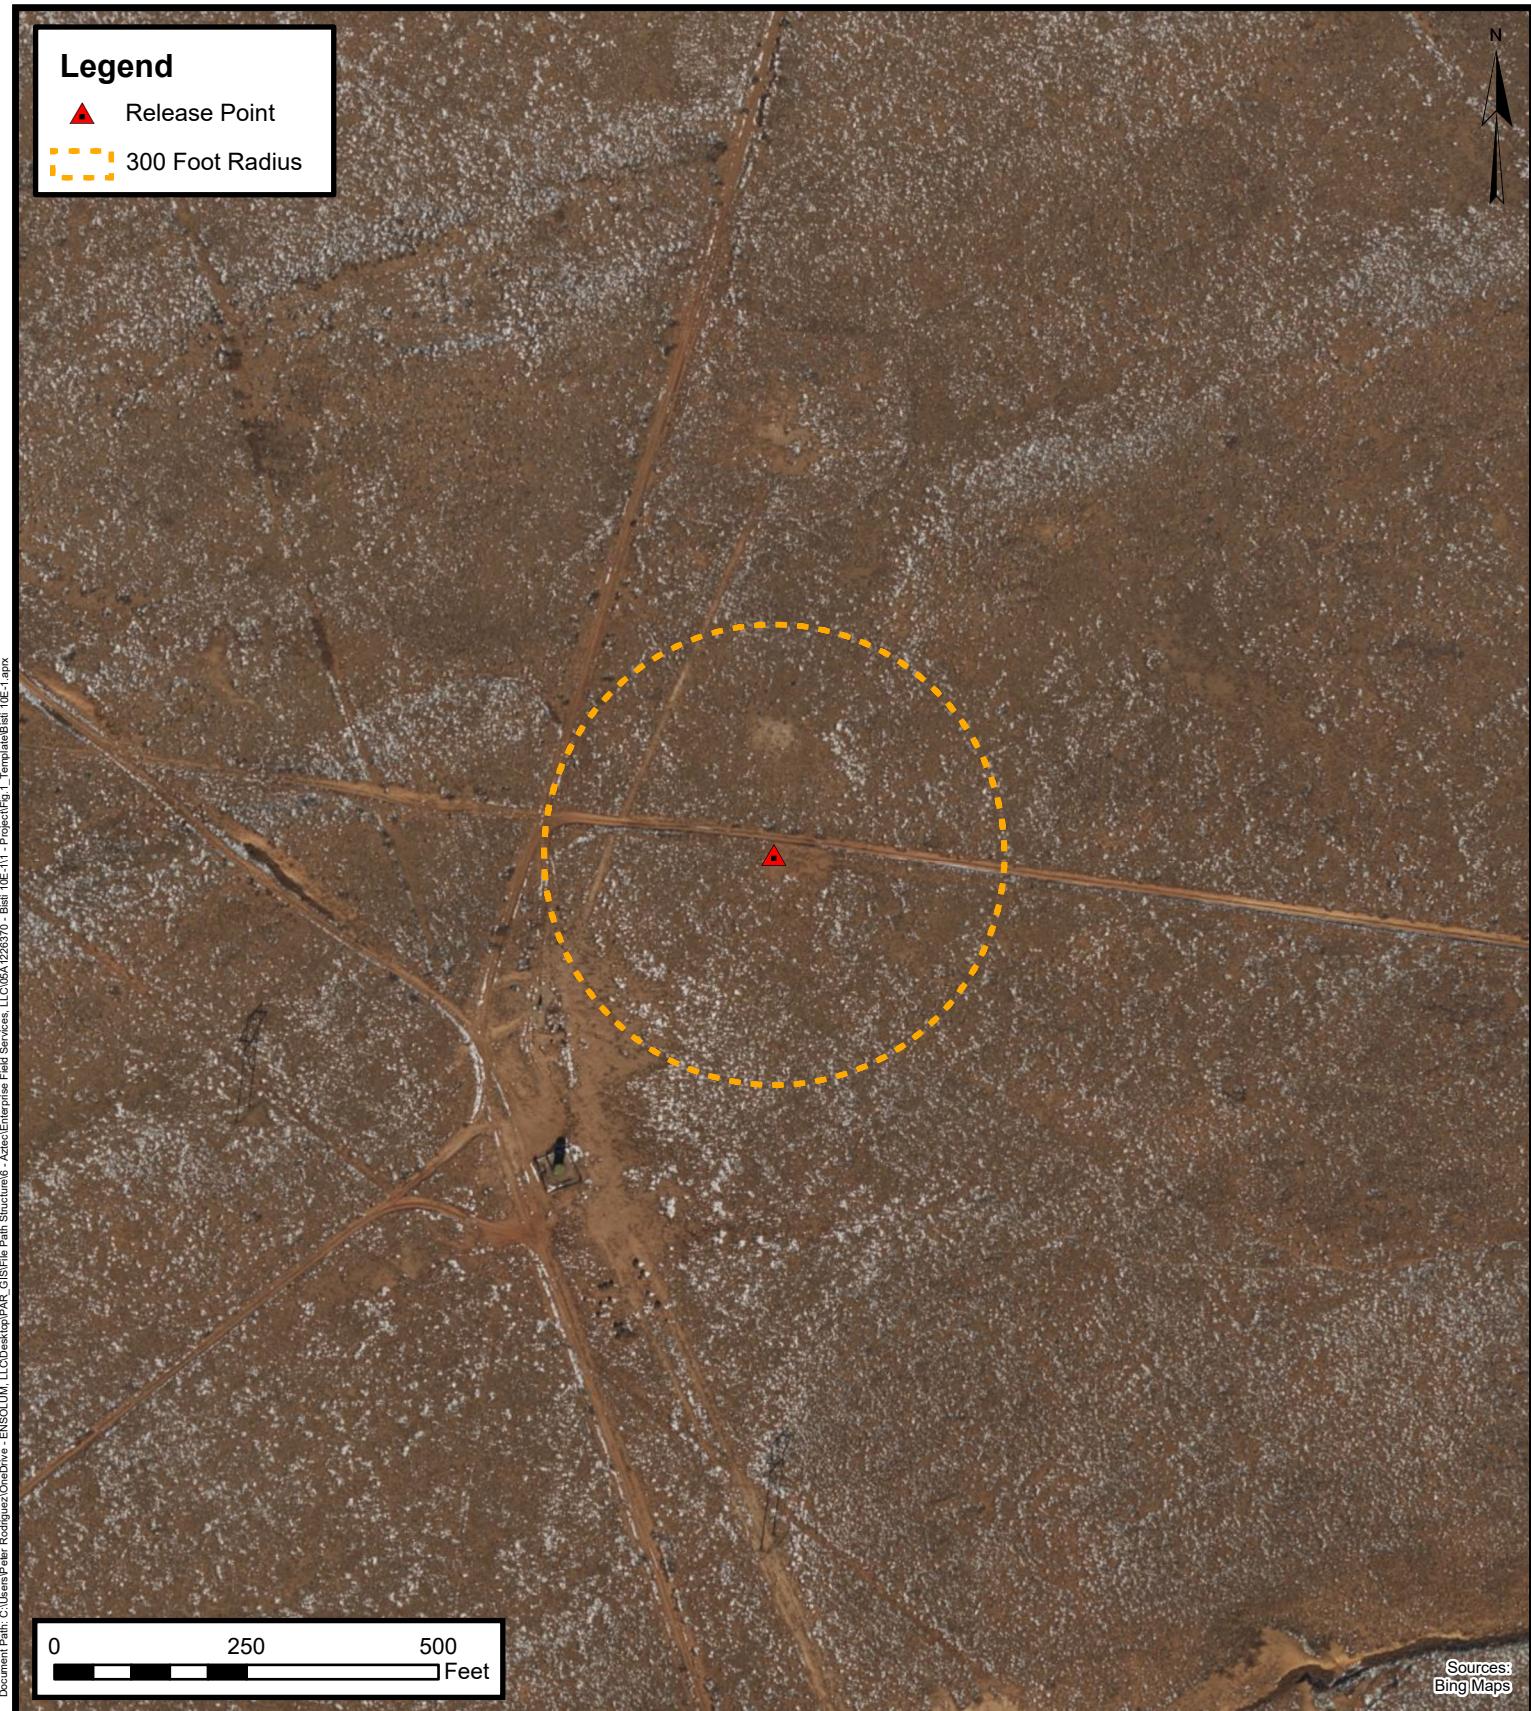
**FIGURE
D**

- The Site is not located within 200 feet of a lakebed, sinkhole, or playa lake.
- The Site is not located within 300 feet of a permanent residence, school, hospital, institution, or church (**Figure D, Appendix B**).

**300 Foot Radius Occupied
Structure Identification**
Enterprise Field Services, LLC
Bisti 10E-1
Project Number: 05A1226370

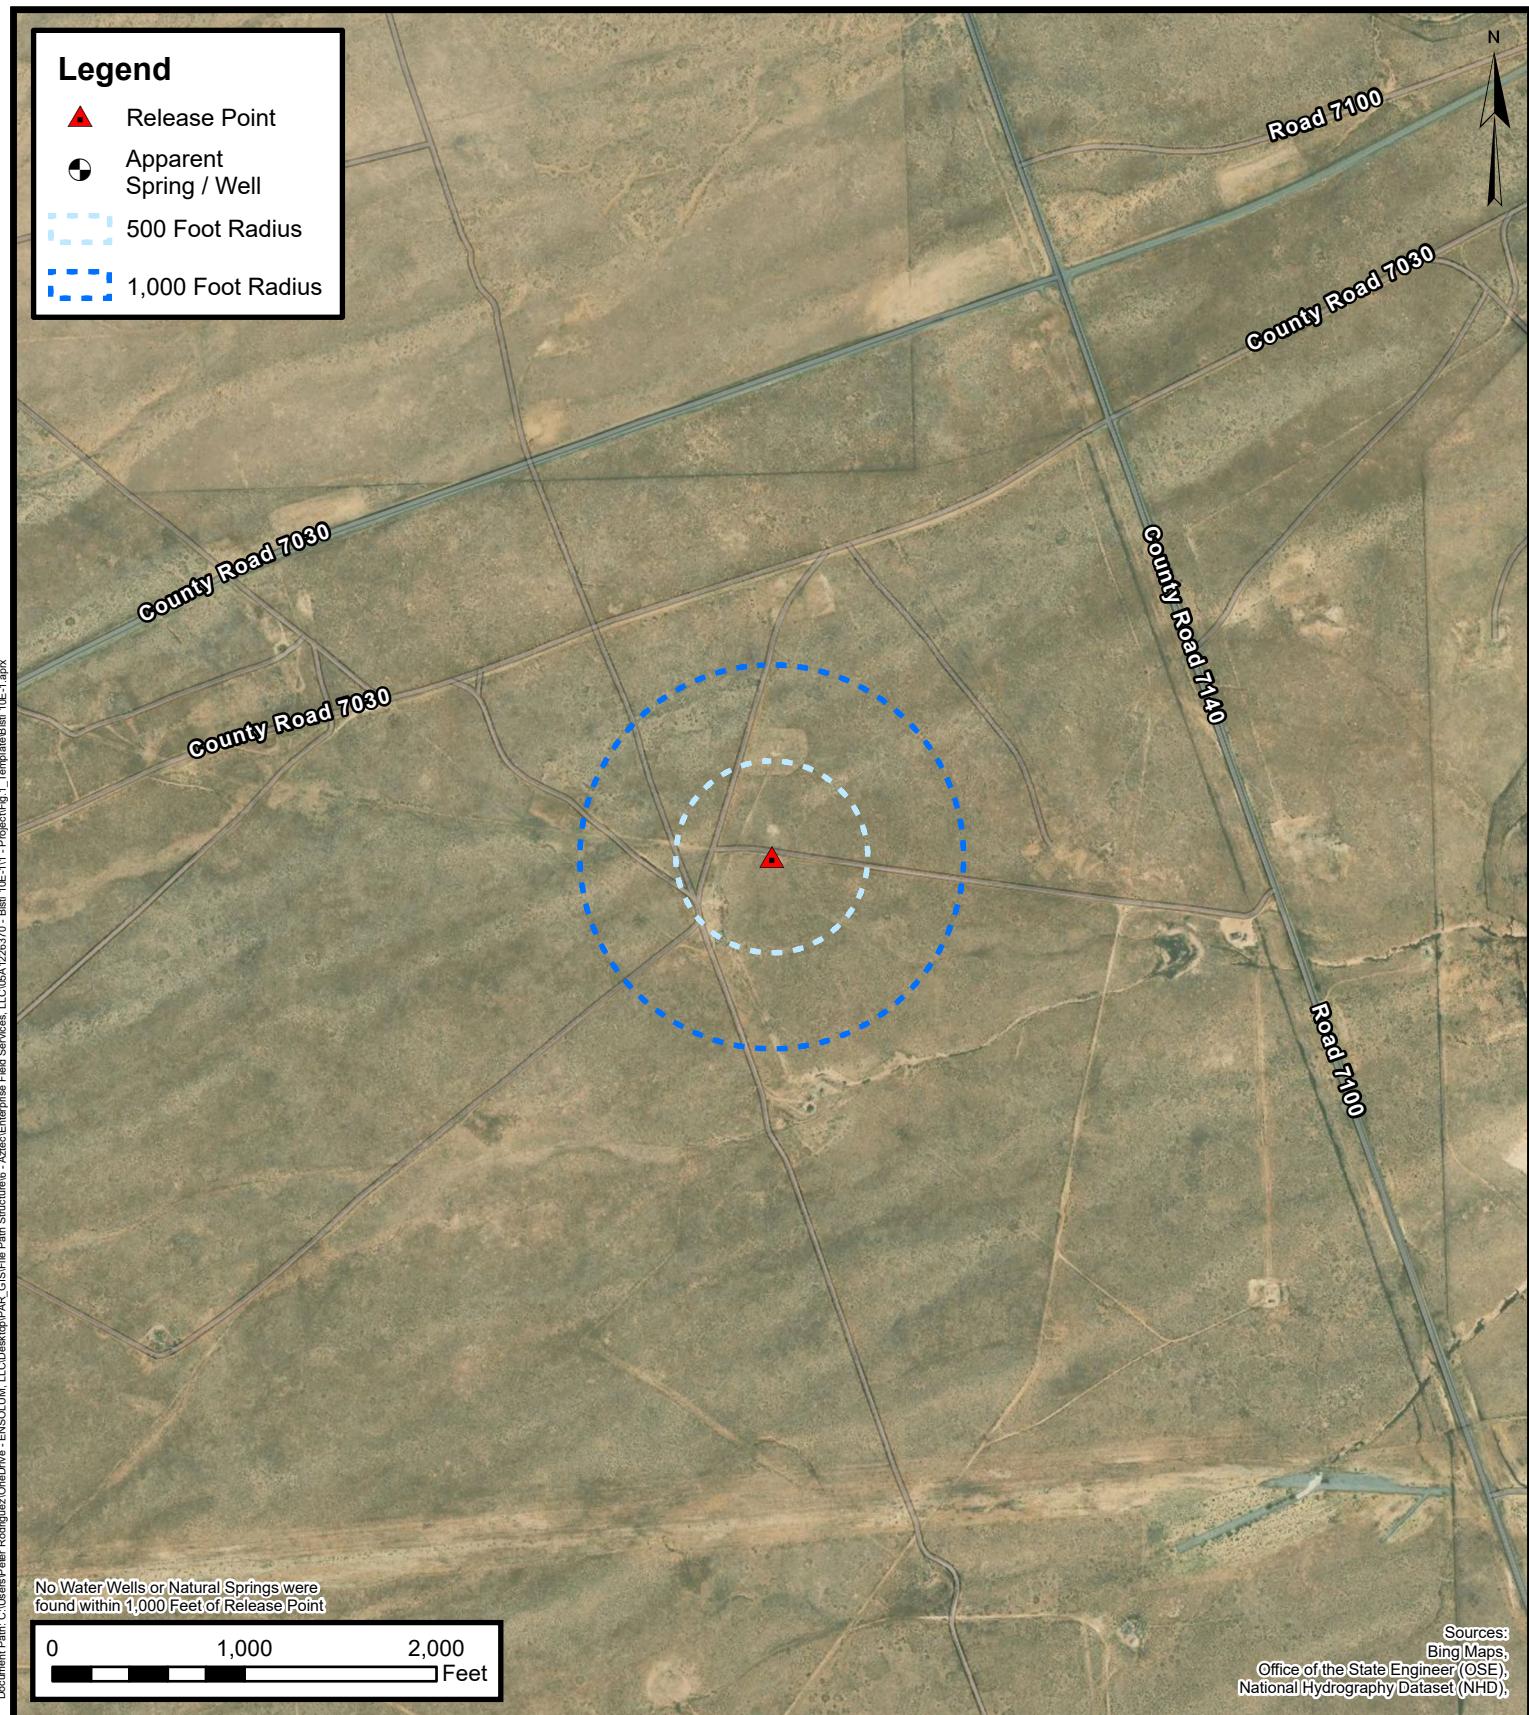
FIGURE
E

- No springs, or private domestic freshwater wells used by less than five households for domestic or stock watering purposes were identified within 500 feet of the Site (**Figure E, Appendix B**).

- No freshwater wells or springs were identified within 1,000 feet of the Site (**Figure E, Appendix B**).
- The Site is not located within incorporated municipal boundaries or within a defined municipal fresh water well field covered under a municipal ordinance adopted pursuant to New Mexico Statutes Annotated (NMSA) 1978, Section 3-27-3.

Water Well and Natural Spring Location
