CLOSURE REPORT

Bisti 10E-1
Unit Letter F, S36 T27N R13W
San Juan County, New Mexico

New Mexico EMNRD OCD Incident ID No. NAPP2514846148

Ensolum Project No. 05A1226370

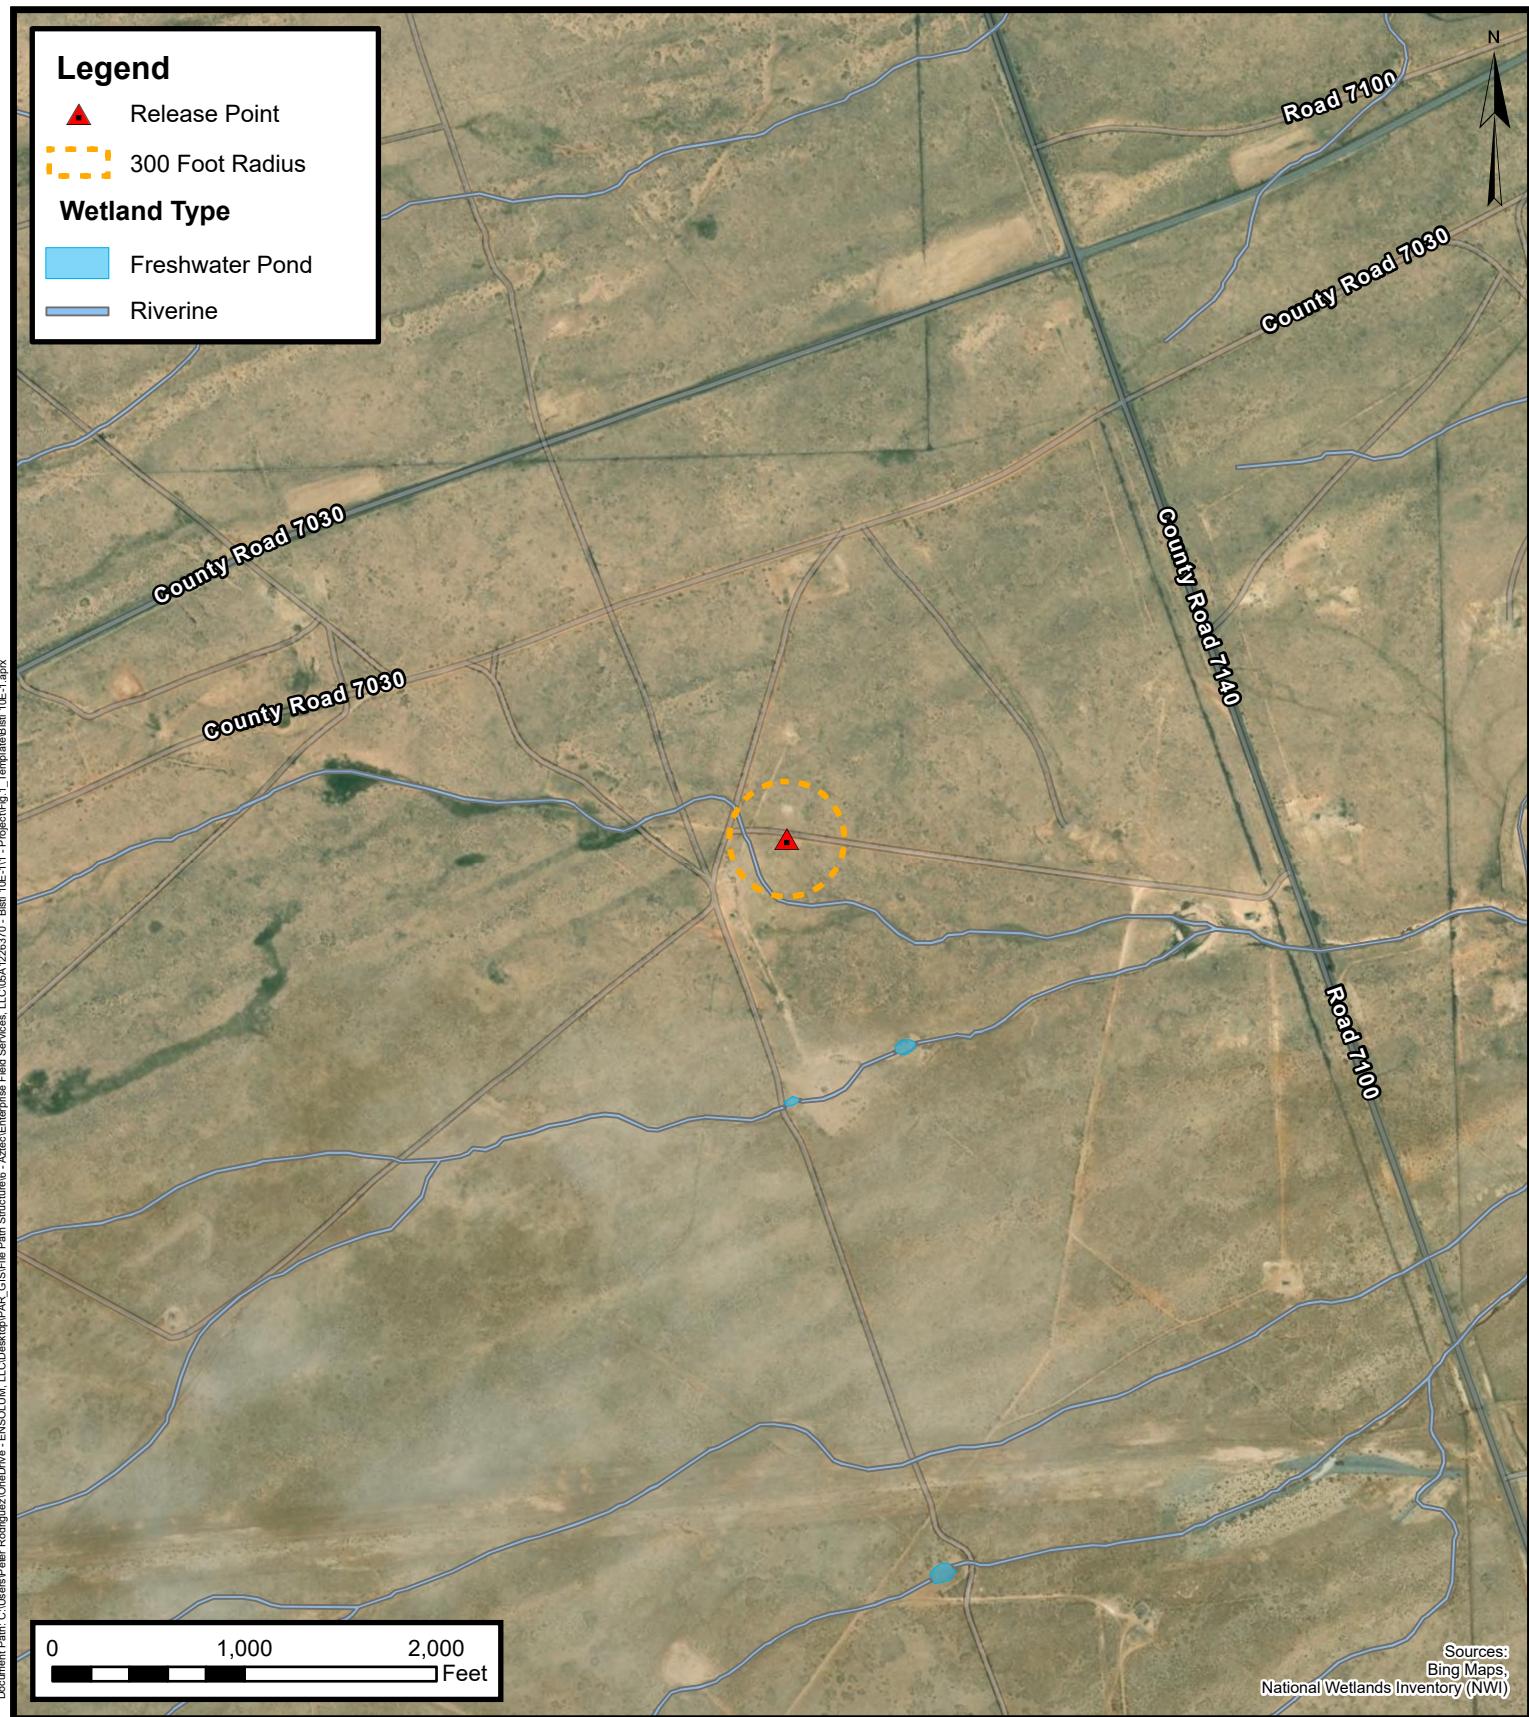
FIGURE
F

- Based on information identified in the U.S. Fish & Wildlife Service National Wetlands Inventory Wetlands Mapper, the Site is within 300 feet of a wetland (**Figure F, Appendix B**). The closest wetland is a seasonally flooded riverine located approximately 1190 feet west of the Site.

Wetlands
Enterprise Field Services, LLC
Bisti 10E-1
Project Number: 05A1226370
Unit Letter F, S36 T27N R13W, San Juan County, New Mexico
36.533561, -108.173207

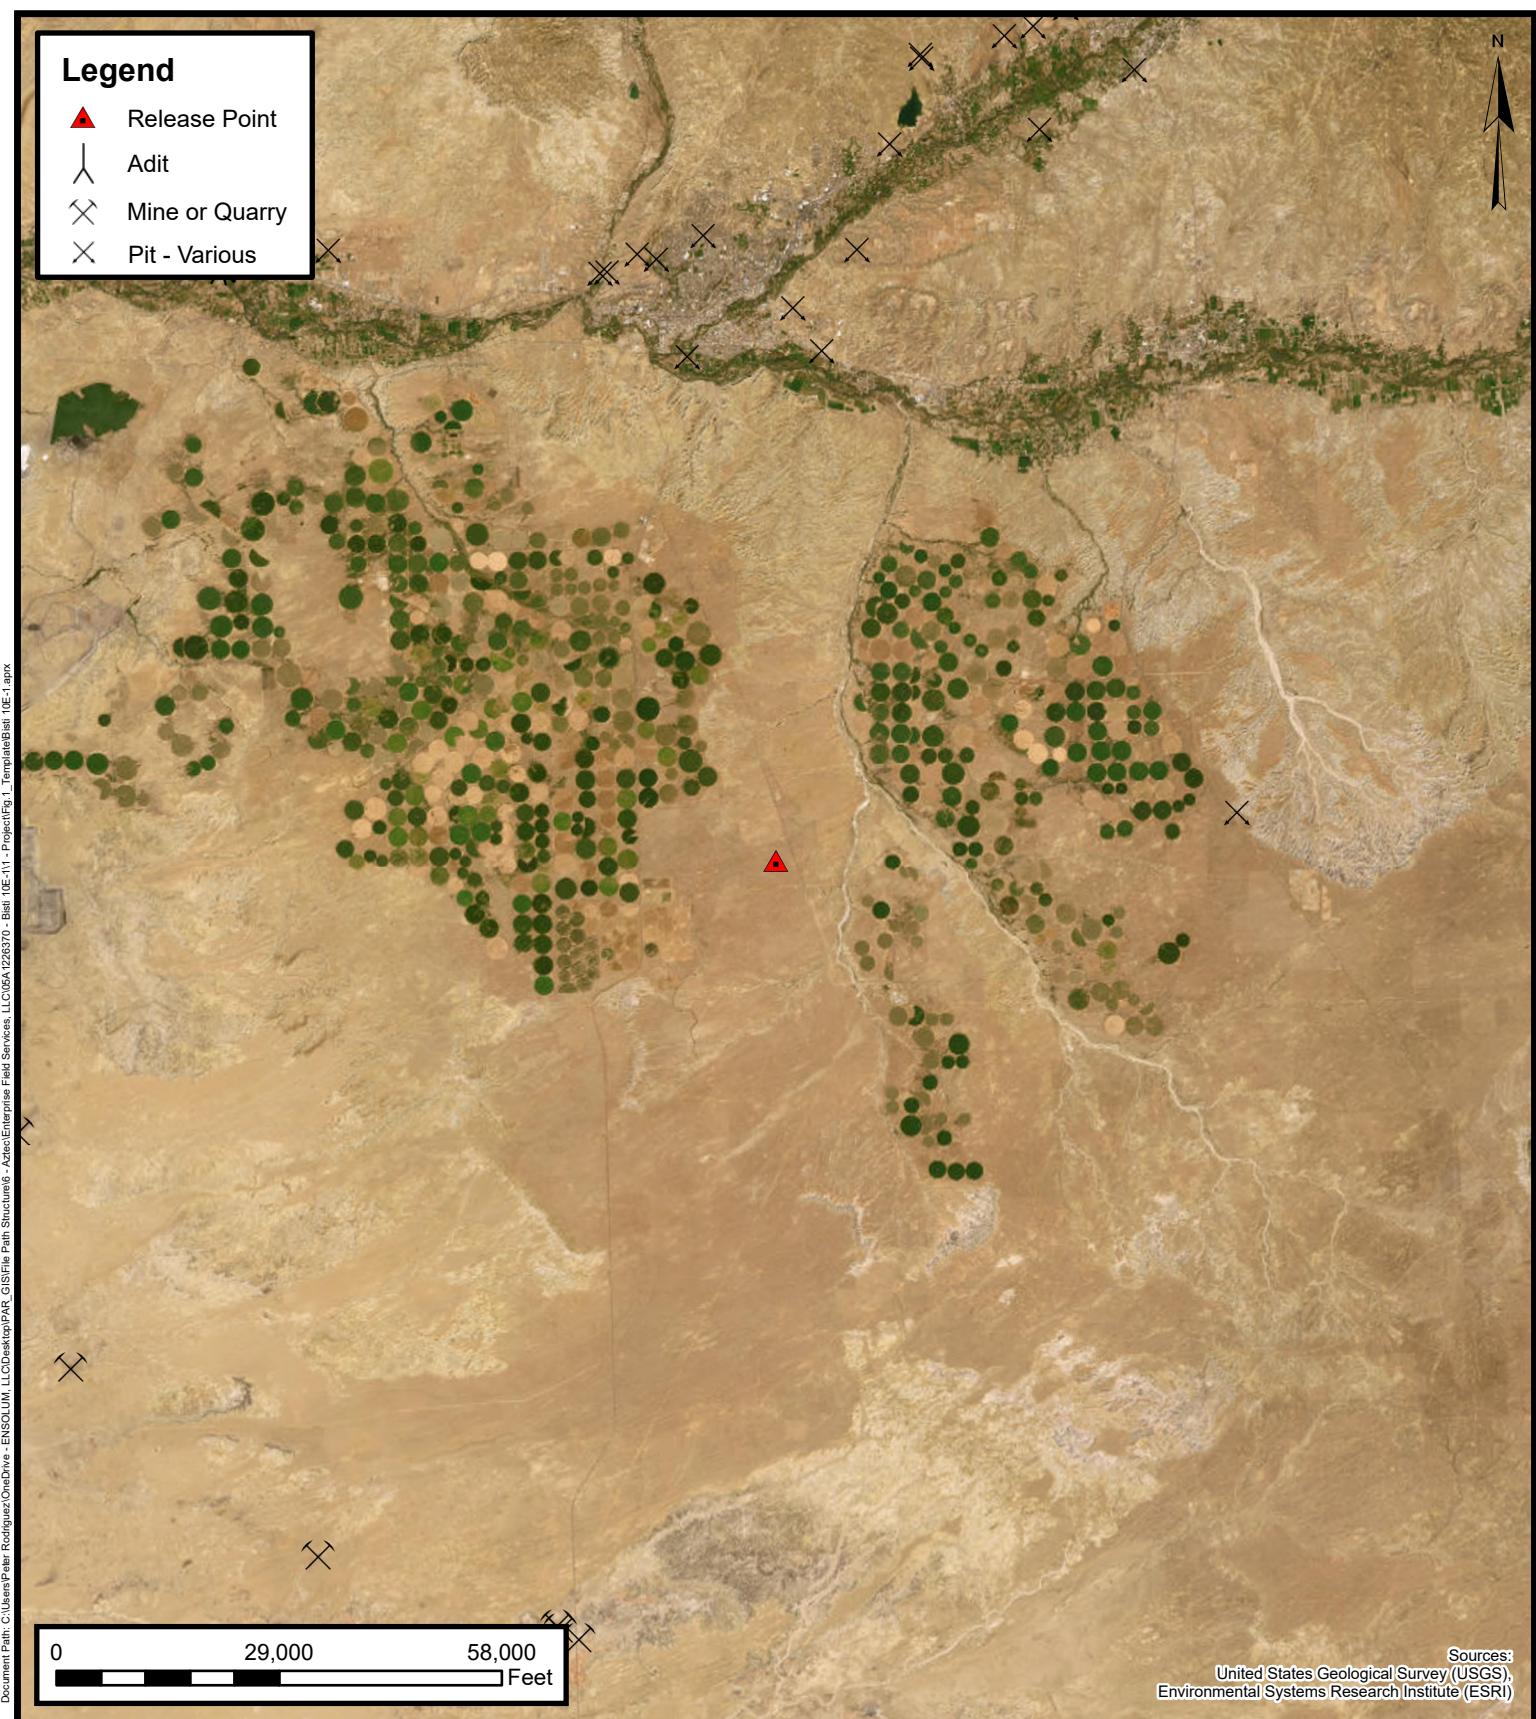
**FIGURE
G**

- Based on information identified in the NM Mining and Minerals Division’s Geographic Information System (GIS) Maps and Mine Data database, the Site is not within an area overlying a subsurface mine (**Figure G, Appendix B**).

Mines, Mills, and Quarries

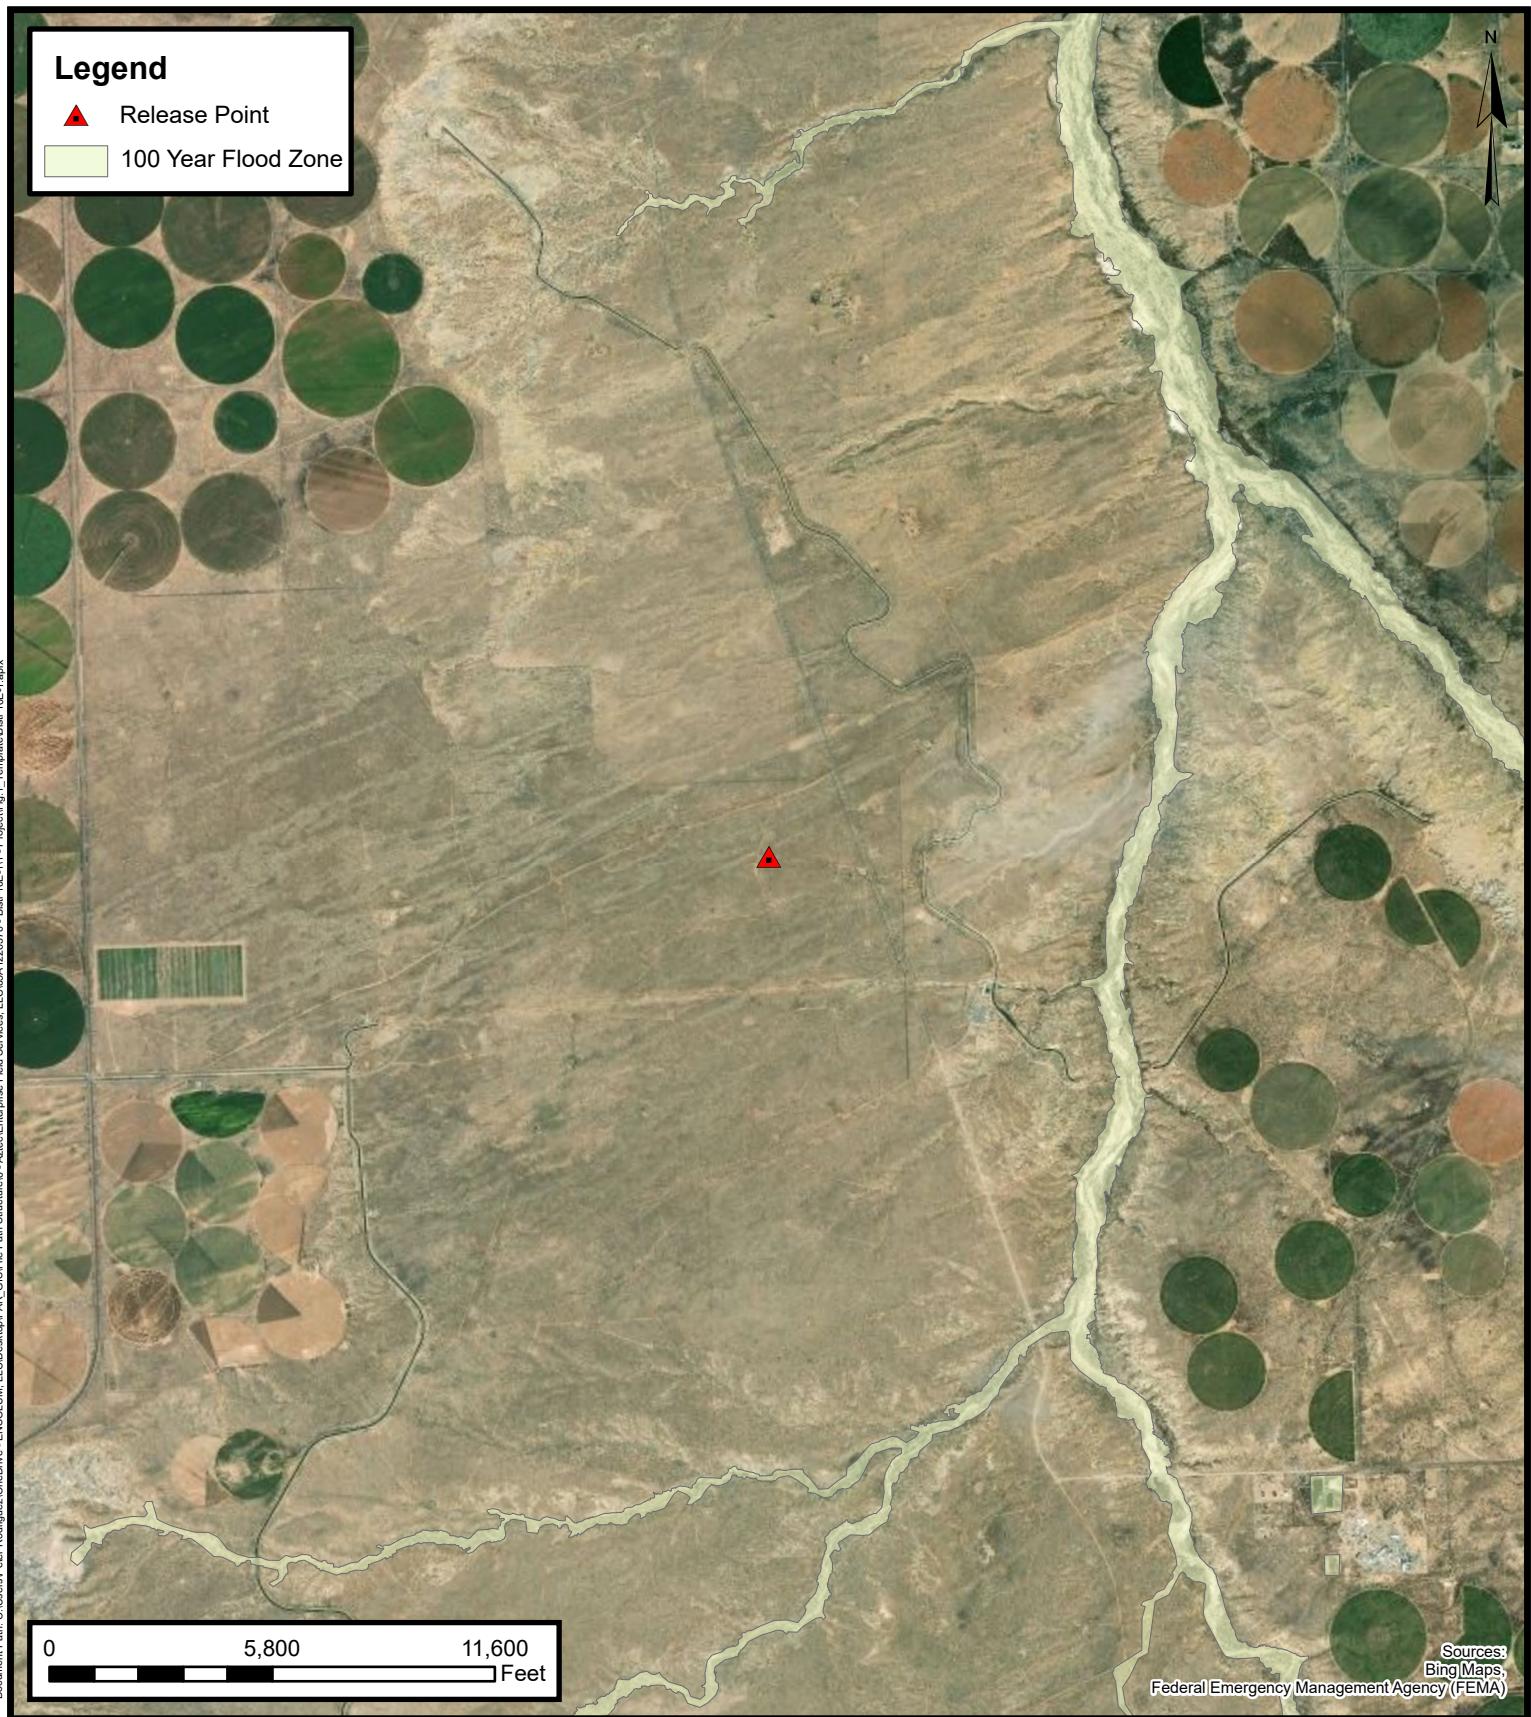
FIGURE
H

- The Site is not located within an unstable area per Paragraph (6) of Subsection U of 19.15.2.7 NMAC.
- Based on information provided by the Federal Emergency Management Agency (FEMA) National Flood Hazard Layer (NFHL) geospatial database, the Site is not within a 100-year floodplain (**Figure H, Appendix B**).

100-Year Flood Plain Map

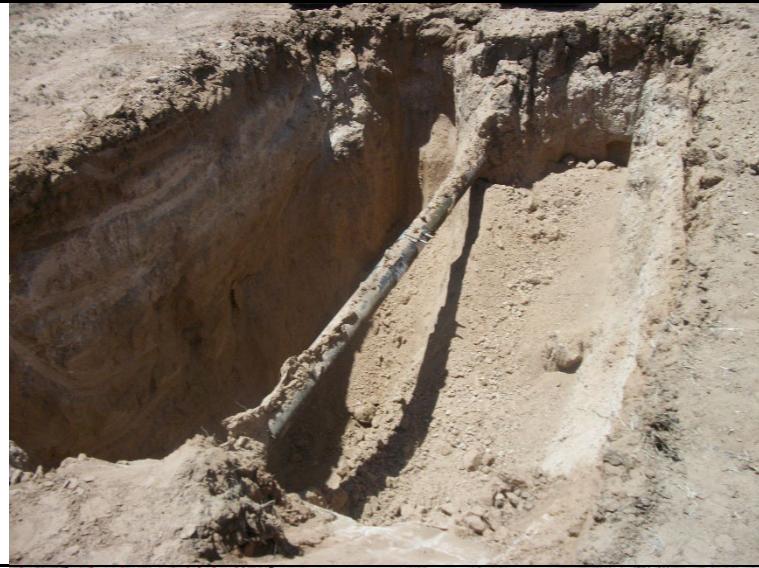
**Photograph 1**

The excavation measured approximately 18 feet long and 9 feet wide at the maximum extents. The maximum depth of the excavation measured approximately 14 feet bgs, with an approximate 162 ft² footprint. The lithology encountered during the completion of remediation activities consisted primarily of unconsolidated silty sand.

Photograph Description: View of the in-process excavation activities.

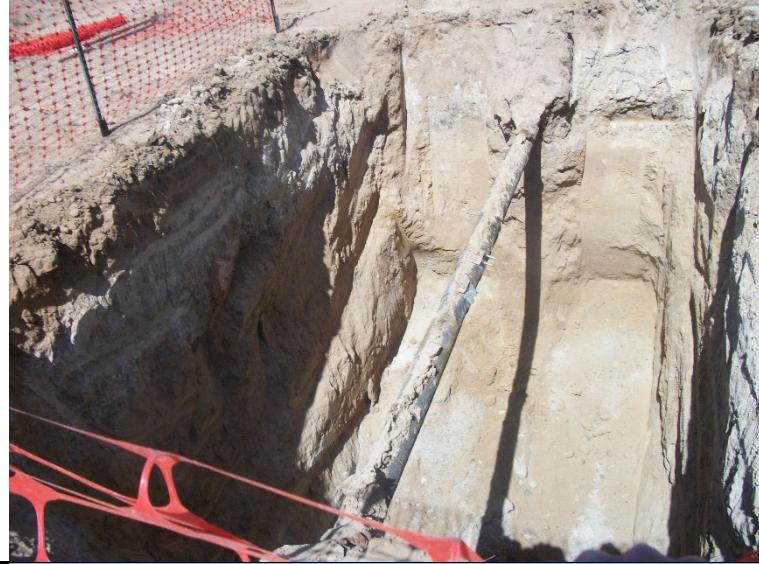
**Photograph 2**

Photograph Description: View of the final excavation.

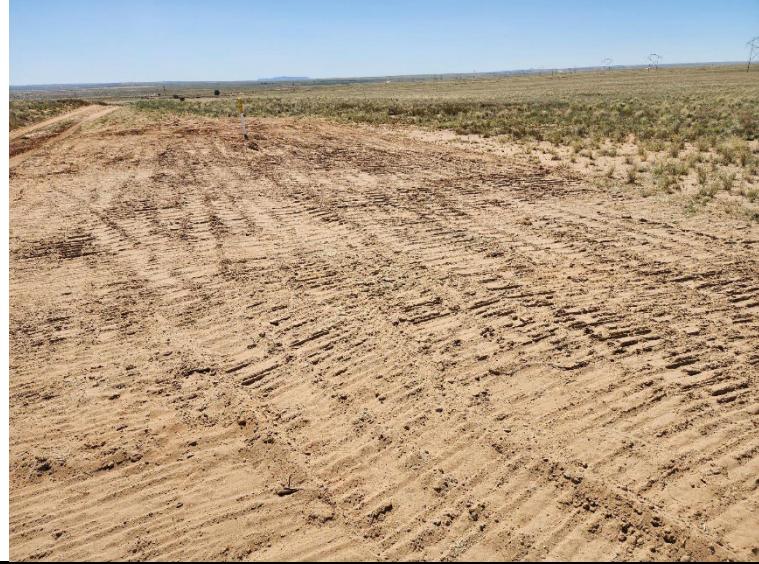
**Photograph 3**

Photograph Description: View of the backfilled excavation.

The excavation was backfilled with imported fill and then contoured to the surrounding grade. The backfill and the upper four feet of the excavation have been analytically verified to be below the Tier I soil standards of 50 mg/kg BTEX, 10 mg/kg benzene, 100 mg/kg total combined TPH, and 600 mg/kg Chloride. See **APPENDIX D** and **APPENDIX F** for further documentation.
