Remediation Report and Closure Request  
SJ 32-8 # 15 Pipeline Release  
Lat: 36.88299 Long: -107.62956  
San Juan County, New Mexico

Photo Page  
SJ 32-8 #15 Pipeline Release  
Lat: 36.88299 Long: -107.62956

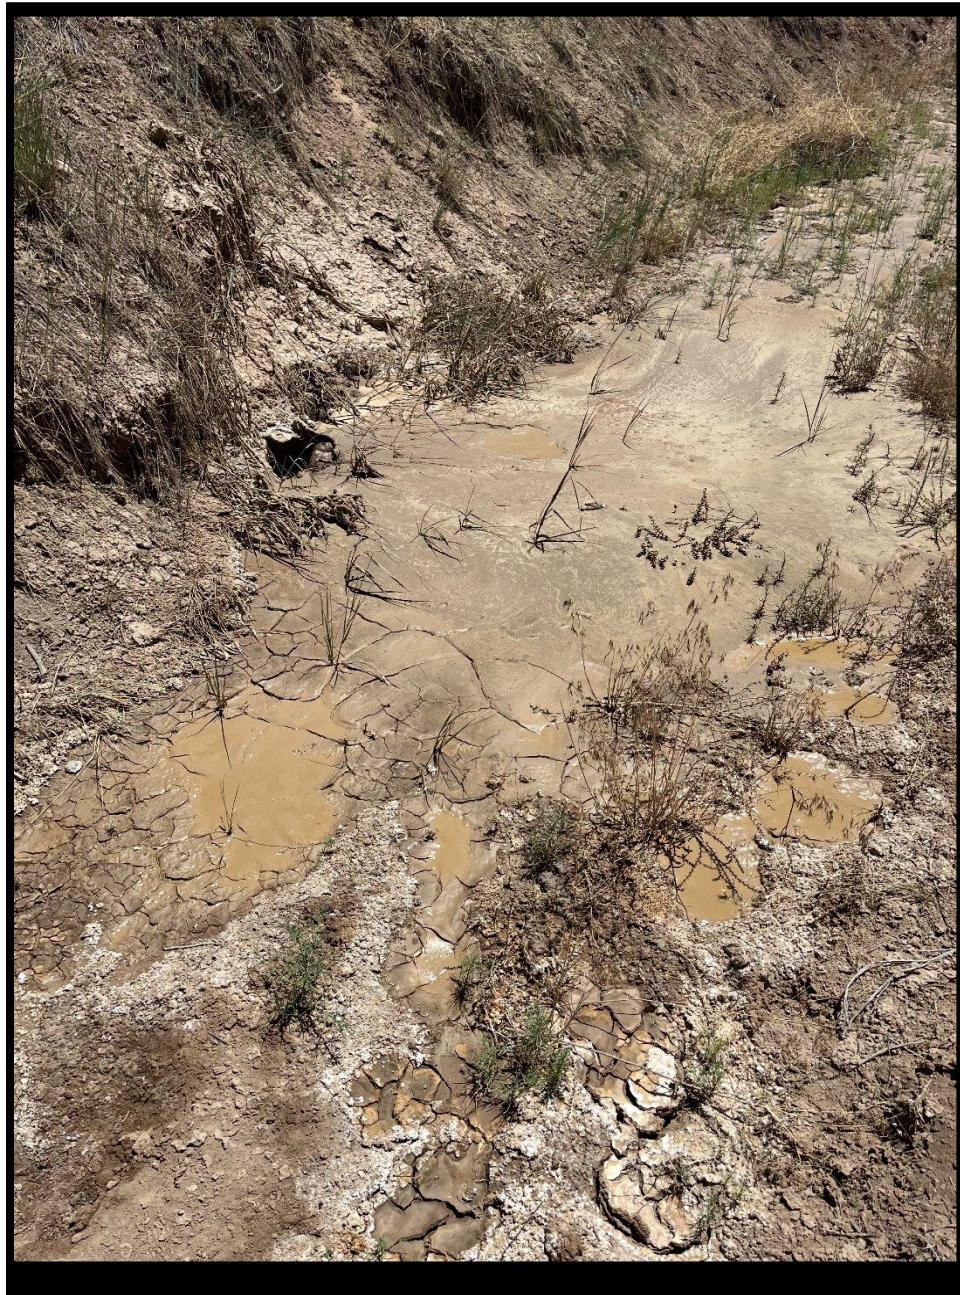
Photo 1: Release Discovery on 7/10/2025

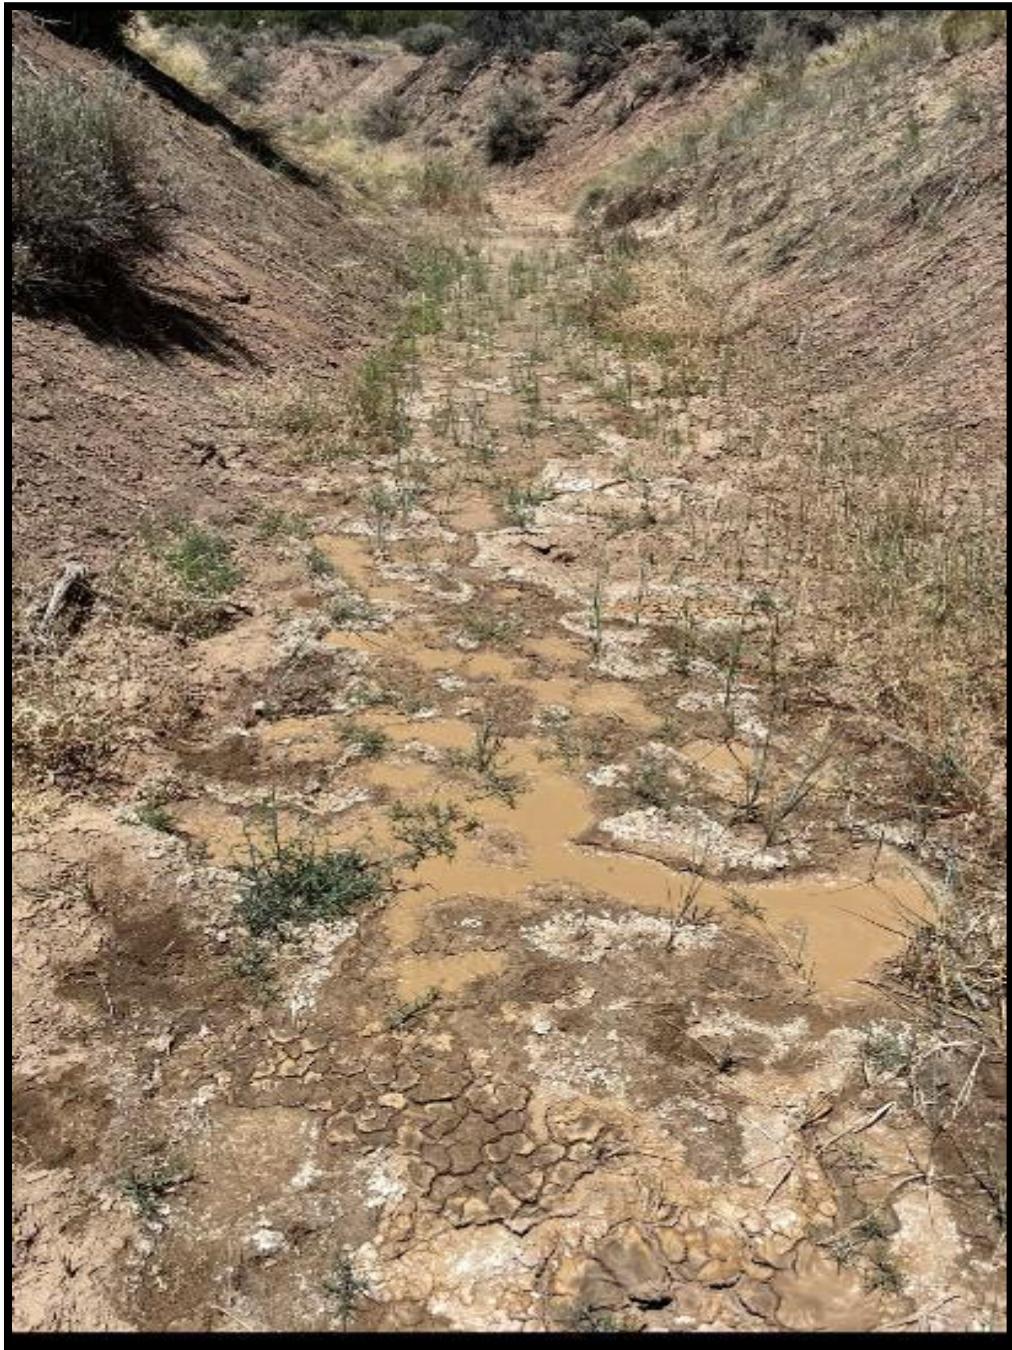
Photo 2: Release Discovery on 7/10/2025

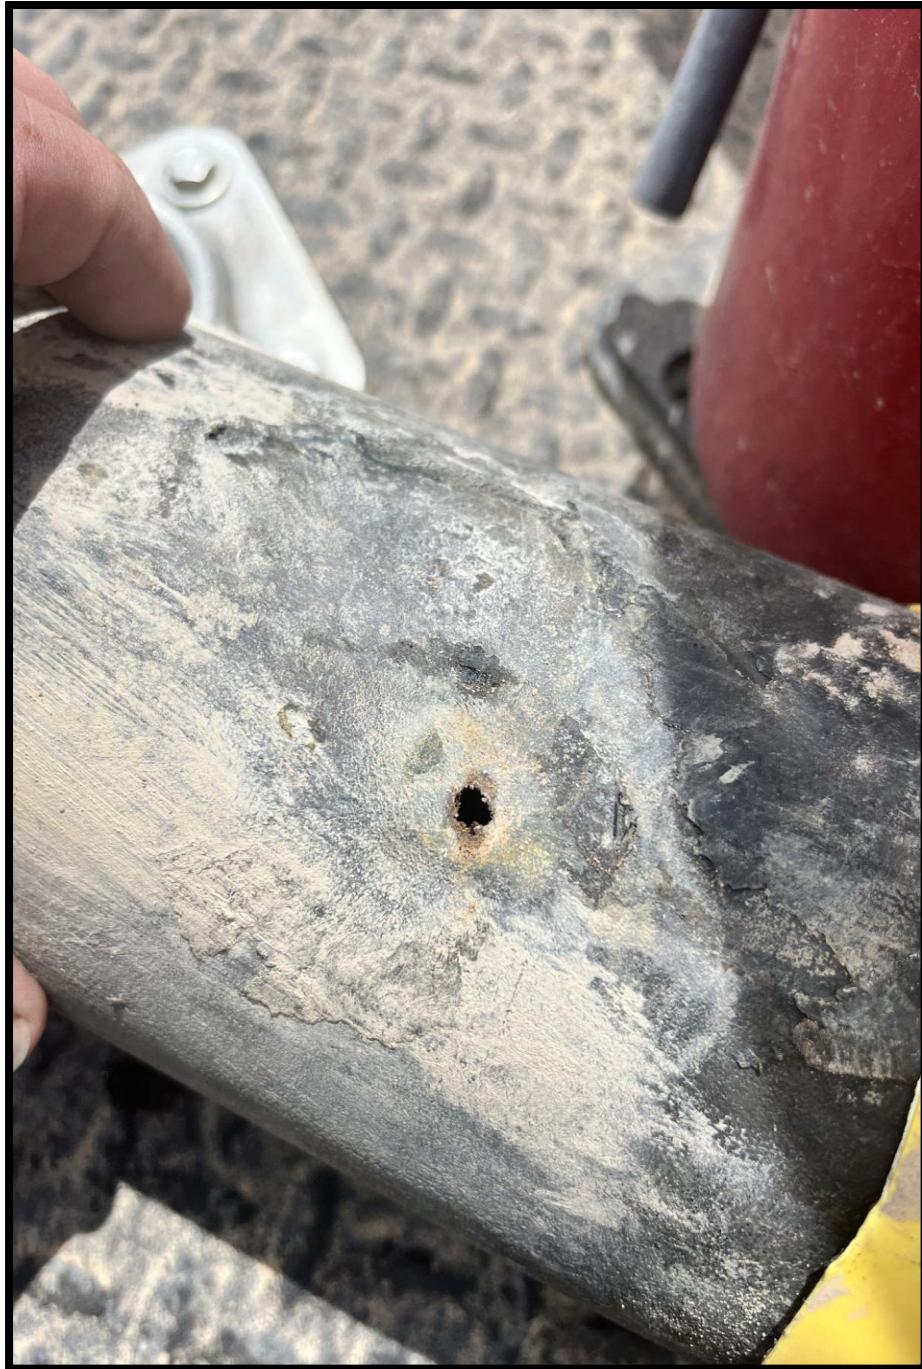
Harvest was notified of a potential release on the SJ 32-8 #15 pipeline. A Harvest tech responded to the notification and confirmed there to be a pipeline leak. Tech isolated and blew down the pipeline stopping the release. The release was discovered in a wash with produced water impacting the area. 1.4 barrels of produced water were calculated to have been released from the pipeline. A NOR was submitted on the NMOCD E-permitting website and assigned incident number nAPP2519153121. Email notification was sent to Nolan Craun and Emmanuel Adeloye of the BLM.

Photo 3: Pin hole in pipeline that caused the release.

A crew was onsite to remove contaminated soil and make repairs to the pipeline. 35ft of the pipeline was cut out and replaced with 35ft of new pipe, all welds were primed and taped. Harvest personnel arrived on site to perform sampling activities. A total of seven – five-point composite samples were collected from the excavated area. An eighth – five-point composite sample was collected in part of the wash that was impacted by the release but was not excavated. The sample identified as "Bottom" collected from the floor of the excavation was collected approximately eight-ten inches beneath surface shown in the photos on the attached photo page. Samples collected from each wall consisted of the entire surface of the wall. Samples were sent in for lab analysis of BTEX, GRO, DRO, ORO and Chlorides. Each sample collected was within a 200 sq ft area. See attached *"Sample Map"* for reference.

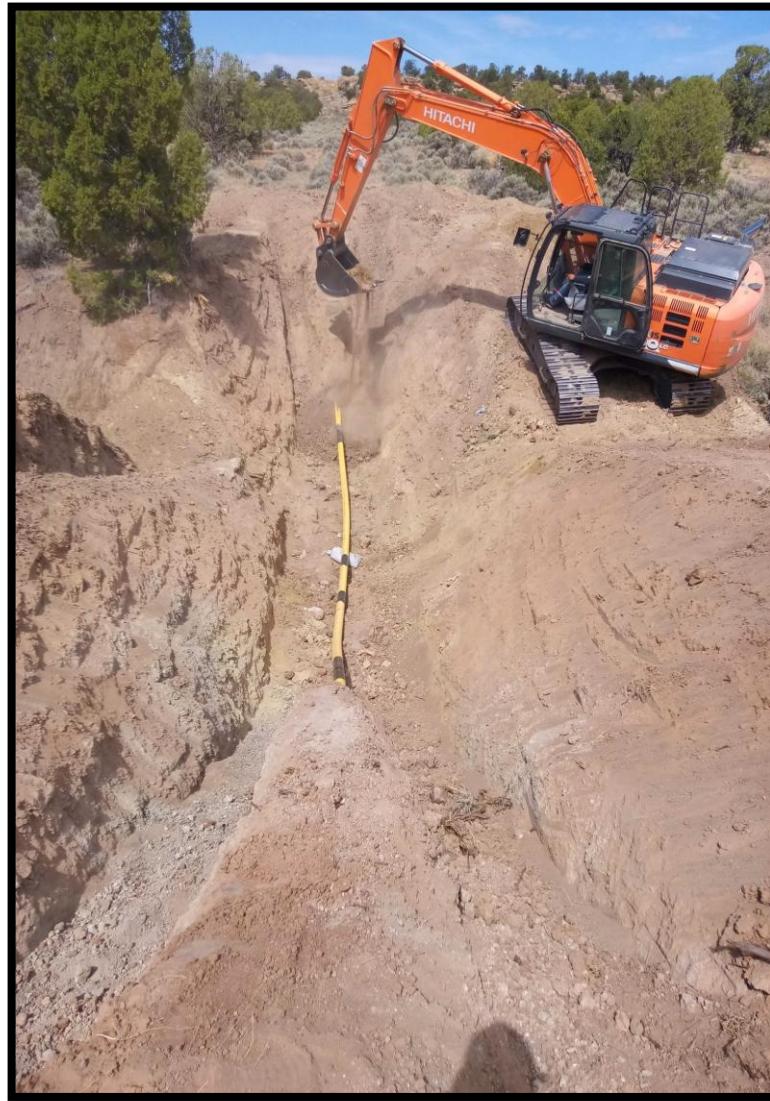
Photo 4: Fully Remediated Area

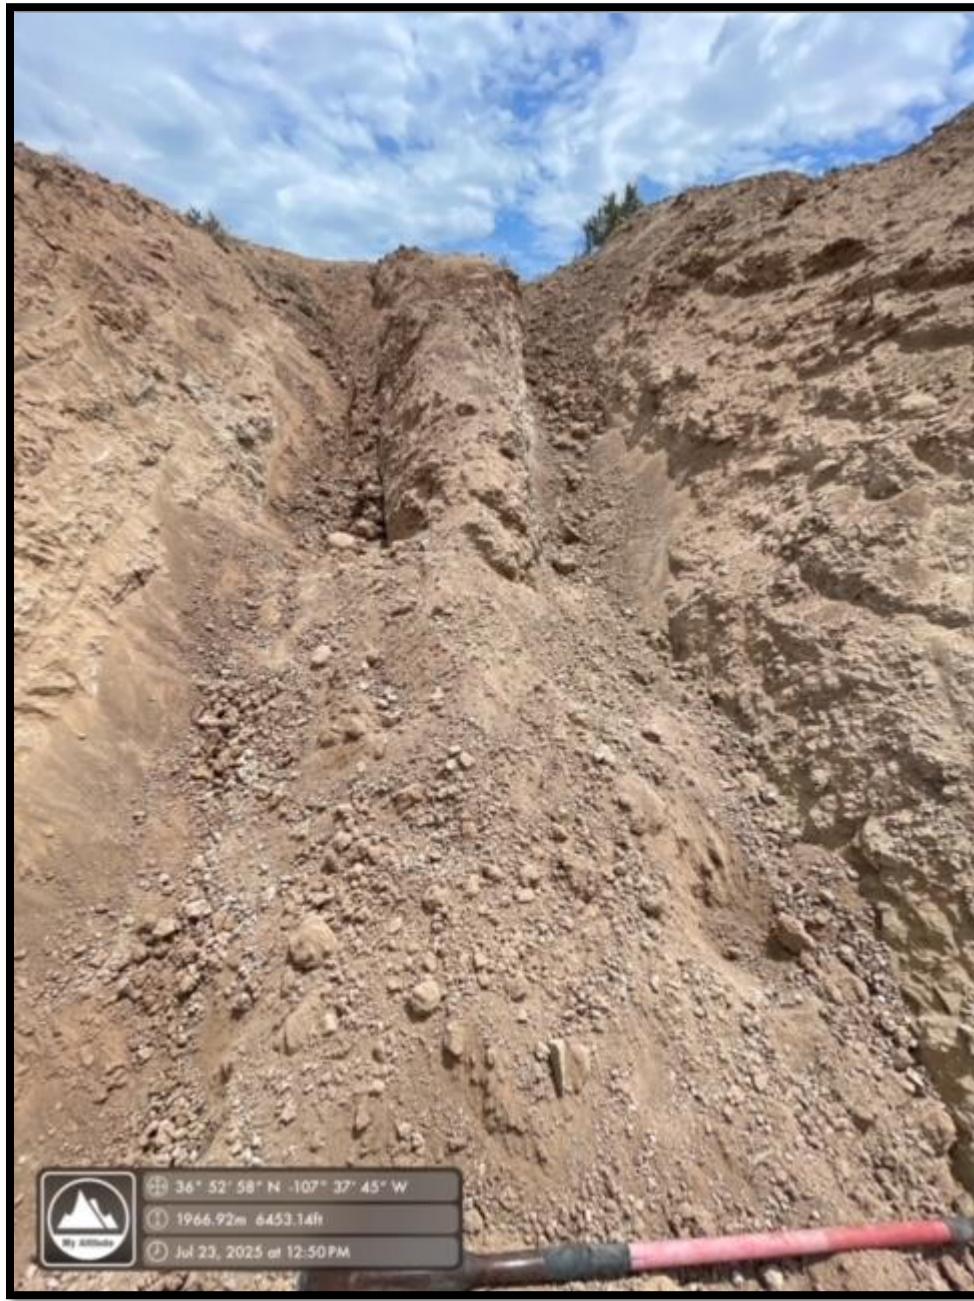
Photo 5: "East Wall" Sampling event on 7/23/2025

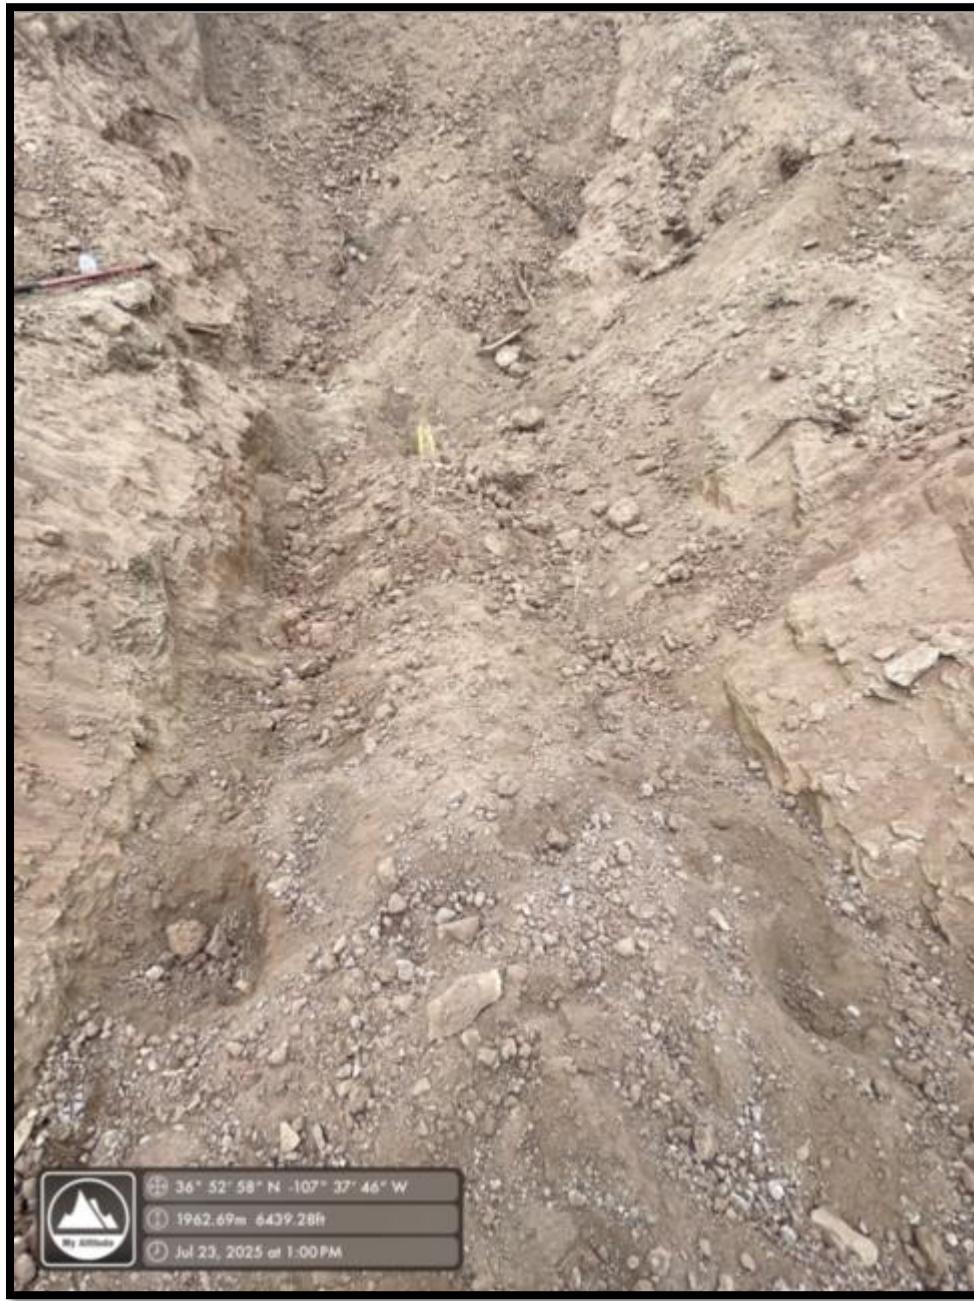
Photo 6: "Bottom" Sampling event on 7/23/2025

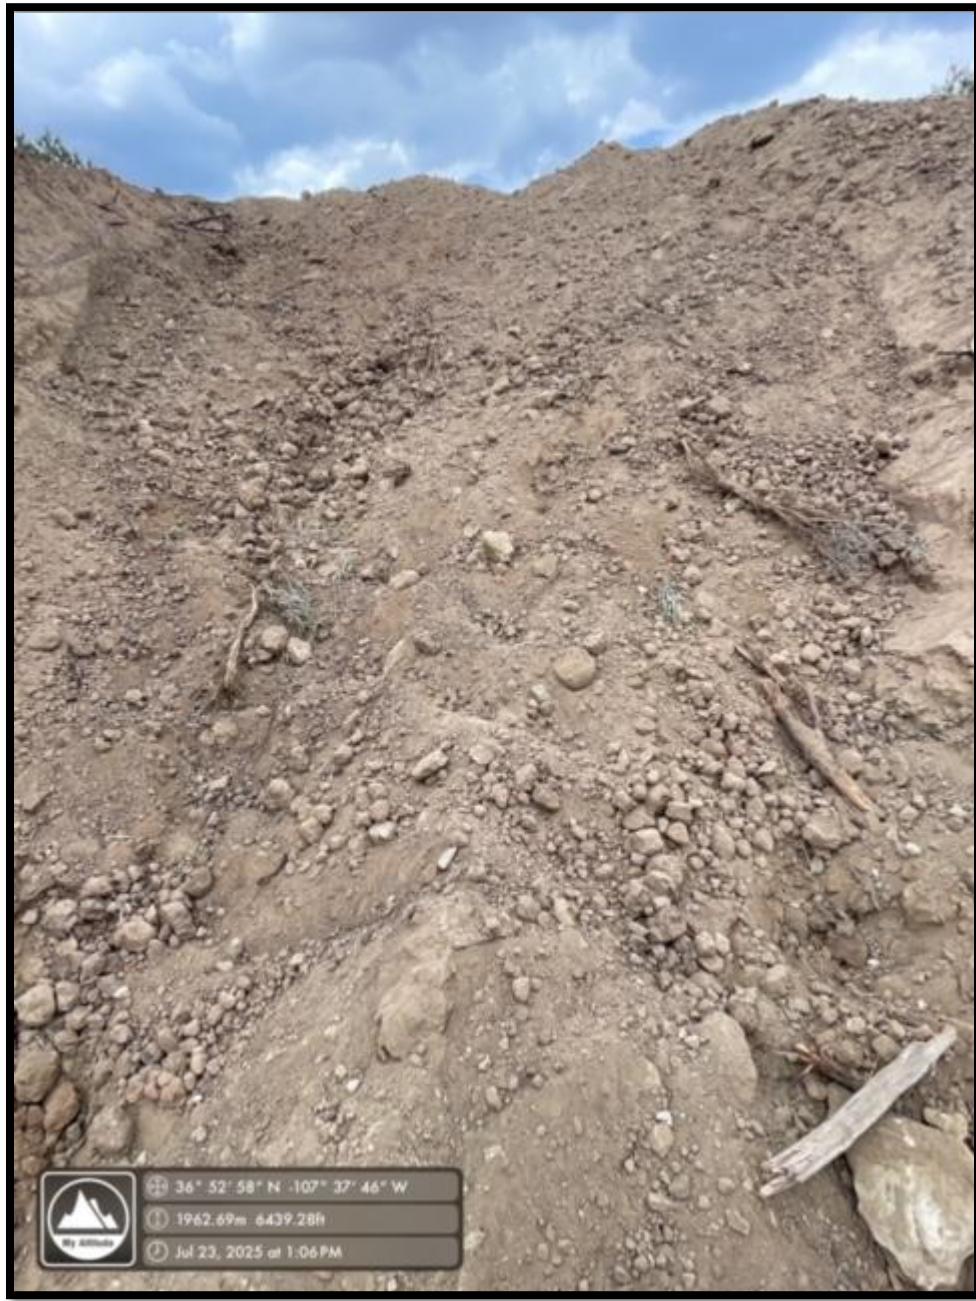
Photo 7: "West Wall" Sampling event on 7/23/2025

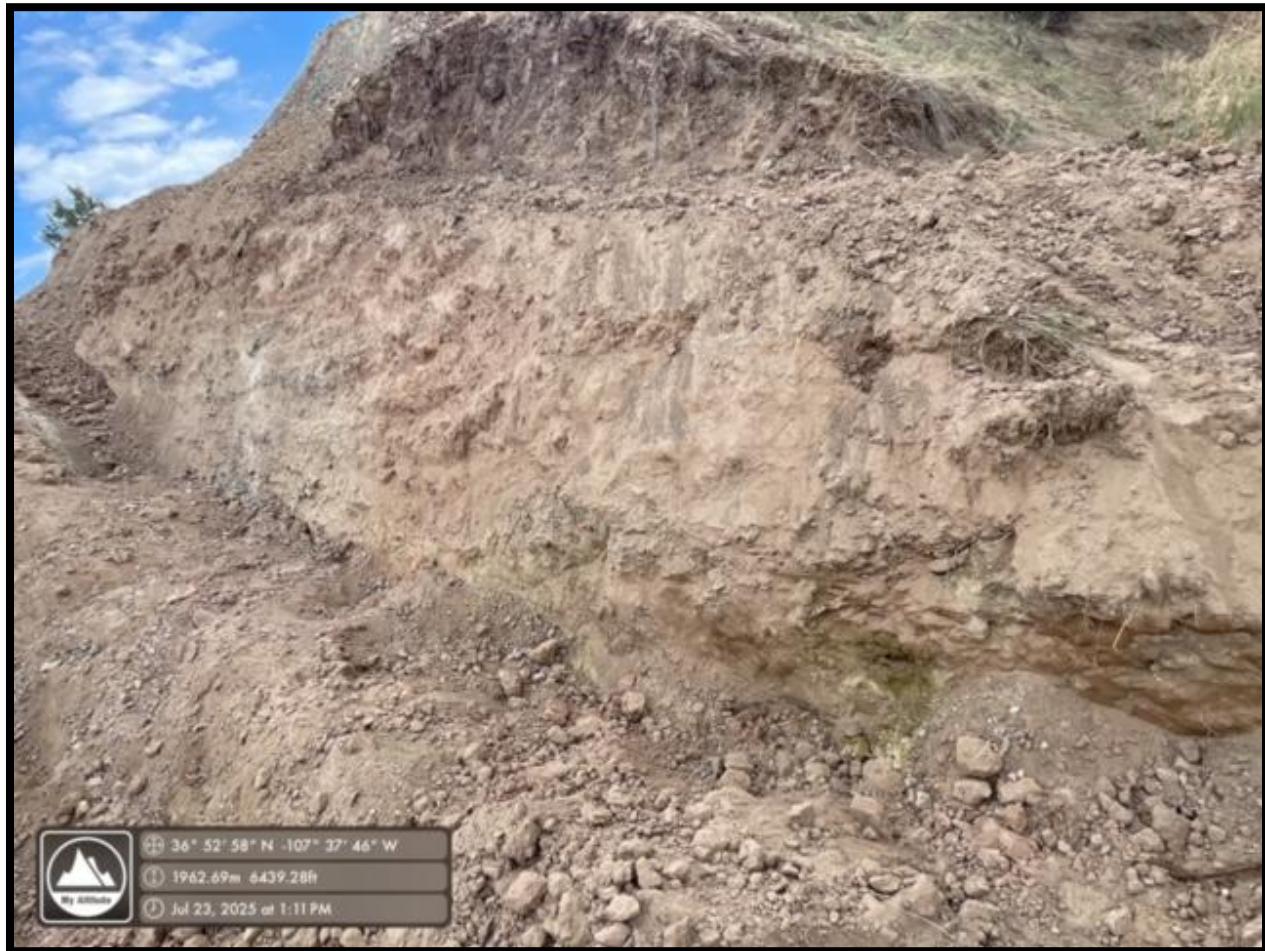
Photo 8: "South Wall 1" Sampling event on 7/23/2025

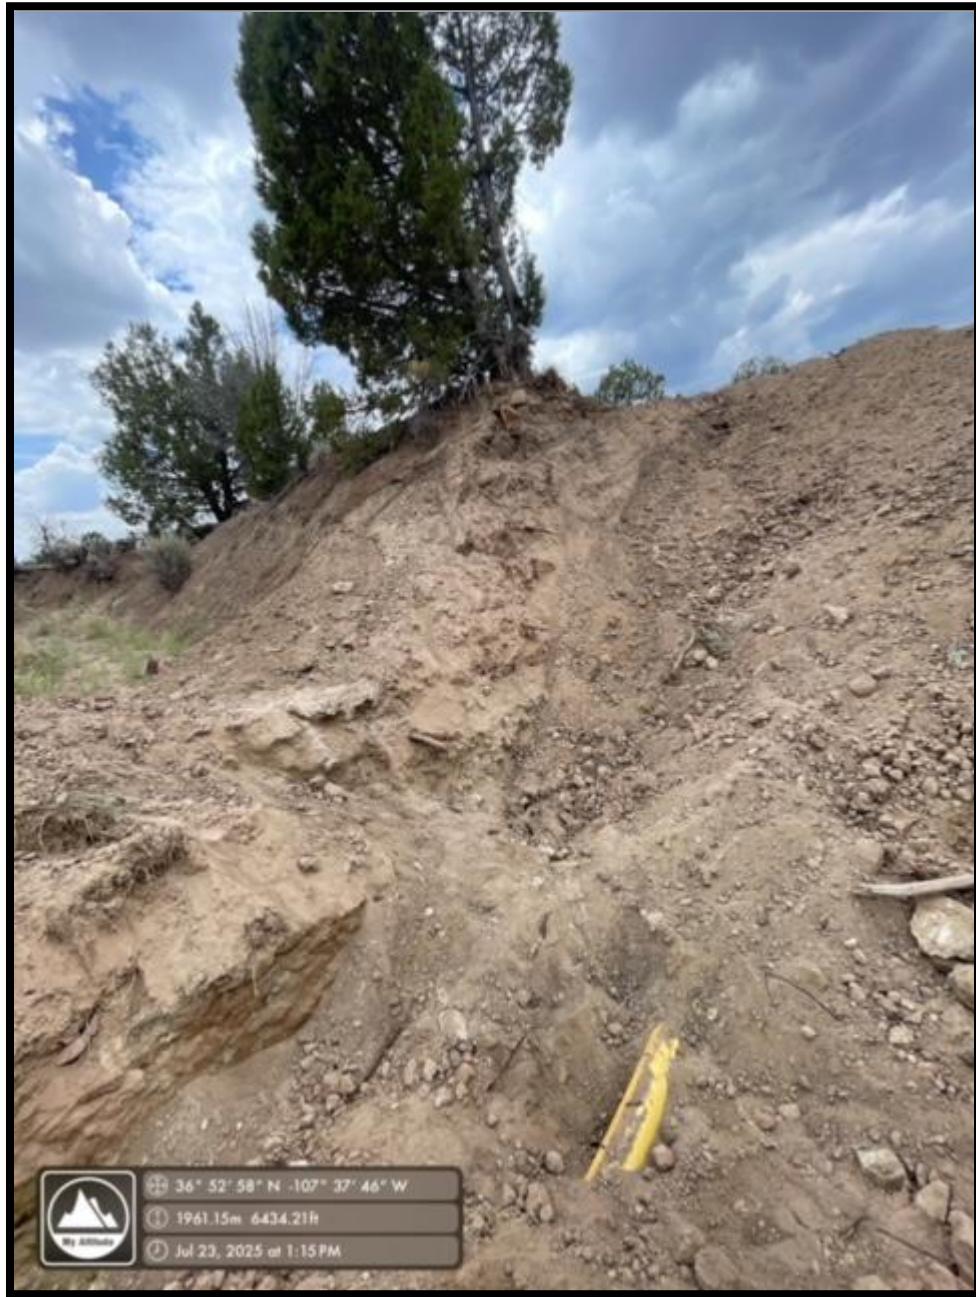
Photo 9: "South Wall 2" Sampling event on 7/23/2025

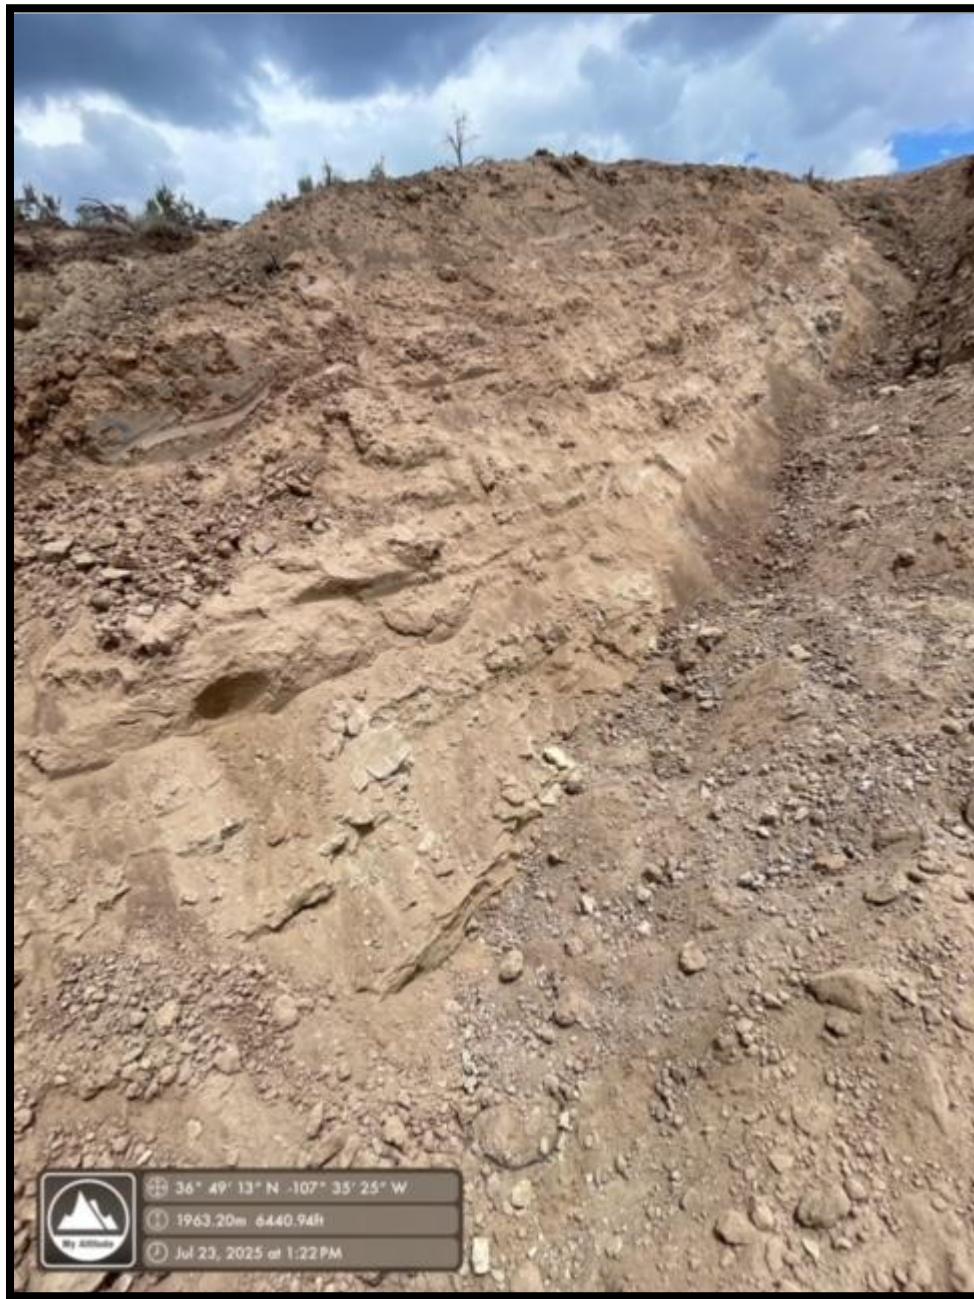
Photo 10: "North Wall 1" Sampling event on 7/23/2025

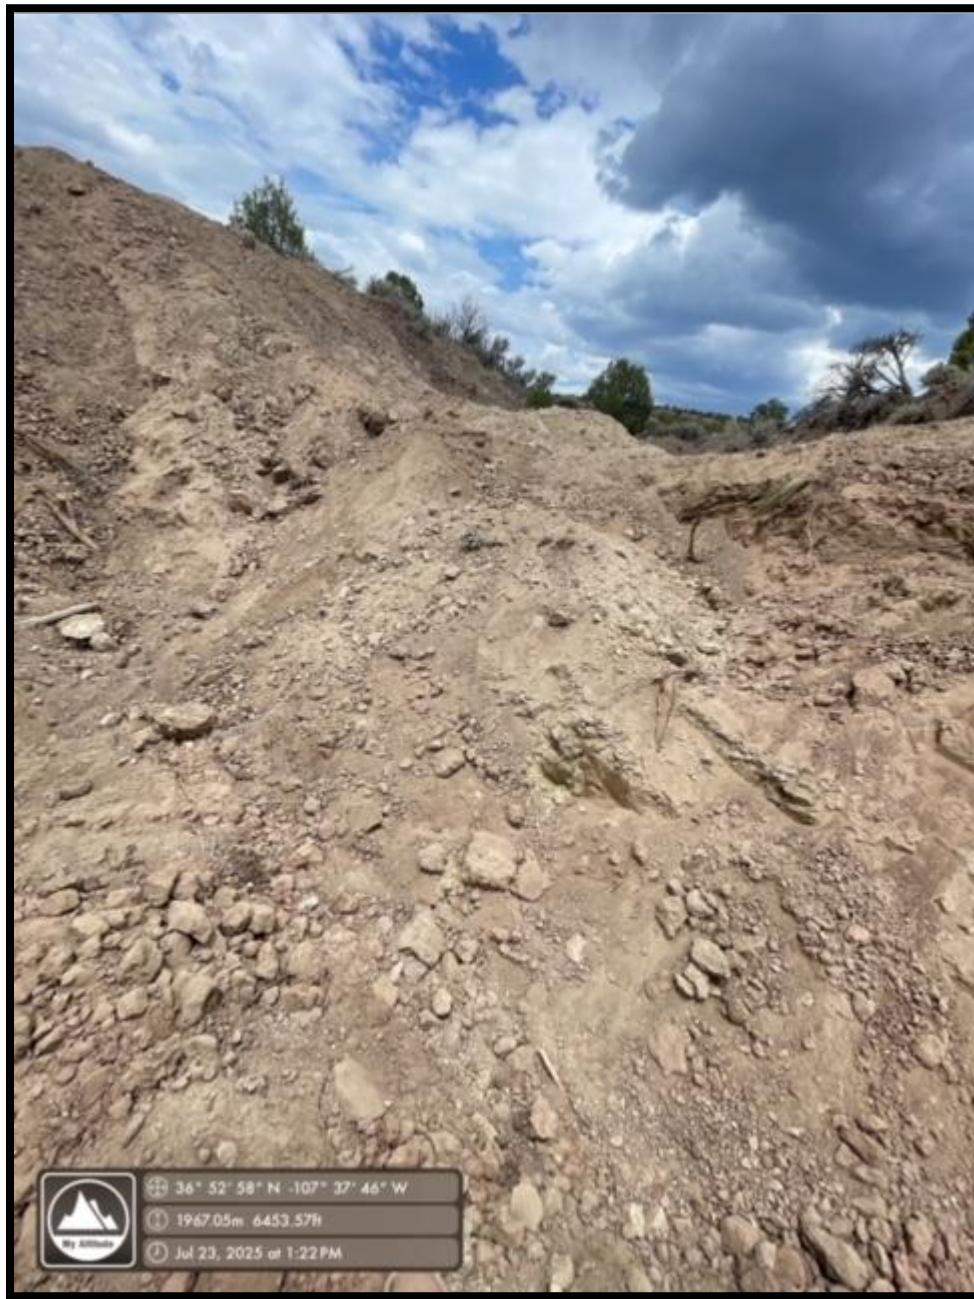
Photo 11: "North Wall 2" Sampling event on 7/23/2025

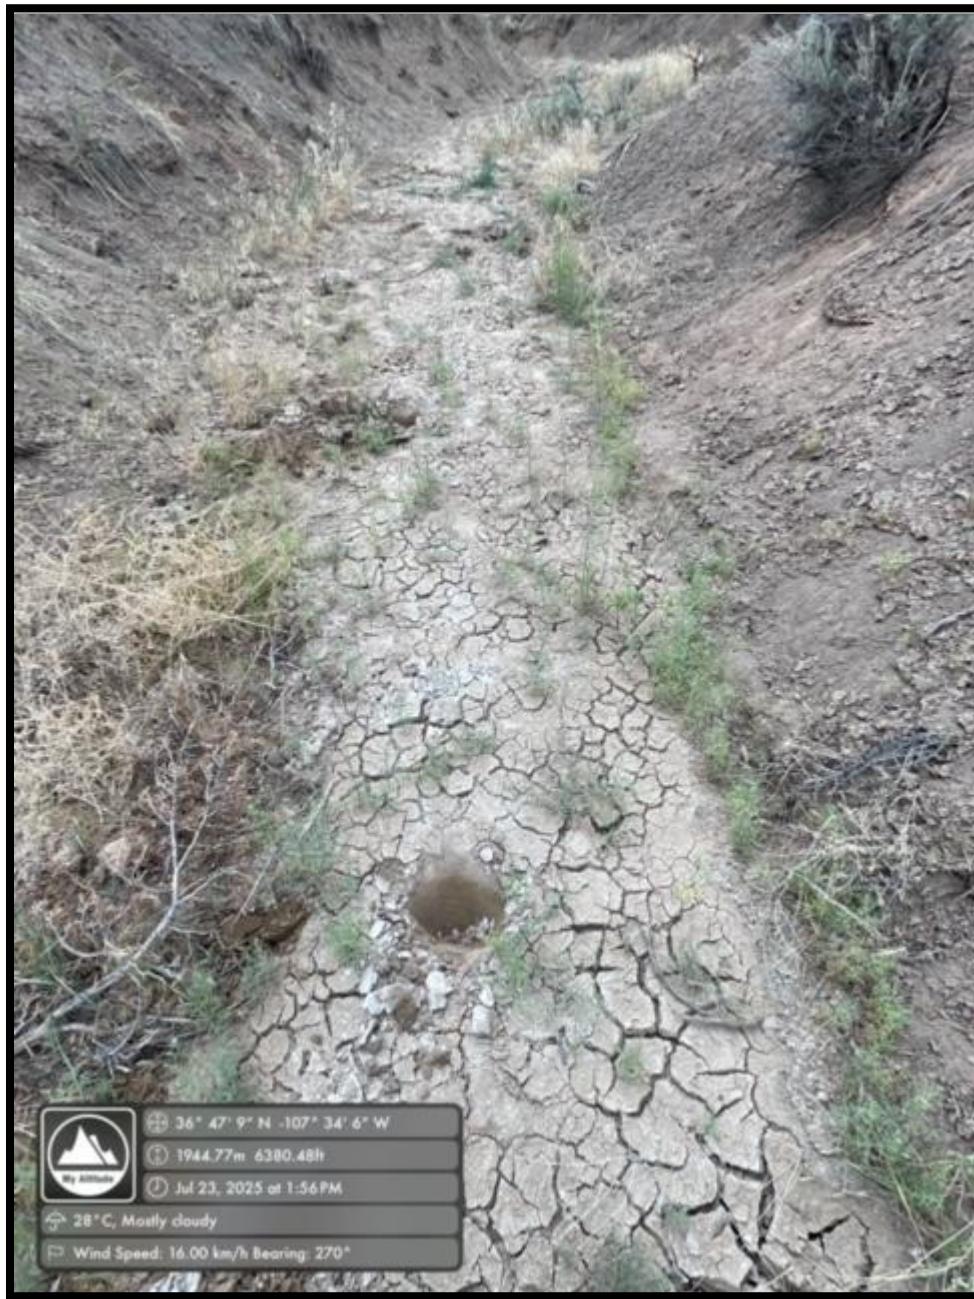
Photo 12: "Wash" Sampling event on 7/23/2025

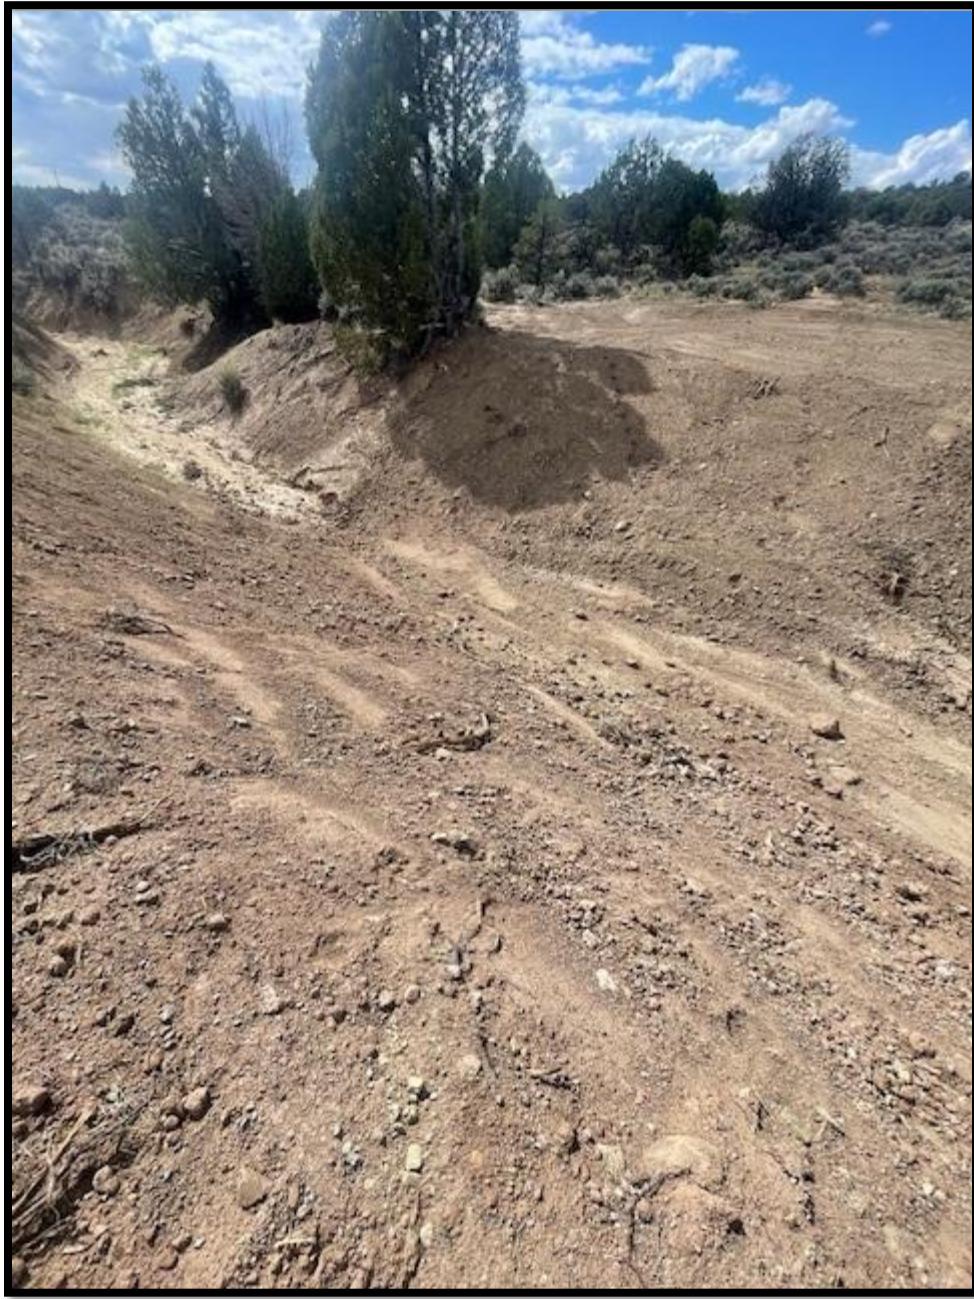
Photo 13: Excavation Backfilled

Site was backfilled with BLM approved soil from Envirotech land farm and contoured to sites existing grade.

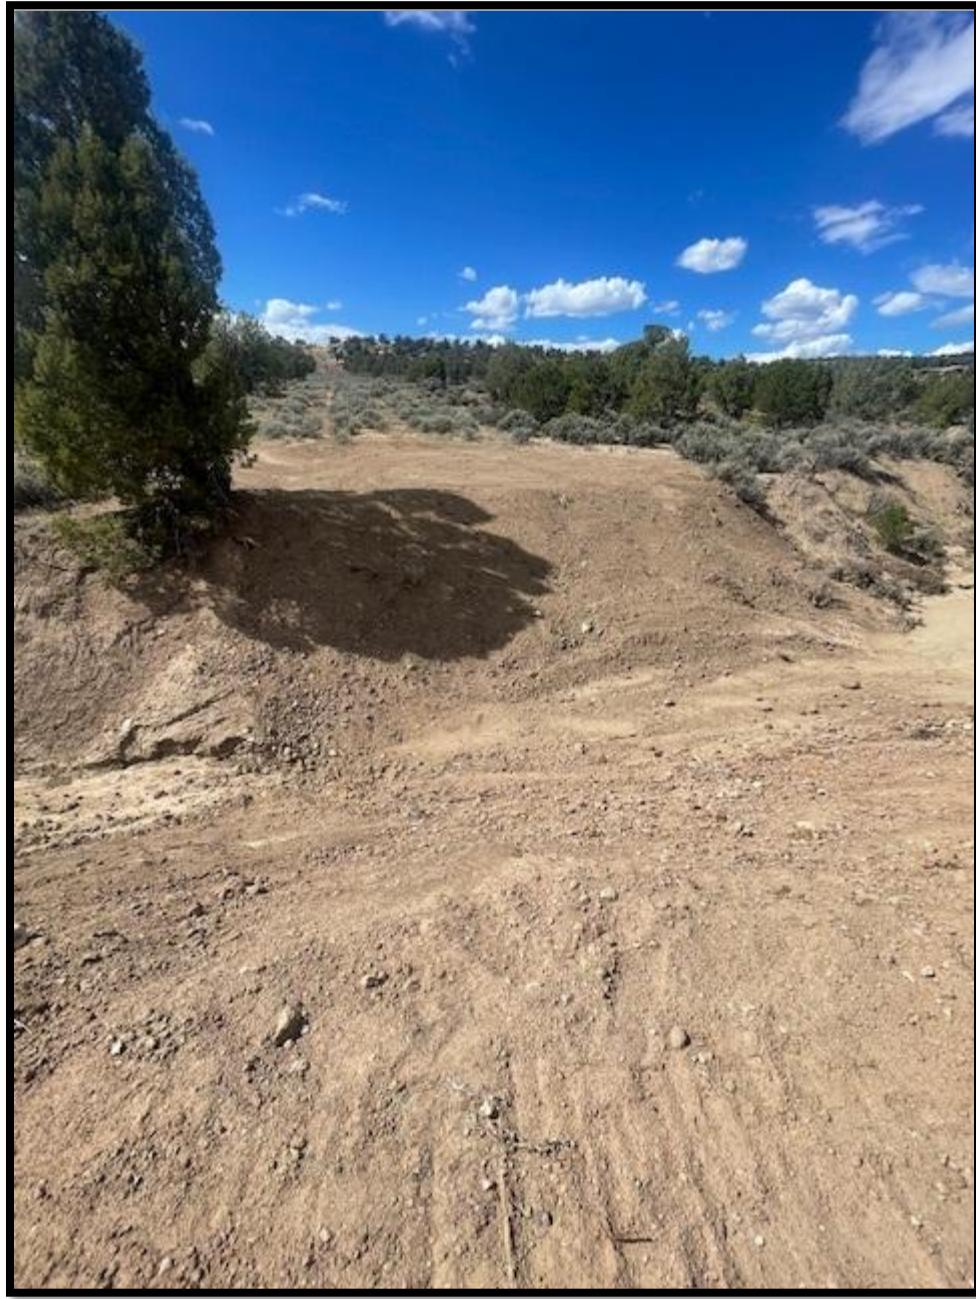
Photo 14: Excavation Backfilled

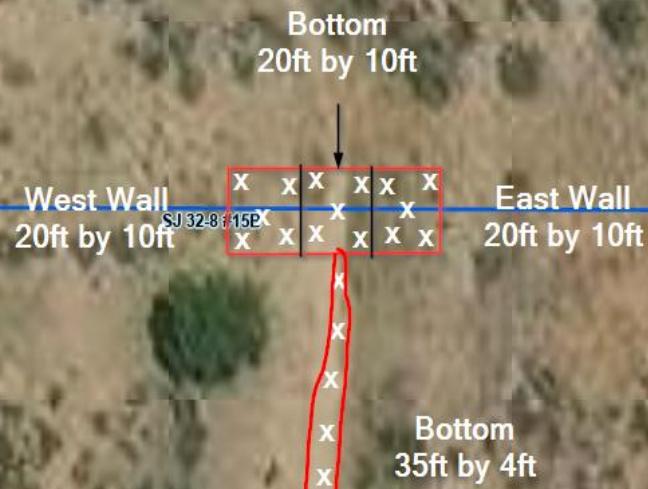
## Sample Map 7/23/2024

North Wall 2  
30ft by 6ftNorth Wall 1  
30ft by 6ft

South Wall 2  
30ft by 6ftSouth Wall 1  
30ft by 6ft
