## Release Assessment and Closure

Corral Canyon Federal Com #001H  
Section 06, Township 25 South, Range 29 East  
API: 30-015-43428  
County: Eddy  
Vertex File Number: 25A-05224

**Prepared for:**  
ExxonMobil Production Company

**Prepared by:**  
Vertex Resource Services Inc.

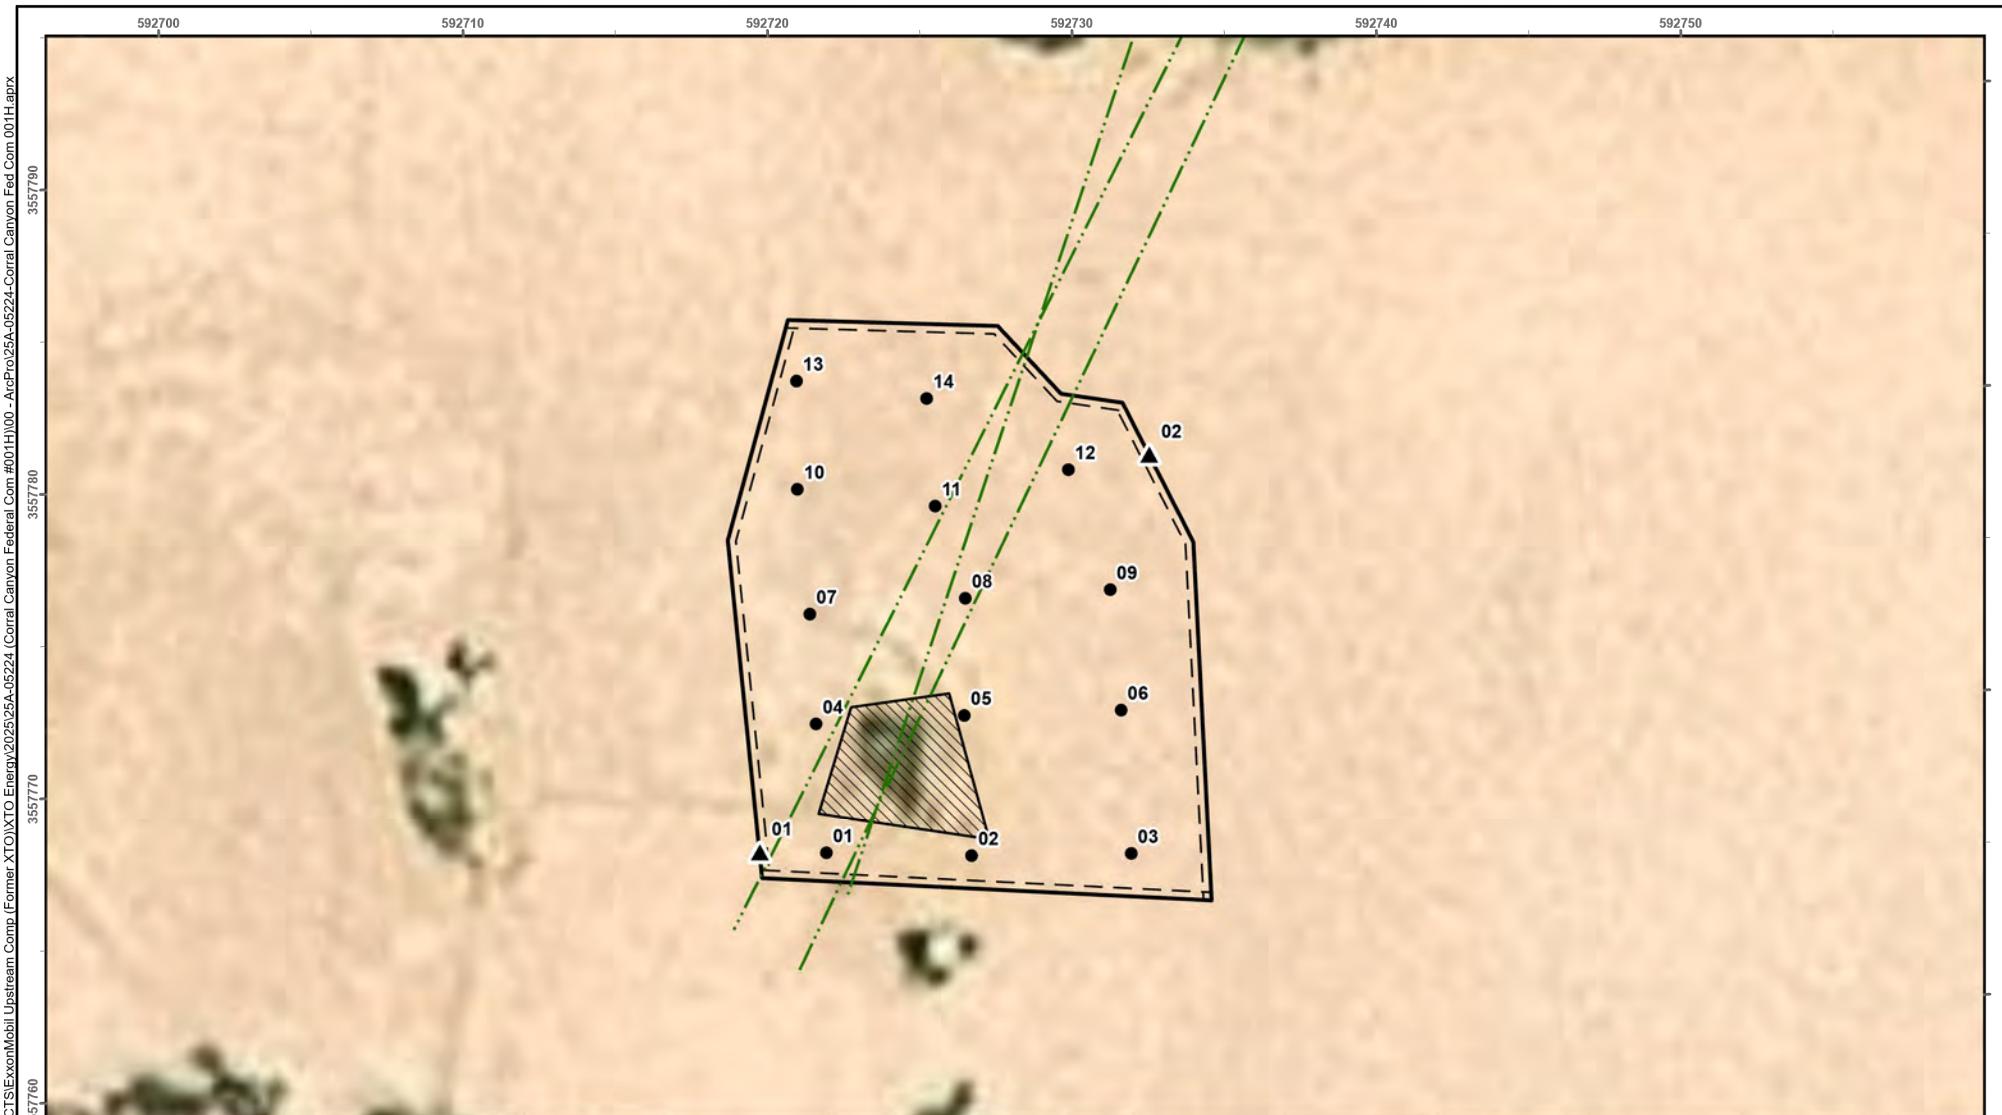
- Base Sample (Prefixed by "BS25-")
- ▲ Wall Sample (Prefixed by "WS25-")
- Electrical line (Underground)
- Production Equipment
- Excavation to 1' bgs (~2,755 sq.ft. | 204 ft.)

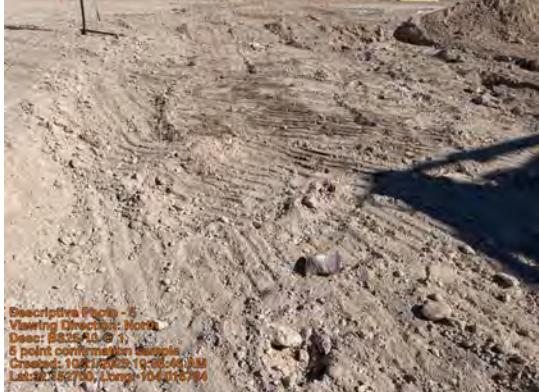
<p><b>Viewing Direction: North</b></p>

<p>Descriptive Photo - 7 Viewing Direction: North Desc: BS25-10 @ 1' 5 point confirmation sample Created: 10/21/2025 10:23:46 AM Lat:32.152710, Long:-104.213724</p> <p>BS25-10 @ 1' 5 point confirmation sample</p>	<p><b>Viewing Direction: East</b></p>

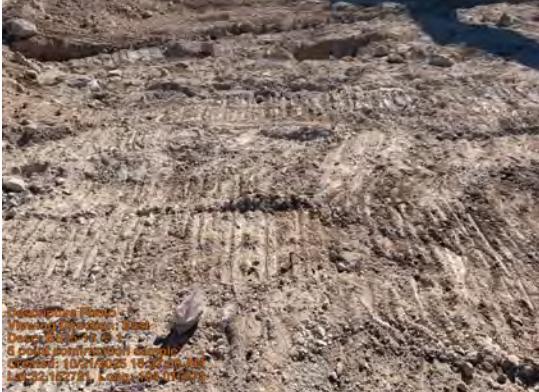
<p>Descriptive Photo - 8 Viewing Direction: East Desc: BS25-13 @ 1' 5 point confirmation sample Created: 10/21/2025 10:23:46 AM Lat:32.152710, Long:-104.213724</p> <p>BS25-13 @ 1' 5 point confirmation sample</p>
<p><b>Viewing Direction: North</b></p>

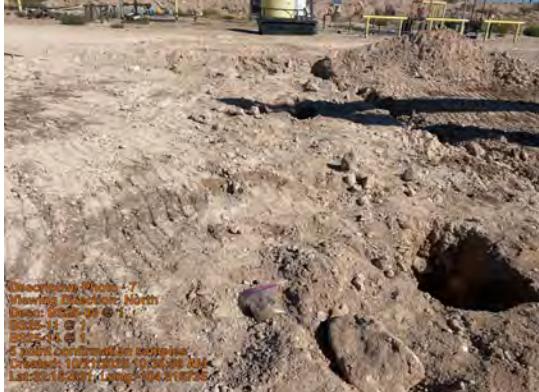
<p>Descriptive Photo - 7 Viewing Direction: North Desc: BS25-08 @ 1' BS25-11 @ 1' BS25-14 @ 1' 5 point confirmation samples Created: 10/21/2025 10:23:46 AM Lat:32.152504, Long:-104.213725</p> <p>BS25-08 @ 1' BS25-11 @ 1' BS25-14 @ 1' 5 point confirmation samples</p>	<p><b>Viewing Direction: Northeast</b></p>

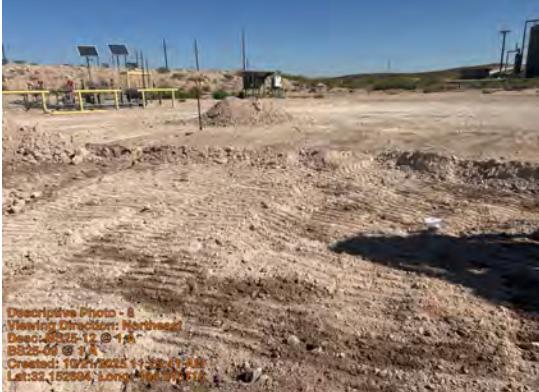
<p>Descriptive Photo - 8 Viewing Direction: Northeast Desc: BS25-12 @ 1' BS25-09 @ 1' Created: 10/21/2025 10:23:46 AM Lat:32.152504, Long:-104.213725</p> <p>BS25-12 @ 1' BS25-09 @ 1'</p>
