Re: Remediation Closure Request
J R Oil, Ltd. Co.
JF Janda NCT I #001 Battery Release
Unit Letter B, Section 2, Township 23 South, Range 36 East
Lea County, New Mexico
Incident ID# NCH1830627946
1RP-5250

Remediation Closure Request
September 15, 2025

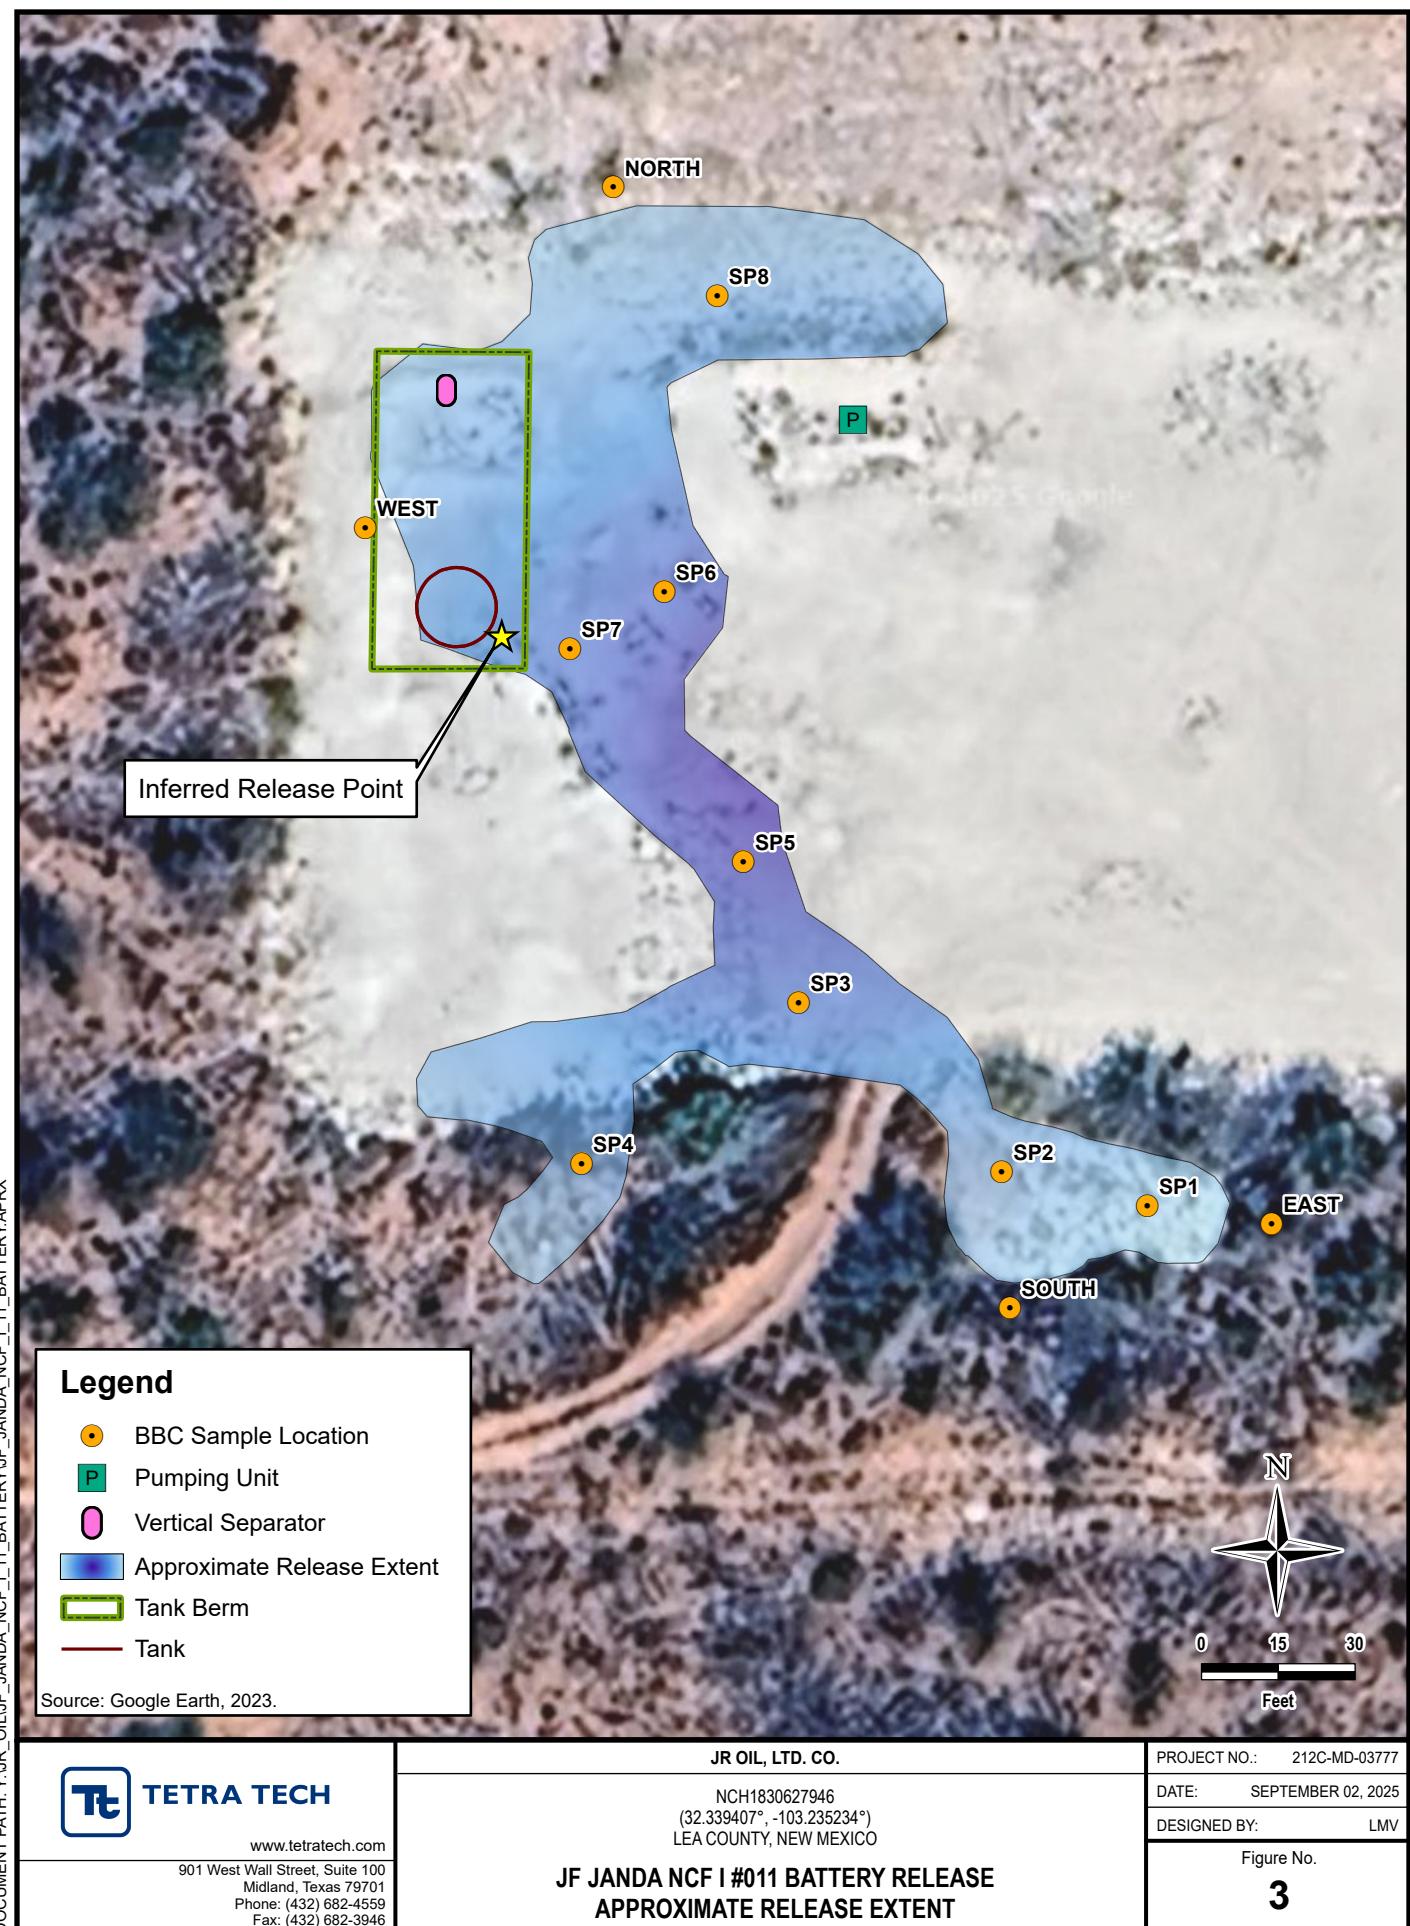
According to the State of New Mexico Oil Conservation Division (NMOCD) Initial C-141 Form, the release was discovered on August 27, 2018. The release occurred as a result of a lightning strike on a fiberglass water tank causing a fire and the associated release. Approximately 0.5 barrels (bbls) of crude oil and 47.6 bbls of produced water were released, of which no volume was recovered. The release extent remained primarily on pad, but sections flowed onto pastureland south of the pad. Based on the available data, the inferred release point coordinates are 32.339407°, -103.235234°. The inferred release point and approximate release extent is shown in Figure 3.

According to available documentation, Oxy performed initial response activities and removed some of the impacted soil shortly following the release. Upon completion of the initial response activities, BBC collected soil samples from a total of twelve (12) locations for assessment and delineation of the remaining extent. On September 25 and 26, 2018, BBC collected a total of forty (40) soil samples from eight (8) locations (SP1 through SP8) within the release extent for vertical delineation and four (4) locations outside the release extent for horizontal delineation. Analytical laboratory results associated with the September 2018 sampling event indicated elevated chloride concentrations down to a maximum depth of 4 feet bgs and elevated TPH concentrations in surface soil samples. Sample locations from the initial assessment and delineation are depicted in Figure 3.

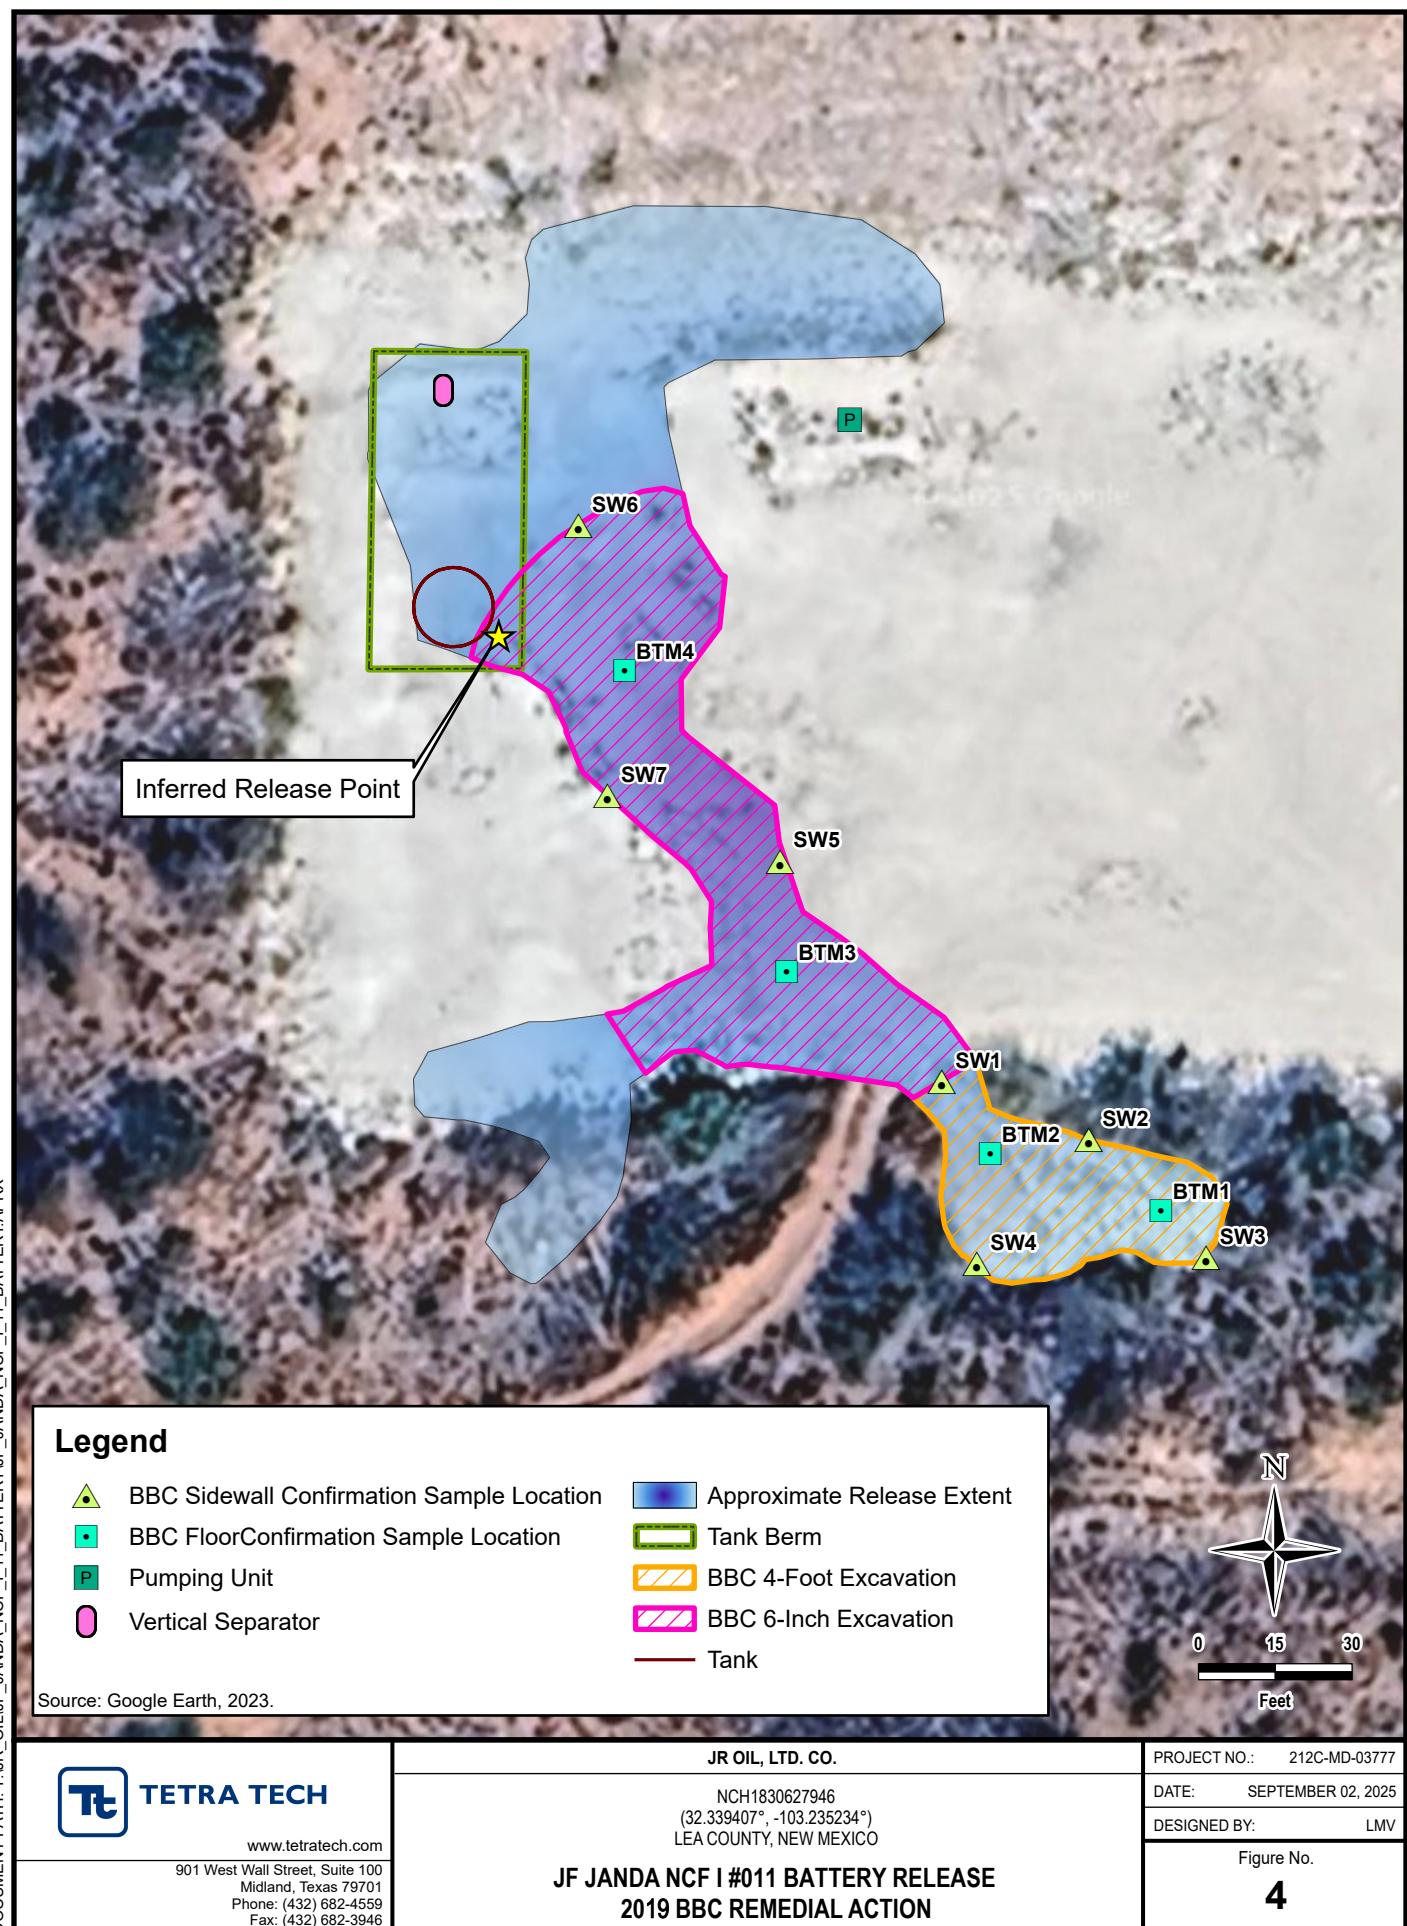
From January to February 2019 BBC executed the approved remediation plan on behalf of Oxy by excavating the areas of the release extent surrounding assessment locations SP1 and SP2 to four (4) feet bgs, and excavating the areas surrounding assessment locations SP3, SP5, SP6, and SP7 to a depth of six (6) inches. Per the approved BBC Delineation Workplan, the remaining areas of the release extent did not require excavation. Excavated areas and depths from the BBC remedial action are indicated in Figure 4.

Following the excavation, confirmation samples were collected at a total of eleven (11) locations, including four (4) floor locations and seven (7) sidewall locations. Confirmation floor sample locations were labeled “Bottom #” and confirmation sidewall sample locations were labeled “Sidewall #” and submitted to an accredited laboratory (Cardinal Laboratories in Hobbs, NM) to be analyzed for TPH, BTEX, and chloride.

The results of the BBC confirmation soil sampling event from February, 2019 are summarized in Table 1. Laboratory analytical data results associated with the confirmation samples collected by BBC were below the most stringent 19.15.29 NMAC Table I closure criteria for soils. Following receipt of the confirmation sampling results, the excavation was backfilled with clean soil.

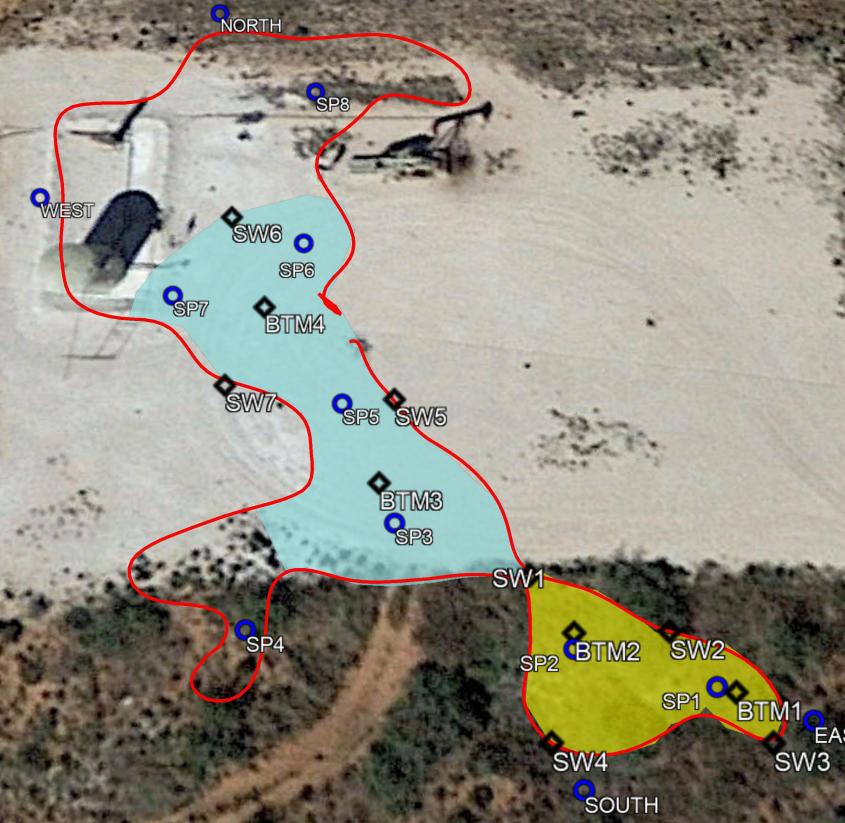
Leak date: 8/27/18
Lea County, NM
AP# 30-025-36396
1RP-5250

In the BBC Delineation Workplan, a Google Earth figure is included with sample locations, an approximate release extent, and proposed 6-inch remediation extent. BBC also included a short statement in their Delineation Workplan “*OXY will excavate the spill area as depicted on the following site diagram. The leak areas near SP1-SP3 and SP5-SP7 (YELLOW shade on diagram) will be excavated to a depth of 6 inches.*” Ryan Mann of the New Mexico State Land Office (NMSLO) approved the BBC Delineation Workplan on November 19, 2018 with the following comments: “*Please provide photographs of the area around SP4 in subsequent reports to verify the vegetation was not impacted. Also the area around SP1 and SP2 will need further excavation. These areas are off pad and will need 4 feet of soil.*” Christina Hernandez of the NMOCD approved the plan on January, 17, 2019, with the following condition: “*Excavate top 4' at SP1 and SP2.*” Record of the BBC Delineation Workplan and regulatory approval correspondence can be found in the file for 1RP-5250 on the OCD Permitting website.

- 4 ft Excavation
- 6 in Excavation
- Confirmation samples
- Leak Area
- Sample points
