**Re: Remediation Work Plan**  
**PLU 18 TWR West Battery**  
**Incident Number nAPP2510144301**  
**Eddy County, New Mexico**

Ensolum, LLC (Ensolum) on behalf of XTO Energy, Inc. (XTO), has prepared this *Remediation Work Plan (Work Plan)* to document the findings of a liner integrity inspection, delineation, excavation, and soil sampling activities conducted at the PLU 18 TWR West Battery (Site) following a release of crude oil within a 574 square foot steel, lined containment. The containment contains production equipment and piping, a lease automatic custody transfer (LACT) unit, and pumps. The following *Work Plan* describes remediation and soil sampling activities completed and proposes additional delineation.

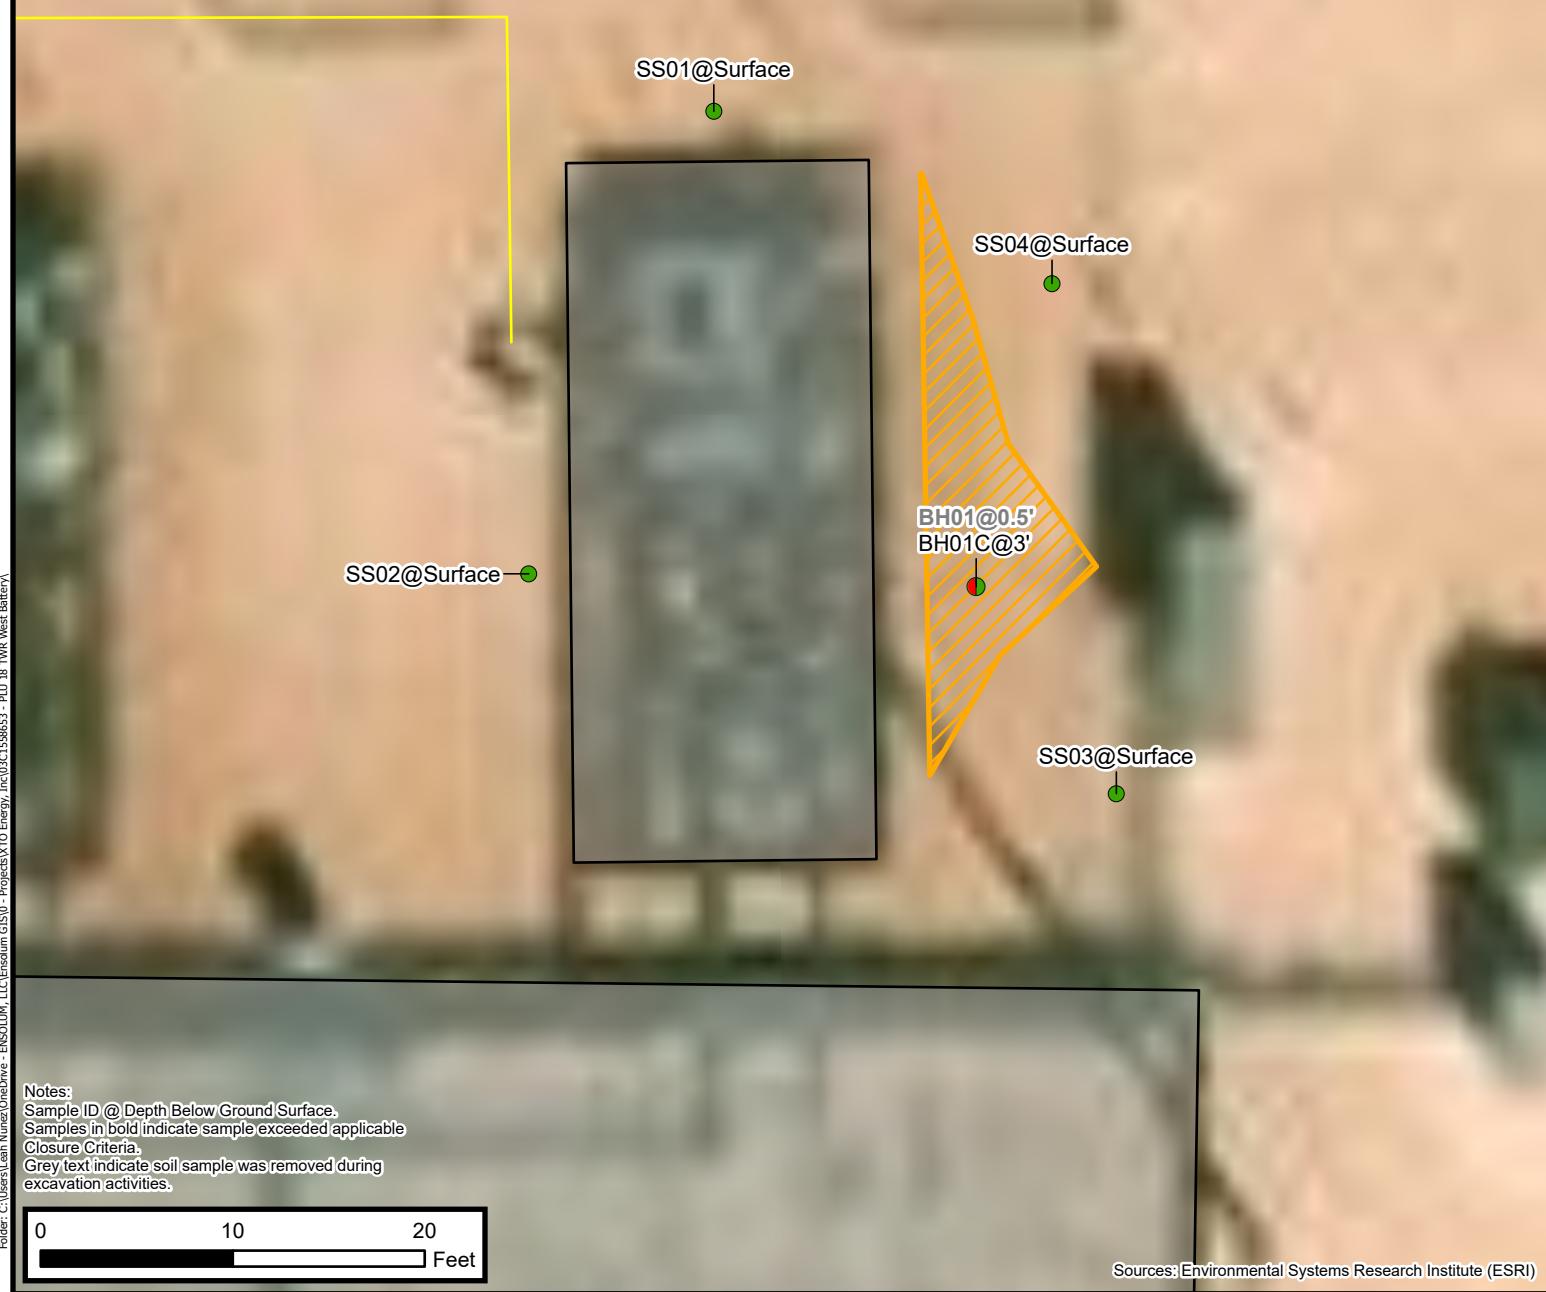
**FIGURE  
2**

On May 1, 2025, Ensolum personnel returned to the Site to oversee surface scraping and delineation soil sampling activities. One delineation borehole was advanced via hand auger within the release extent to a terminal depth of 3 feet bgs within the release extent. Discrete delineation soil samples were collected from the borehole at depths ranging from 0.5 feet to 3 feet bgs. The release extent was surface scraped via hand shovels. One 5-point composite confirmation soil sample, CS01, was collected to assess for the presence or absence of impacted soil. On June 24, 2025, Ensolum personnel returned to the Site to collect additional delineation soil samples SS01 through SS04 from ground surface to define the lateral extent of the release. All soil samples collected were field screened for volatile organic compounds (VOCs) utilizing a calibrated photoionization detector (PID) and chloride utilizing Hach® chloride QuanTab® test strips. Field screening results and observations for the borehole were logged on a lithologic/soil sampling log, which is included in Appendix C. The delineation soil sample locations are depicted on Figure 2.

Laboratory analytical results for the delineation soil sample BH01, collected from 0.5 feet bgs, indicated Benzene, BTEX, and TPH concentrations exceeded Closure Criteria but soil sample BH01C was in compliance with Closure Criteria at 3 feet bgs. Laboratory analytical results for the confirmation soil sample, CS01, indicated BTEX and TPH concentrations exceeded Closure Criteria at 0.5 feet bgs, indicating additional remediation was needed. Delineation soil samples SS01 through SS04 indicated all COCs were in compliance with reclamation requirements, successfully defining the lateral extent of the release.

## Delineation Soil Sample Locations

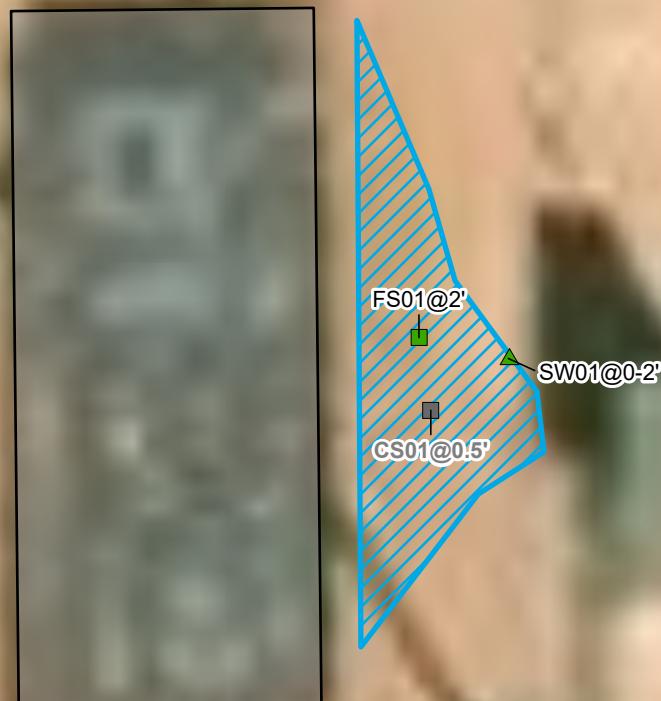
**FIGURE  
3**

On June 23, 2025, Ensolum personnel oversaw excavation activities utilizing a backhoe and transport vehicle. The entire overspray area was excavated to approximately 2 feet bgs. Ensolum personnel collected 5-point composite soil samples representing no more than 200 square feet from the floor and sidewall of the excavated area. The 5-point composite soil samples were collected by placing five equivalent aliquots of soil into a 1-gallon, resealable plastic bag and homogenizing the samples by thoroughly mixing. Confirmation soil sample FS01 was collected from the floor of the excavation from a depth of 2 feet bgs. Confirmation soil sample SW01 was collected from the sidewall of the excavation at depths ranging from ground surface to 2 feet bgs. The soil samples were collected, handled, and submitted for the same COCs mentioned above, and were delivered to Cardinal. Photographic documentation of all Site activities is included in Appendix B. The excavation extent and confirmation soil sample locations are depicted in Figure 3.

Laboratory analytical results for confirmation soil samples FS01 and SW01 indicated all COCs were in compliance with Closure Criteria, successfully removing impacted soil identified in delineation soil sample BH01 and confirmation soil sample CS01. Laboratory analytical results are summarized in Table 1, and all laboratory analytical reports are included in Appendix D.

## Confirmation Soil Sample Locations

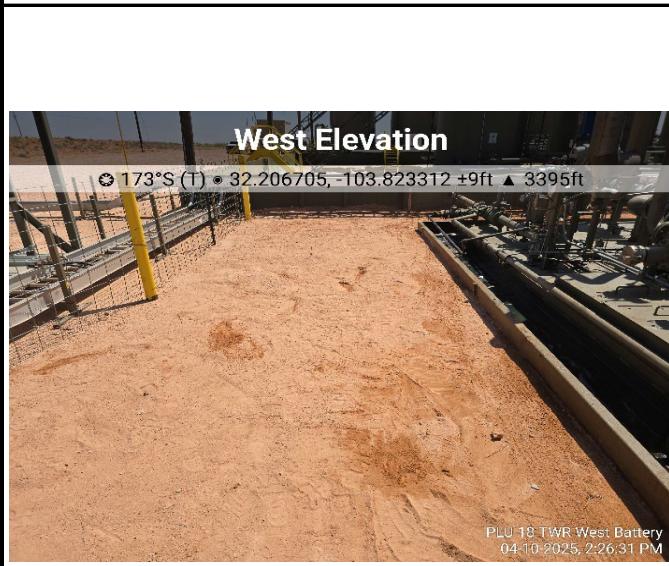
On April 9, 2025, a valve on a pump was inadvertently left open resulting in the release of 11 barrels (bbls) of crude oil into a lined containment; approximately 8 gallons sprayed east of the lined containment, onto the surface of the pad. A vacuum truck was dispatched to the Site to recover free-standing fluid, 10 bbls of released fluids were recovered. XTO reported the release to the New Mexico Oil Conservation Division (NMOCD) via a Notification of Release (NOR) on and an Initial C-141 Application (C-141) on April 11, 2025. The release was assigned Incident Number nAPP2510144301.

Photograph: 1 Date: 4/10/2025  
Description: Initial release staining  
View: South

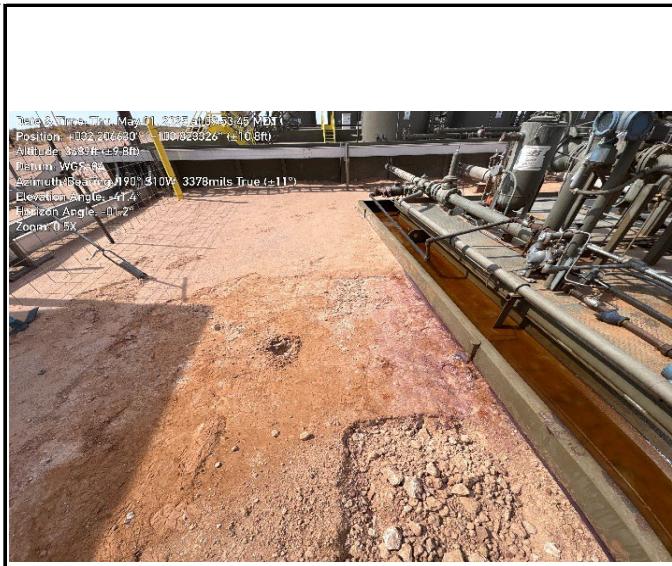
Photograph: 2 Date: 5/1/2025  
Description: Delineation activities; near BH01  
View: South

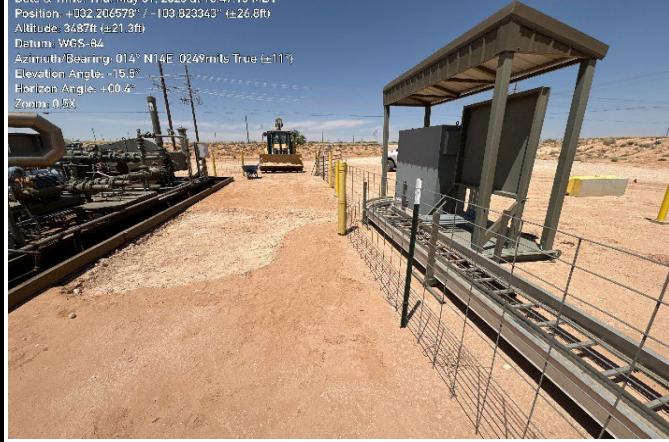
Photograph: 3 Date: 5/1/2025  
Description: Excavation activities  
View: North

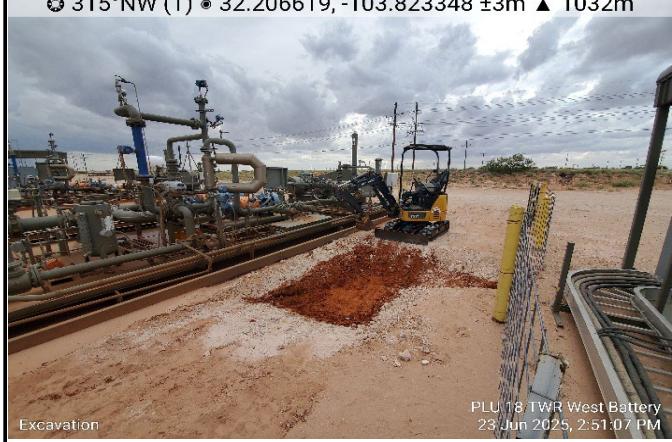
Photograph: 4 Date: 6/23/2025  
Description: Excavation activities  
View: Northwest

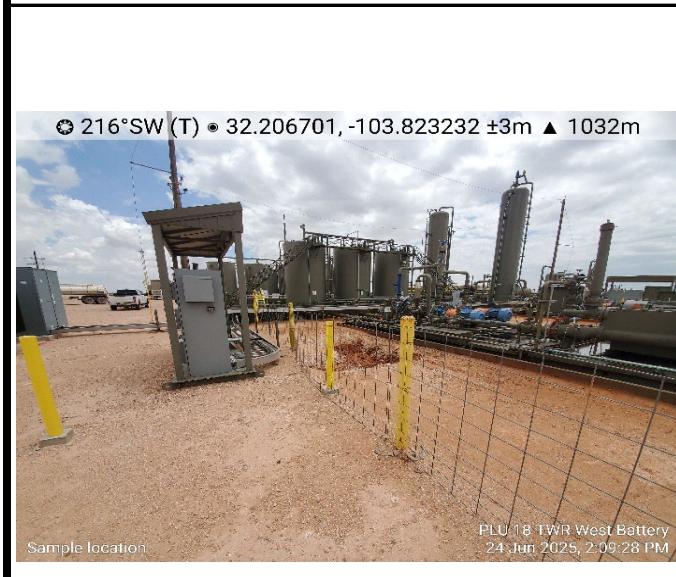
The final excavation extent measured an estimated 150 square feet. A total of 11 cubic yards of impacted soil were removed during the excavation activities. The impacted soil was transported and properly disposed of at the R360 Disposal Facility in Hobbs, New Mexico. The excavation was backfilled on September 30, 2025, with locally purchased caliche material and recontoured to existing grade.

Photograph: 5 Date: 6/24/2025  
Description: Final excavation extent  
View: Southwest

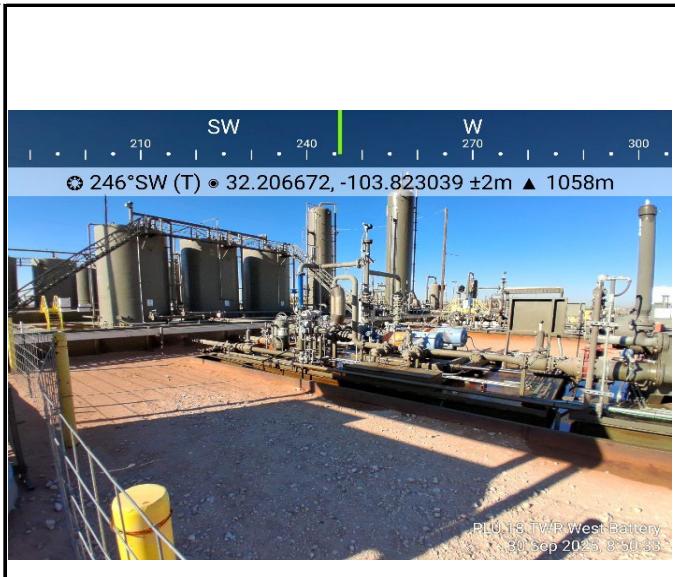
Photograph: 6 Date: 9/30/2025  
Description: Backfilled excavation extent  
View: Southwest

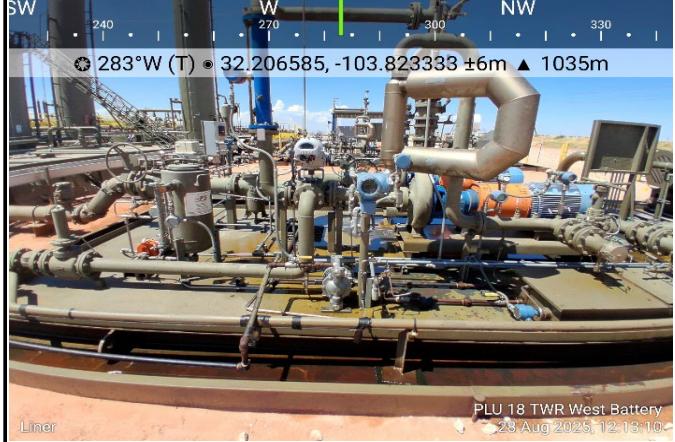
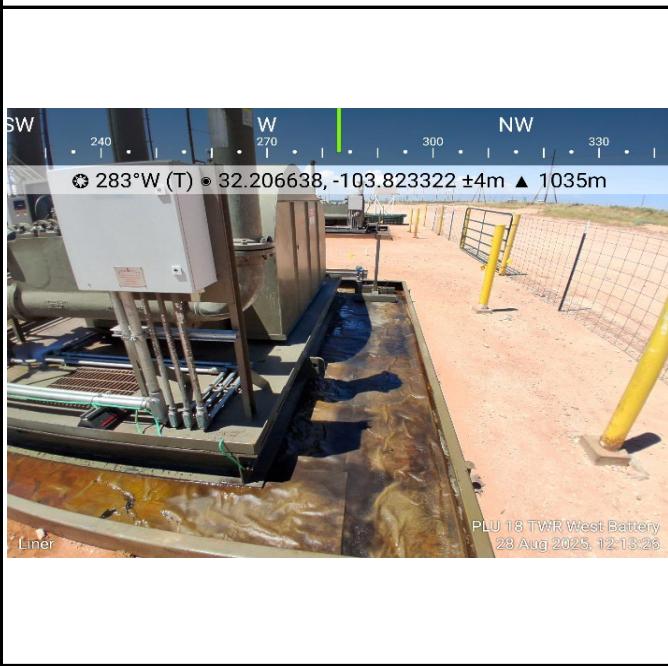
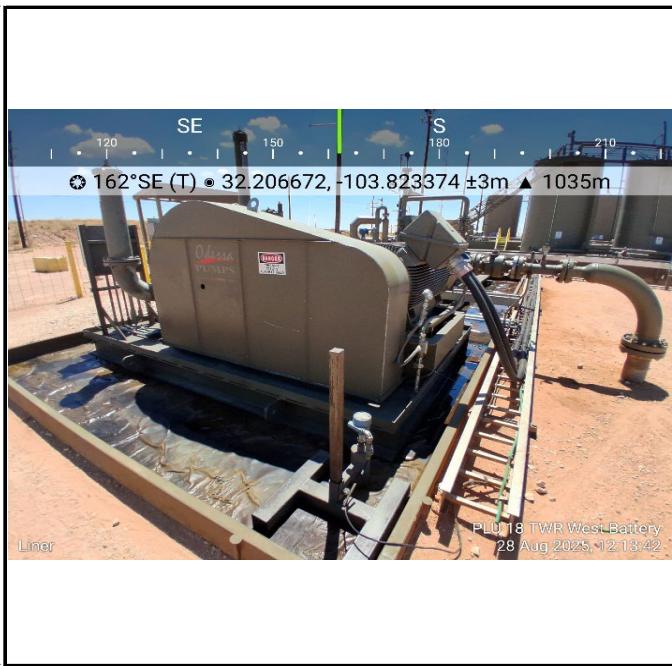
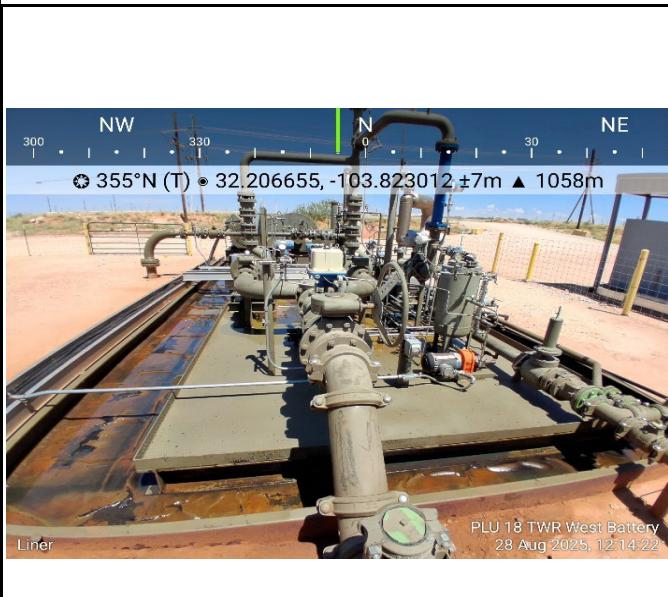
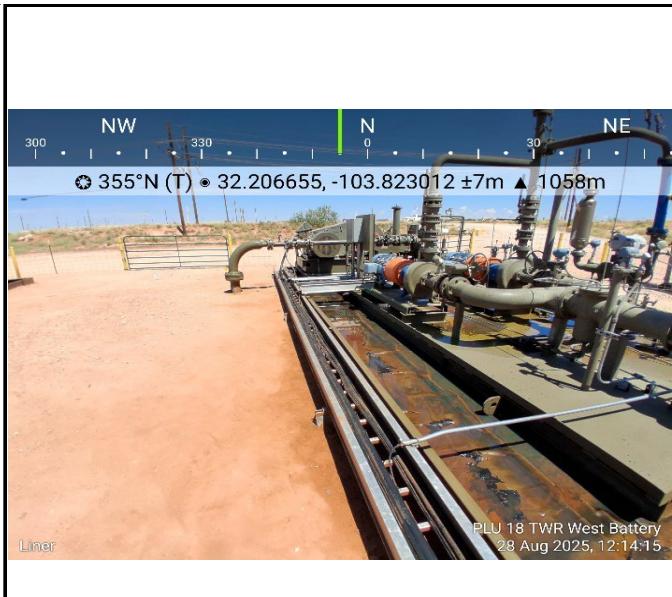
After a review of the C-141 and release photographs it was confirmed the release occurred within a lined containment. The lined containment was cleaned of all debris, power washed, and a 48-hour advance notice of the liner inspection was submitted on August 26, 2025. On August 28, 2025, the lined containment was inspected by Ensolum personnel and was determined to contain one tear on the floor of the liner, and a few areas of where the superficial liner material is peeling. Delineation of the release that occurred within the lined containment in the areas of where the liner is breached is warranted. Photographic documentation of the inspection is included in Appendix B.

Photograph: 8 Date: 8/28/2025  
Description: Liner inspection activities  
View: West

Photograph: 9 Date: 8/28/2025  
Description: Liner inspection activities  
View: West

Photograph: 10 Date: 8/28/2025  
Description: Liner inspection activities  
View: Southeast

Photograph: 11 Date: 8/28/2025  
Description: Liner inspection activities  
View: North

Photograph: 12 Date: 8/28/2025  
Description: Liner inspection activities  
View: North

- Delineation boreholes will be advanced within the lined containment, in the vicinity of the tear located on the floor of the liner, and in any areas where the liner is fully breached from peeling. The delineation boreholes will be advanced until discrete soil samples confirm all COC concentrations are compliant with the Closure Criteria.
- Lateral delineation soil samples, SS01 and SS02, will be advanced to an equivalent depth of the deepest impacts identified within the lined containment area, to confirm lateral delineation of any potential impacts identified if the impacts exceed 1-foot bgs.
- All delineation soil samples will be field screened, collected, and submitted for analysis of the same COCs mentioned above and submitted to a New Mexico approved laboratory. Following delineation activities, all confirmed liner breaches will be patched.
