CLOSURE REPORT

Fogelson GC #1E
Unit Letter N, S26 T30N R11W
San Juan County, New Mexico

New Mexico EMNRD OCD Incident ID No. NAPP2522643986

Ensolum Project No. 05A1226388

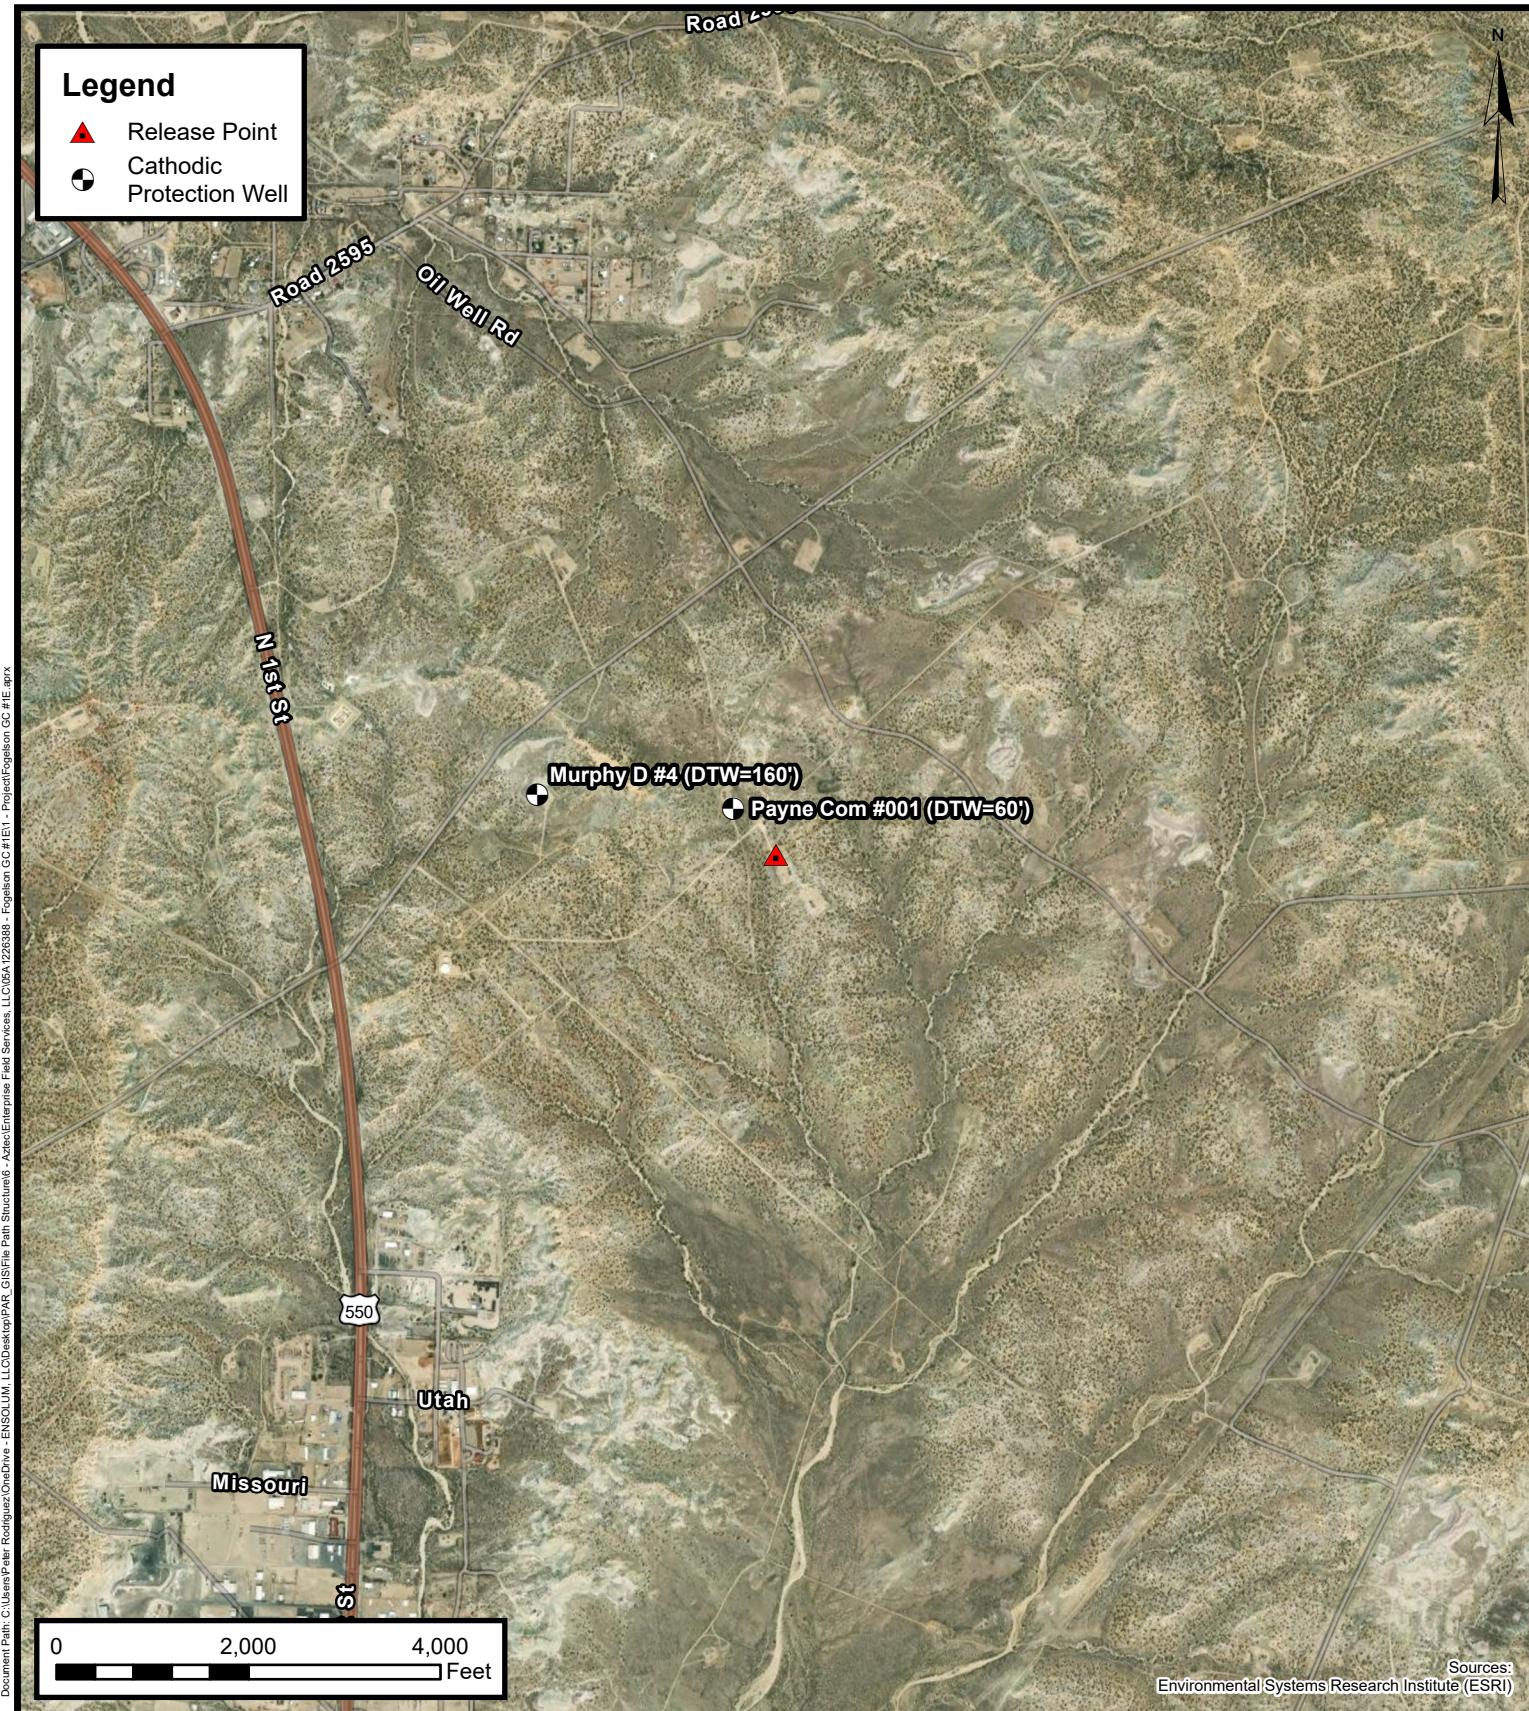
**FIGURE
B**

- Two cathodic protection wells (CPW) with recorded depths to water were identified in the NM EMNRD OCD imaging database near the Site (**Figure B, Appendix B**). Documentation for the closest cathodic protection well, associated with the Payne #1, indicates a depth to water of 60 feet below grade surface (bgs). This CPW is located approximately 770 feet northwest of the Site and is approximately 5 feet higher in elevation than the Site. Documentation for the cathodic protection well associated with the Murphy D #4 indicates a depth to water of 160 feet bgs. This CPW is located approximately 2,550 feet west of the Site and is approximately 50 feet higher in elevation than the Site.

**Nearest Cathodic Protection Well(s)
with Recorded Depth(s) to Water**
Enterprise Field Services, LLC
Fogelson GC #1E
Project Number: 05A1226388

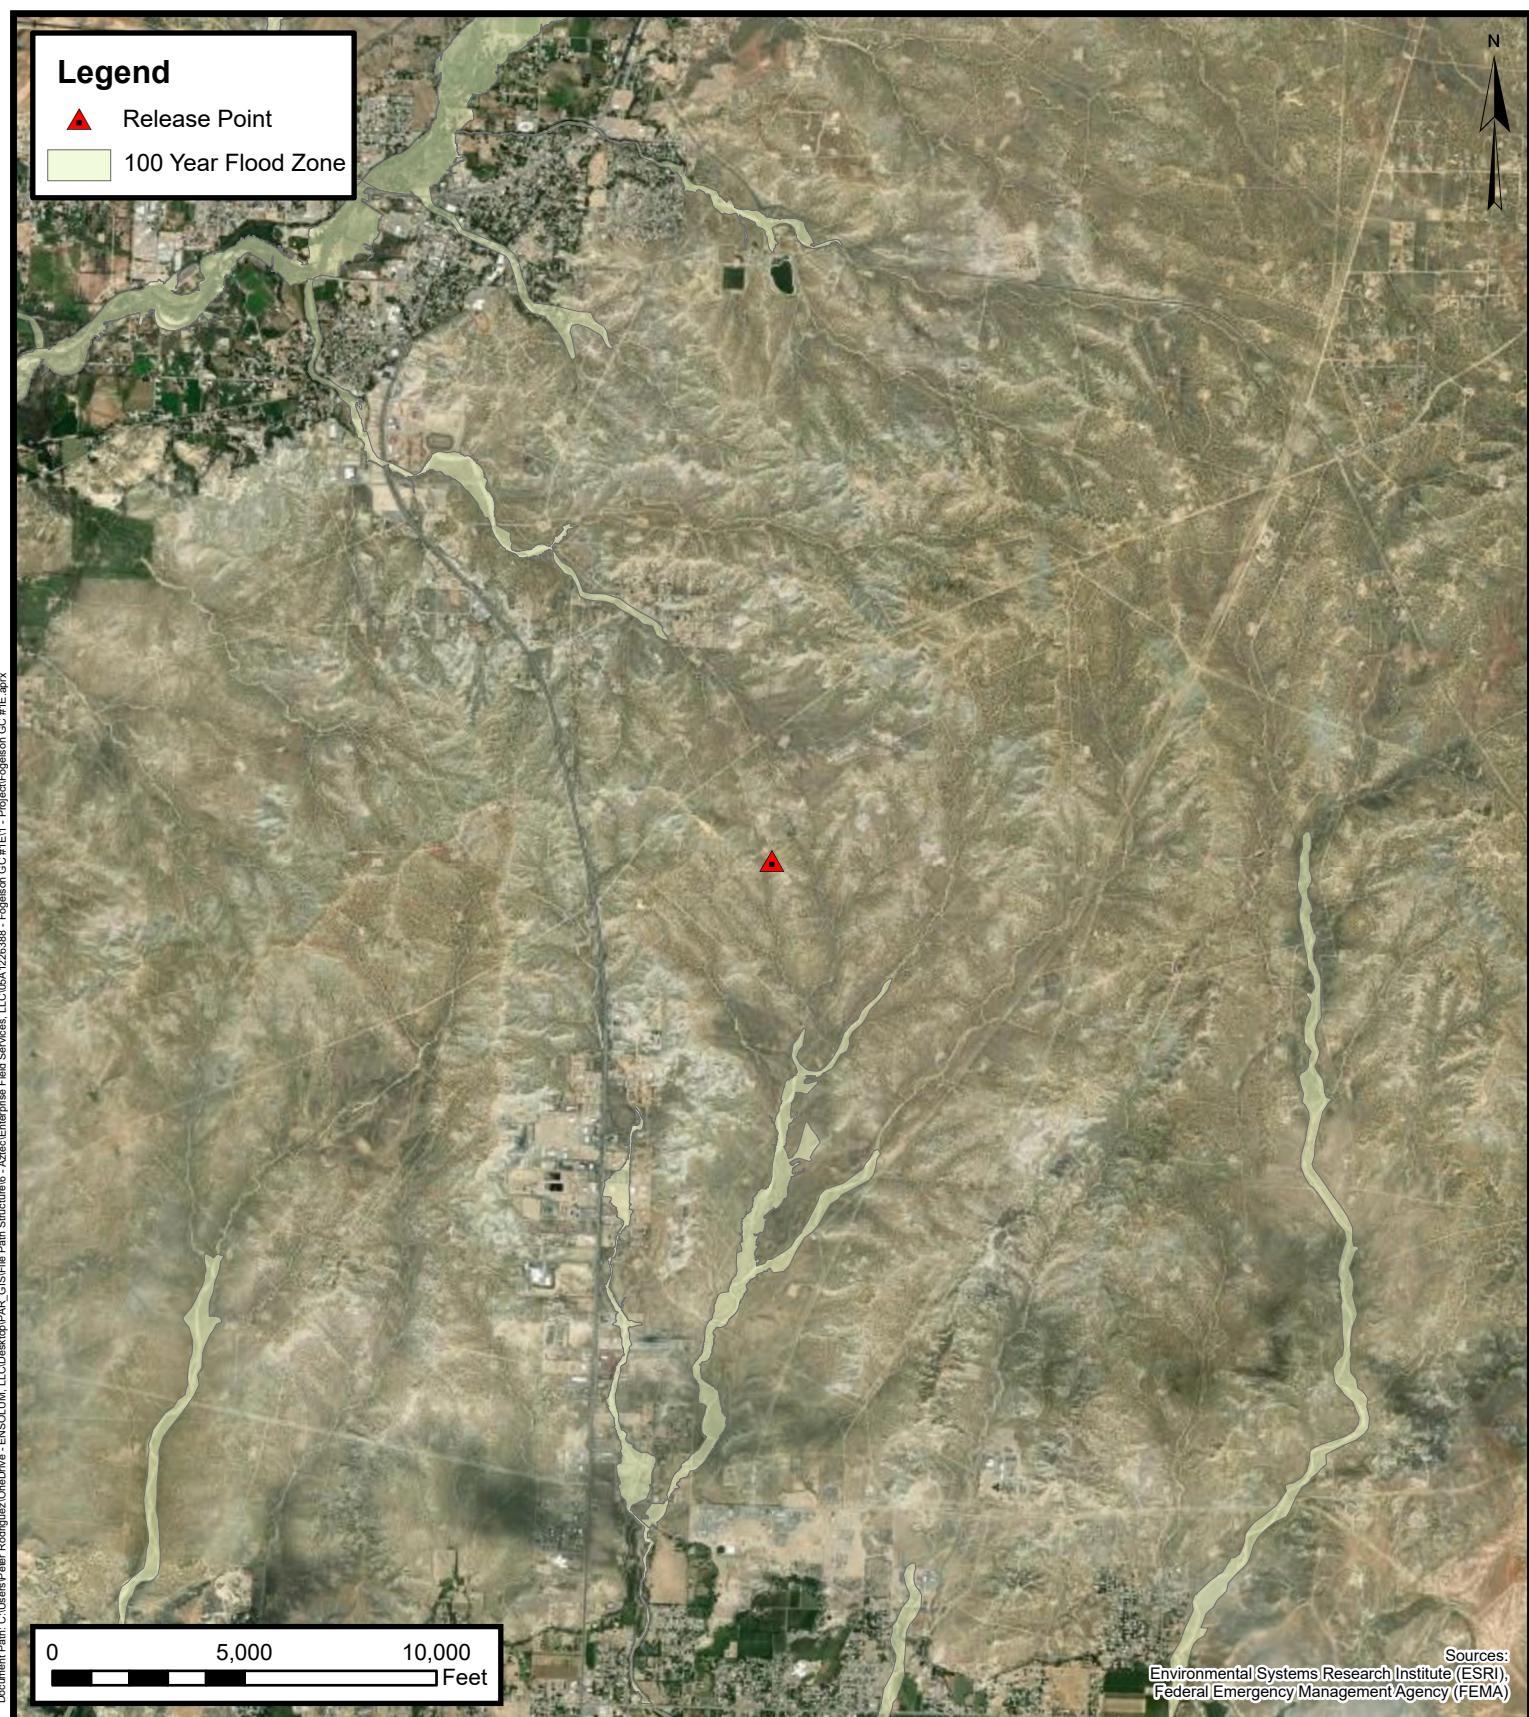
**FIGURE
G**

100-Year Flood Plain Map

- The Site is not located within an unstable area per Paragraph (6) of Subsection U of 19.15.2.7 NMAC.
- Based on information provided by the Federal Emergency Management Agency (FEMA) National Flood Hazard Layer (NFHL) geospatial database, the Site is not within a 100-year floodplain (**Figure H, Appendix B**).

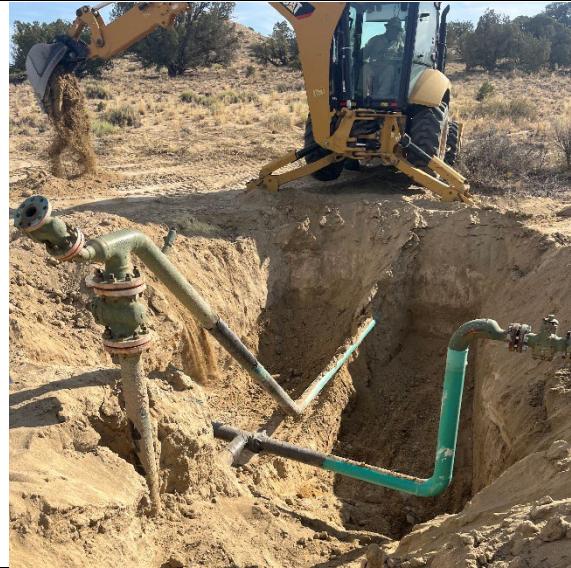
**Photograph 1**

Photograph Description: View of the in process excavation activities.

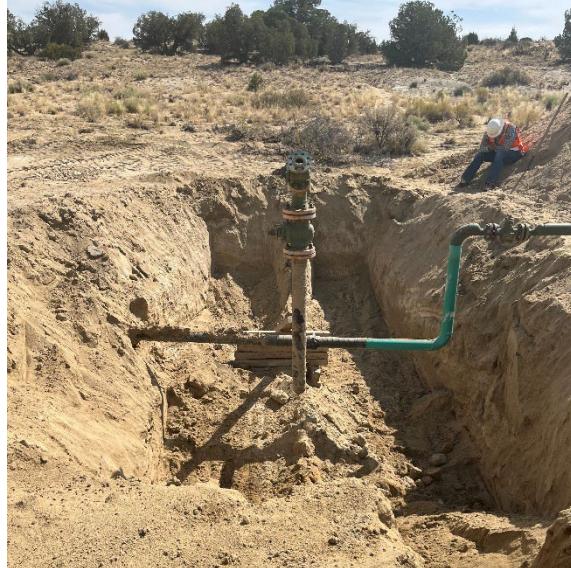
**Photograph 2**

Photograph Description: View of the in process excavation activities.

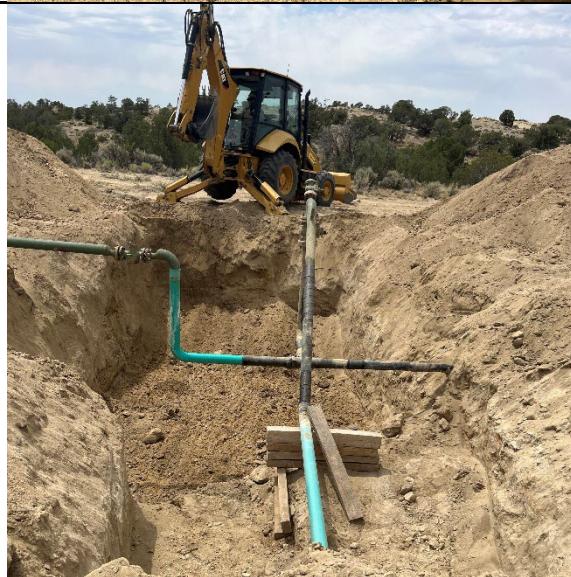
**Photograph 3**

Photograph Description: View of the final excavation.

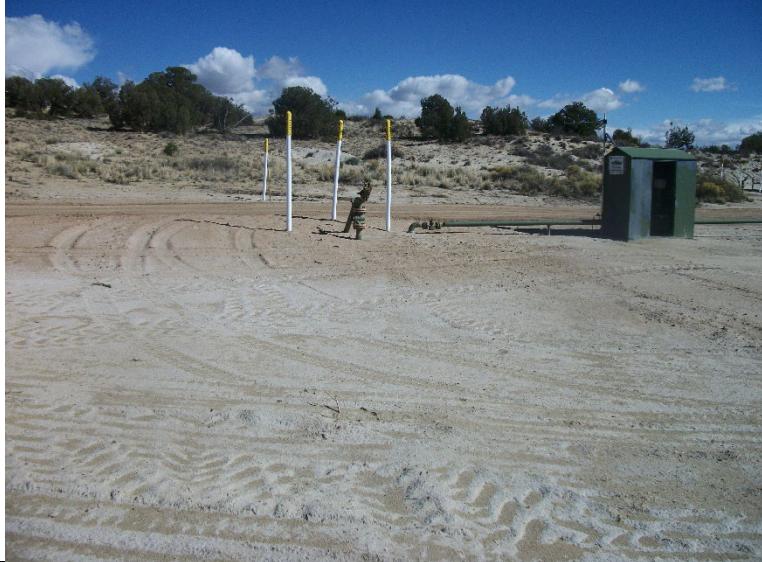
Photograph 4

Photograph Description: View of the final excavation after initial restoration.

The excavation was backfilled with imported fill and then contoured to the surrounding grade. The backfill and the upper four feet of the excavation have been analytically verified to be below the Tier I soil standards of 50 mg/kg BTEX, 10 mg/kg benzene, 100 mg/kg total combined TPH, and 600 mg/kg Chloride. See **Appendix D** and **Appendix F** for further documentation.
