**Re: Remedial Action Report  
Vaca Line Strike  
1RP-5243  
EOG Resources, Inc.  
Site Location: Unit A, Sec. 36, T 24-S, R 33-E  
(Lat 32.180794°, Long -103.518761°)  
Lea County, New Mexico**

**AERIAL MAP  
SITE ASSESSMENT REPORT  
EOG RESOURCES  
VACA LINE STRIKE  
LEA COUNTY, NEW MEXICO**

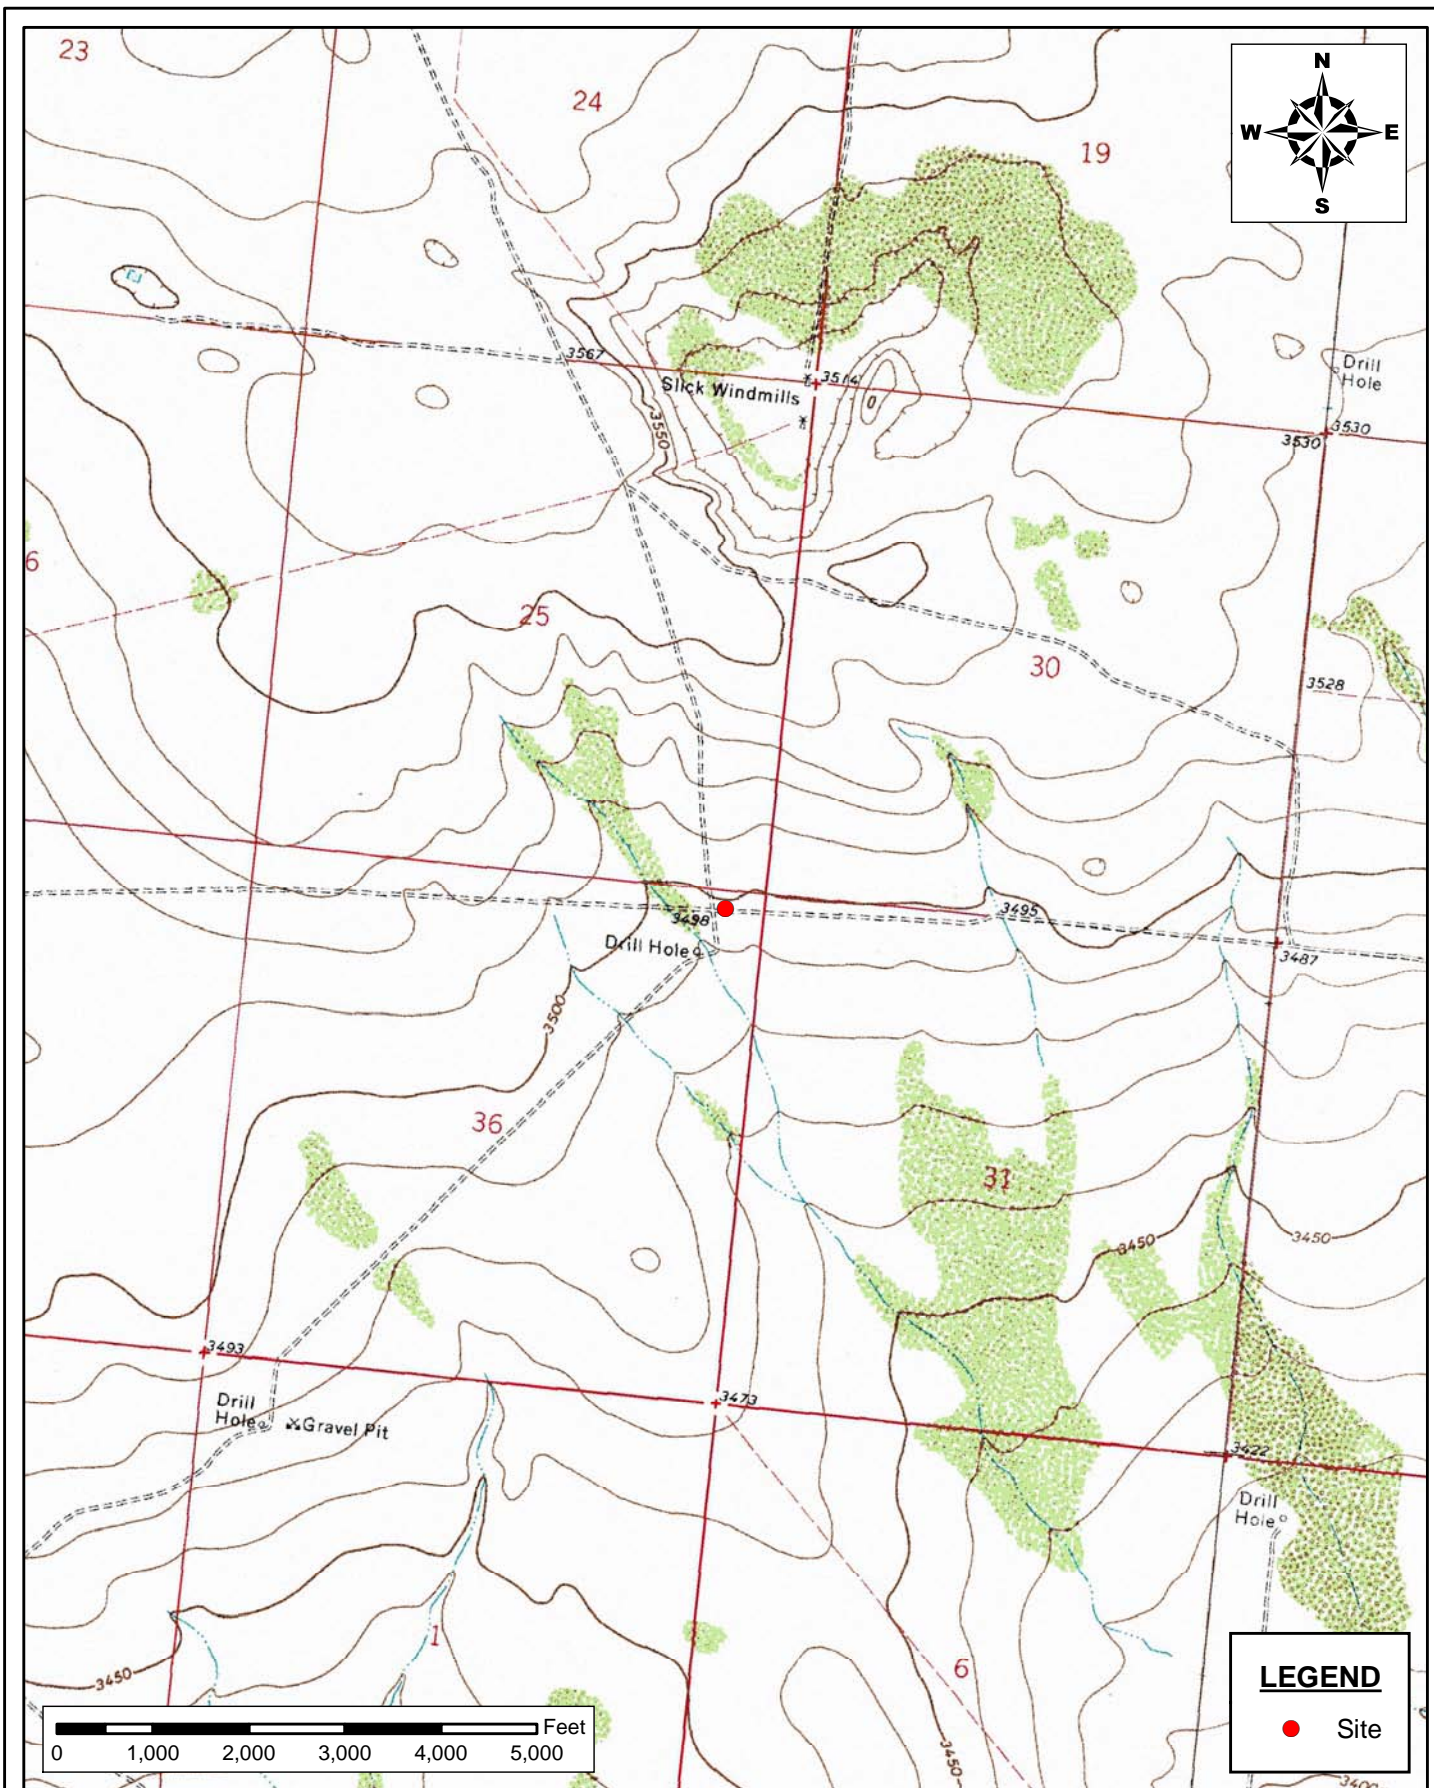
**FIGURE 2**

**AREA MAP**  
**SITE ASSESSMENT REPORT**  
 EOG RESOURCES  
 VACA LINE STRIKE  
 LEA COUNTY, NEW MEXICO

At the request of EOG Resources, Inc. (EOG), New Tech Global Environmental, LLC (NTGE) has prepared this letter to document remedial action activities following a release at the Vaca Line Strike (Site). The Site is an active produced water line at the intersection of Vaca Lane and Resource Lane within Unit C, Section 36, Township 24 South, Range 33 East, approximately 19.6 miles northwest of Jal, New Mexico (Figures 1 and 2).

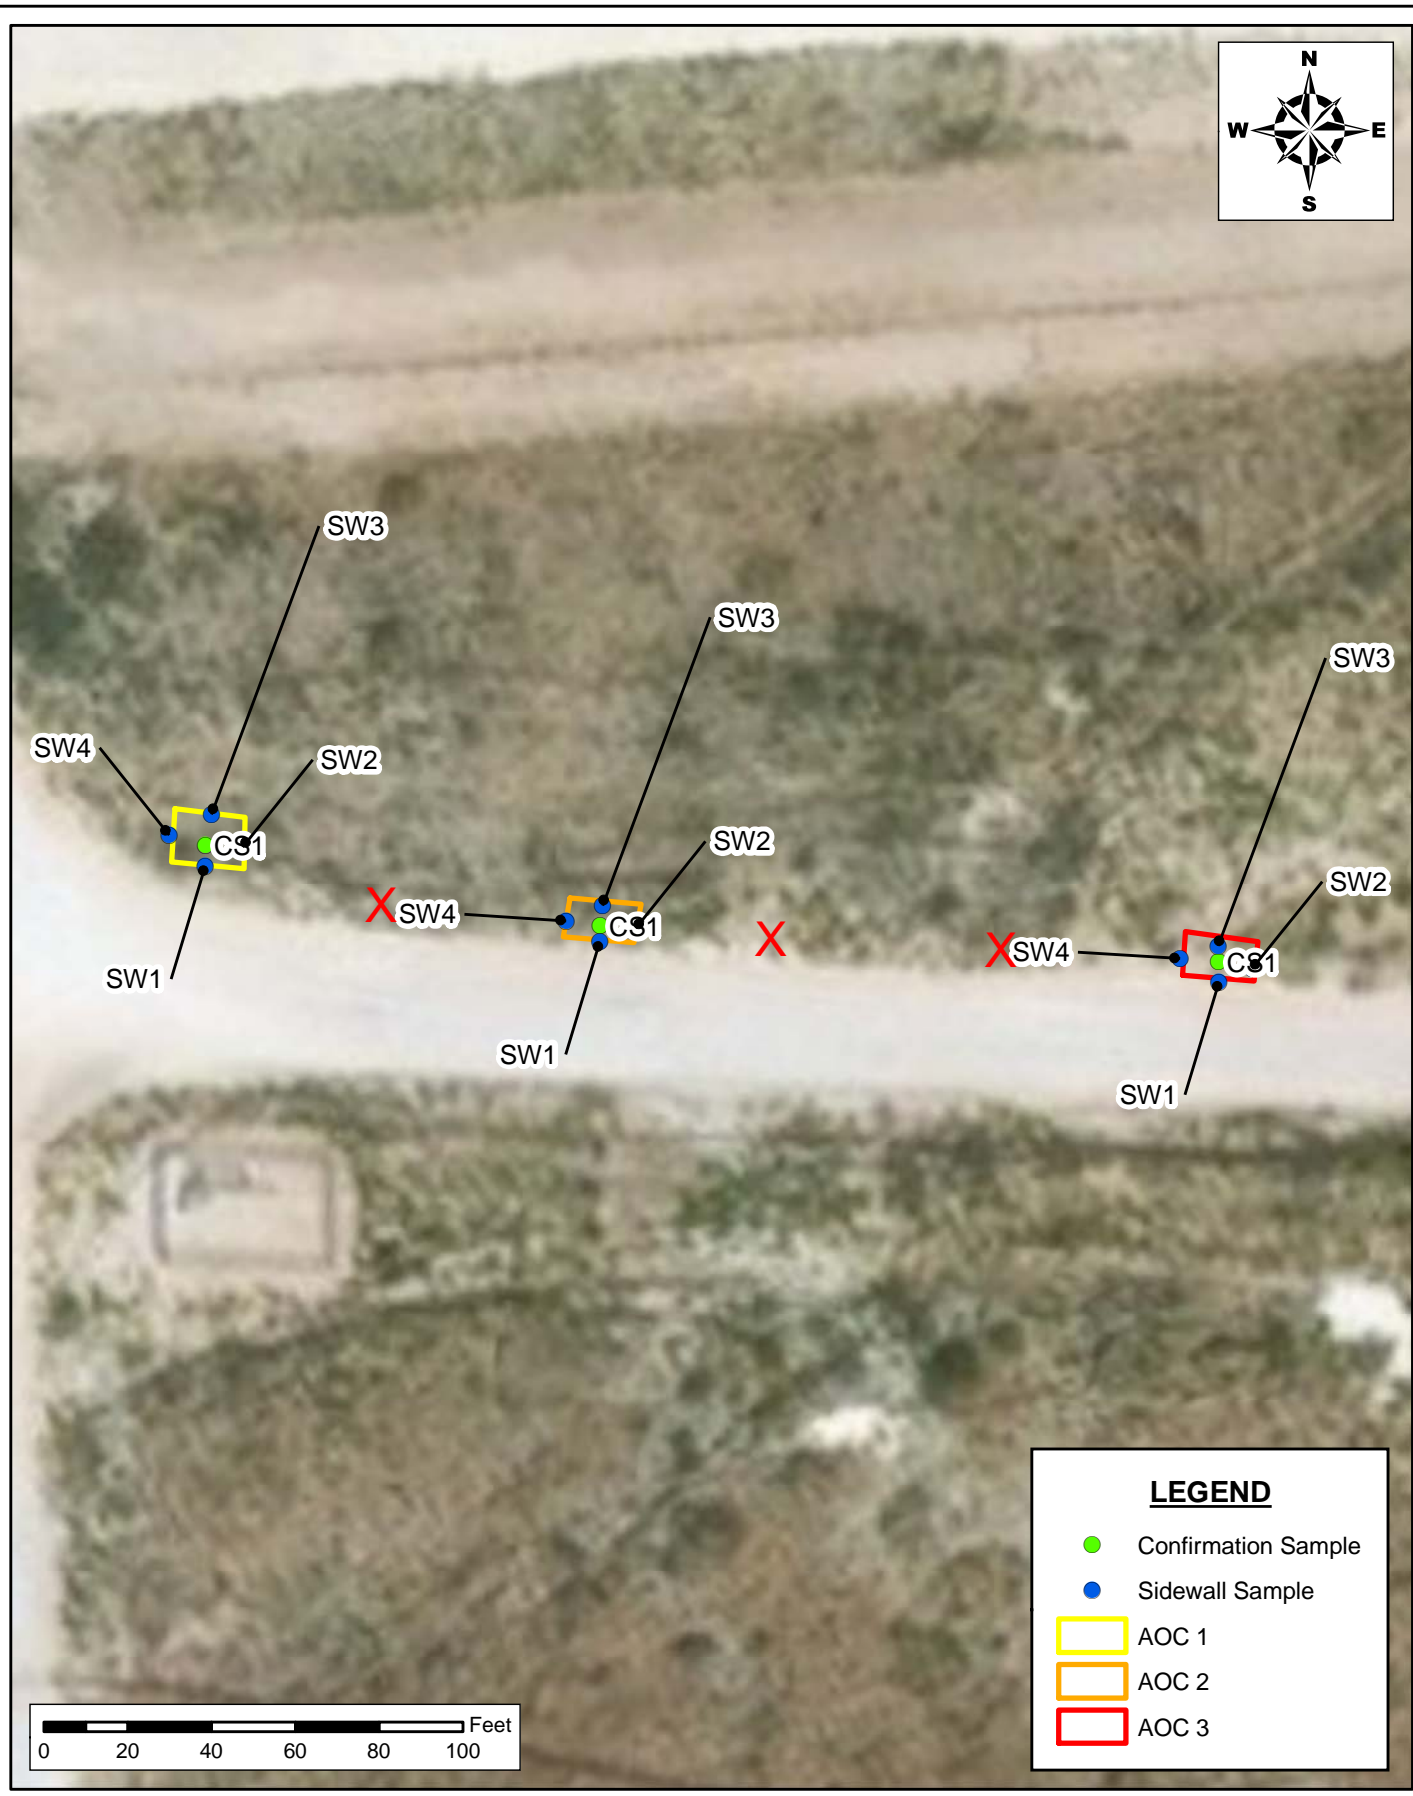
- Confirmation Sample
- Sidewall Sample
- AOC 1
- AOC 2
- AOC 3

On May 28, 2019, excavation began in the areas of TP1, TP3, and TP4. These will be referred to as AOC1, AOC2, and AOC3 respectfully.

Soils in the areas of AOC1 and AOC 3 were excavated to a depth of 4 ft bgs and soils in AOC2 were excavated to a depth of 5 ft bgs. The bottoms and sidewalls were field screened using Hach Quantab Chloride Strips to ensure all impacts had been removed. Soil confirmation samples were collected from the sidewalls and bottoms of the excavation for lab analysis. After reviewing the laboratory results, it is determined that chloride levels at soil sample locations, AOC3 SW1 (603 mg/kg) and AOC3 SW3 (649 mg/kg) were above regulatory limits. Due to the proximity of the excavation to an active saltwater disposal line to the north and a road to the south, further excavation was not feasible without undermining the integrity of the onsite equipment and adjacent road. Excavation and confirmation sample locations are illustrated on Figure 3, attached. Site Photographs taken at the time of excavation and sample collection are included in the attached photographic log.

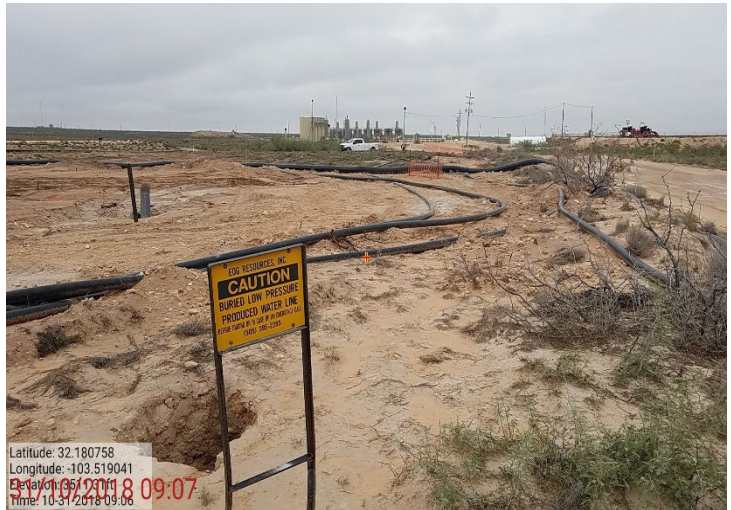
View of spill trajectory looking east. Note Resource Lane to the south.

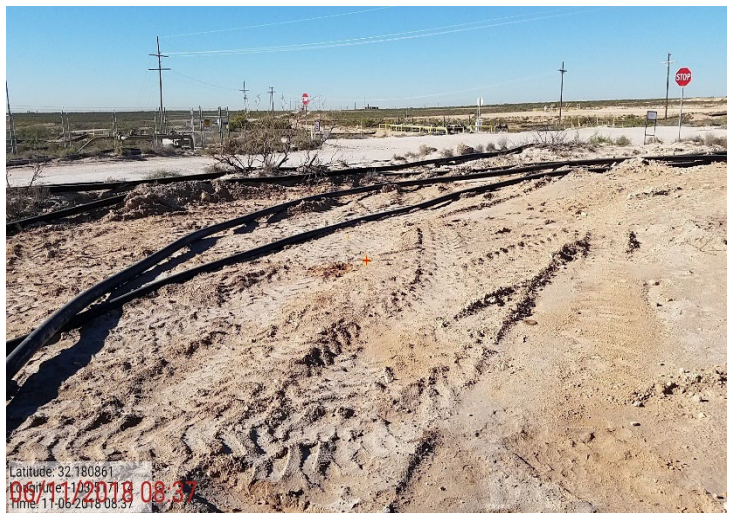
### Photograph No. 2

View of point of release and area of TP 1 looking southwest. Note intersection of Vaca Lane (N to S) and Resource Land (E to W).

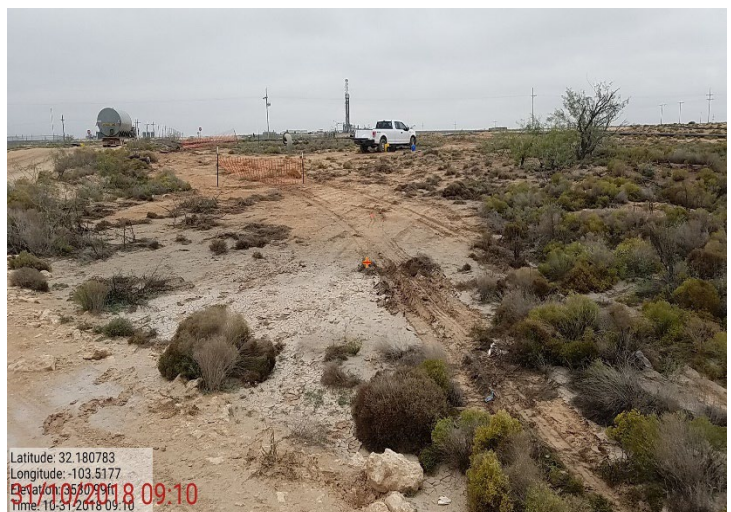
### Photograph No. 3

View of spill trajectory looking west from area of TP5.
