**Rivers CTB**

**Remediation Closure Request**

**Incident Numbers: nAPP2536041442, nAPP2602044329**

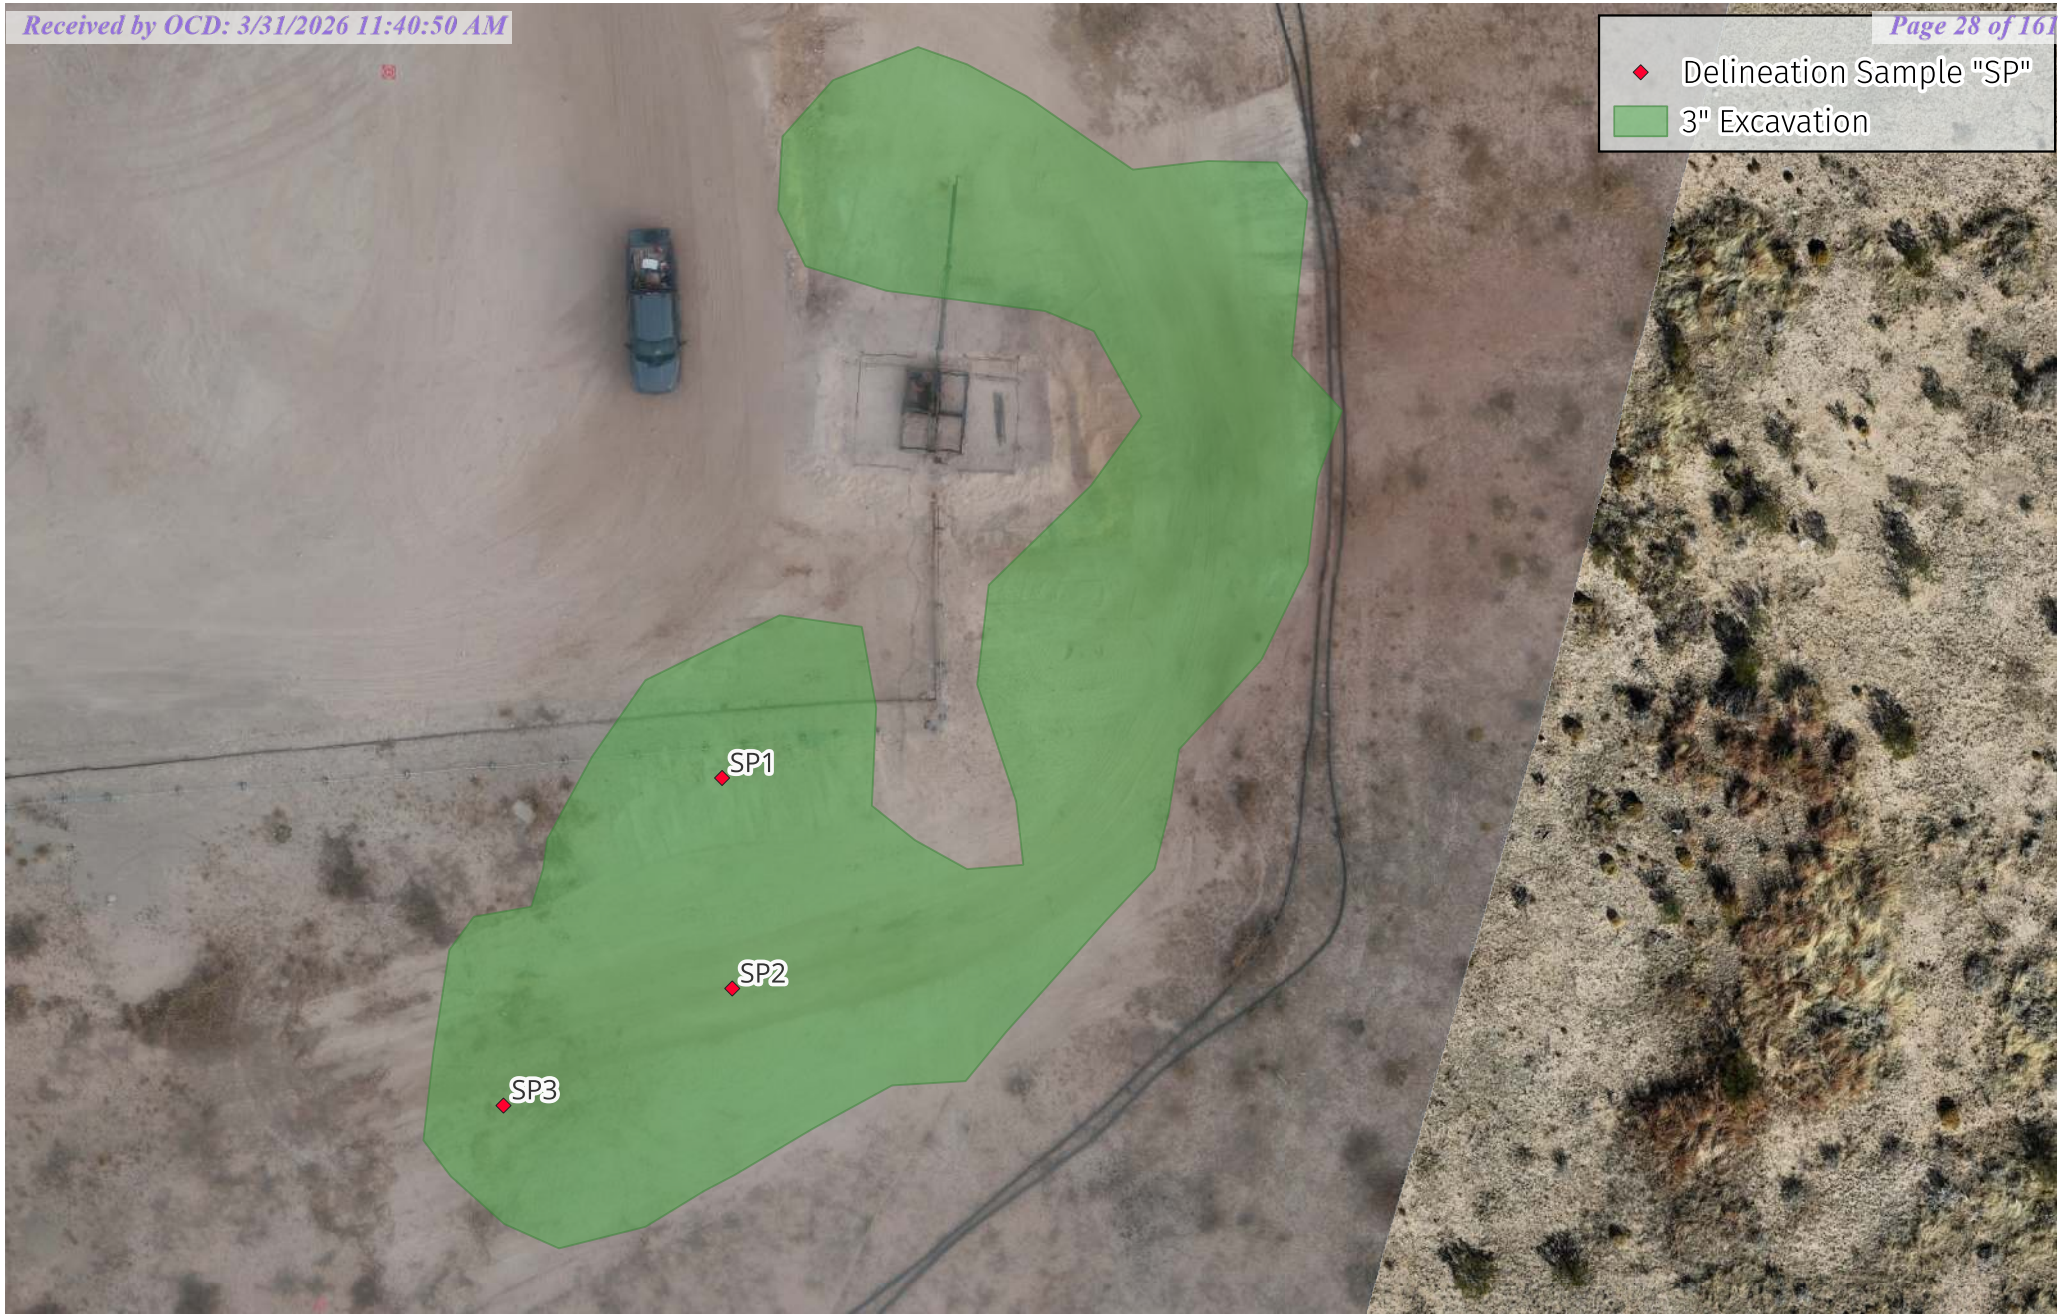
All highlighted areas have been excavated, and the locations marked in red exceeded the site RRALs.

◆ Delineation Sample "SP"  
 ■ 3" Excavation

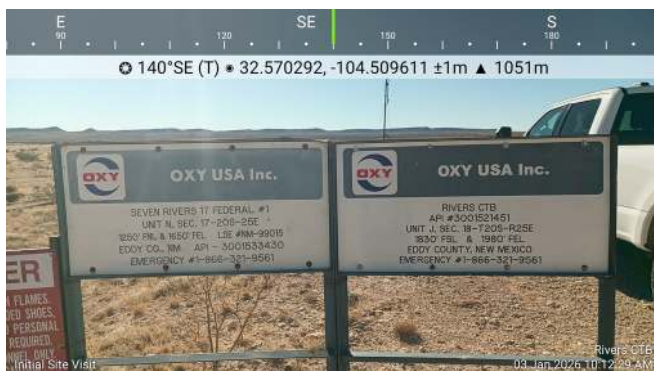
Figure 1

### Rivers CTB Combined Releases nAPP2536041442, nAPP2602044329 Scrape Completion
