Closure Report
Yukon Gold 31 CTB 2
Incident ID: NAPP2605673419
Unit H, Sec 31, T23S, R30E
Eddy County, New Mexico
32.262993°, -103.913058°

Produced Water Release
Point of Release: Pinhole leak on water dump line
Release Date: 02.25.2026
Volume Released: 25 Barrels of Produced Water
Volume Recovered: 24 Barrels of Produced Water

**Re: Closure Report
Yukon Gold 31 CTB 2
Devon Energy Production Company
Incident ID: NAPP2605673419
Site Location: Unit H, S31, T23S, R30E
(Lat 32.262993°, Long -103.913058°)
Eddy County, New Mexico**

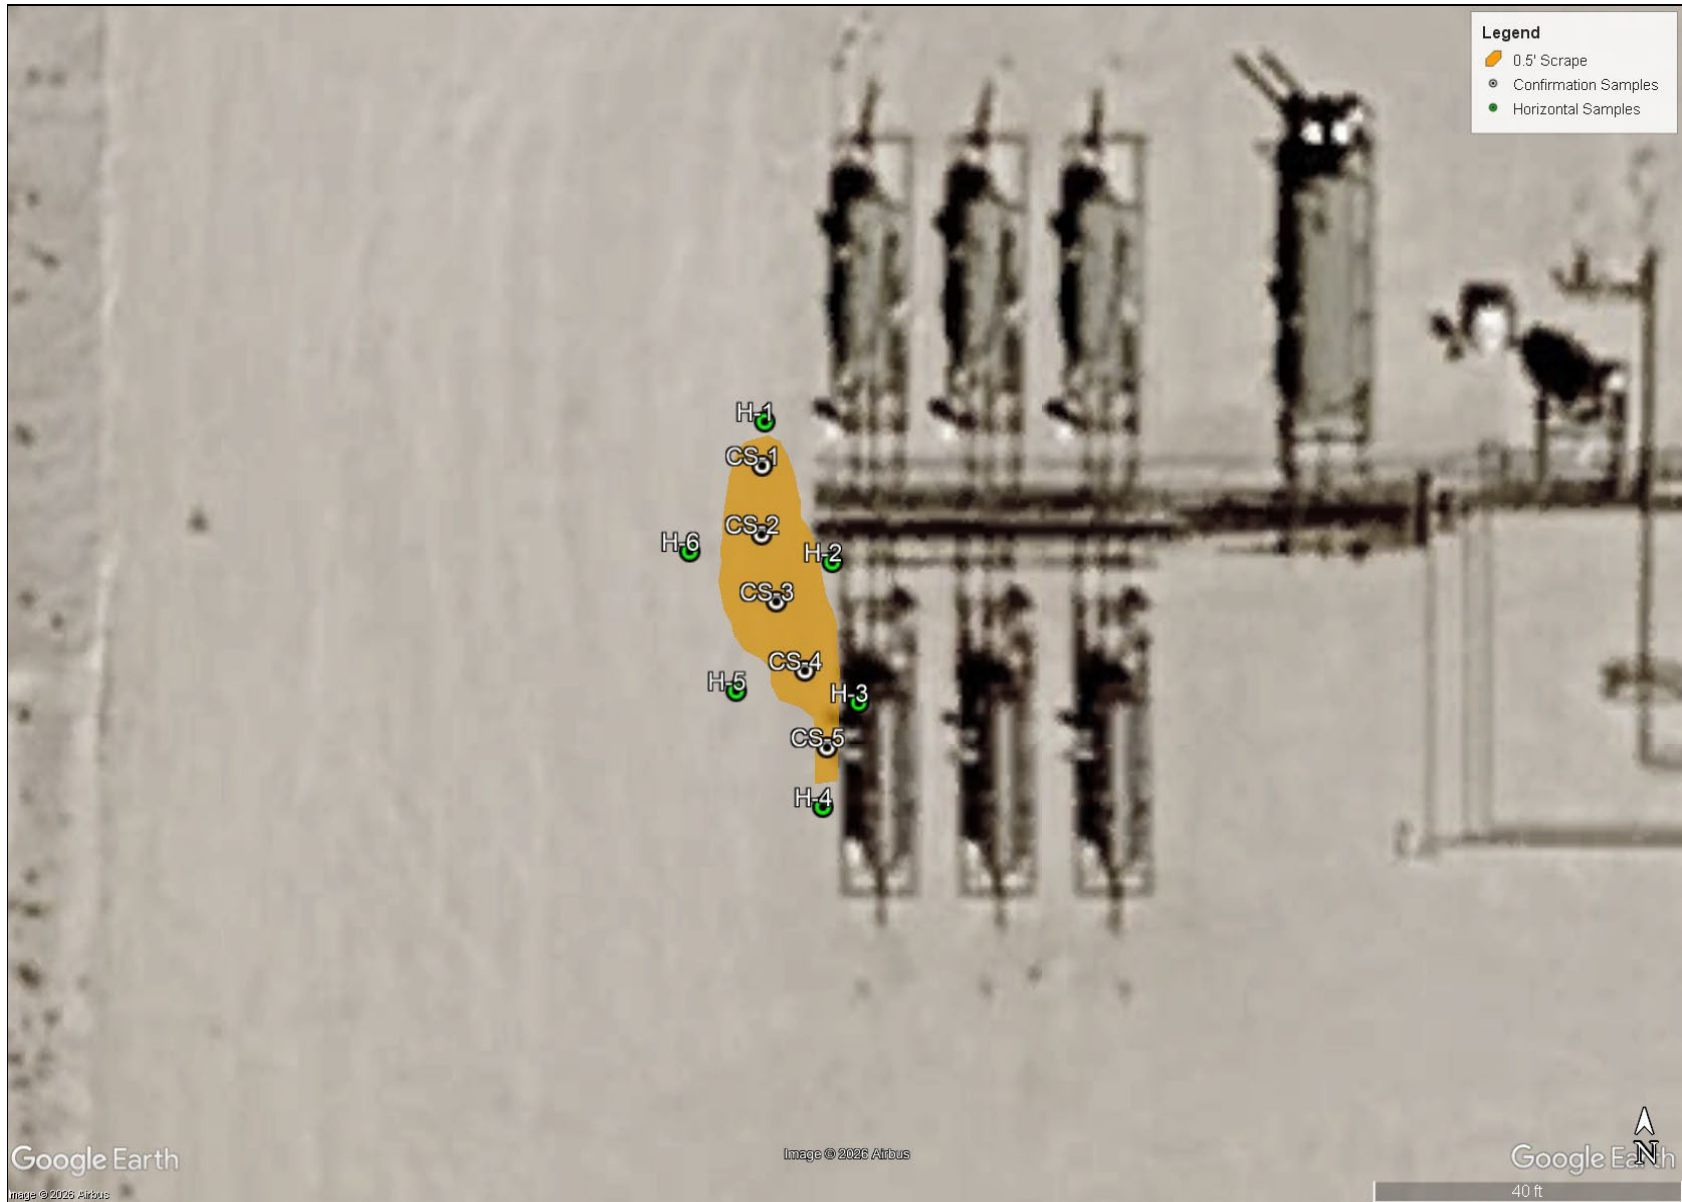
<p>EXCAVATION DEPTH MAP DEVON ENERGY PRODUCTION COMPANY YUKON GOLD 31 CTB 2 (02.25.2026) EDDY COUNTY, NEW MEXICO 32.262993°, -103.913058°</p>	<p>CARMONA RESOURCES

Based on the initial C-141 obtained from the New Mexico Oil Conservation Division (NMOCD), the release was discovered on February 25, 2026, due to a pinhole leak on the water dump line. It resulted in the release of twenty-five (25) barrels of produced water, with twenty-four (24) barrels of produced water recovered. The spill boundaries are shown in Figure 3. The initial C-141 form is attached in Appendix C.

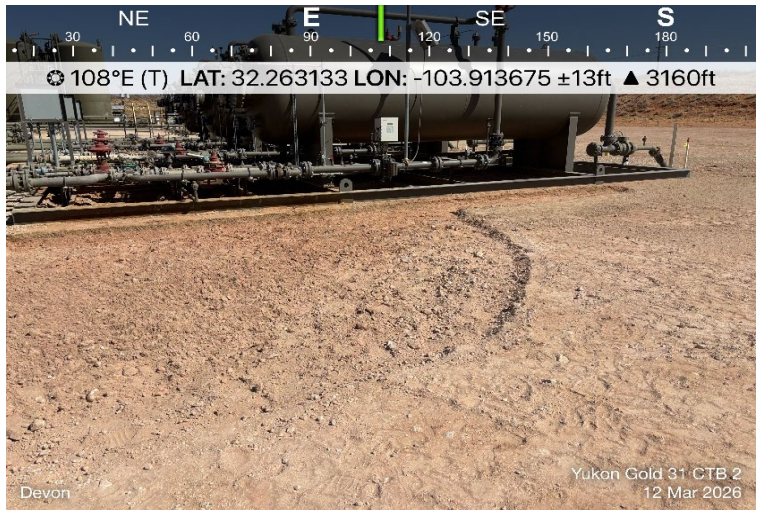
Photograph No. 2

Description:
View East, area of CS-1 through CS-5.

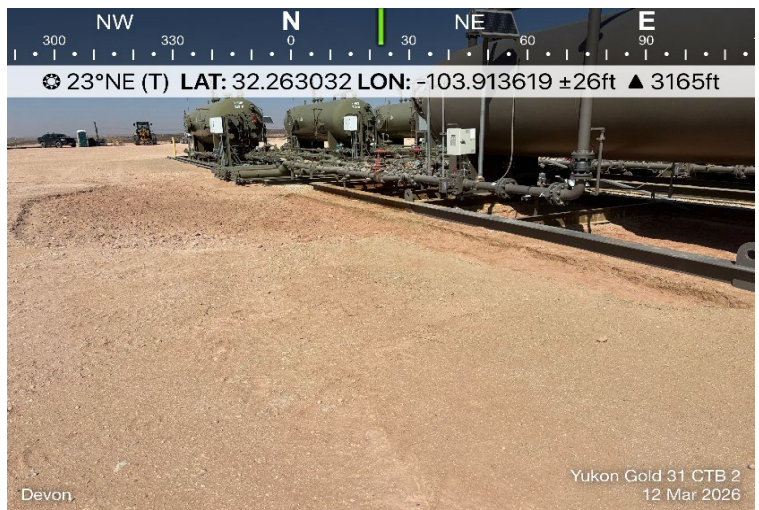
Photograph No. 3

Description:
View Northeast, area of CS-1 through CS-5.
