November 10, 2025

**Re: Release Characterization and Closure Request
Chevron Asset Retirement
State 4 27 #009 Flowline Release
Unit Letter J, Section 27, Township 17 South, Range 35 East
Lea County, New Mexico
Incident ID# nDEV4210**

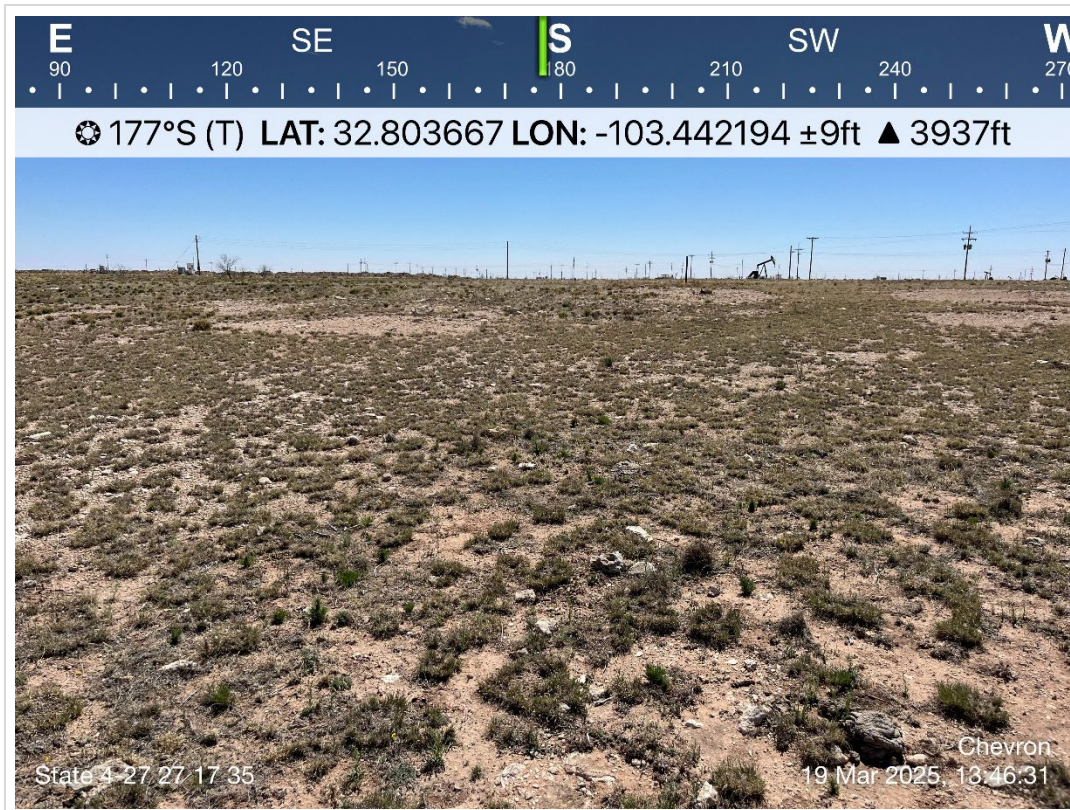
TETRA TECH, INC. PROJECT NO. 212C-MD-03824	DESCRIPTION	View south. Vegetative growth on reclaimed pad.	5
	SITE NAME	State 4 27 #009	03/19/2025

Based on 19.15.29.13 NMAC, revegetation is complete, and no further restoration is required. All disturbed areas have uniform vegetative cover native to the area. Based on sampling results, non-waste containing, uncontaminated, earthen material with chloride concentrations less than 600 mg/kg as analyzed by EPA Method 300.0 is located in the former release area. Photographic documentation of the former release area is presented in Appendix C.

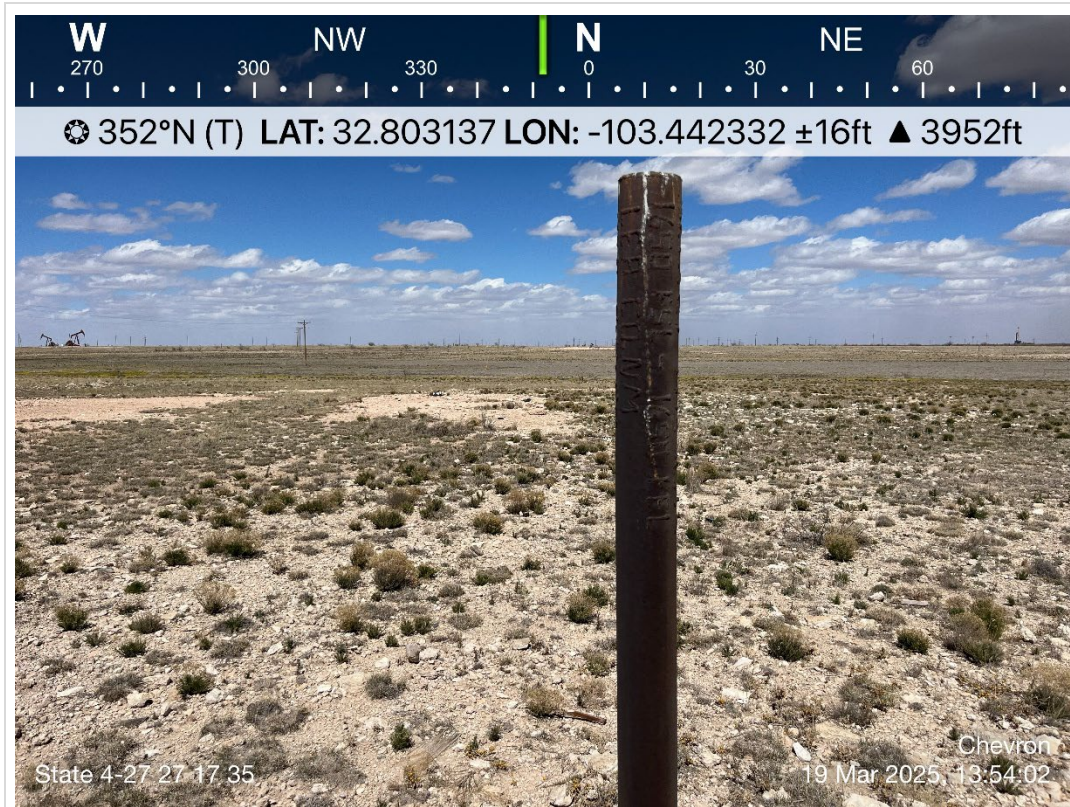
TETRA TECH, INC. PROJECT NO. 212C-MD-03824	DESCRIPTION	View north. Well marker on reclaimed pad.	6
	SITE NAME	State 4 27 #009	03/19/2025

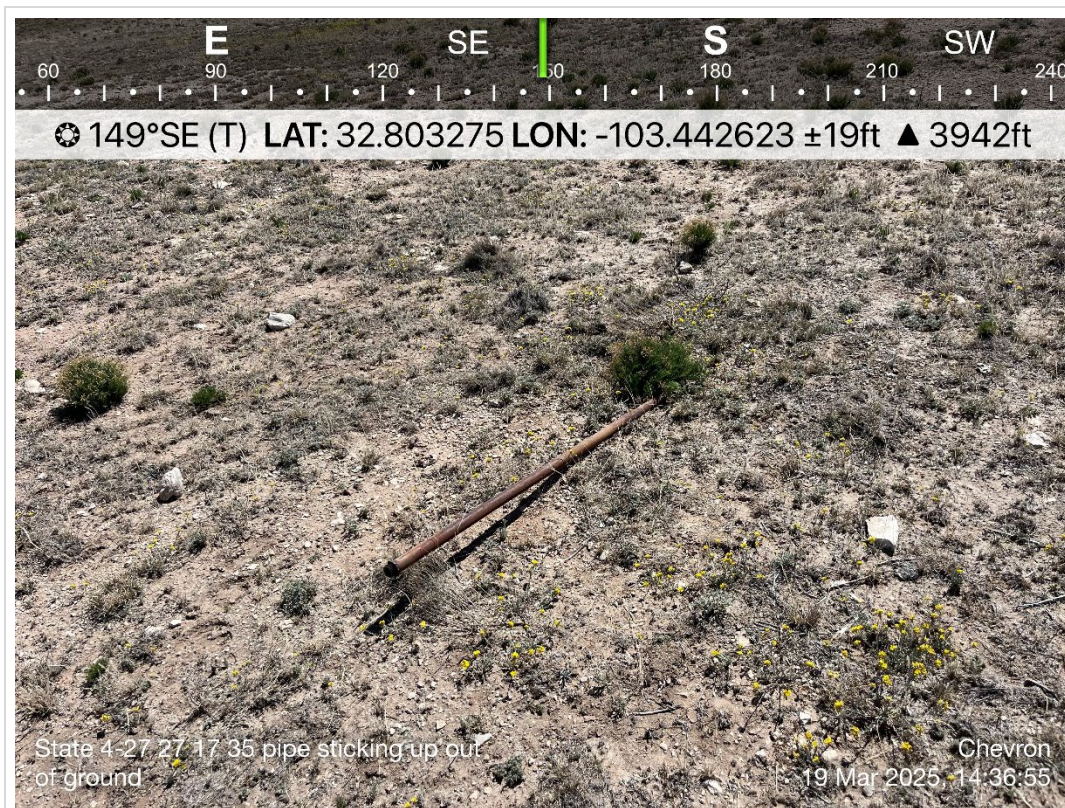
- The previous pad and associated lease road areas were observed to contain uniform vegetative cover that reflects a life-form ratio of plus or minus fifty percent of pre-disturbance levels.
- A decommissioned subsurface steel flowline was observed immediately adjacent to the reclaimed pad area.
- Site features include the well marker and a buried pipeline.

TETRA TECH, INC. PROJECT NO. 212C-MD-03824	DESCRIPTION	View southeast. Disconnected steel line adjacent to former pad.	7
	SITE NAME	State 4 27 #009	03/19/2025
