**Re: Reclamation Report
Golden 8 Federal #001
Incident Numbers nKMW1035646177, nKMW1106629393, nJMW1333053660,
nAB1422637219, nAB1607837012, nAB1633656856, nAB1803638613, and
nAB1929041495
Eddy County, New Mexico**

Ensolum, LLC (Ensolum), on behalf of XTO Energy, Inc (XTO), has prepared the following *Reclamation Report* for the Golden 8 Federal #001 (Site). This *Reclamation Report* documents the Site history, reclamation activities completed to date, and proposes a vegetation monitoring plan.

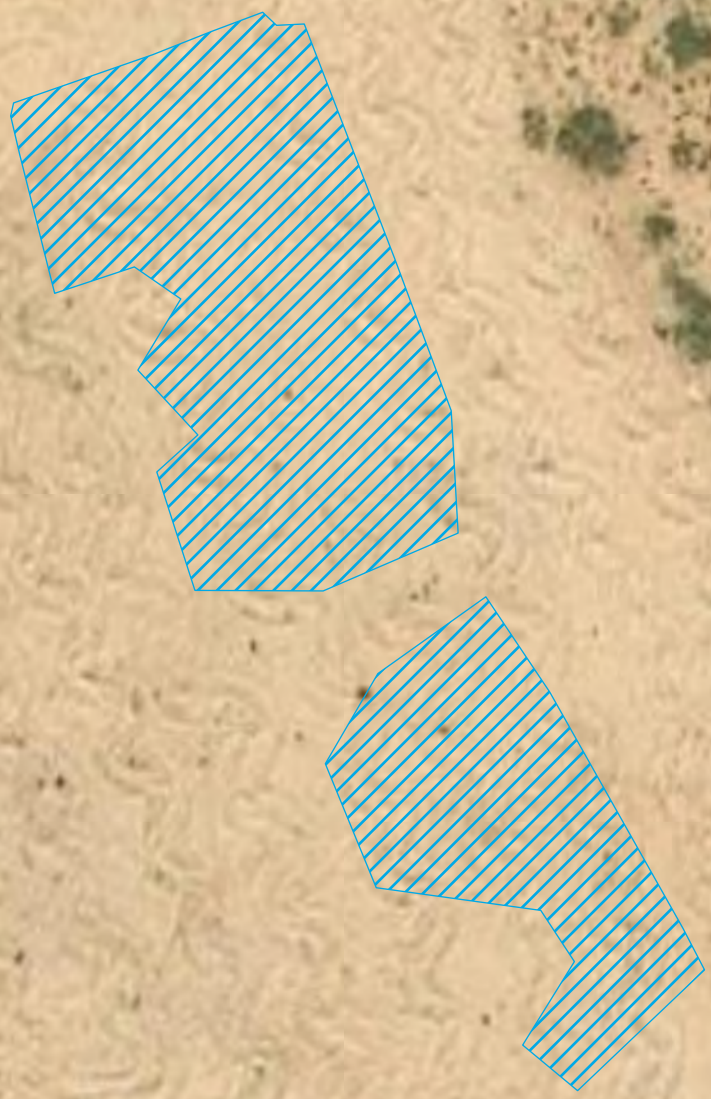
FIGURE 1

Excavation and Reclamation Area

Upon completion of excavation activities and receipt of final laboratory analytical results, the excavations were backfilled and the disturbed areas were restored to the original condition. The excavations were backfilled with locally procured soil. Following backfill activities, the entire well pad was reclaimed and recontoured to match the surrounding topography. The excavation extents are shown on the attached Figure 1 and the well pad reclamation area is shown on the attached Figure 2.

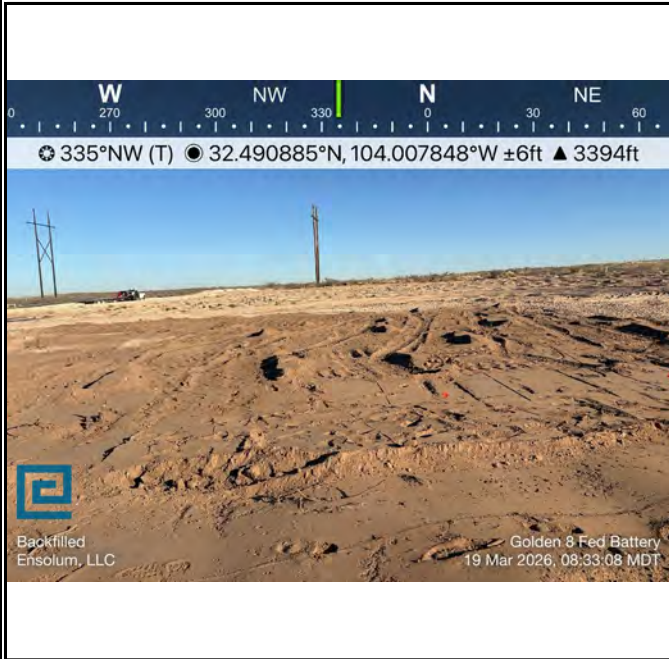
Photograph 1 Date :3/19/2026
Description: Backfilled excavation area
View: Northwest

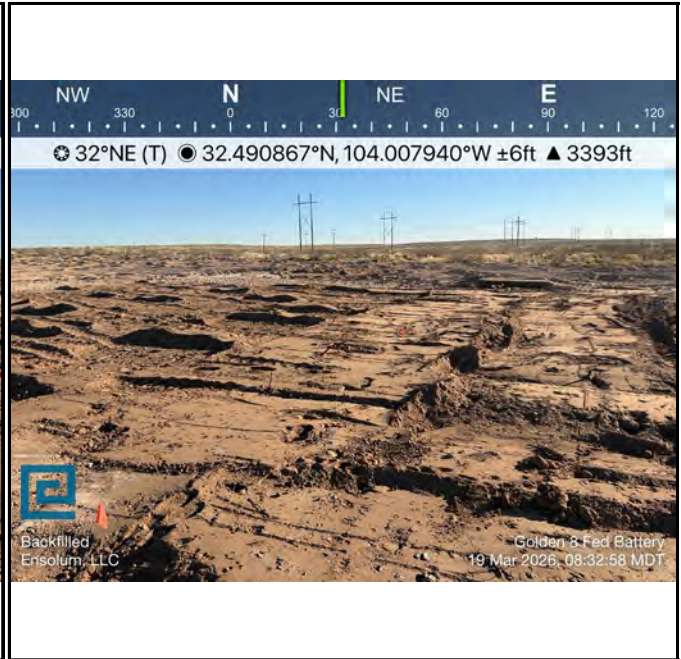
Photograph 2 Date :3/19/2026
Description: Backfilled excavation area
View: Northeast

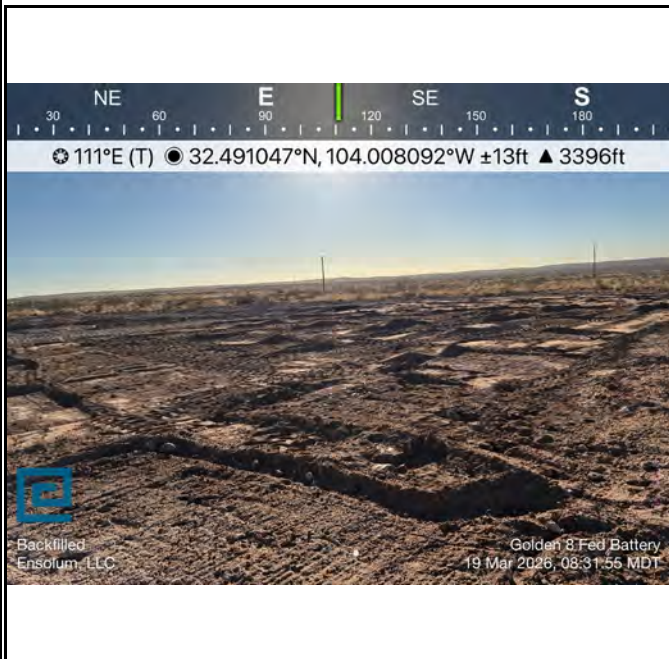
Photograph 3 Date :3/19/2026
Description: Backfilled excavation area
View: East

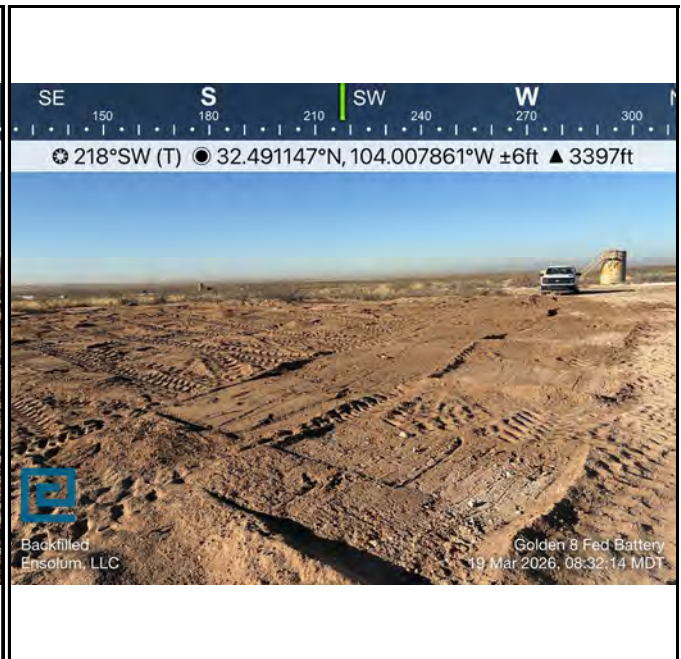
Photograph 4 Date :3/19/2026
Description: Well pad overview
View: Southwest

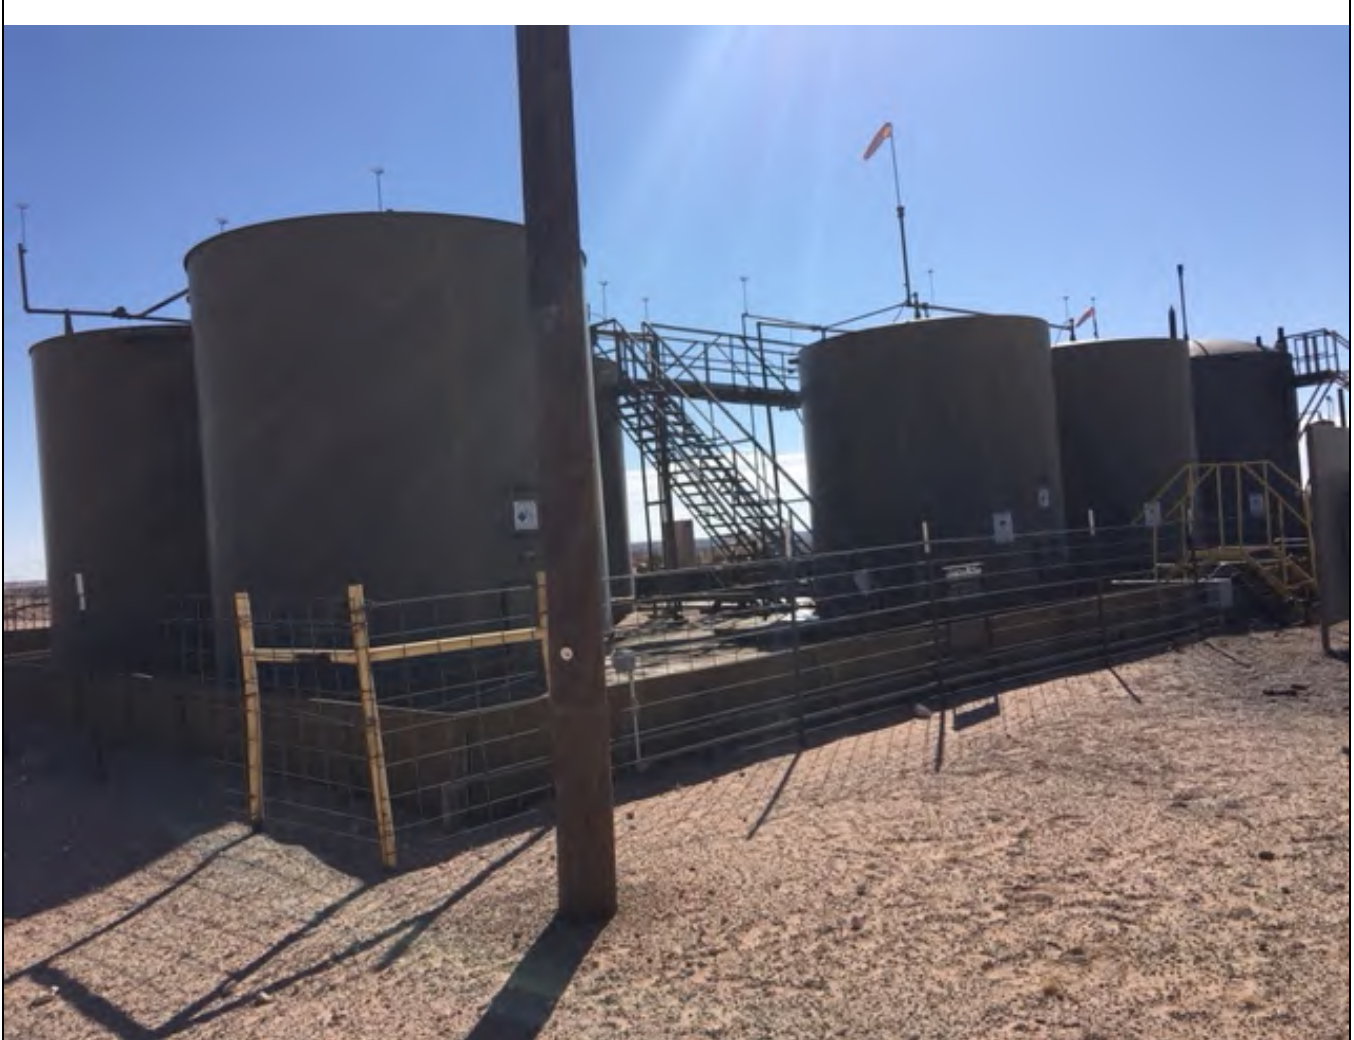
Western view of lined tank battery containment.

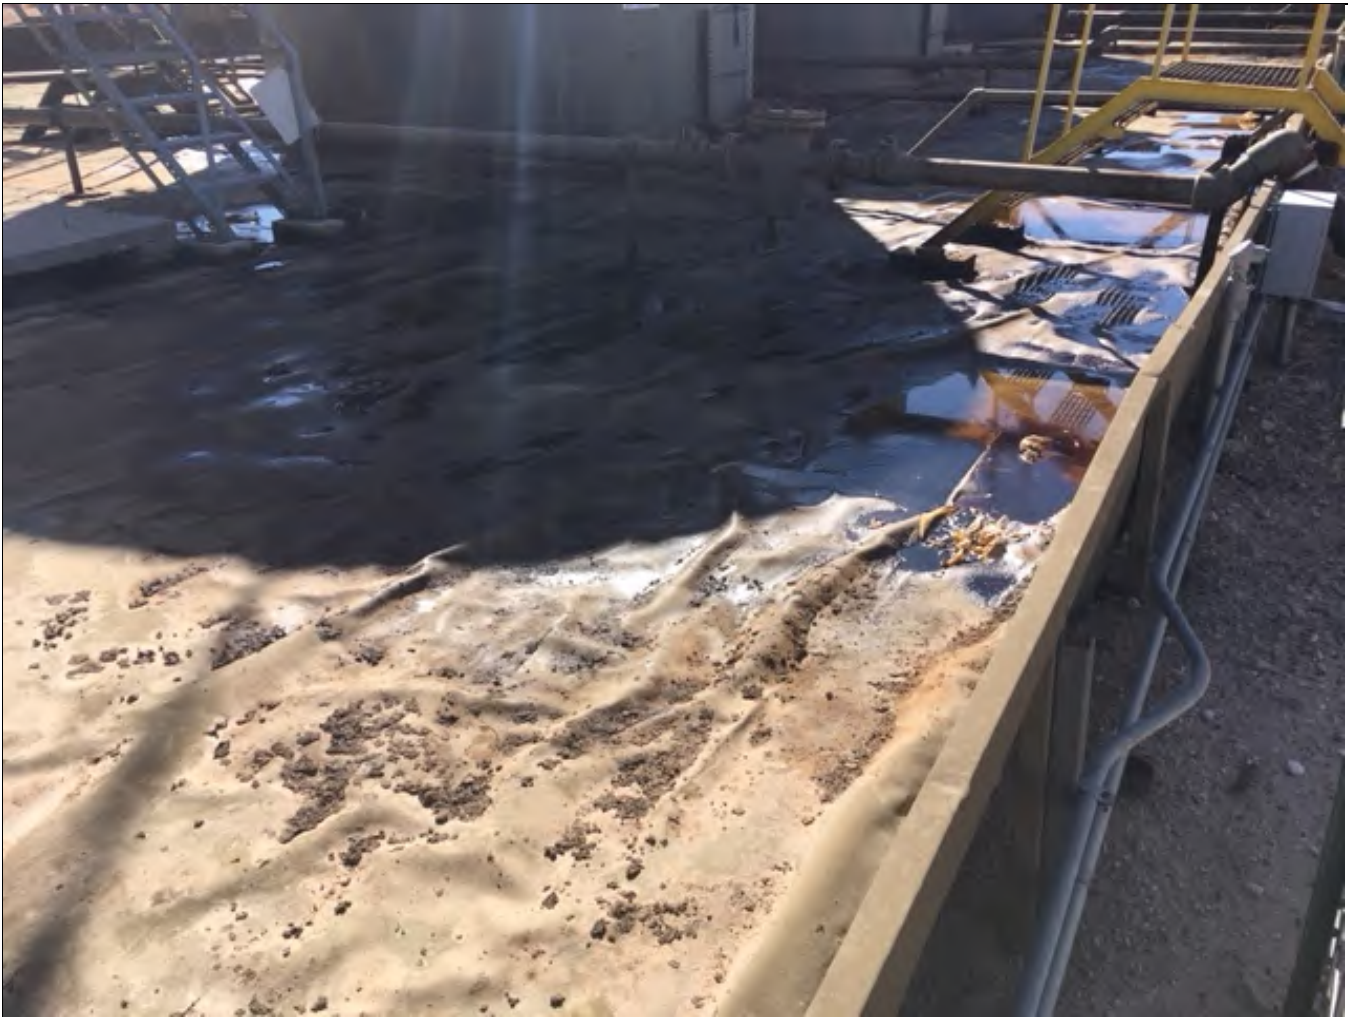
View of lined tank battery containment and liner hole during soil sampling activities.

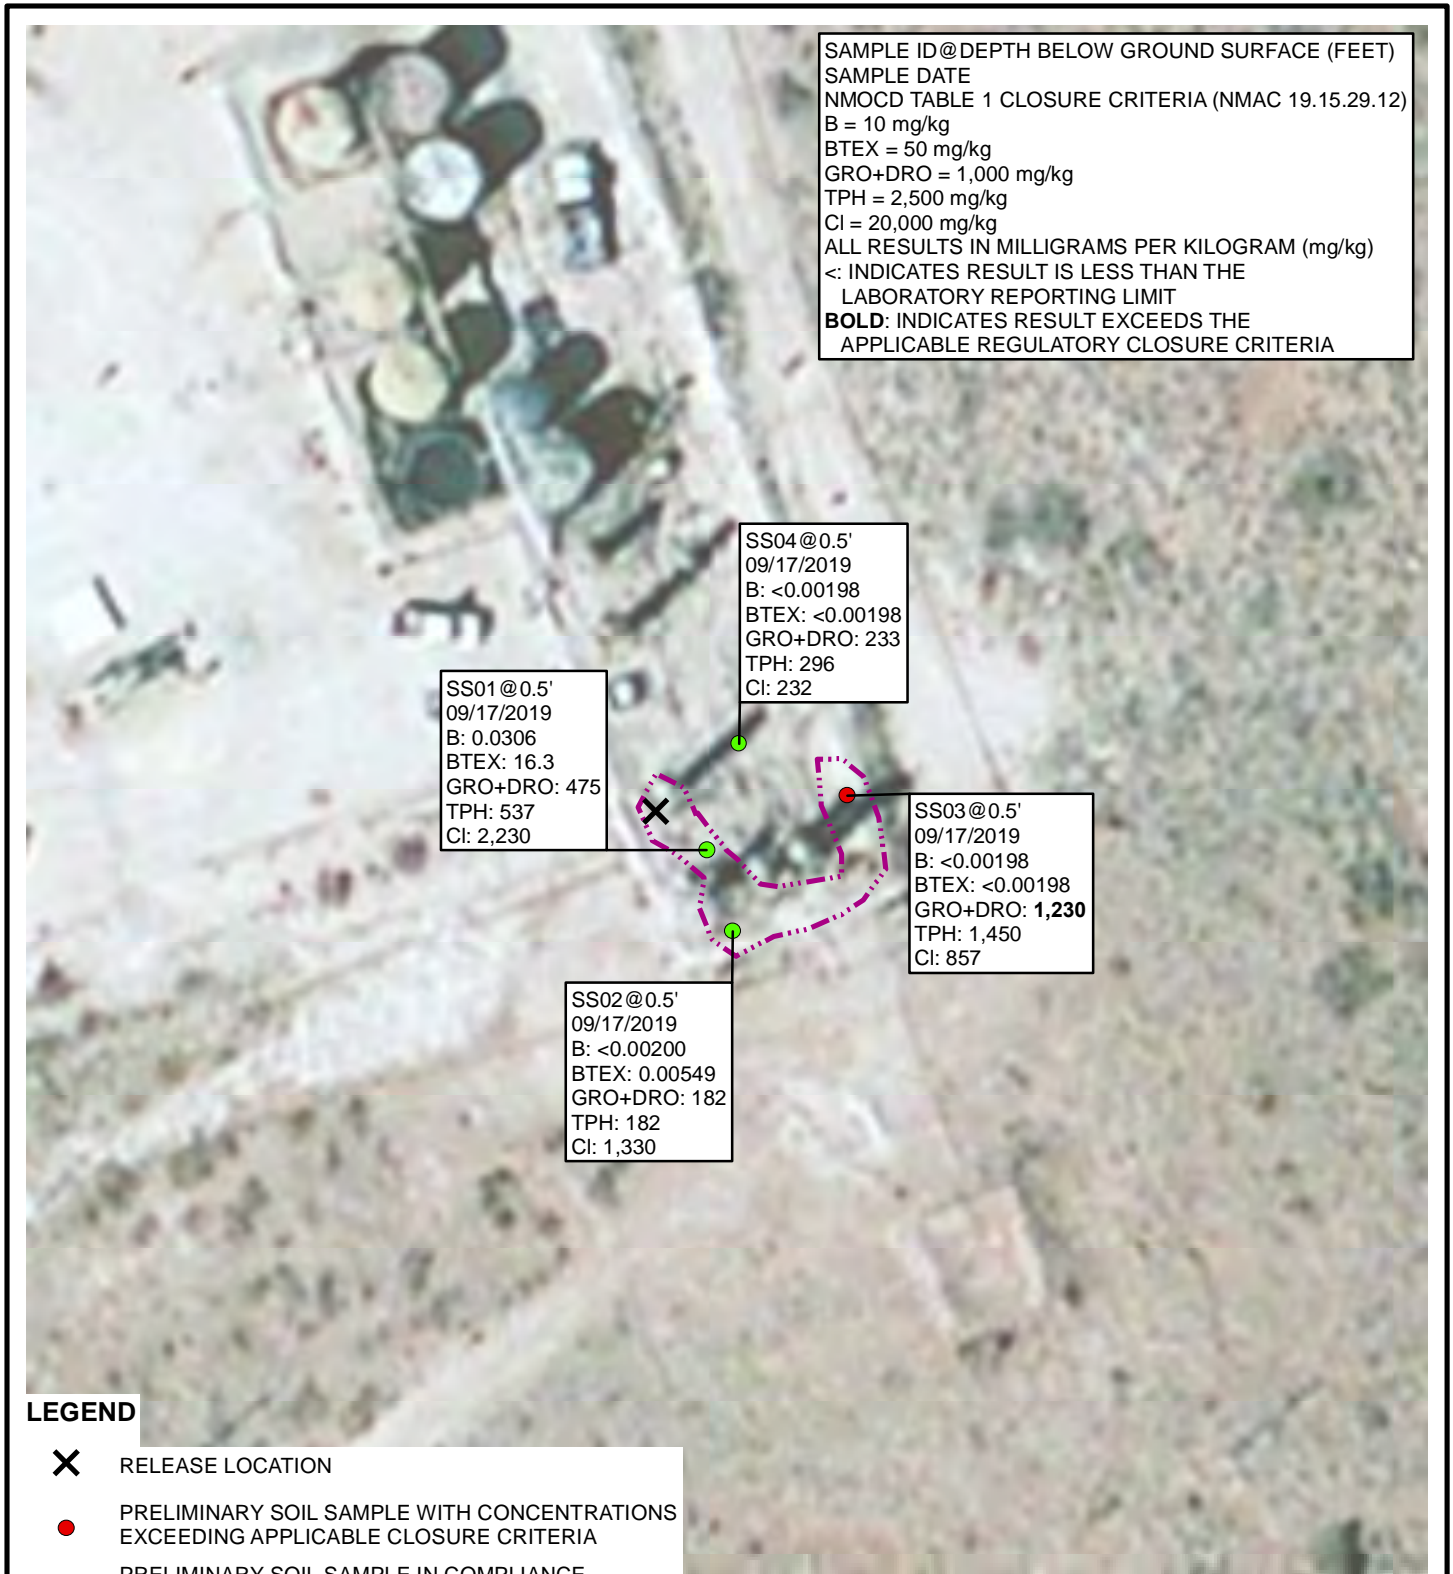
FIGURE 2
 PRELIMINARY SOIL SAMPLE LOCATIONS
 GOLDEN 8 FEDERAL BATTERY 1
 UNIT K SEC 8 T21S R29E
 EDDY COUNTY, NEW MEXICO
XTO ENERGY, INC.

SS01@0.5'
 09/17/2019
 B: 0.0306
 BTEX: 16.3
 GRO+DRO: 475
 TPH: 537
 Cl: 2,230

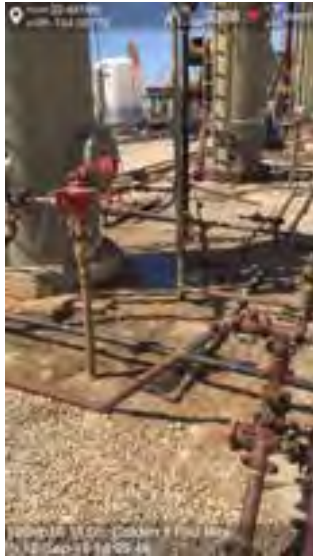
Photograph 1: Northwest view of release staining between equipment.

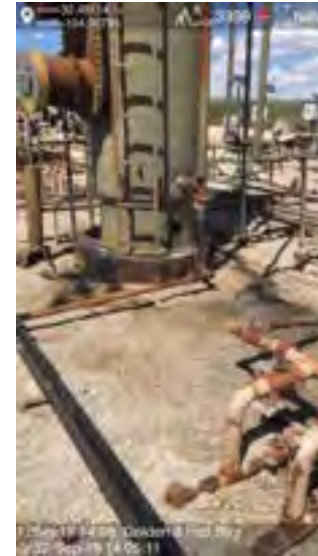
Photograph 2: Northern view of surficial staining within release extent.

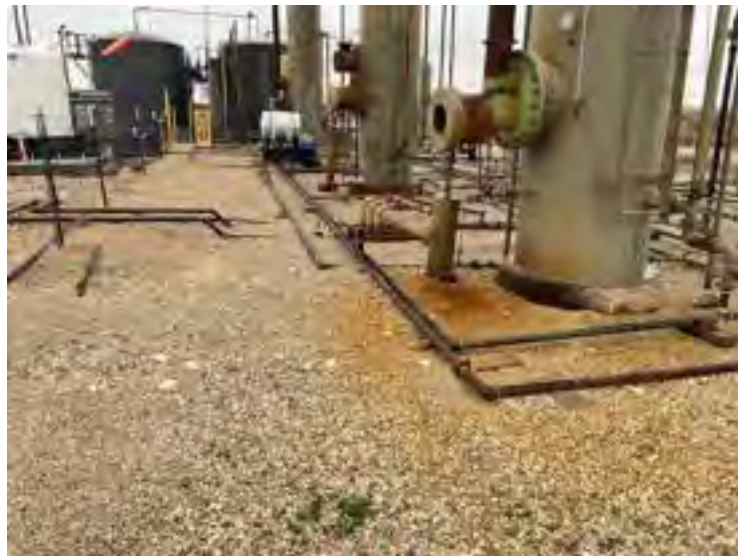
Photograph 3: Surficial staining between equipment.

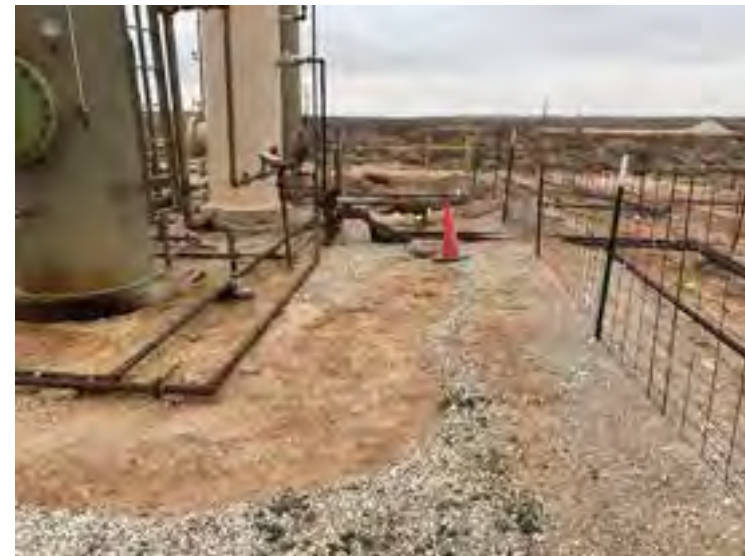
Photograph 4: View of equipment after hand shoveling activities.

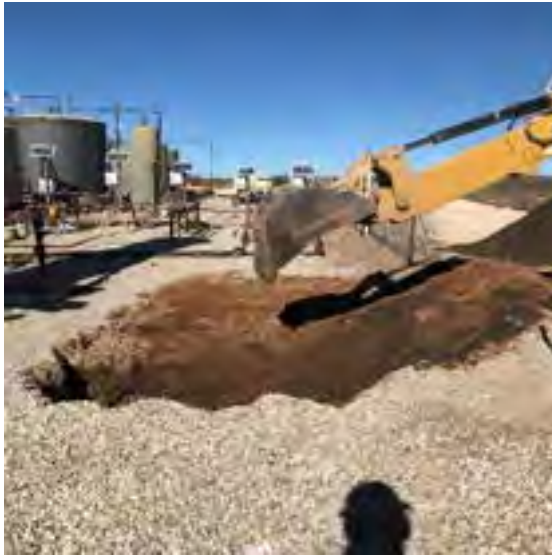
Photograph 5: Northern view of eastern excavation activities.

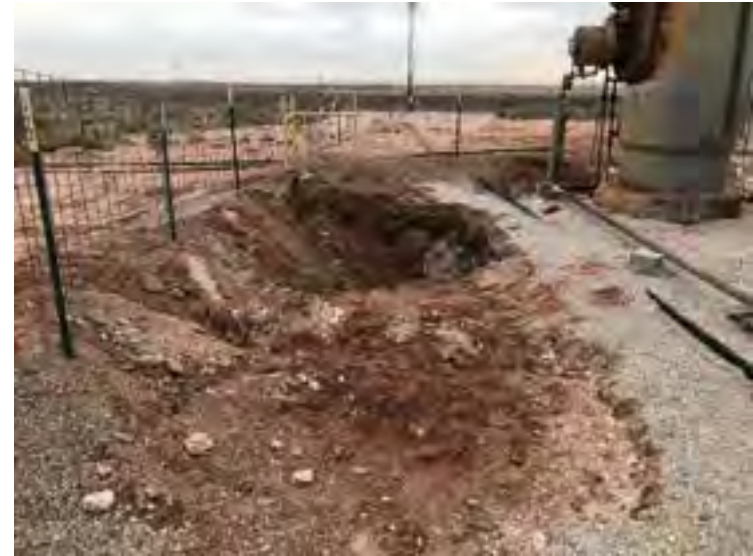
Photograph 6: Southern view of eastern excavation activities.

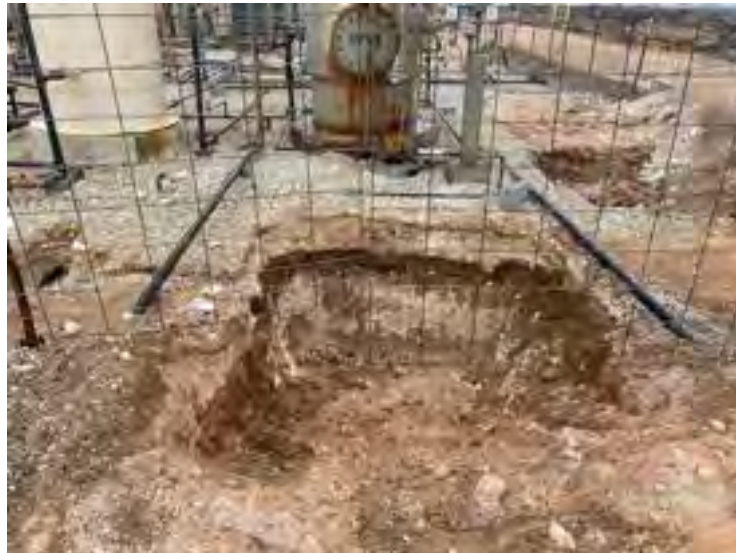
Photograph 7: View north of southern excavation activities.

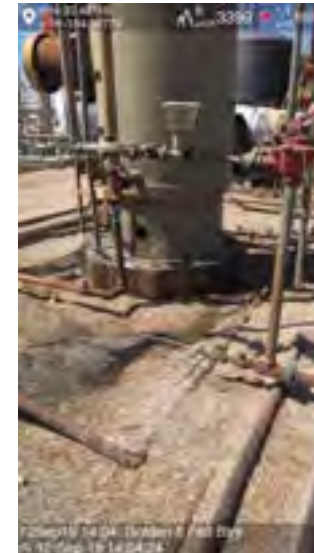
Photograph 8: Surficial staining before hand shoveling activities.

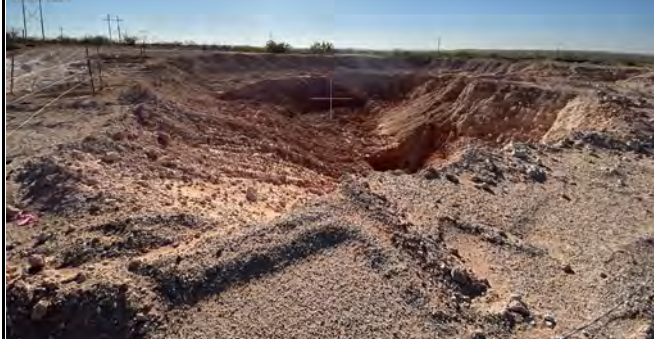
Photograph 1 Date :5/3/2024
Description: North portion of northern excavation
View: East

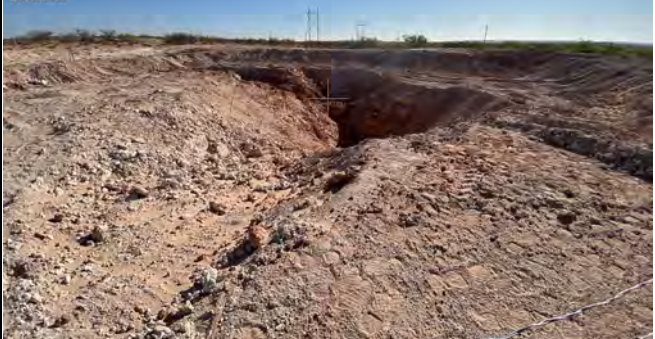
Photograph 2 Date :5/3/2024
Description: Northern excavation
View: Northeast

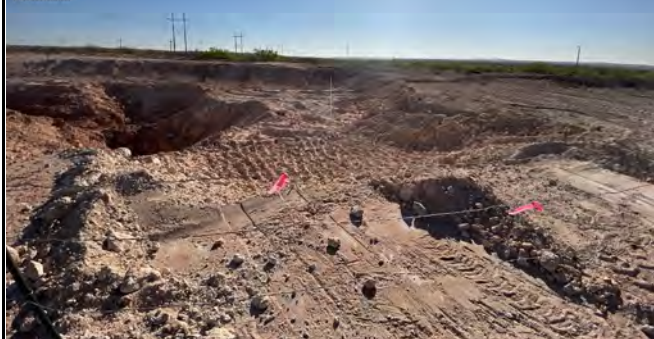
Photograph 3 Date :5/3/2024
Description: South portion of northern excavation
View: Northeast

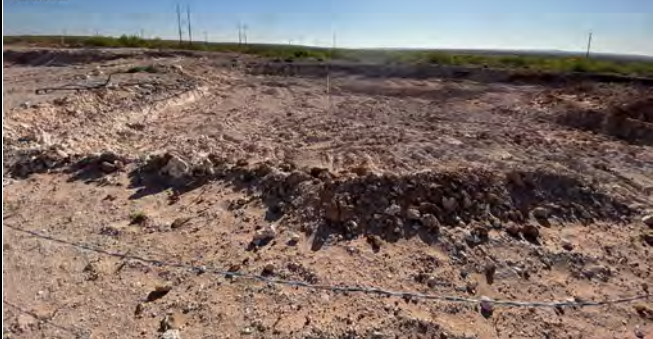
Photograph 4 Date :5/3/2024
Description: Southern excavation
View: Northeast

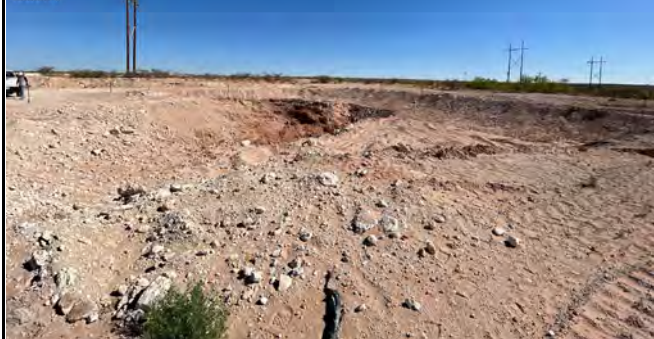
Photograph : 5 Date :6/3/2024
Description: Northern excavation
View: North

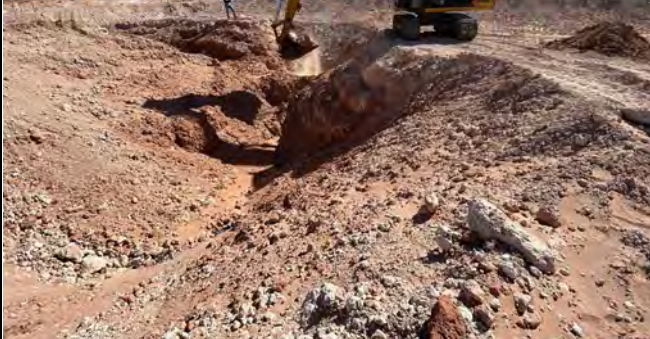
Photograph : 6 Date :6/3/2024
Description: Northern excavation
View: Northeast

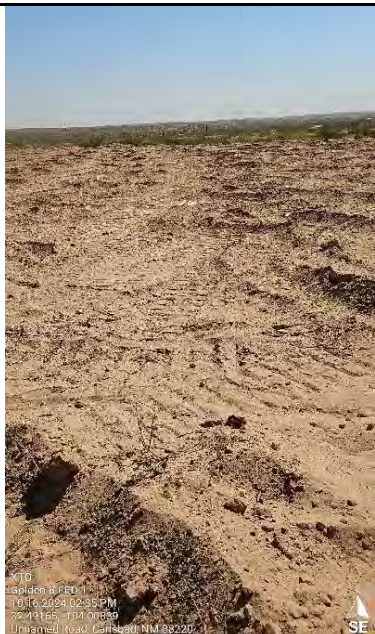
Photograph : 7 Date :10/16/2024
Description: Reclaimed well pad
View: Southeast

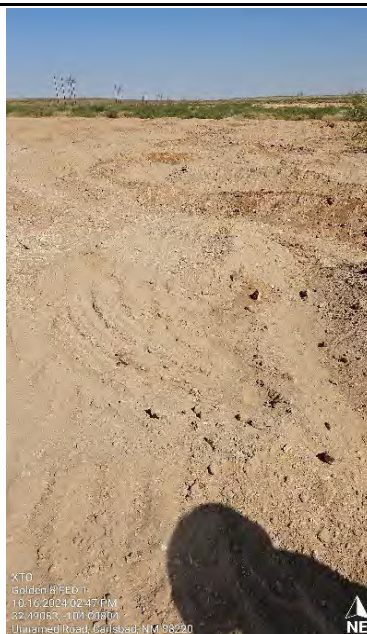
Photograph : 8 Date :10/16/2024
Description: Reclaimed well pad
View: Northwest

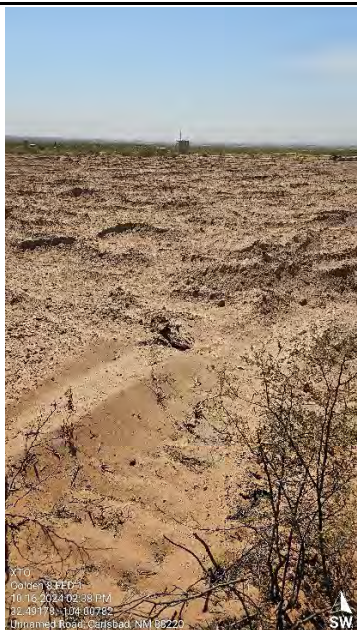
Photograph : 9 Date :10/16/2024
Description: Reclaimed well pad
View: Southwest

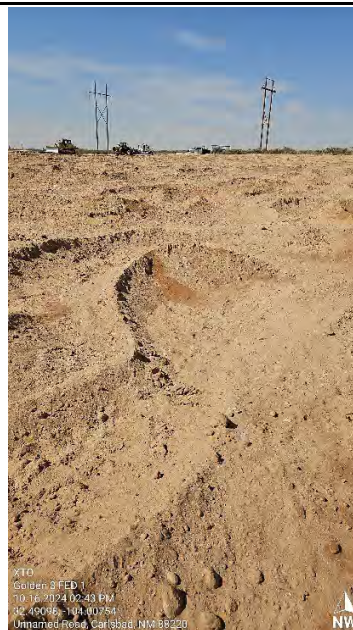
Photograph : 10 Date :10/16/2024
Description: Reclaimed well pad
View: Northwest

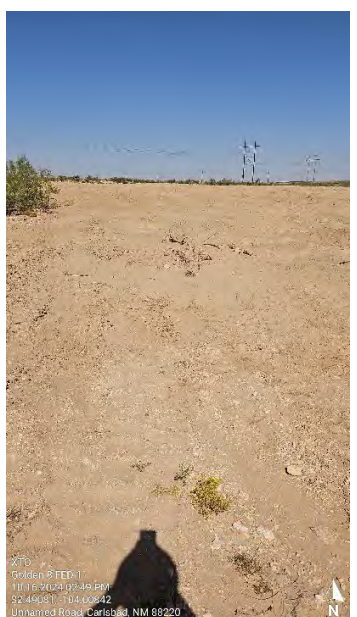
Photograph : 11 Date :10/16/2024
Description: Reclaimed well pad
View: North

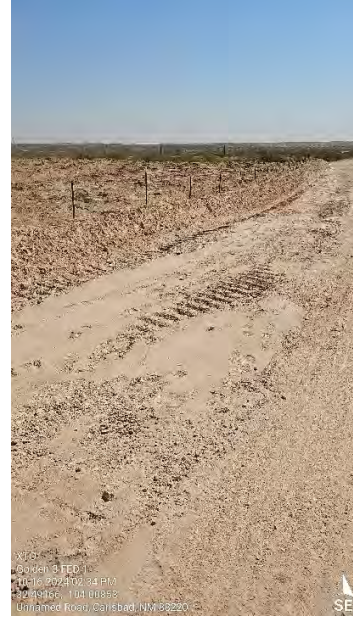
Photograph : 12 Date :10/16/2024
Description: Bermed and fenced well pad
View: Southeast

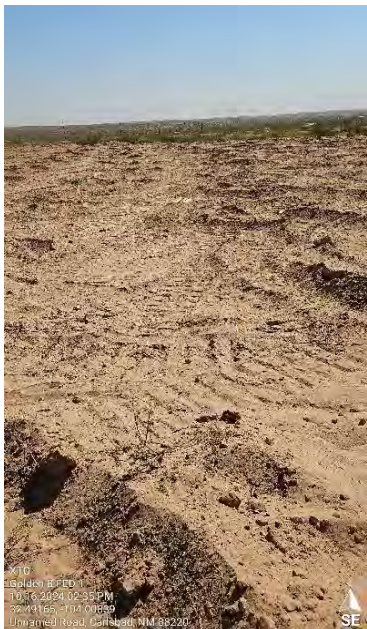
Photograph 1 Date :10/16/2024
Description: Reclaimed well pad
View: Southeast

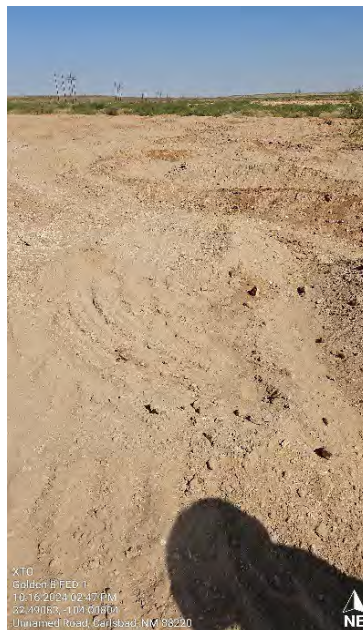
Photograph 2 Date :10/16/2024
Description: Reclaimed well pad
View: Northwest

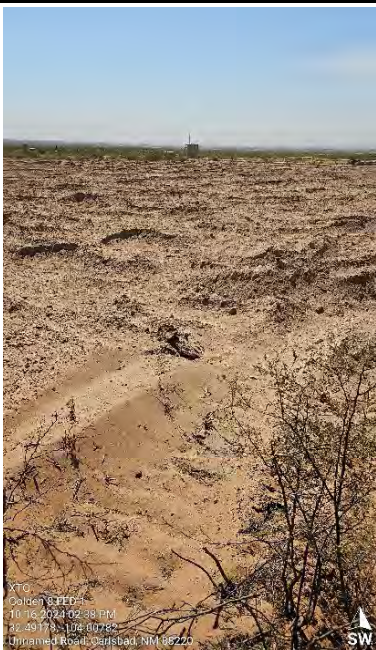
Photograph 3 Date :10/16/2024
Description: Reclaimed well pad
View: Southwest

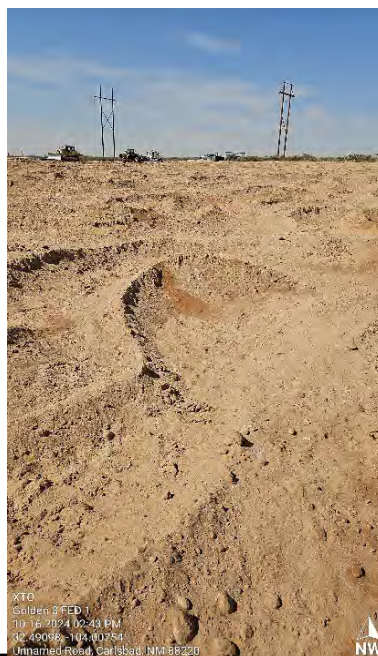
Photograph 4 Date :10/16/2024
Description: Reclaimed well pad
View: Northwest
