Hilcorp – San Juan Gas Plant Remediation Closure Report

San Juan Gas Plant
36.731985, -107.969295
NMOCD Incident # nAPP2536374542
Section 14, Township 29 North, Range 11 W
San Juan County, New Mexico

March 16, 2026

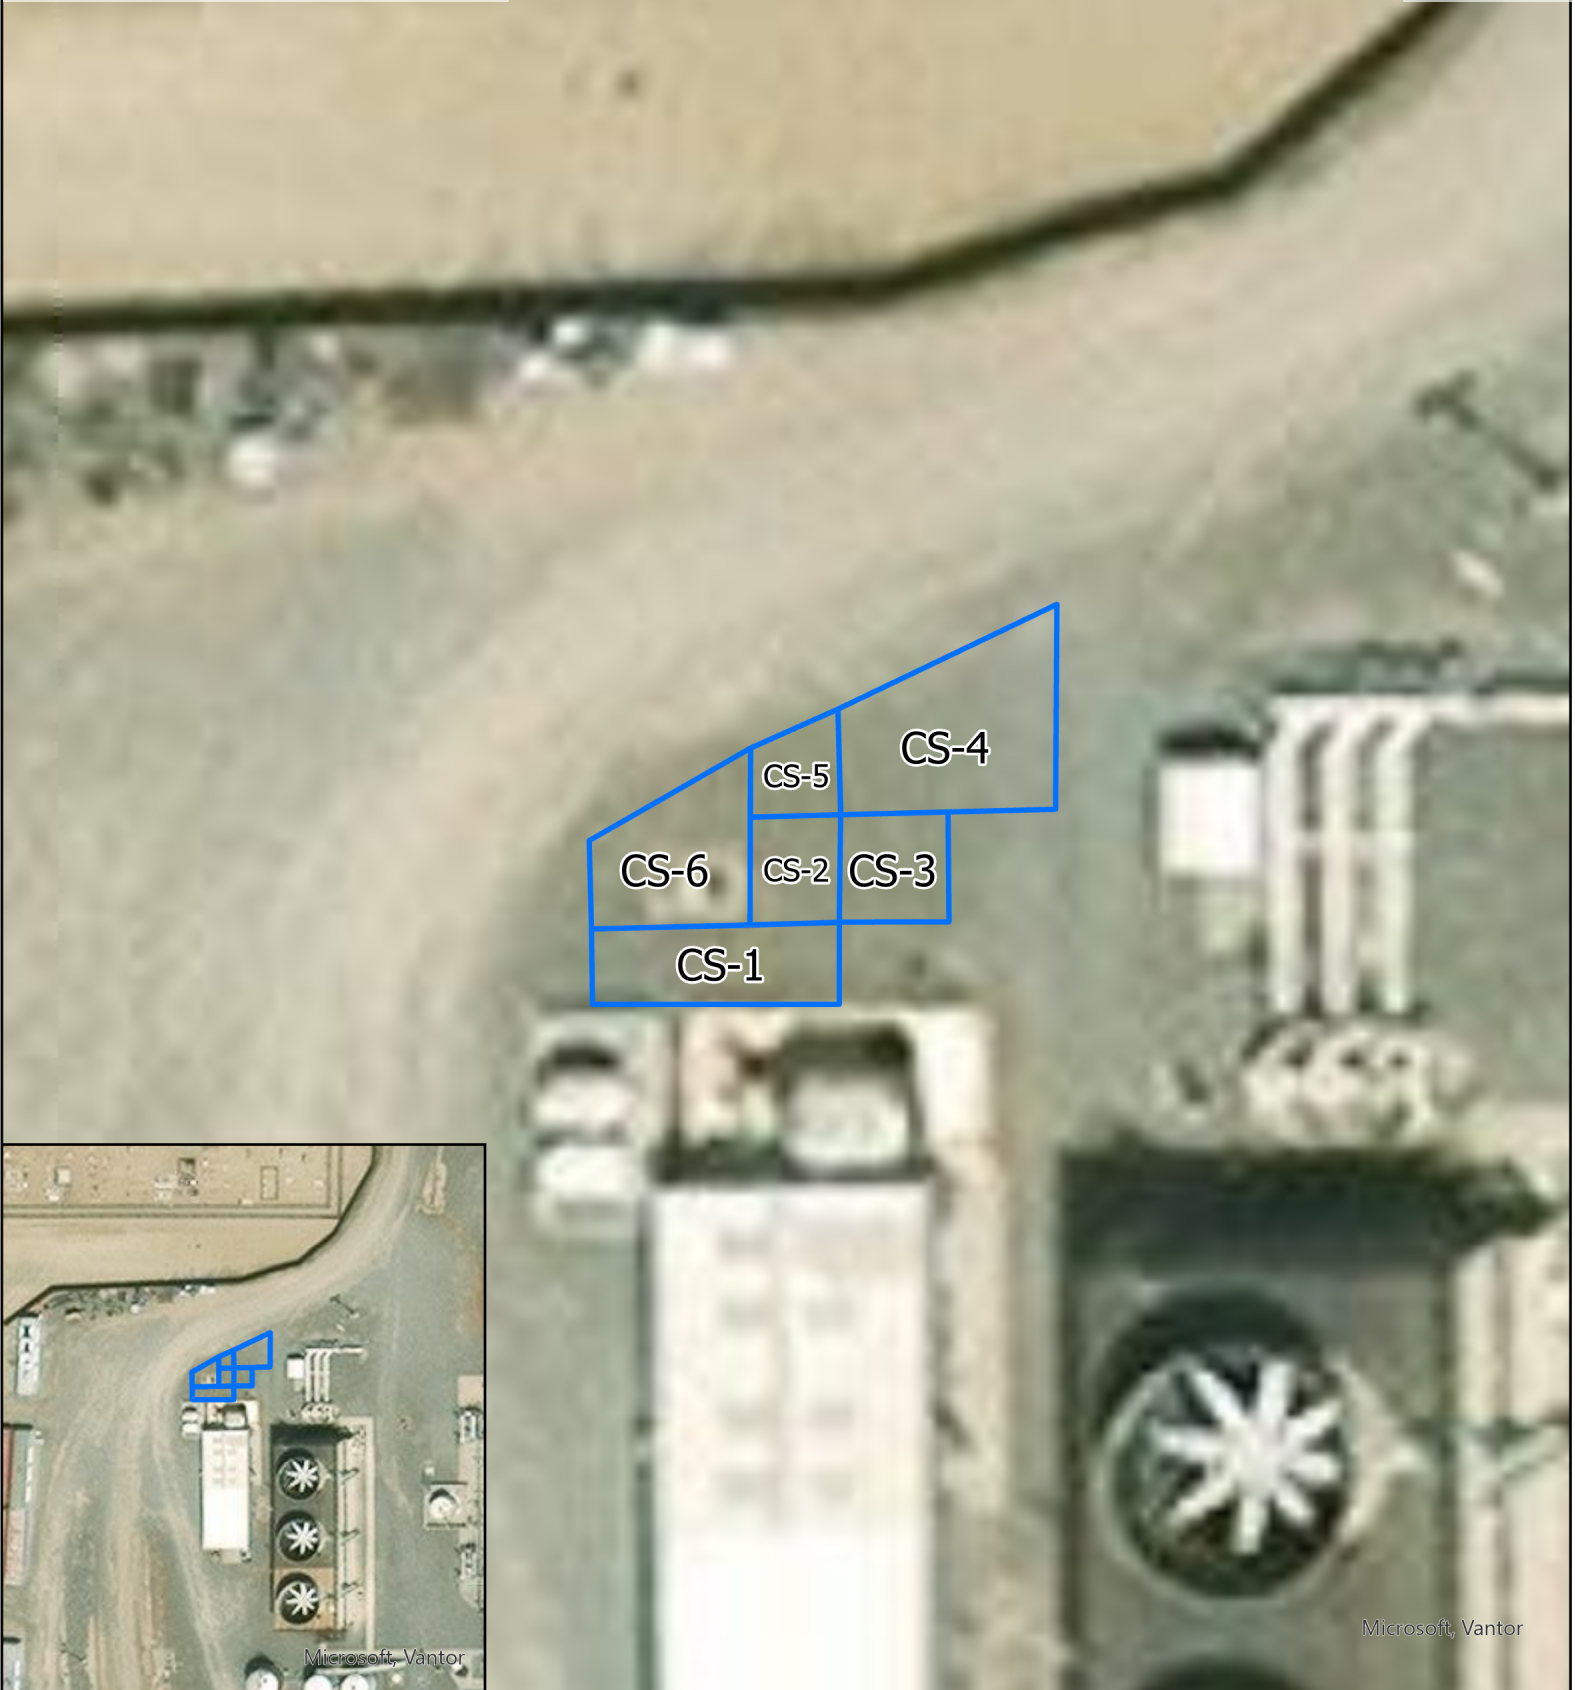
Figure #2, Site Map

Following field screening, the excavation footprint was divided into six sampling sections, each 200 square feet or less, to comply with current New Mexico Oil Conservation Division composite sampling guidance. From each section, a five-point composite sample was collected by obtaining approximately equal aliquots from five locations distributed across the section, homogenizing the material in a clean container, and transferring the composite into laboratory-supplied jars. Samples were labeled, placed on ice in a cooler, and transported under chain-of-custody to the analytical laboratory for pH determination. Laboratory results for samples CS-1 through CS-6

ranged from pH 7.58 to 7.96, and the background sample measured pH 7.81, indicating that all confirmation samples were within the neutral range and consistent with background conditions, demonstrating that residual acidic impacts were not present in the remaining soil.

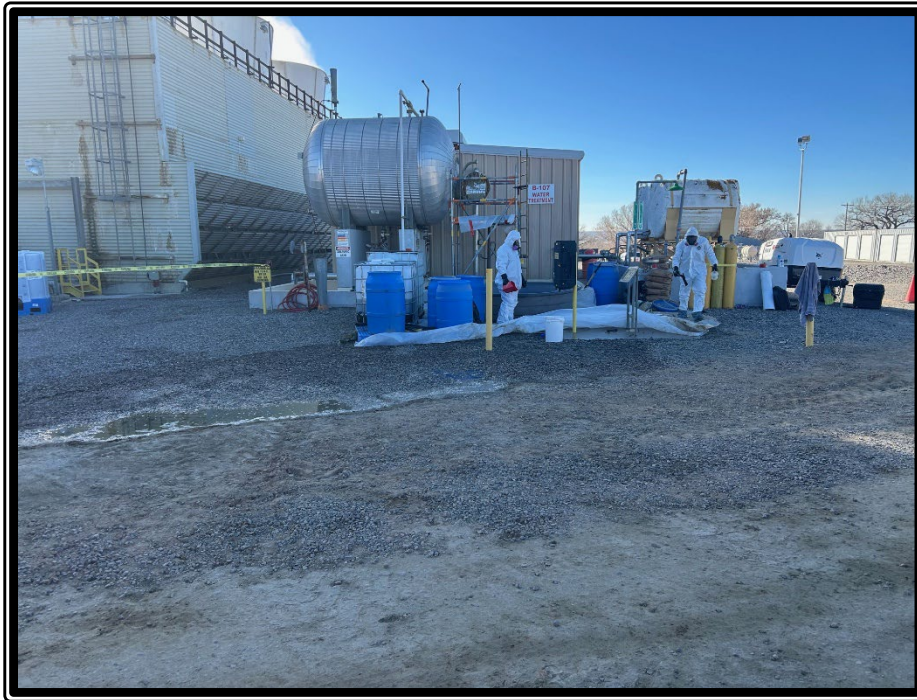
During the week of December 15th-19th, 2025, Envirotech and Hilcorp personnel identified a release of Water used to clean out a Sulfuric acid holding tank, at the San Juan Gas Plant. During the maintenance and cleanout phase of the project, acidic water was pumped from the tank into a large plastic containment pool for neutralization using soda ash (sodium carbonate).

At the end of one workday, due to time constraints, a portion of the acidic water was left in the pool to continue neutralizing overnight. During the night, an leak occurred when the solution corroded a metal drain plug at the base of the containment pool. The plug should have been made of a more resistant material (plastic). This failure allowed approximately 100–200 gallons of acidic solution to release to the surrounding soil. The affected area was promptly identified, secured, neutralized, and covered with 500mil Poly for the remainder of the tank cleaning process. No surface water bodies, groundwater wells, or off-site migration were impacted, and the incident was promptly reported as required.

Photo 1: Spill Area

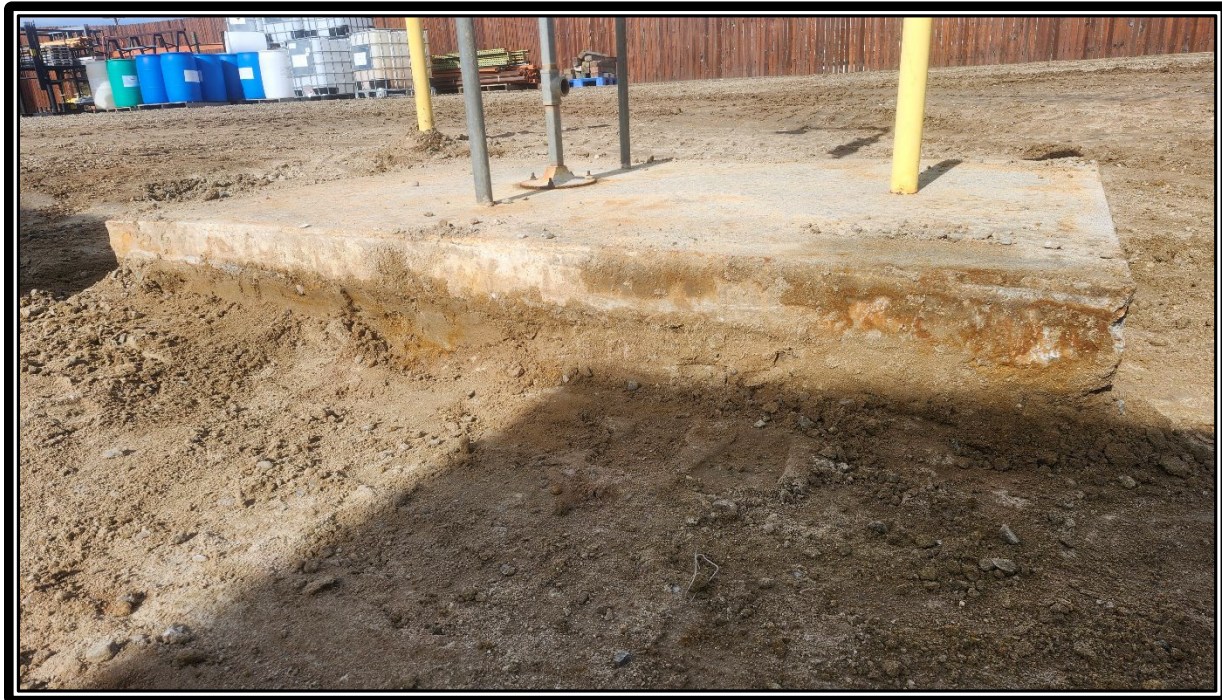
Photo 2: Excavated soil around concrete pad

A total of approximately 25 cubic yards of soil was excavated and placed in a containment south of the spill area, pending proper disposal at an approved facility. Excavation depths varied throughout the spill area, with a max depth of six (6) inches. On January 13th, excavation and field screening activities concluded.

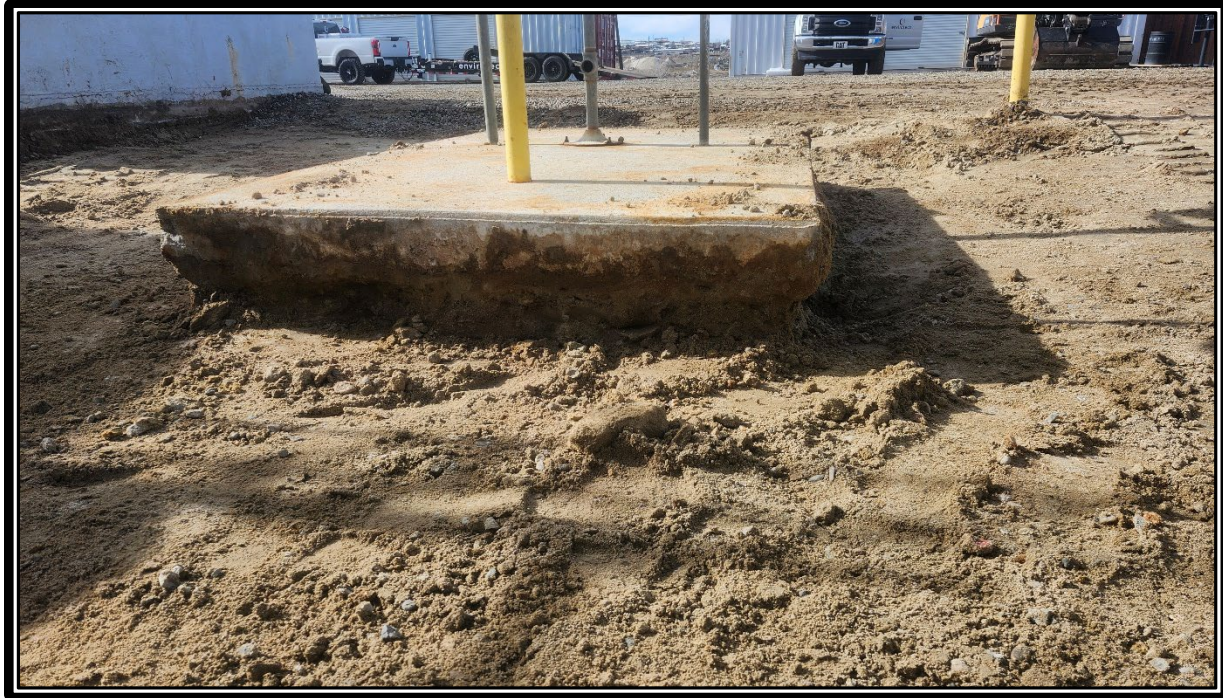
Photo 3: Excavated area around concrete

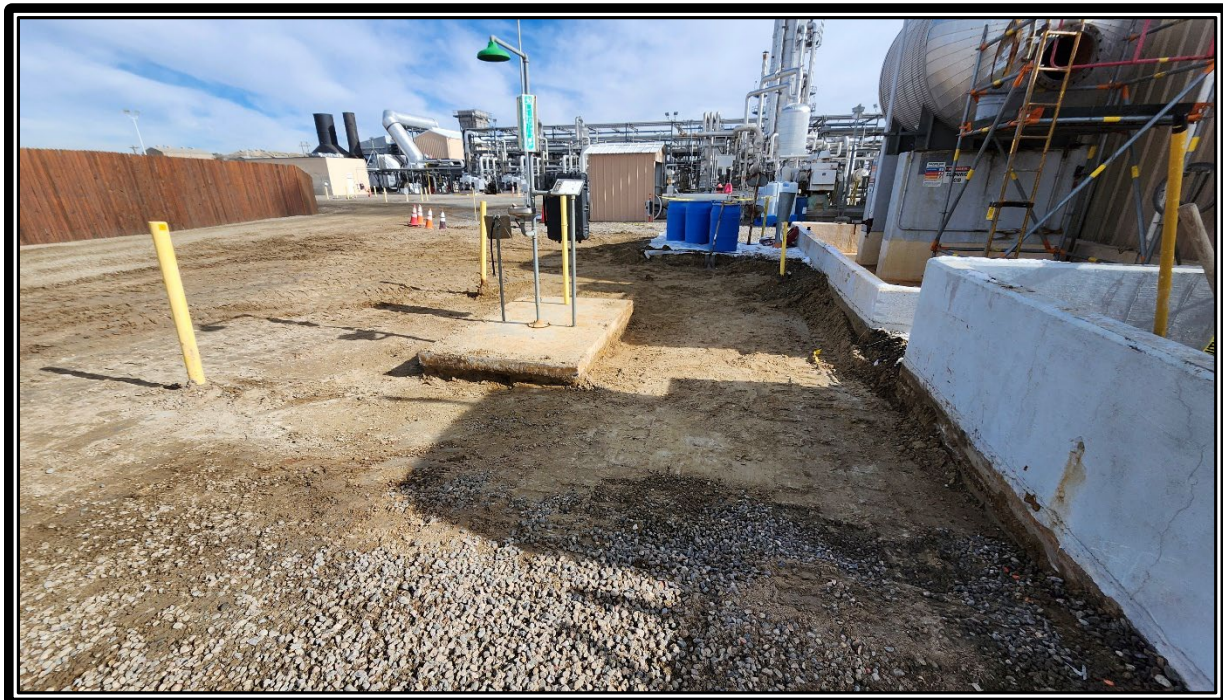
Photo 4: Overall Excavation

On January 12th, 2025, Envirotech arrived on site to uncover and assess the contaminated area. The contaminated soil area was delineated, and excavation activities were initiated. Field pH screening was conducted to guide excavation depth and boundaries. The impacted area was divided into six sampling sections, each 200 square feet or smaller, to ensure adequate characterization and documentation.

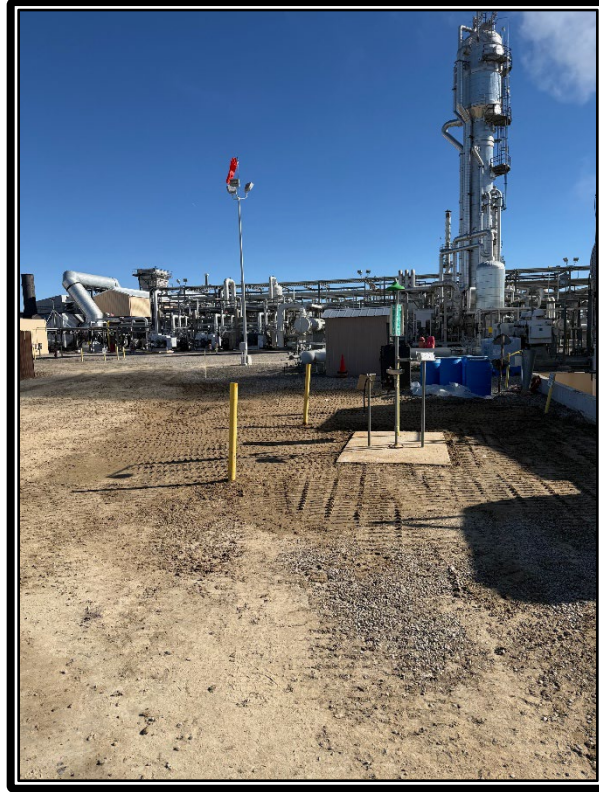
Photo 5: Backfilled area

The excavation was backfilled with clean material, leveled, and compacted to provide a stable base and prevent future subsidence. The backfilled area was then graveled to match existing site surfacing and to promote drainage consistent with surrounding operational areas. Following backfilling and surfacing, the location was contoured to the surrounding grade to maintain existing drainage patterns and to prevent ponding or erosion. These activities restored the affected area to pre-incident conditions suitable for ongoing facility use and access.

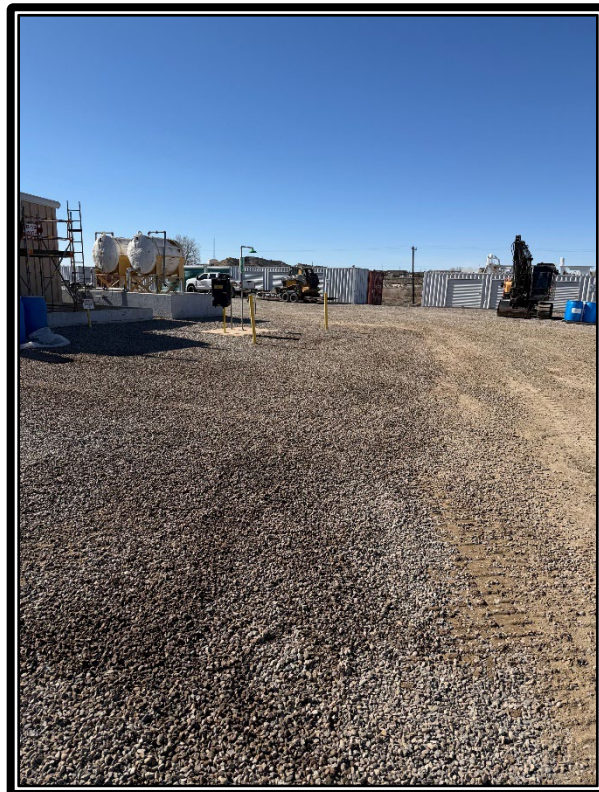
Photo 6: Backfilled area
