RE: Summary of Events
Enterprise Field Services, LLC
Chaco Plant – B Plant Fire
UL M Section 16 T26N R26W; 36.482090, -108.121991
NMOCD Incident #nAPP2602936959

Enterprise Field Services, LLC (Enterprise) is submitting this Summary of Events to the New Mexico Oil Conversation Division (NMOCD) documenting the fire that occurred at Chaco Plant on January 28, 2026. This submittal is a closure request for NMOCD Incident Number nAPP26029369598, which was reported on January 28, 2026.

Photographs
Chaco Plant – B Plant Fire
UL M Section 16 T26N R26W; 36.482090, -108.121991
NMOCD Incident #nAPP2602936959

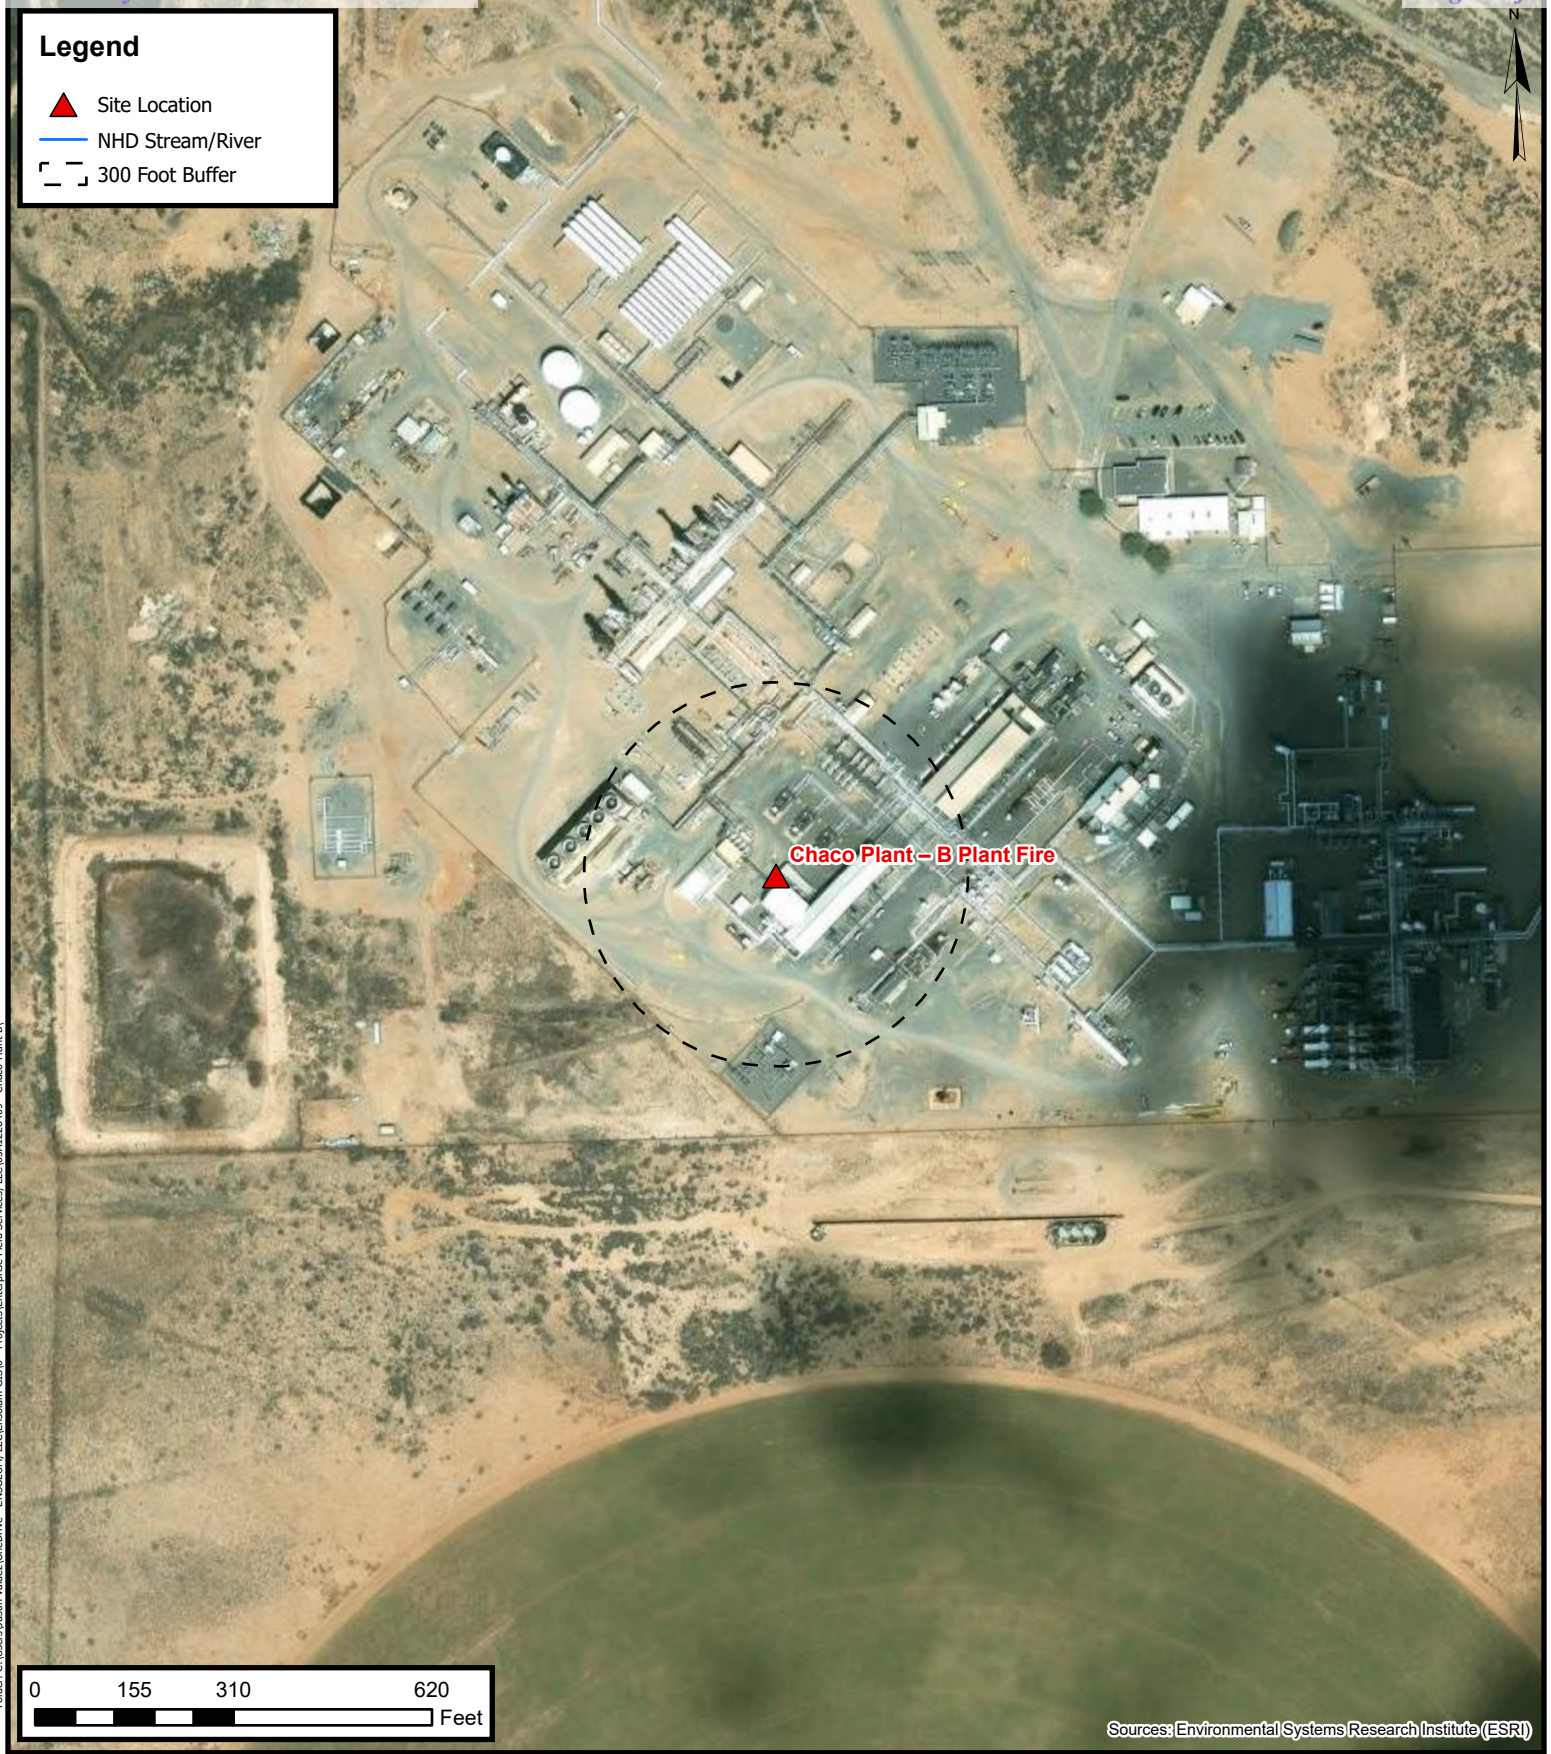
FIGURE C

300 Foot Radius Watercourse and Drainage Identification
 Enterprise Field Services, LLC
 Chaco Plant - B Plant Fire
 Project Number: 05A1226409
 Unit M, Section 16, T 26N, R 12W, San Juan County, New Mexico
 36.482090, -108.121991

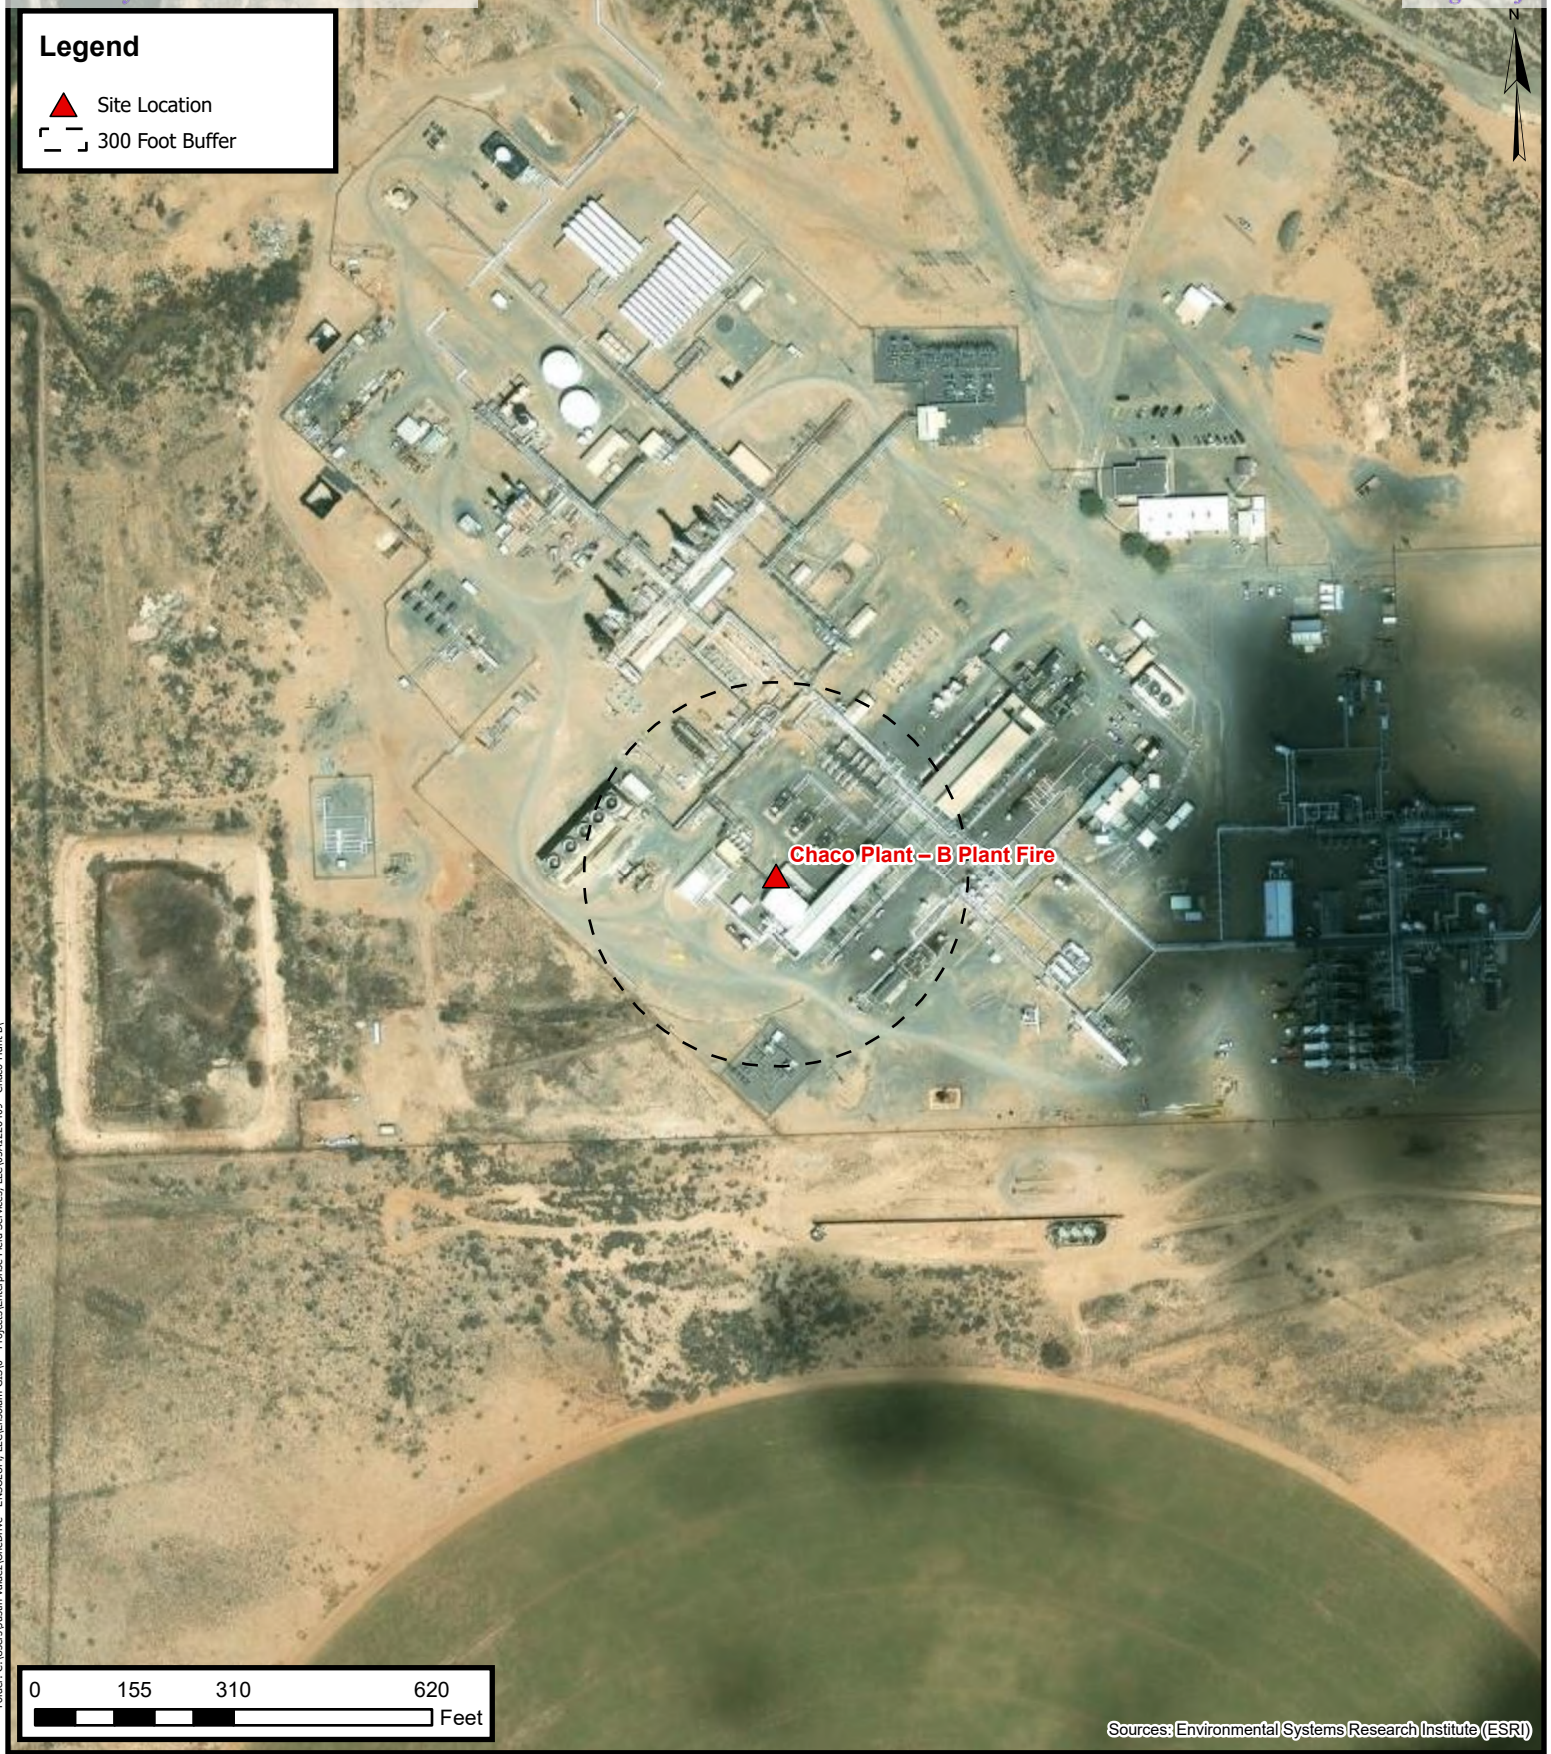
**FIGURE
D**

**300 Foot Radius Occupied
Structure Identification**

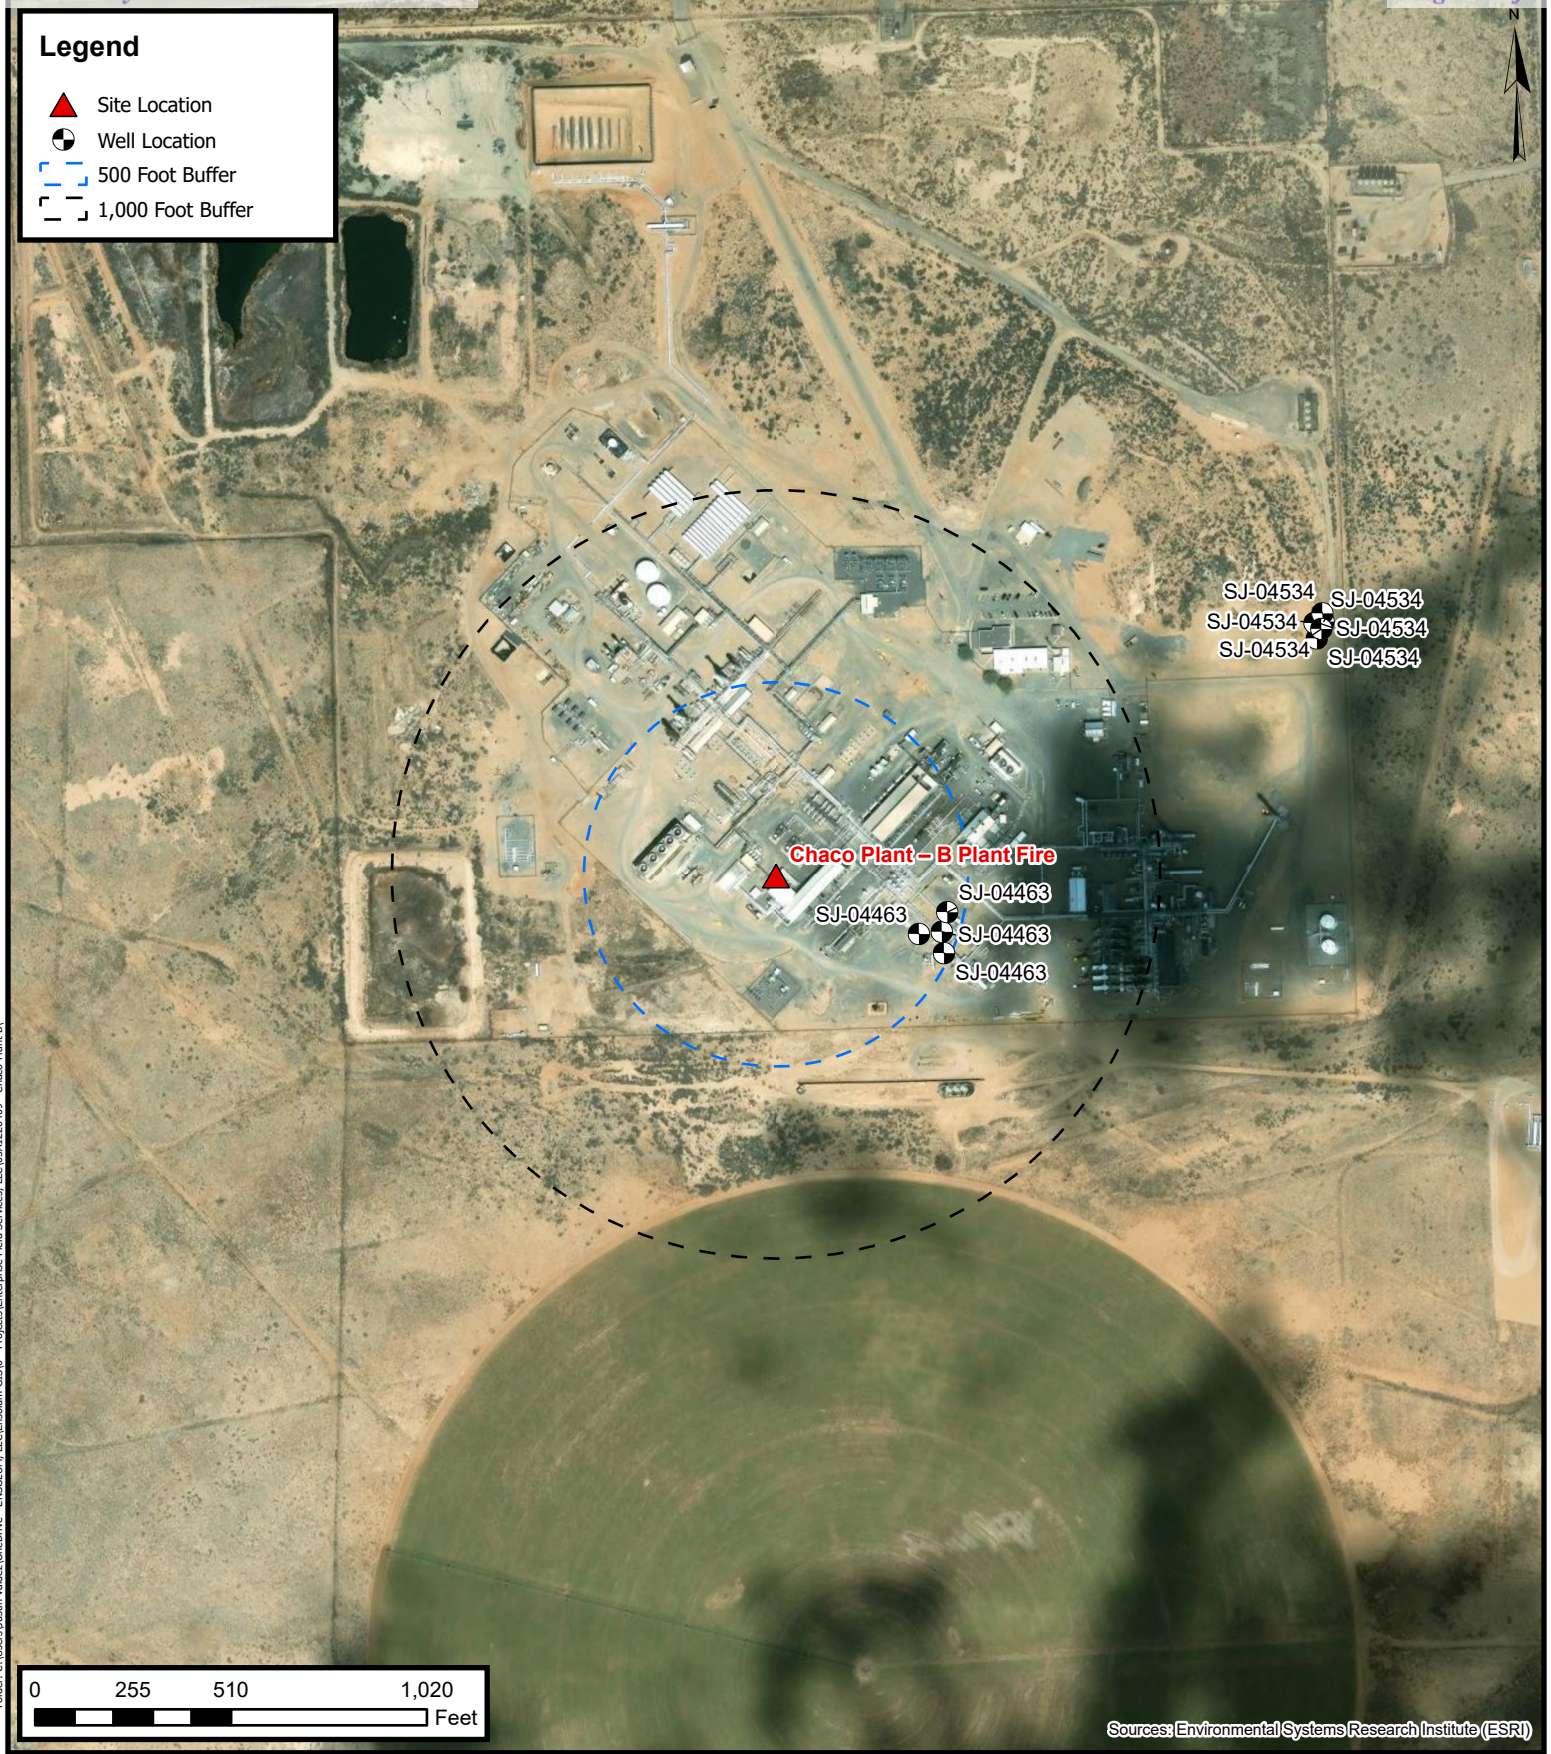
**FIGURE
E**

Water Well and Natural Spring Location

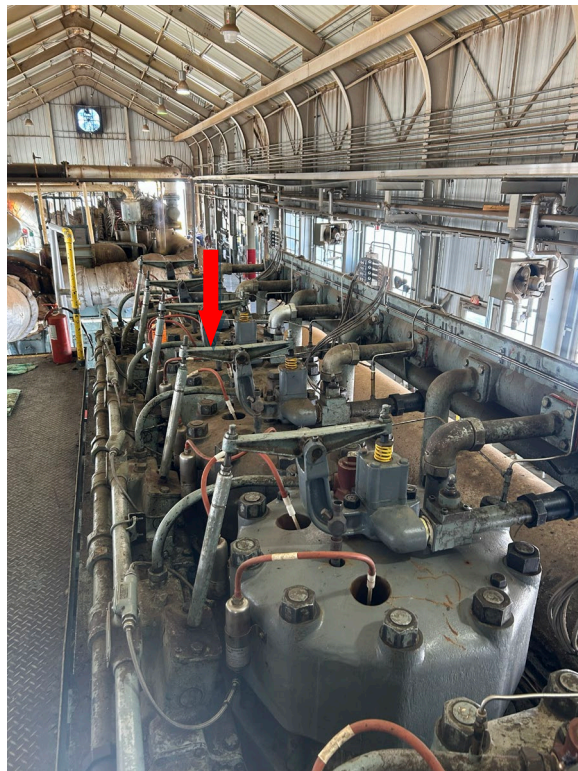
On January 28, 2026, at approximately 15:15 MT, a fire occurred at the Chaco Plant – B Plant. There were no injuries nor fatalities. No emergency services responded. No liquids were released. The fire self-extinguished. The fire was a result of a cracked bonnet on a cylinder head in which the fire eye caught the flame and caused emergency shutdown.

Photo 2: View of where the flash fire occurred.

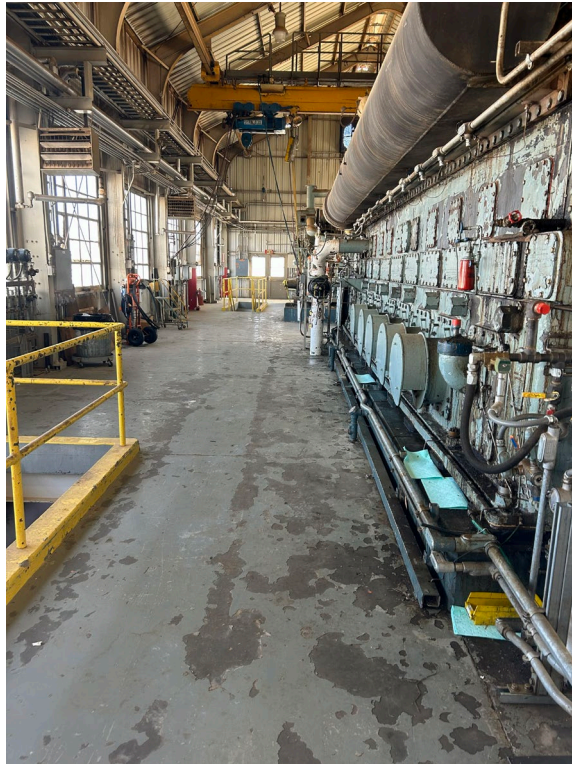
Per 19.15.29.7 New Mexico Administrative Code (NMAC), this event is defined as a “Major Release,” and soil sampling would ordinarily be required. Enterprise is requesting a variance to the soil sampling requirement per 19.15.29.12.D (1) NMAC, since the fire occurred inside the B Plant building, which has a concrete floor and no liquids were released.

Photo 3: View of concrete floor below the compressor.

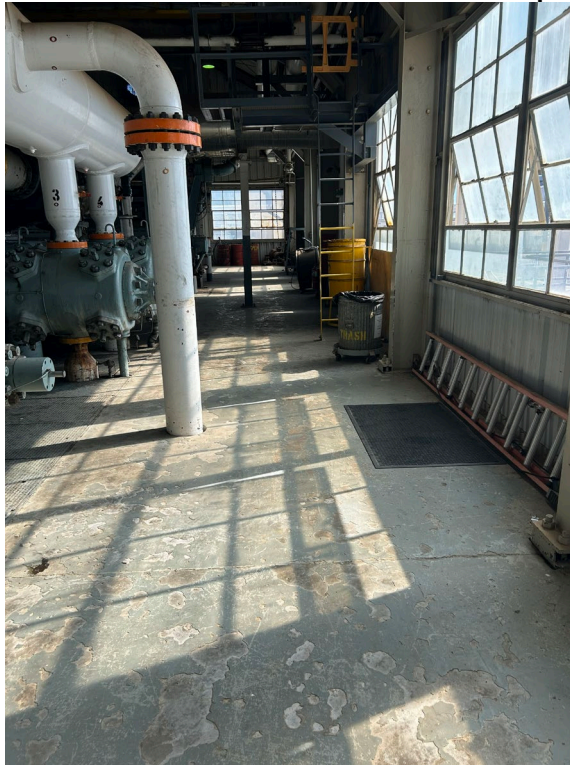
Photo 4: View of concrete floor below the compressor.
