**REMEDIATION UPDATE REPORT  
DENTON GAS PLANT  
UNIT NWSE, SECTION 2, TOWNSHIP 15S, RANGE 37E  
LEA COUNTY, NEW MEXICO  
33.044544, -103.169415  
NMOCD INCIDENT #NRM2033752202  
RANGER REFERENCE #6116**

**DAVIS GAS PROCESSING, INC.  
P.O. BOX 51670  
MIDLAND, TEXAS 79710**

**RANGER ENVIRONMENTAL SERVICES, LLC  
P.O. BOX 201179  
AUSTIN, TEXAS 78720**

**APRIL 1, 2026**

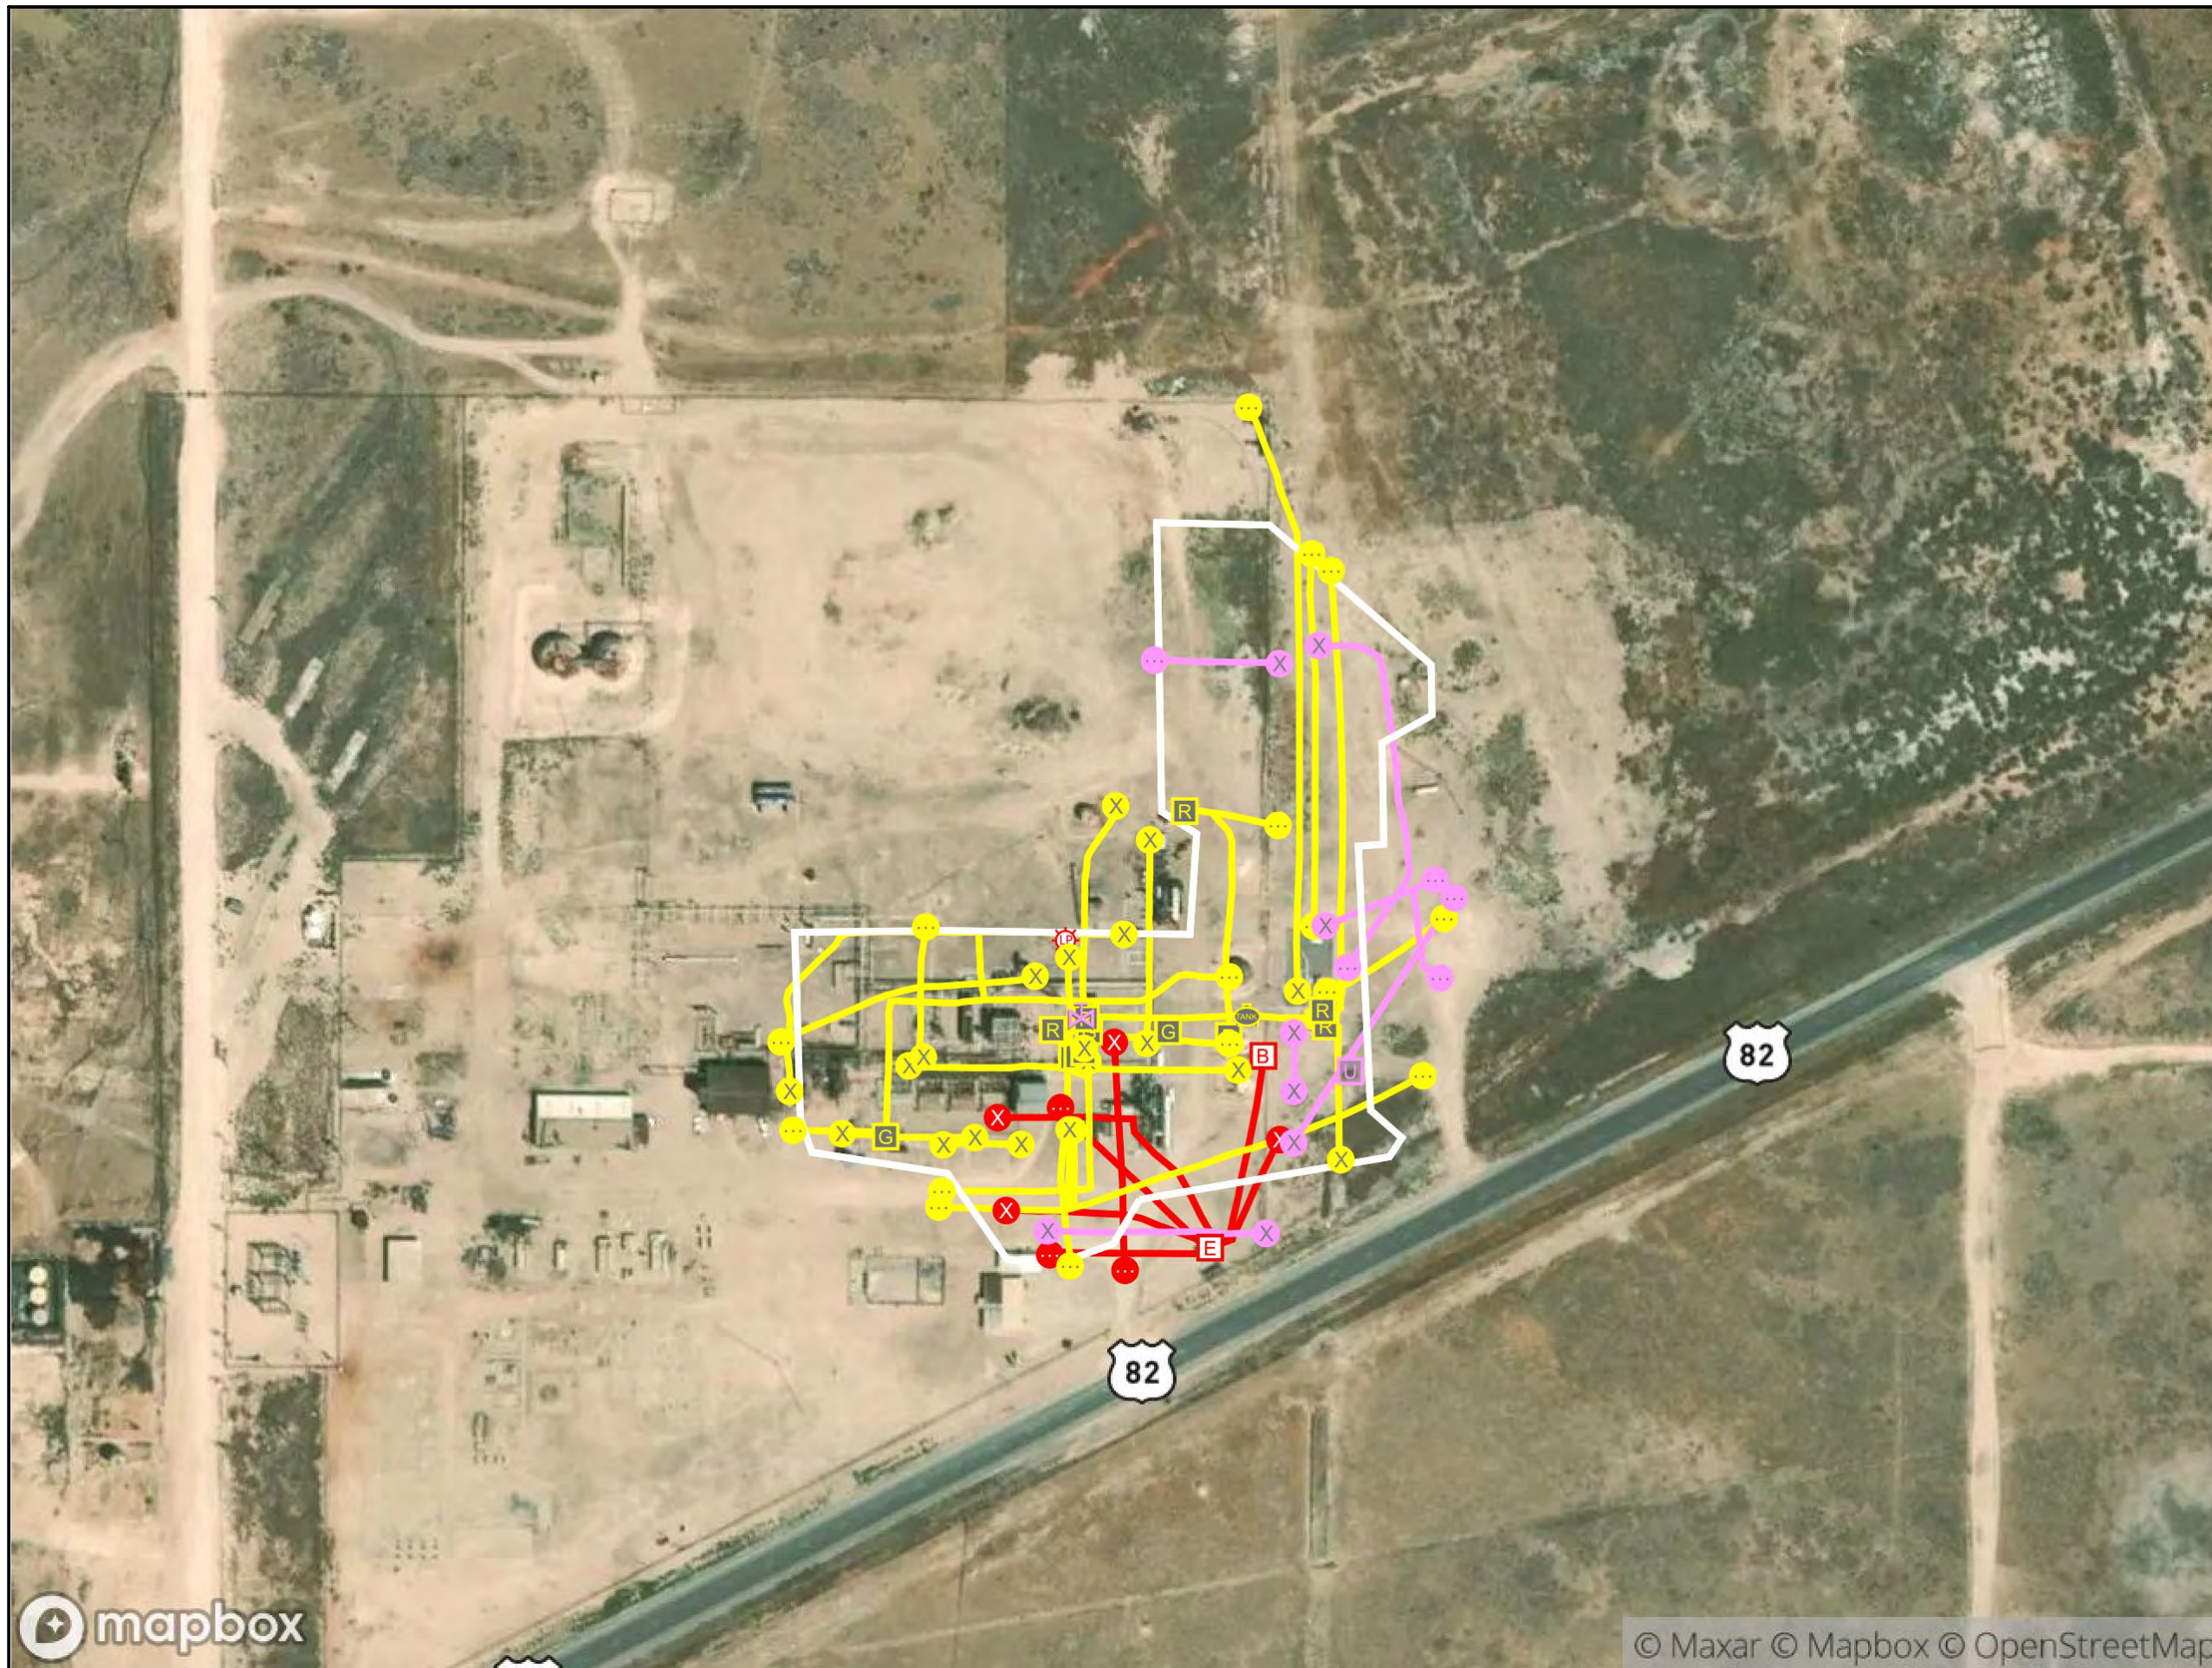
**GPRS UTILITY FINDINGS MAP (NOT SURVEY GRADE)**

Given the Site's operational history, numerous underground utilities were expected to be located within the project remediation area. To assist in locating utilities in the remediation area, DGP engaged Ground Penetrating Radar Systems, LLC (GPRS) to complete a geophysical remote sensing survey of the areas to be included in the remediation efforts. On February 11 and 12, 2026, GPRS completed a survey at the Site using an underground ground penetrating radar antenna and an electromagnetic pipe and cable locator. The survey included the approximate 4.83 acre remediation area and the immediate surrounding areas. The survey successfully located numerous lines within the remediation area; however, as reported by GPRS report and discussed below, some lines in the remediation area could not be successfully located because the material construction was not conducive to the equipment used.

A map depicting the location of the underground lines and utilities detected during the GPR survey process is included in the Figures section.

During the removal operations, numerous underground lines not identified by either the completed GPR survey or underground utility 1-calls have been encountered. The underground lines constructed of steel and poly material, were observed to be out of service and, based on Site knowledge, are associated with historic operations at the Site. To date, approximately 15 unmarked out-of-service lines have been encountered, assessed, and removed from the current excavation area. As of this report, no confirmed or additional areas have been identified for a remediation deferral request. However, as presented in the Remediation Plan, various areas necessitating a request for deferral of remediation will be included in the subsequent Remediation Update Reports.

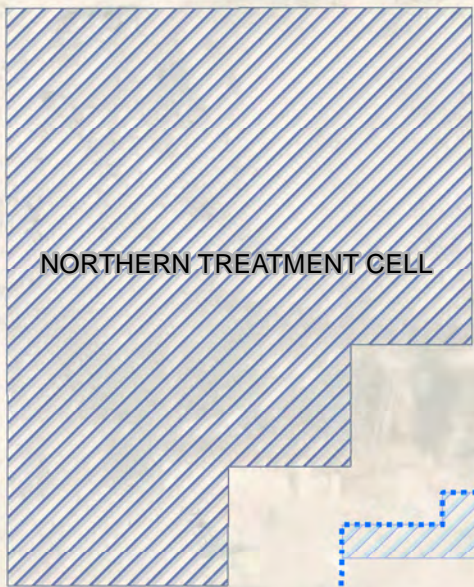
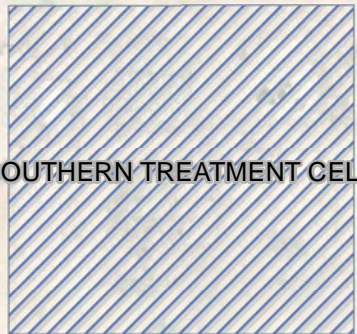
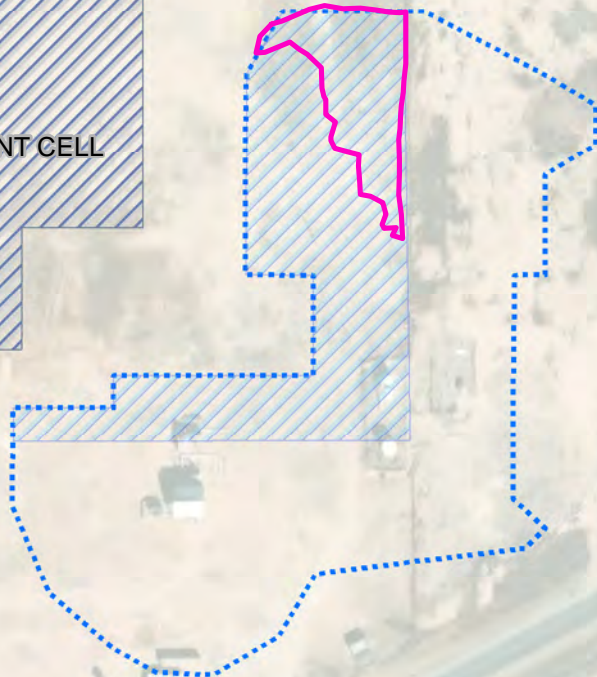
**Status Update Site Map**  
 DENTON GAS PLANT  
 LEA COUNTY, NM

The location of the constructed treatment cells are depicted in the attached Status Update Site Map. Photos of the completed treatment cells are included in Attachment 1.

As of this report, soil removal in the initial phase is ongoing. To date, approximately 4,500 cubic yards of material have been excavated from the remediation area and transported to and staged within the Northern Treatment Cell for treatment. The extent of the currently completed excavation area is included in the attached Status Update Site Map.

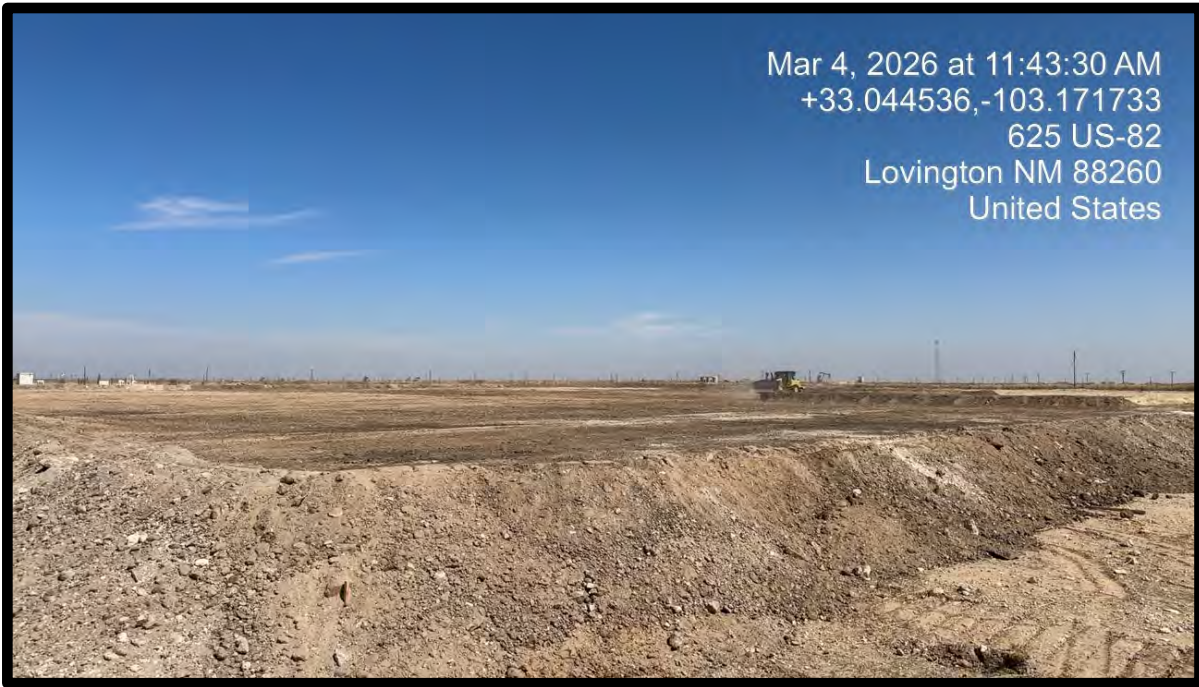
**PHOTOGRAPH NO. 1 – A view of the Northern Treatment Cell during the construction process. The view is towards the northeast.**

Upon mobilization, Charger representatives began constructing the treatment cells as proposed in the Remediation Plan. During the week of February 23, 2026, construction of the northern treatment cell was initiated.

Initial construction operations included preparing the treatment cell areas by leveling and removing debris that could damage the installed liner. Earthen containment berms were then constructed around the boundaries of the treatment cells. Upon completion of the preparation and containment berm construction, the cell footprints and berms were lined with a protective 8-ounce felt padding mat and 40 mil reinforced Visqueen liner. Installation of the treatment cell liner system was delayed on multiple occasions due to high wind conditions at the Site to maintain safe working conditions and ensure proper placement of the liner materials within the cell areas.

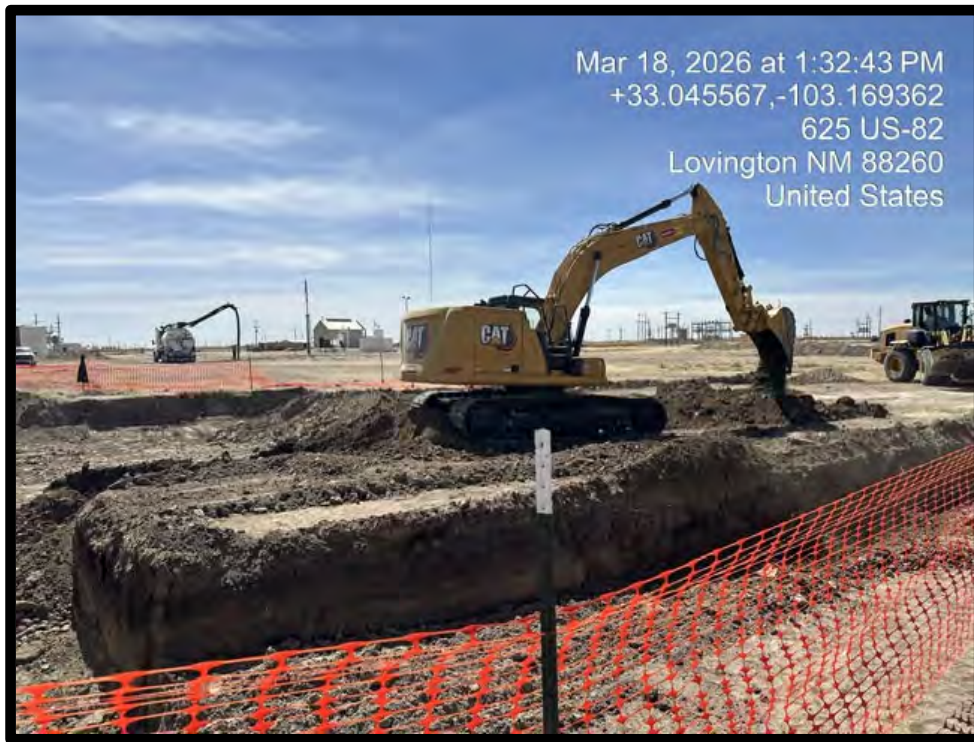
**PHOTOGRAPH NO. 2 – A general view of the initial removal operations at the Site. A hydrovac excavator can be seen locating lines in the background of the photograph. The view is towards the south.**

By the week of March 16, 2026, the Northern Treatment Cell construction and lining had been completed, and remedial soil removal operations had been initiated. As detailed in the Ranger prepared and NMOCD approved Remediation Plan, removal at the Site will be conducted in multiple phases. The initial phase of removal efforts has been initiated in the northern extent of the anticipated remediation area and will include approximately 15,000 cubic yards of material. Due to the number of underground lines detected during the GPRS survey and underground utility locate 1-calls, hydro excavation was completed in efforts to limit any damage to the underground lines prior to their removal. The soil removal operations are currently being completed to an initial depth of four feet below grade as presented in the Remediation Plan.

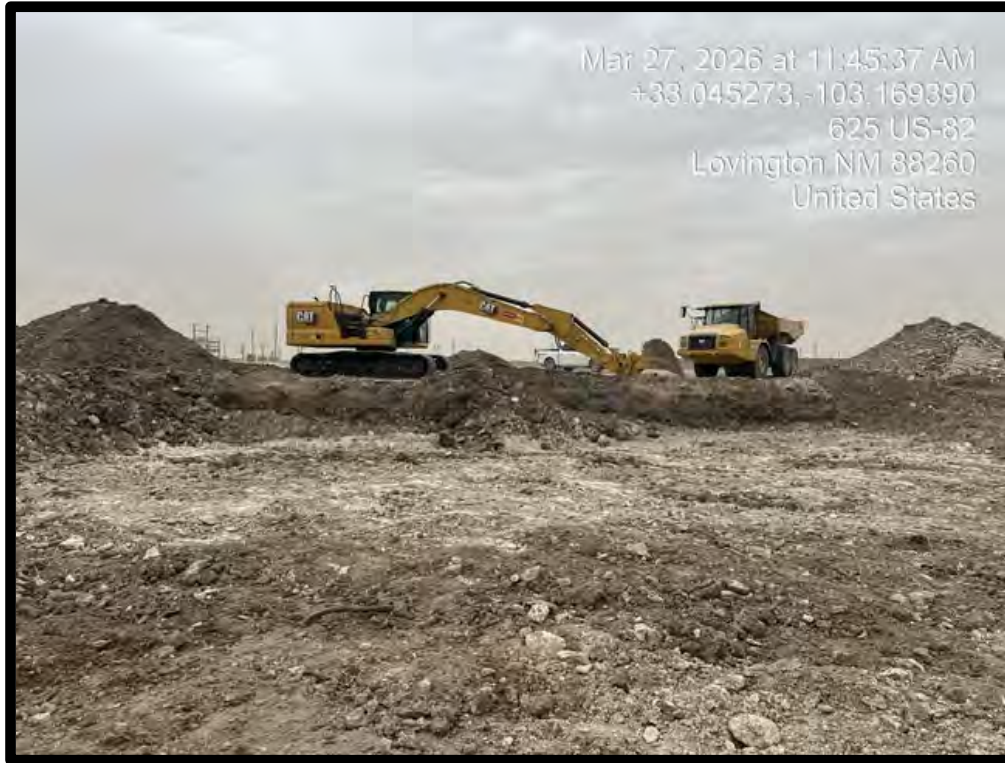
**PHOTOGRAPH NO. 3 – A view of the ongoing excavation activities.**

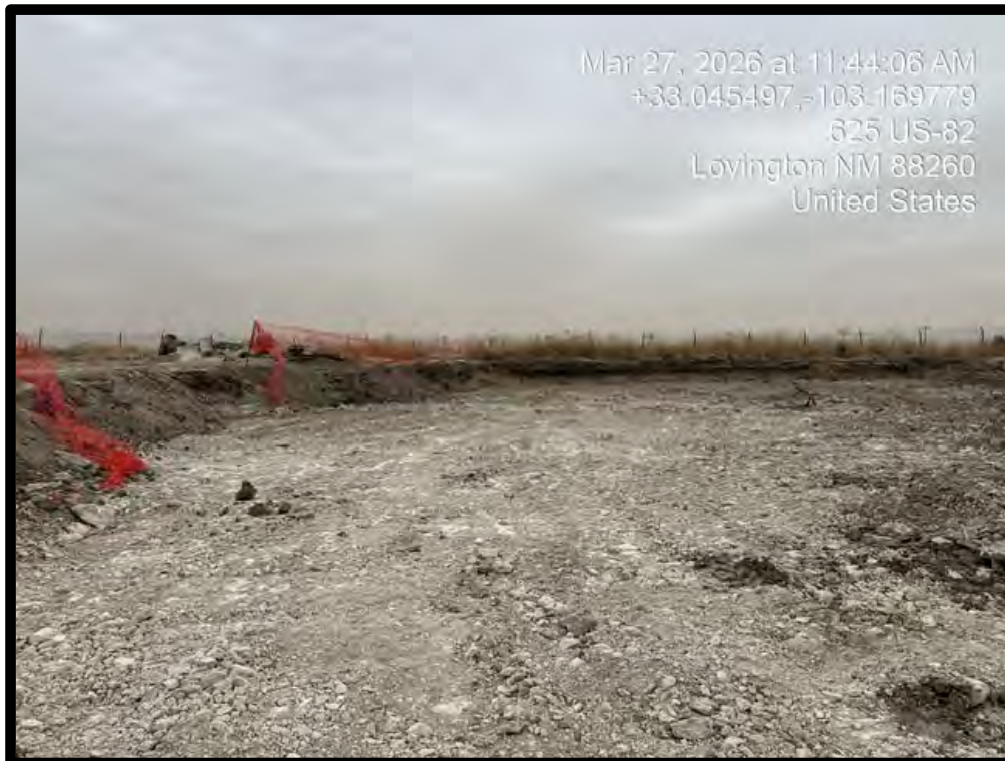
**PHOTOGRAPH NO. 4 – A view of the remediation area included in the March 27, 2026 confirmation sampling activities. The view is towards the east.**

Upon arrival, Ranger personnel reviewed the areas completed to the anticipated boundaries and depths necessary and collected confirmation soil samples from the areas available for sampling. The cleanup confirmation sampling activities were conducted in accordance with NMAC 19.15.29.12, with each cleanup confirmation soil sample collected as a five-part composite sample representing less than 200 square feet. A total of 25 confirmation soil samples were collected from the base of the excavation area.

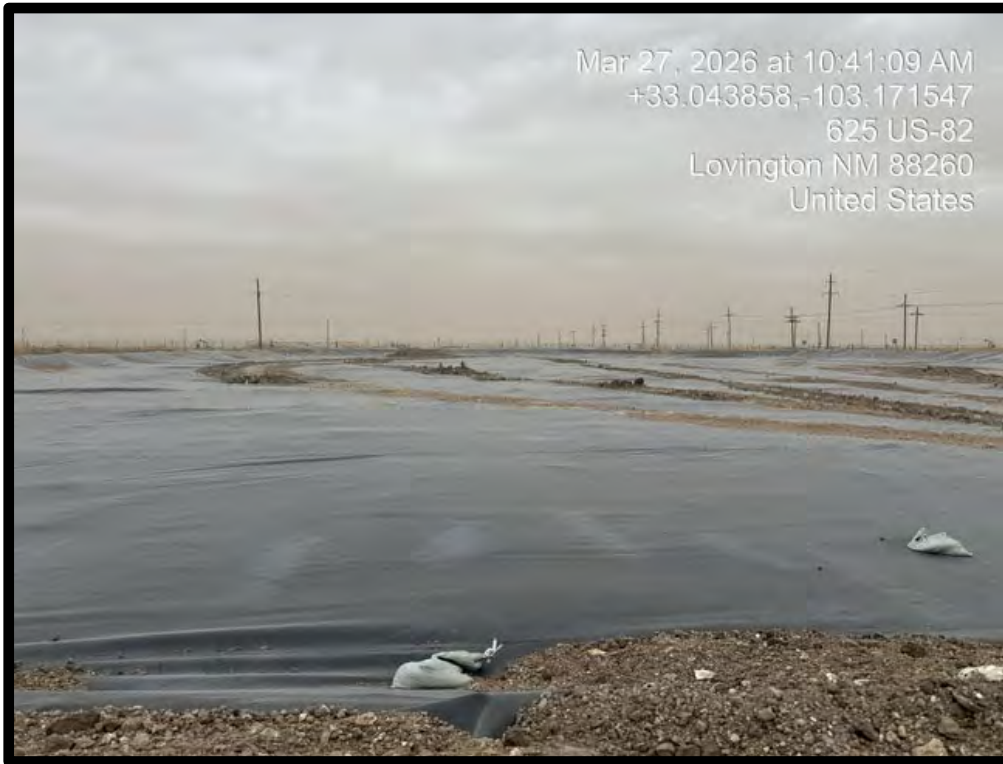
**PHOTOGRAPH NO. 5 – A view of the southern treatment cell awaiting the placement of soils for treatment. The view is towards the south.**

As removal operations are ongoing at the Site, the excavated material is currently being staged in the constructed on-site treatment cells and is awaiting product application. It is currently anticipated that the first phase of removal operations will be completed within two weeks of the date of this report. Once remedial operations are completed, initial treatment operations will be conducted. The initial treatment operations will utilize Piranha® as detailed in the approved Remediation Plan.

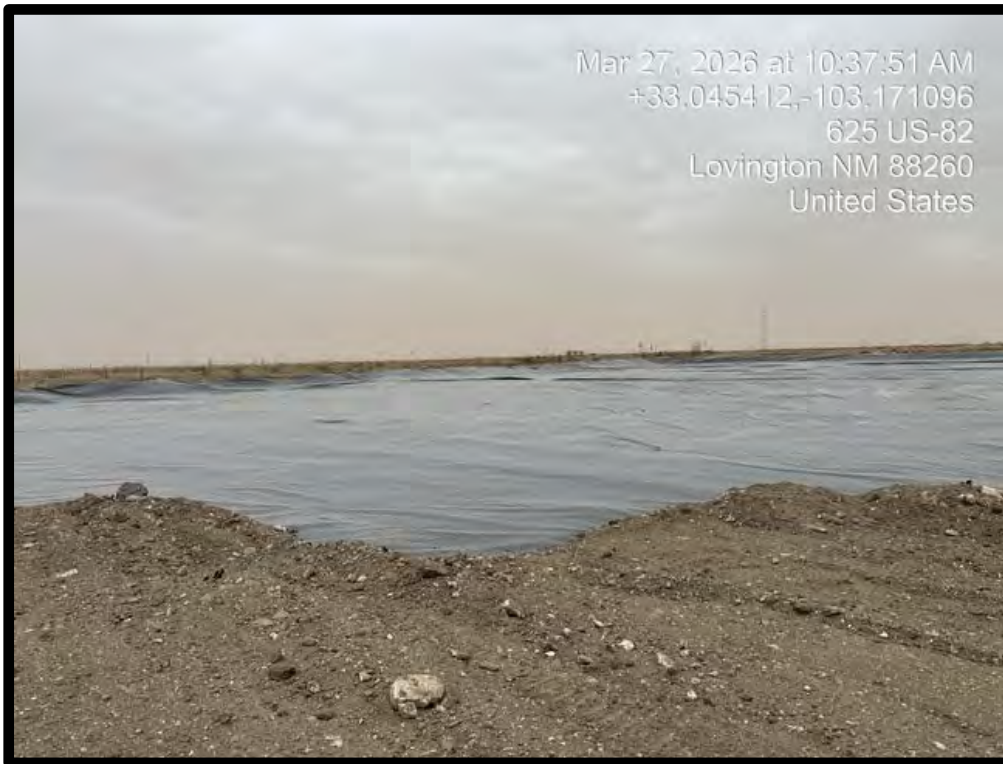
**PHOTOGRAPH NO. 6 – A view of the completed Northern Treatment Cells with excavated material pending treatment. The view is towards the northwest.**

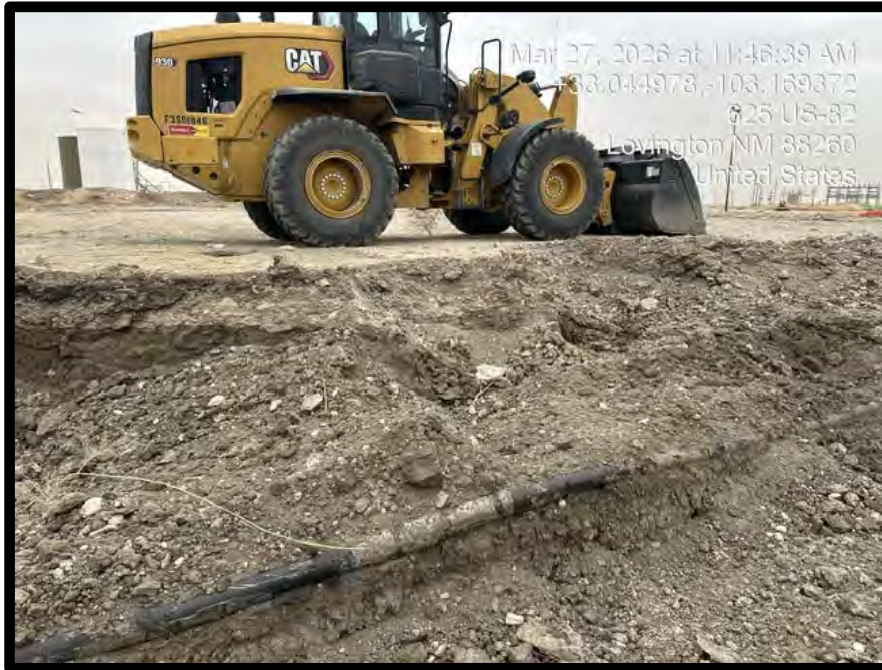
**PHOTOGRAPH NO. 7 – A view of the encountered lines in the remediation area.**
