LEA YL STATE #002 – NOY1707247923

TEXLAND PETROLEUM-HOBBS, LLC
 LEA YL STATE #002
 Incident #NOY1707247923
 32.867981,-103.222923 NAD83
 Lease #B002430006

This report documents the remediation activities conducted at the LEA YL STATE #002. On behalf of TEXLAND PETROLEUM-HOBBS, LLC (Texland), Diamondback Disposal Services, Inc. (Diamondback) prepared this remediation closure report based solely on historical records, including documentation from BCC Inc., emails, photographic evidence, and other available files. Calculations and supporting data were derived from disposal receipts and related historical information. The release is considered historic, and both the spill volume and cause are unknown. Additional details are provided in the Remediation section of this report.

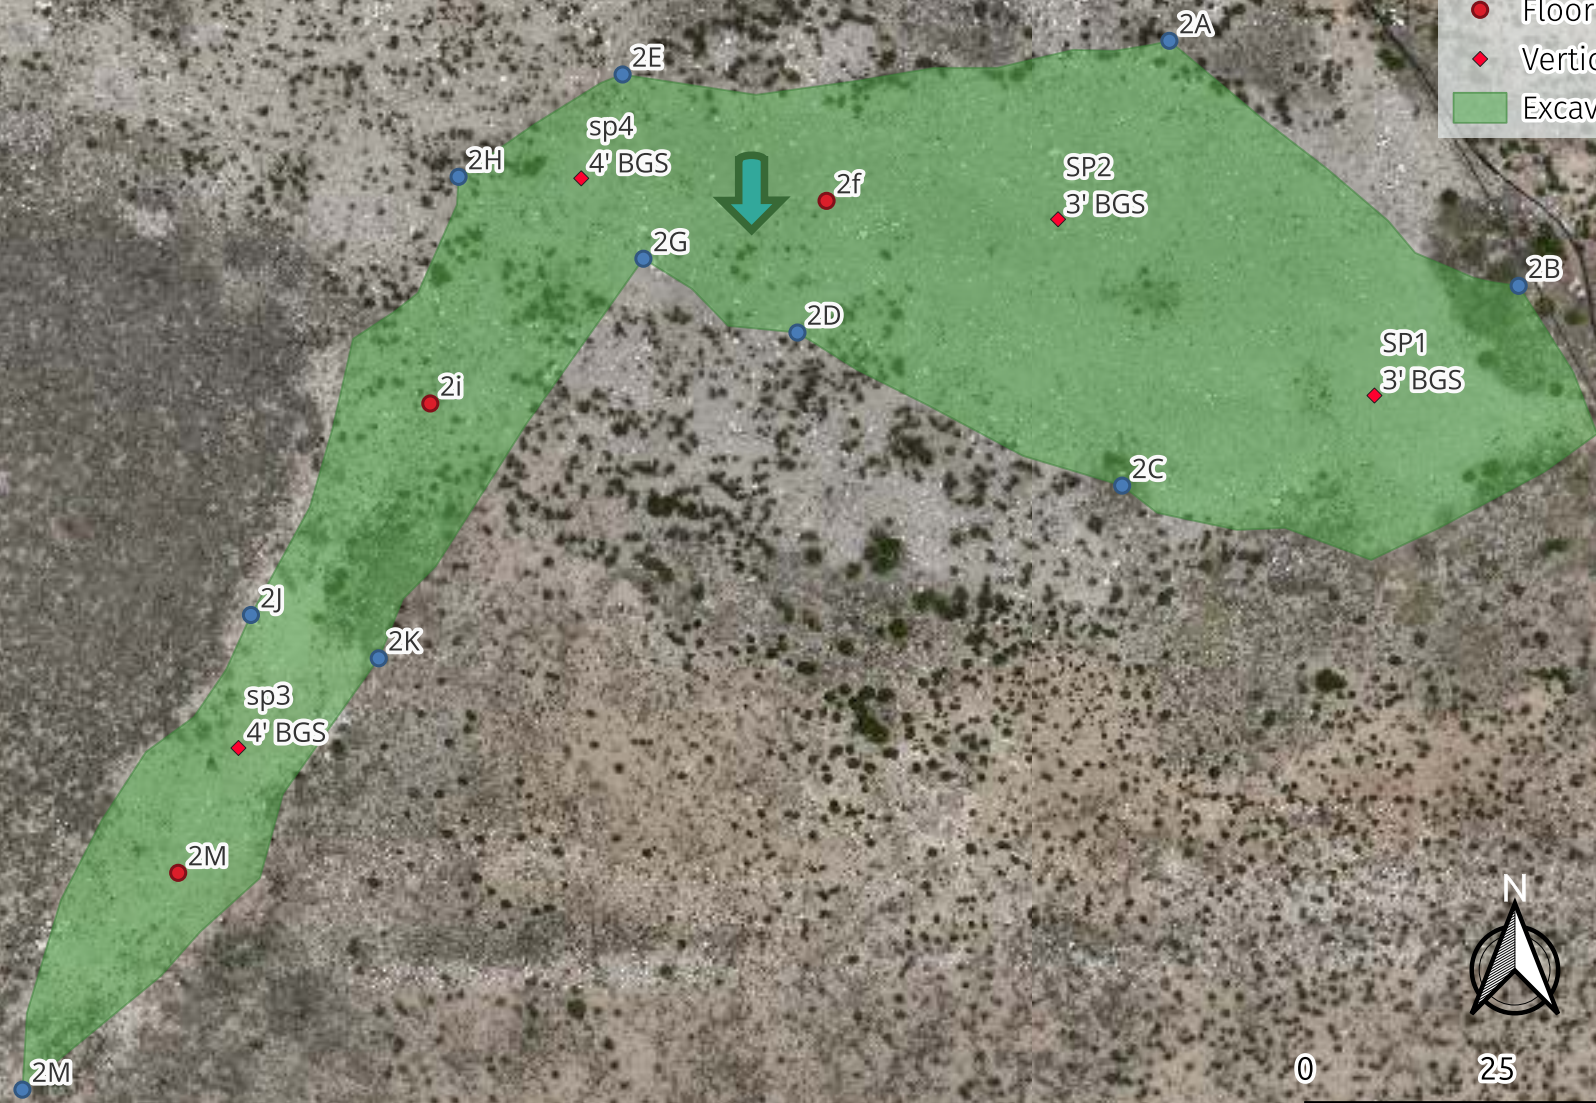
Release Point
-   Wall Sample
-

Floor Samples
-

Vertical Sample "SP"
-

Excavated Area

Laboratory analytical reports associated with delineation events reportedly conducted on March 14, 2017 and April 6, 2017 are not available in existing records. Additional delineation sampling was performed on January 22, 2026 at the locations and depth intervals specifically requested by Shelly Wells with OCD. Sampling conducted within the unlined area extended through the backfill and into the underlying in-situ soils, providing confirmation of subsurface conditions. These sampling locations are shown on the updated sample location map.

Historical TPH exceedances identified in prior reports have been addressed through the additional delineation sampling event. The January 22, 2026 sampling event included the locations and depth intervals requested by Shelly Wells with OCD within the previously identified unvegetated area. The results demonstrate that soil concentrations are below applicable reclamation standards.
