Deferral Request  
Lost Tank 18 Tankless CPF  
nAPP2524524222  
32.38727, -103.71764  
N-18-22S-32E  
Lea County, New Mexico

## **Introduction**

## **Deferral Request**

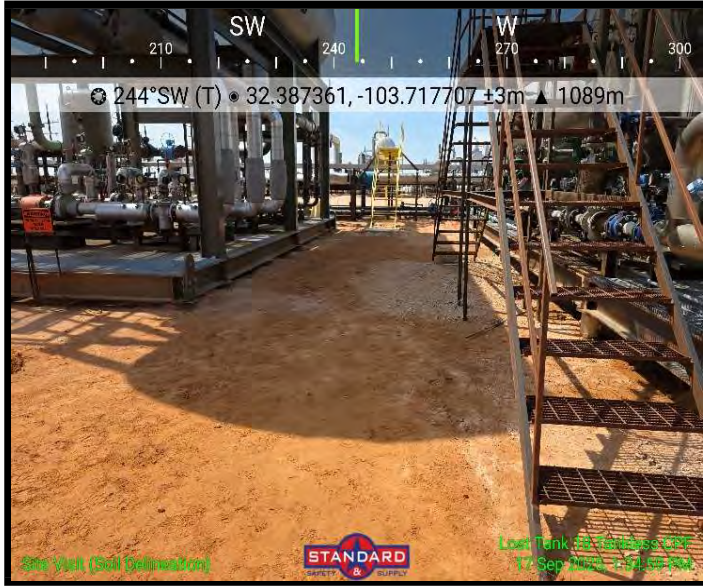
View of Area of Concern

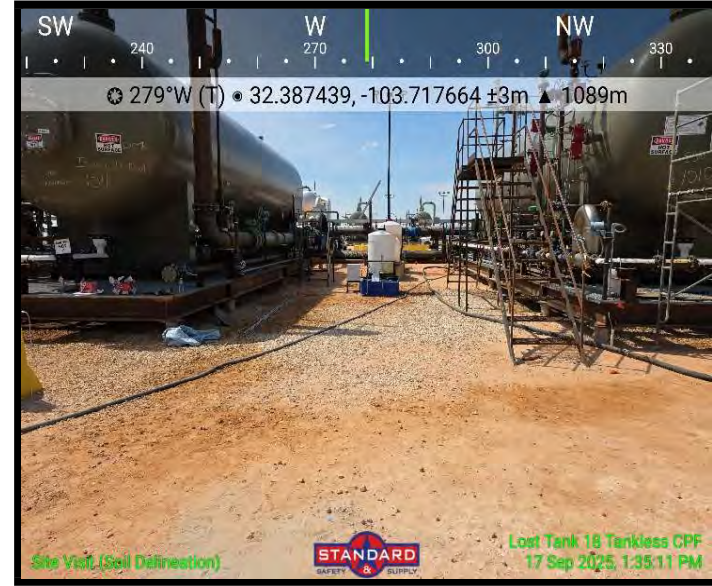
View of Area of Concern

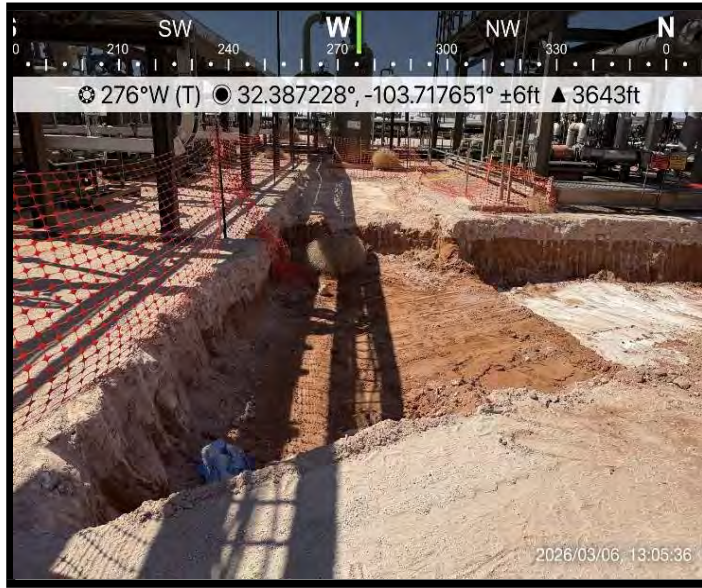
View of Excavation

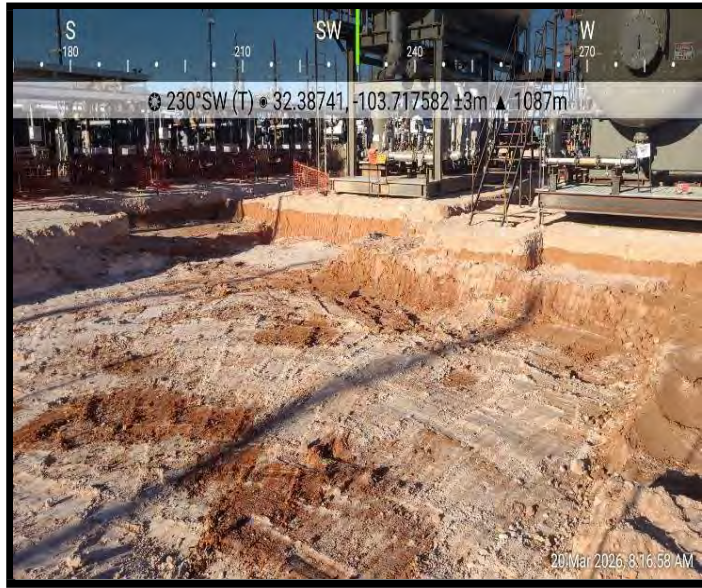
View of Excavation

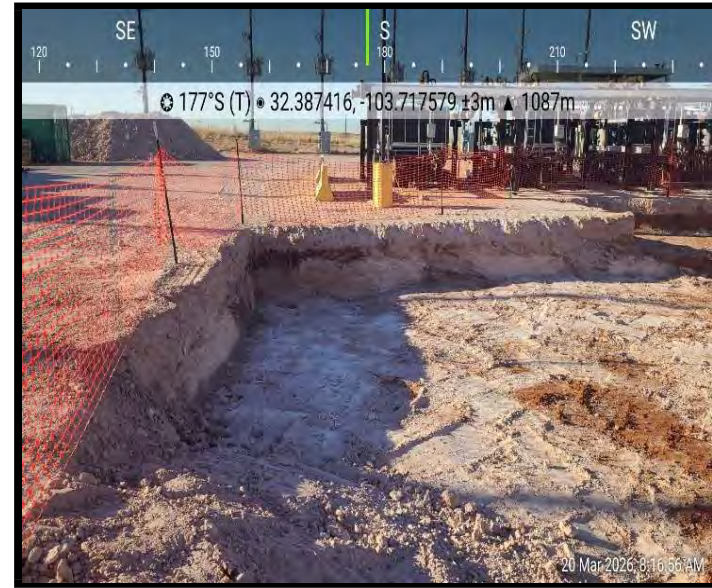
View of Excavation

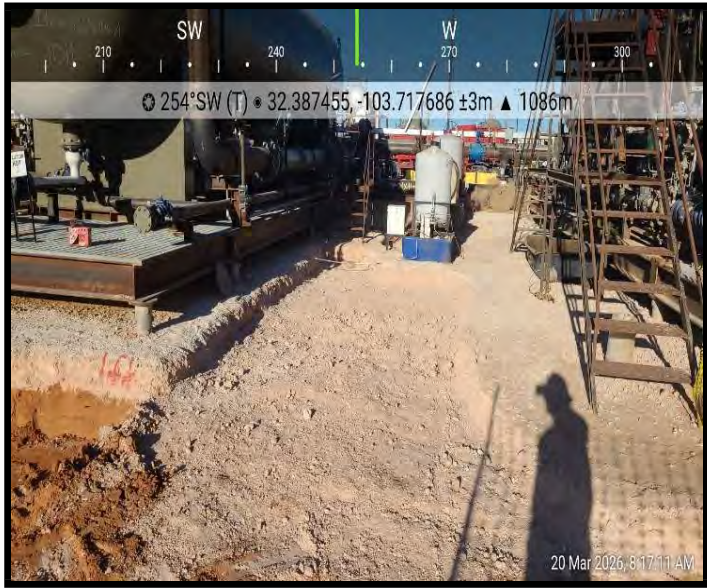
View of Excavation

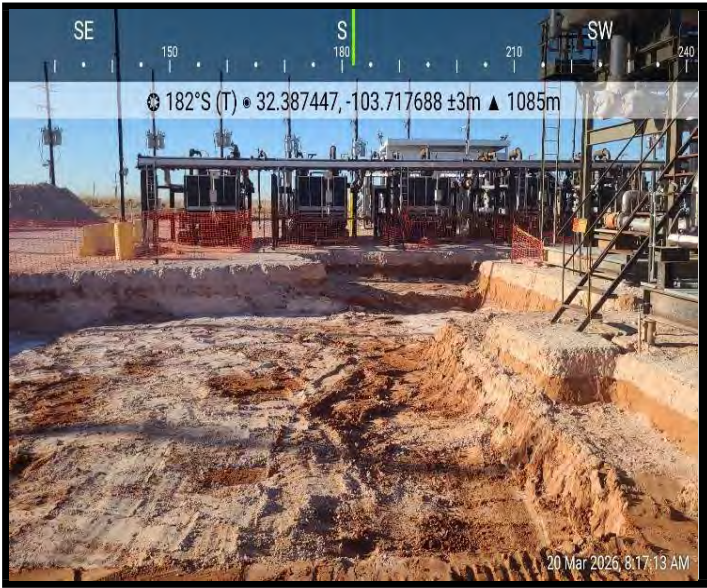
View of Excavation

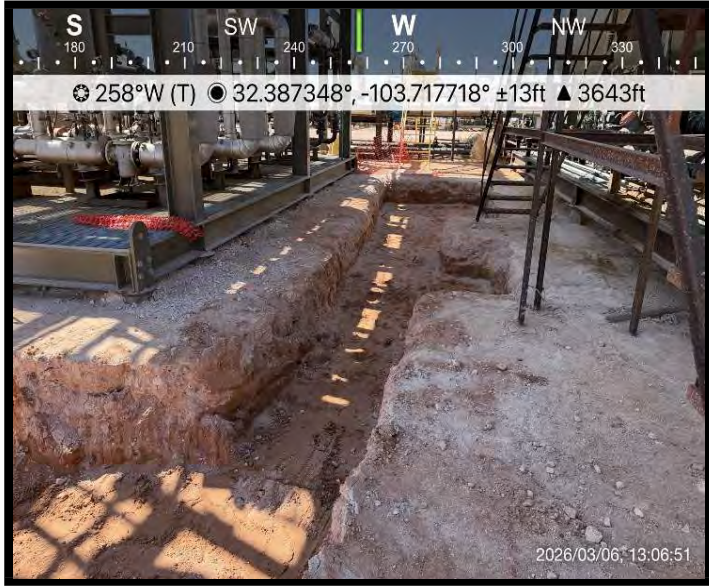
View of Excavation

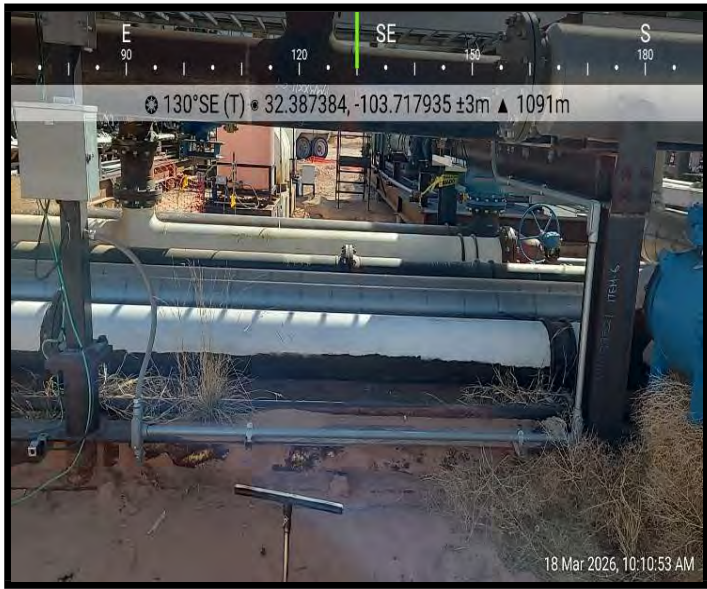
Deferral Sampling

On March 18<sup>th</sup>, 2026, six (6) vertical delineation sample points (i.e., DV-1 through DV-6) were installed with a hand auger in areas inaccessible for further excavation to accurately calculate the cubic yardage of remaining contaminants. All vertical samples were fully delineated. The deferral sampling data can be found in this report under Attachment A: Table 3 Deferral Samples Analytical Data Table and the lab report and chain of custody can be found under Attachment E: Laboratory Analytical Method Documentation with Chain-of-Custody.

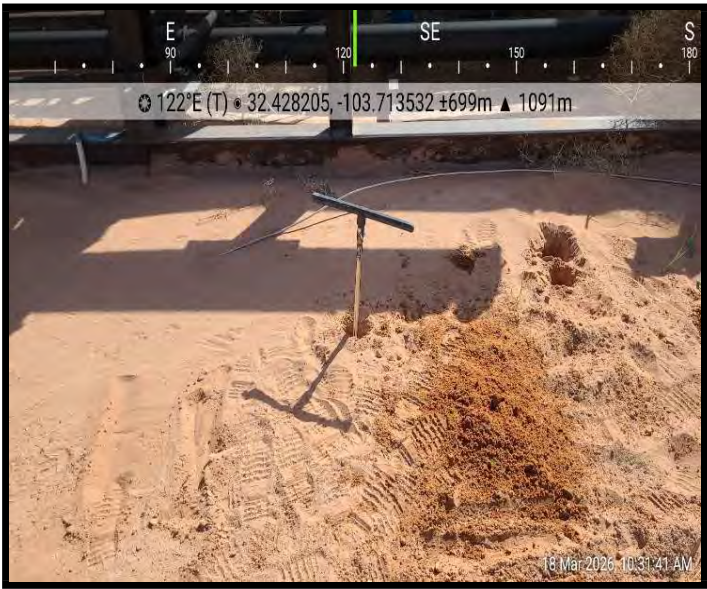
Deferral Sampling

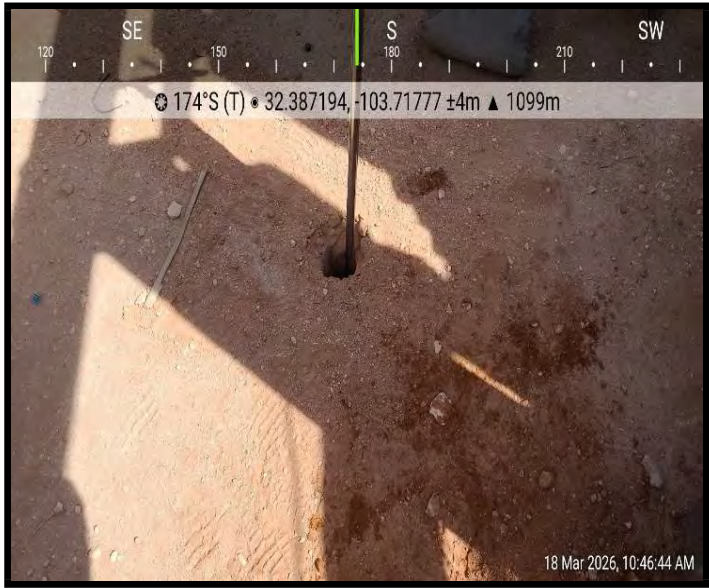
Deferral Sampling

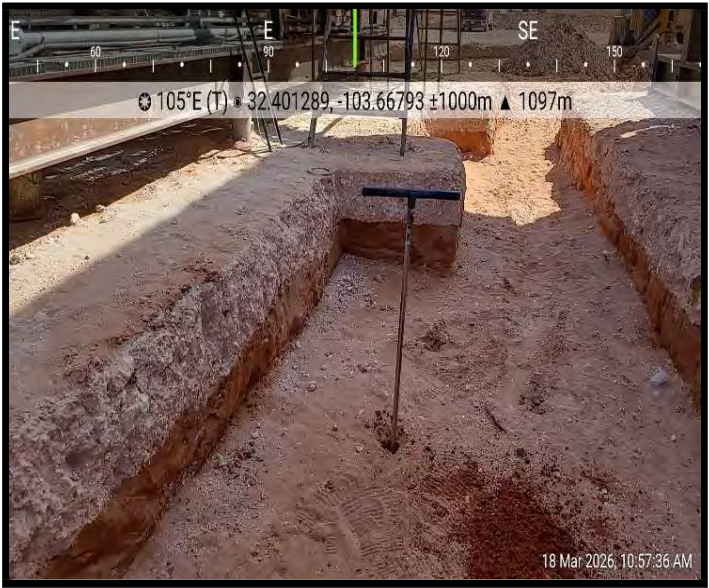
Deferral Sampling

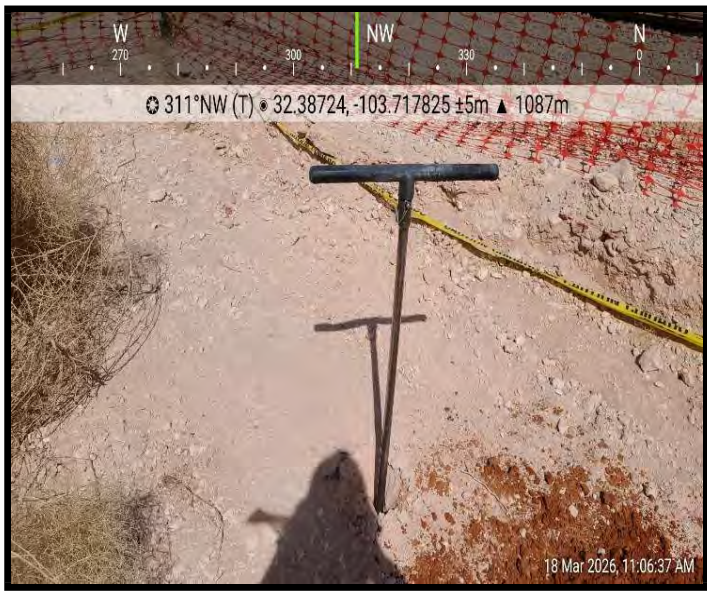
Deferral Sampling

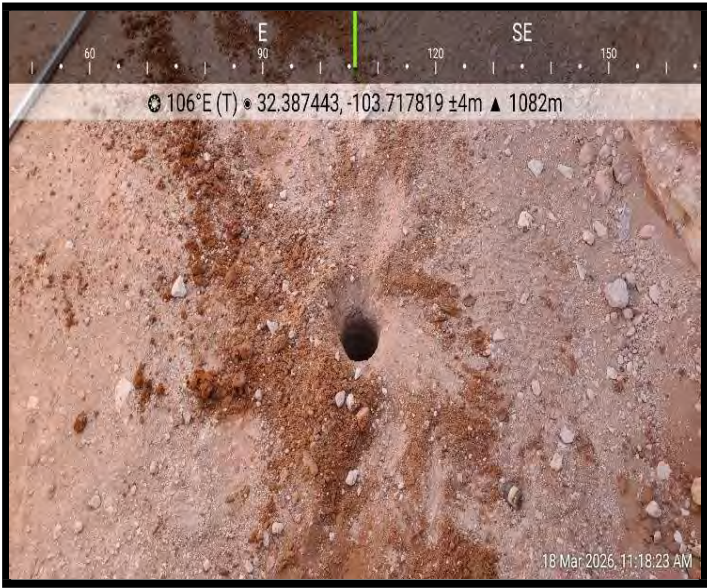
Deferral Sampling
