**Re: Reclamation Report
PLU CVX JV BS 013H
Incident Number nAPP2428842762
Eddy County, New Mexico**

Ensolum, LLC (Ensolum), on behalf of XTO Energy, Inc (XTO), has prepared the following *Reclamation Report* for the PLU CVX JV BS 013H (Site). This *Reclamation Report* documents the Site history, reclamation activities completed to date, and proposes a vegetation monitoring plan.

Photographic Log
XTO Energy, Inc
PLU CVX JV BS 013H
nAPP2428842762

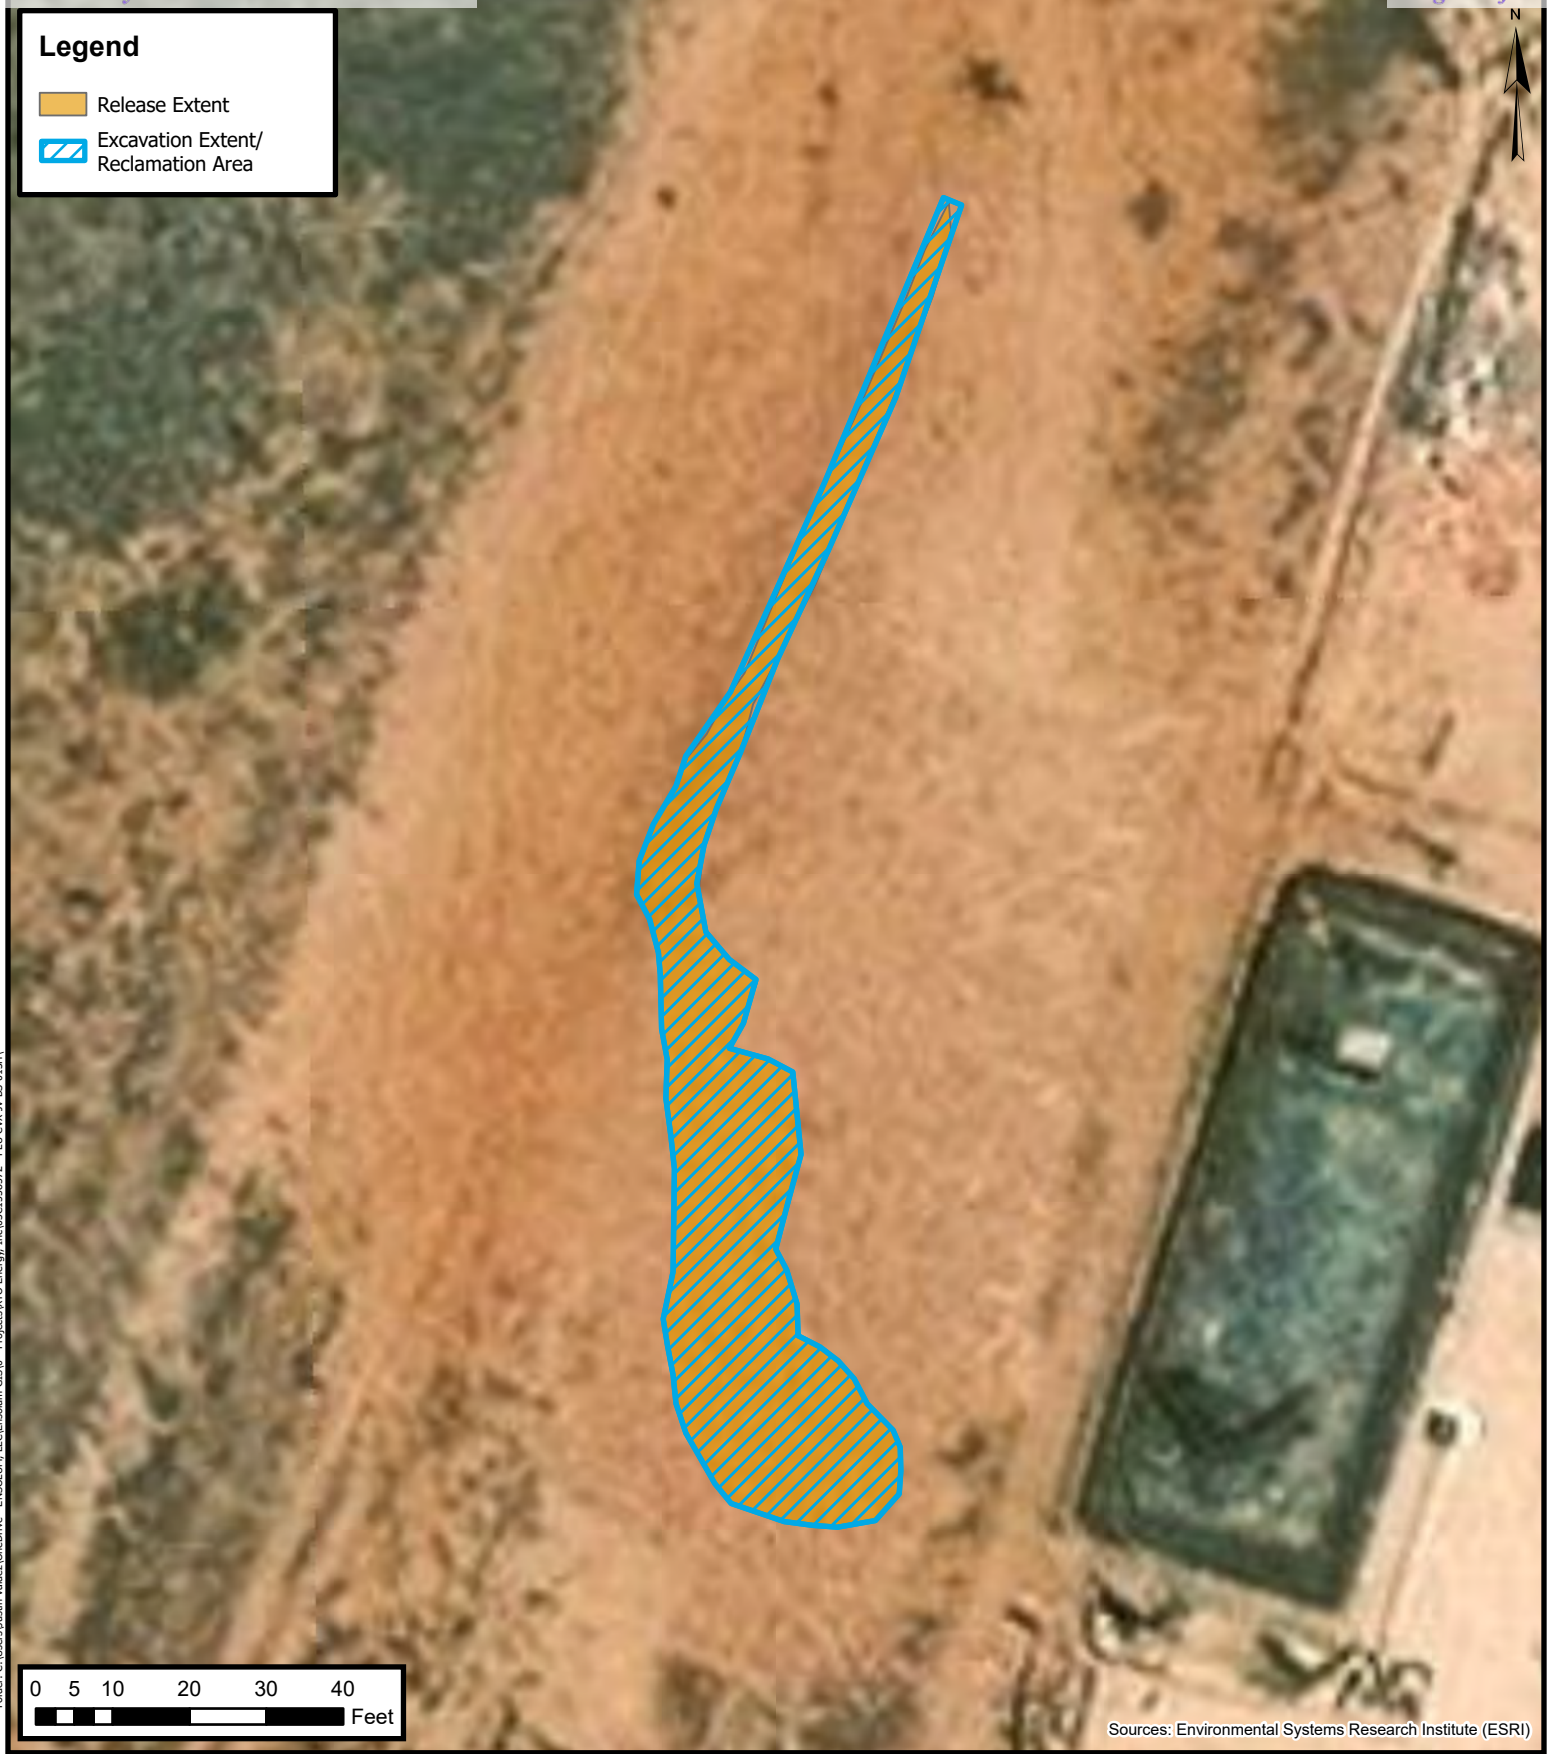
Excavation Extent/
Reclamation Area

pasture was backfilled with locally procured topsoil. Following backfill activities, the disturbed area was graded and contoured to match the surrounding topography. The release extent and reclamation area are shown on the attached Figure 1.

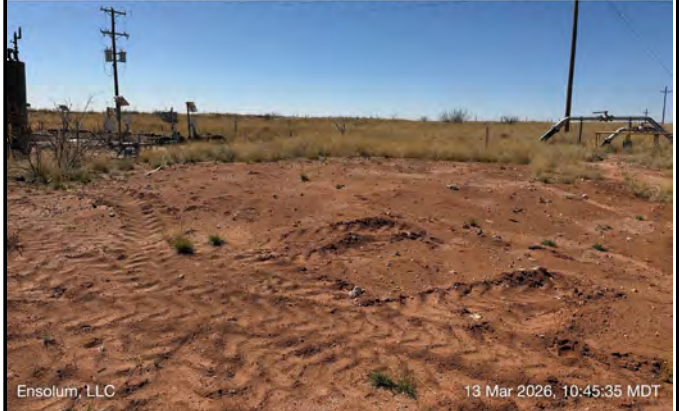
Photograph: 2 Date: 3/13/2026
Description: Backfilled Excavation Area
View: South

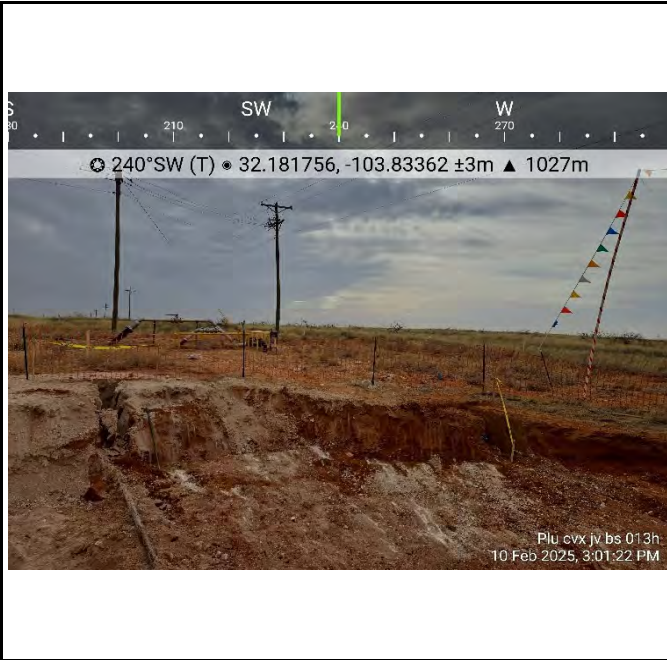
Photograph 1 Date: 2/10/2025
Description: Excavation extent, area of SW02/FS03.
View: Southwest

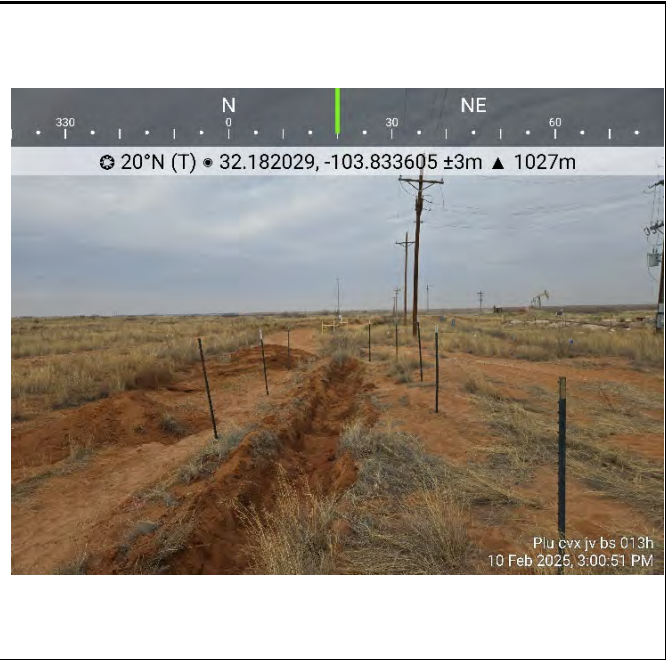
Photograph 2 Date: 2/10/2025
Description: Excavation extent, area of FS09.
View: Northeast

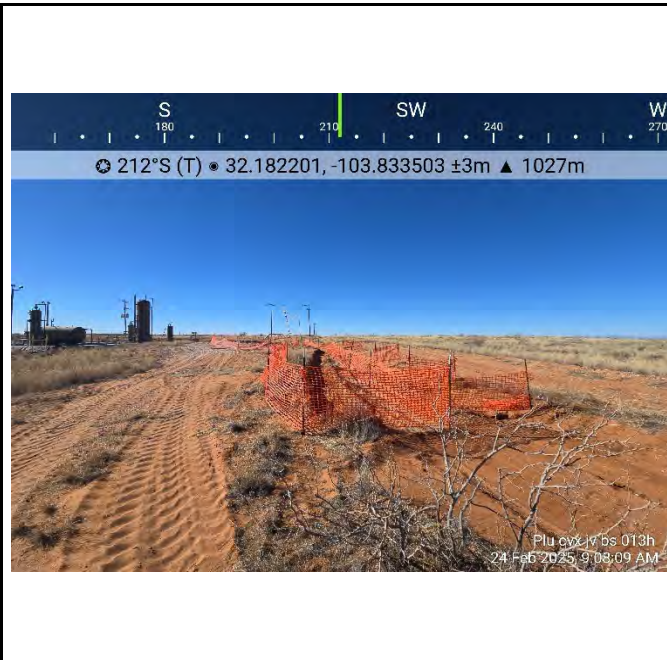
Photograph 3 Date: 2/24/2025
Description: Excavation extent, northern release area.
View: South

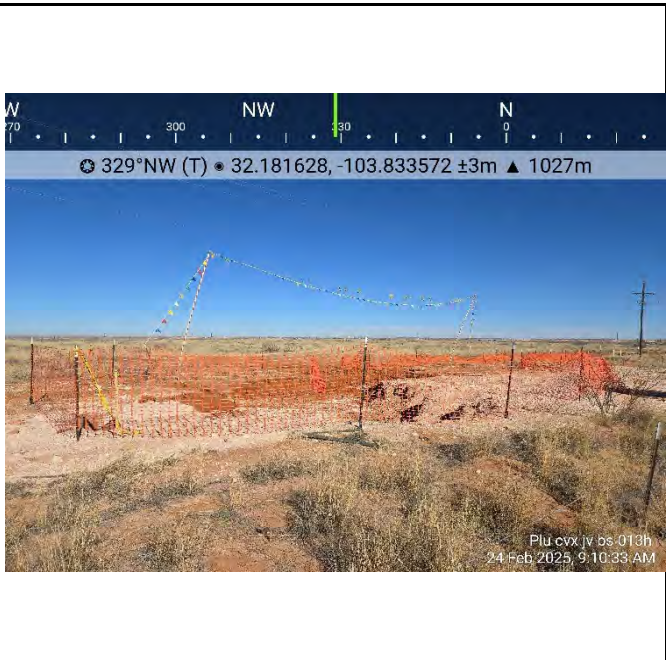
Photograph 4 Date: 2/24/2025
Description: Excavation extent, southern release area.
View: Northwest

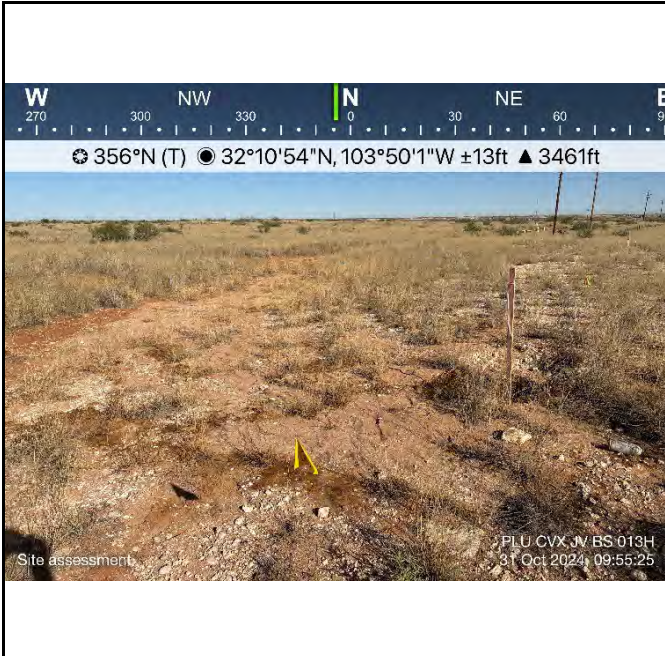
Photograph 1 Date: 10/31/2024
 Description: Site assessment on ROW.
 View: North

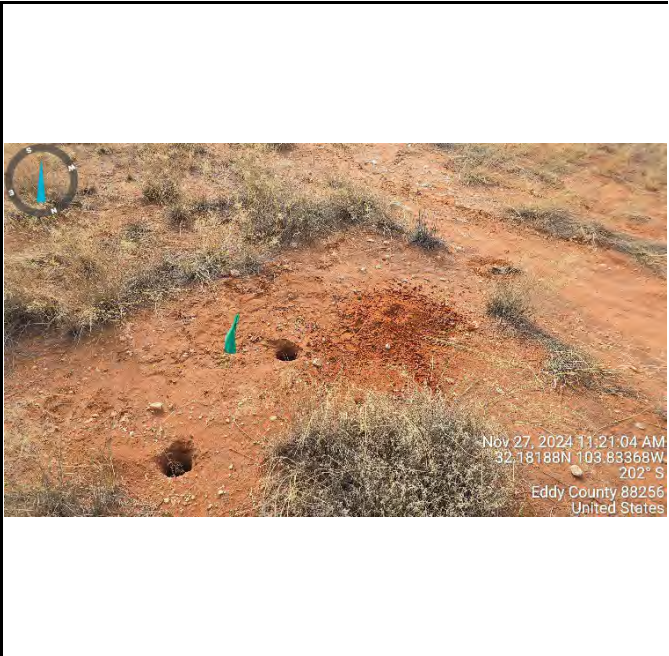
Photograph 6 Date: 11/27/2024
Description: Vertical delineations on ROW.
View: South

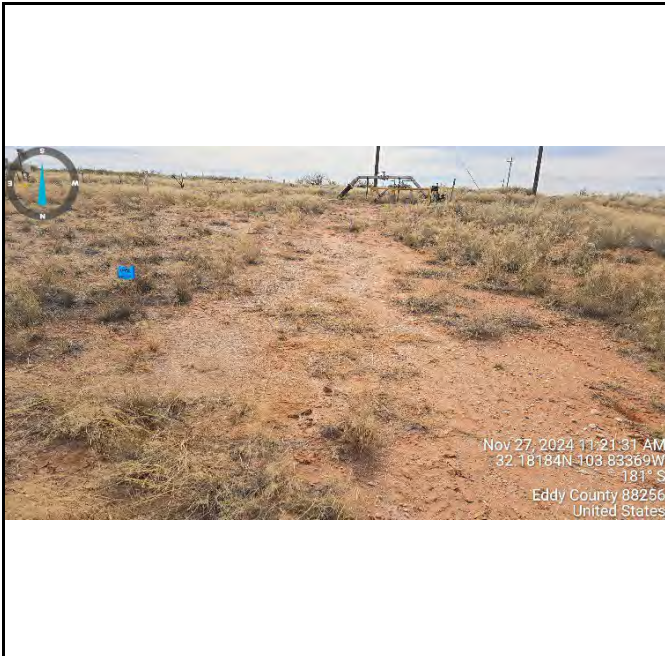
Photograph 7 Date: 11/27/2024
Description: Vertical delineations on ROW.
View: South

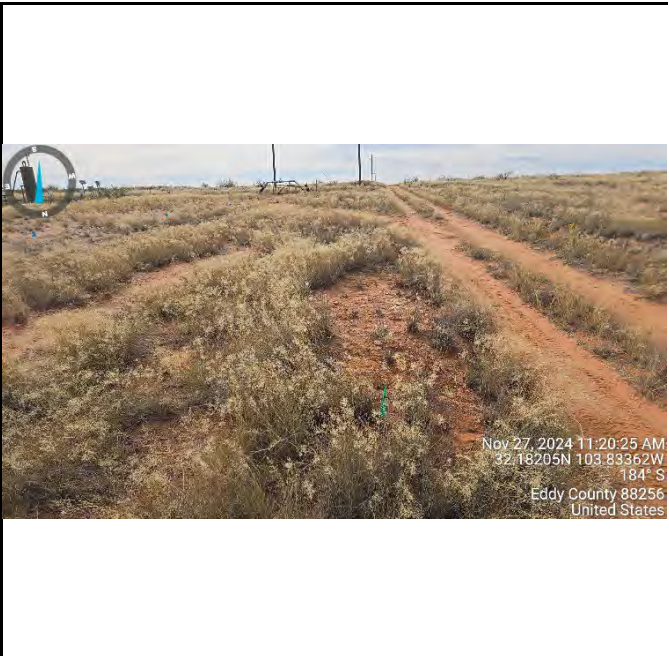
Photograph 8 Date: 11/27/2024
Description: Vertical delineations on ROW.
View: South
