**Re: Remediation Work Plan  
PLU PB 04-26-31 USA Battery  
Incident Number nAPP2435351259  
Eddy County, New Mexico**

Ensolum, LLC (Ensolum), on behalf of XTO Energy, Inc (XTO), has prepared this *Remediation Work Plan (Work Plan)* to document the findings of a liner integrity inspection and delineation activities conducted at the PLU PB 04-26-31 USA Battery (Site) following a release of produced water within a 1,205 square foot, steel walled lined containment. The containment houses vertical separator equipment and production piping. Based on the field observations and soil sample laboratory analytical results, XTO is submitting this *Work Plan*, describing the inspection results and delineation activities, and proposing excavation of impacted soil underneath the lined containment for Incident Number nAPP2435351259.

# **Environmental Karst Study Report PLU PB 04-26-31 USA Battery Eddy County, New Mexico**

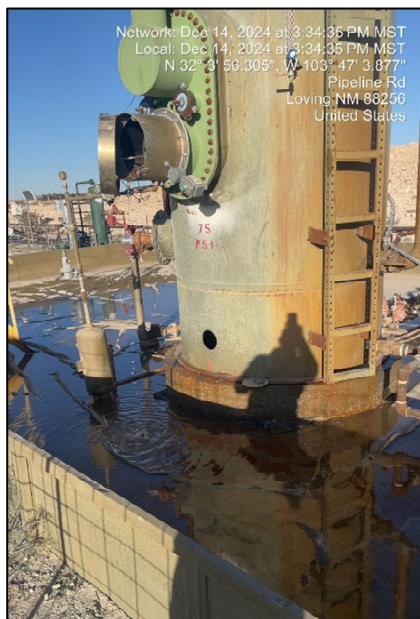
Photograph: 1 Date: 12/14/2024  
Description: Initial release extent  
View: Northwest

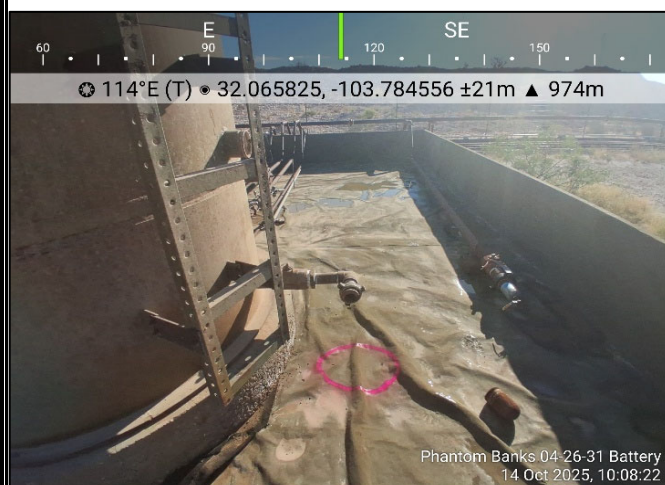
Photograph: 3 Date: 10/14/2025  
Description: Liner inspection activities near identified holes (BH01)  
View: Southeast

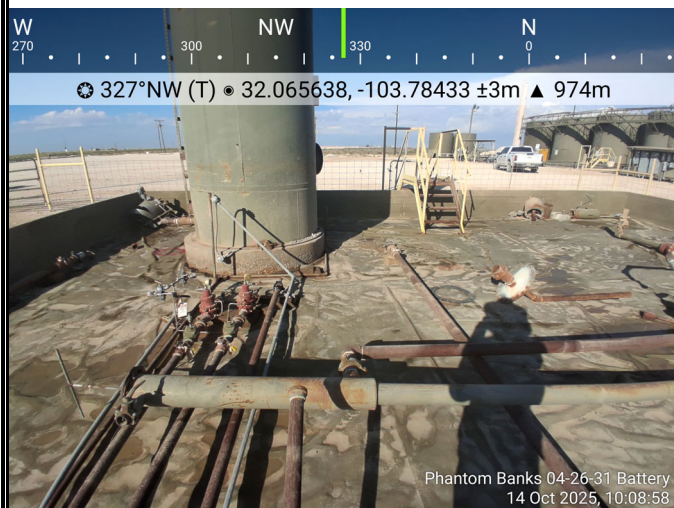
Photograph: 5 Date: 10/14/2025  
 Description: Liner inspection activities near central portion of liner  
 View: Northwest

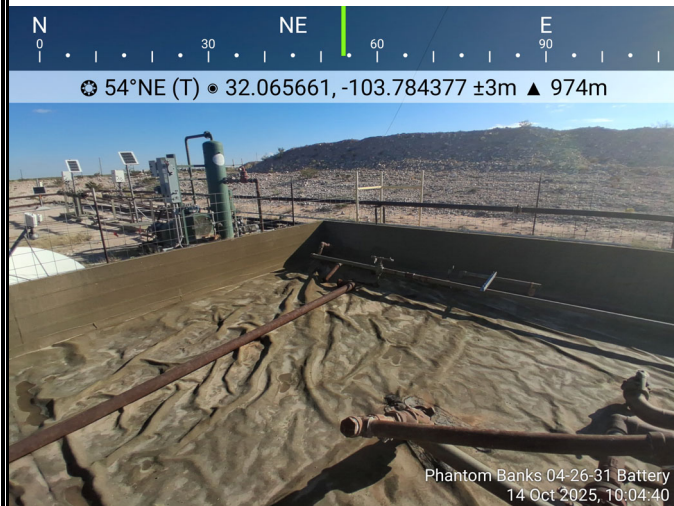
Photograph: 7 Date: 10/14/2025  
 Description: Liner inspection activities near northwest corner  
 View: Northeast

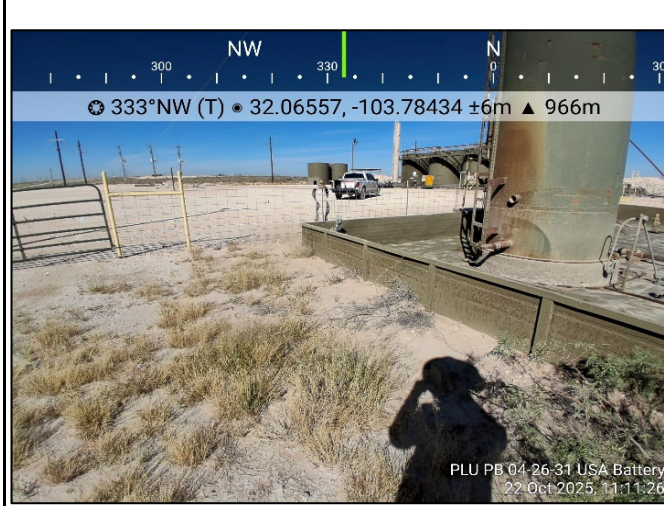
Photograph: 8 Date: 10/22/2025  
 Description: Delineation activities; near SS03  
 View: Northwest

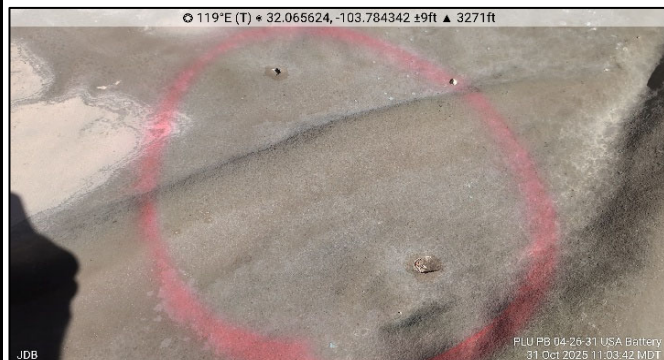
Photograph: 9 Date: 10/31/2025  
Description: Identified holes near BH01; approx 18" apart  
View: Direct

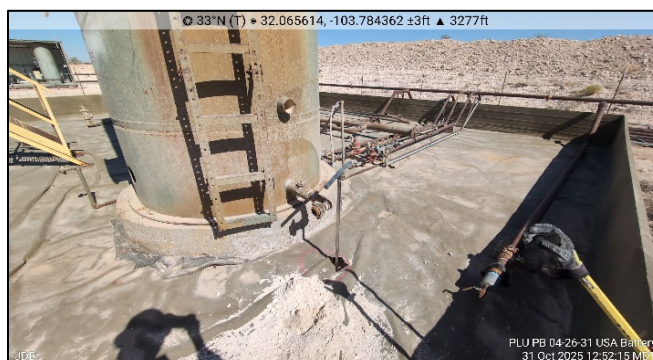
Photograph: 10 Date: 10/31/2025  
Description: Delineation activities; near BH01  
View: North

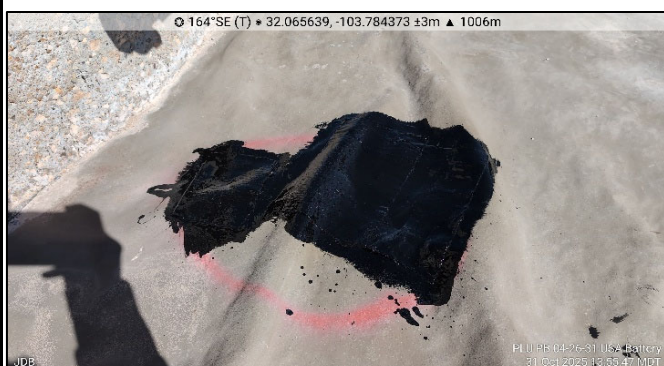
Photograph: 11 Date: 10/31/2025  
Description: Liner patching activities near BH01  
View: Direct

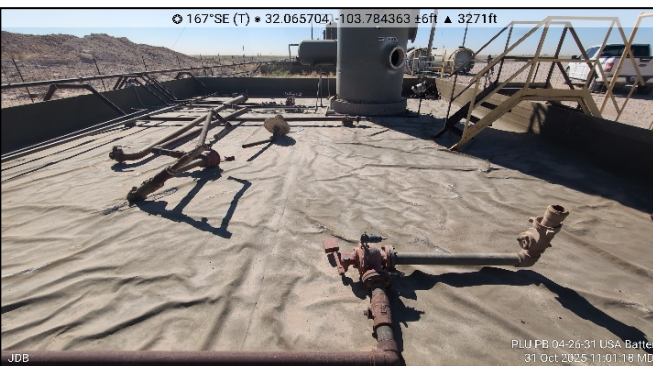
Photograph: 12 Date: 10/31/2025  
Description: Northern section of liner  
View: Southeast

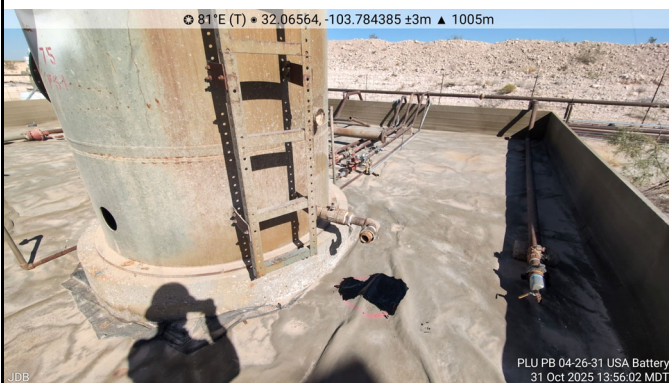
Photograph: 13 Date: 10/31/2025  
Description: Liner patching activities near BH01  
View: East

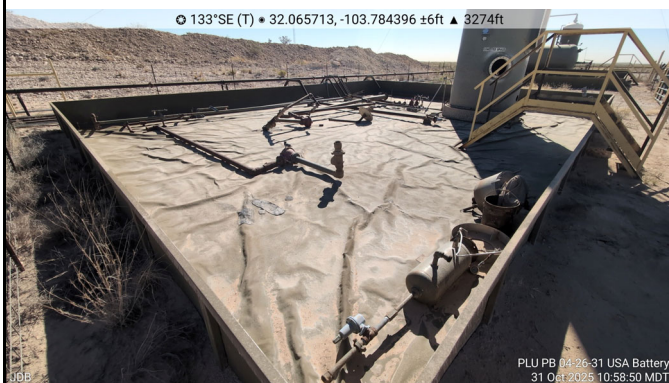
Photograph: 14 Date: 10/31/2025  
Description: Full view of liner, northwest corner  
View: Southeast

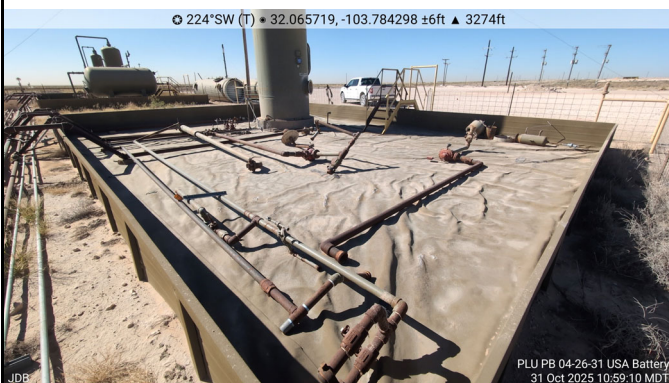
Photograph: 15 Date: 10/31/2025  
Description: Full view of liner, northeast corner  
View: Southwest

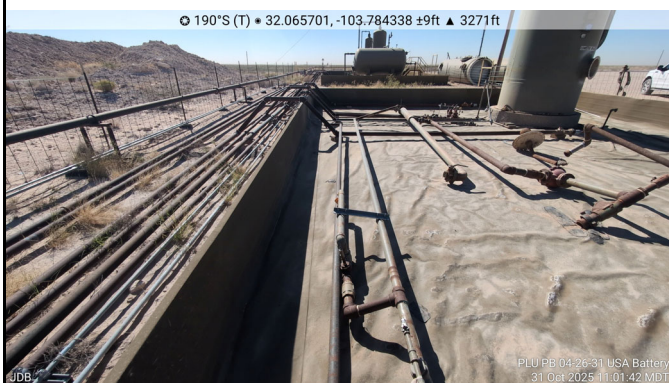
Photograph: 16 Date: 10/31/2025  
Description: Eastern wall  
View: South

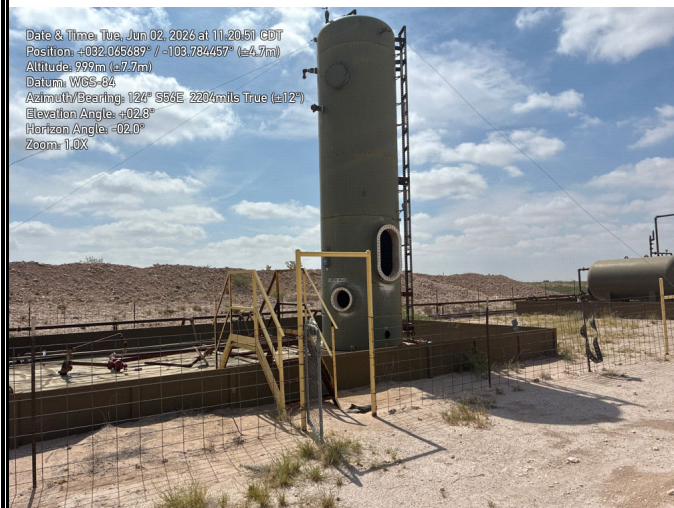
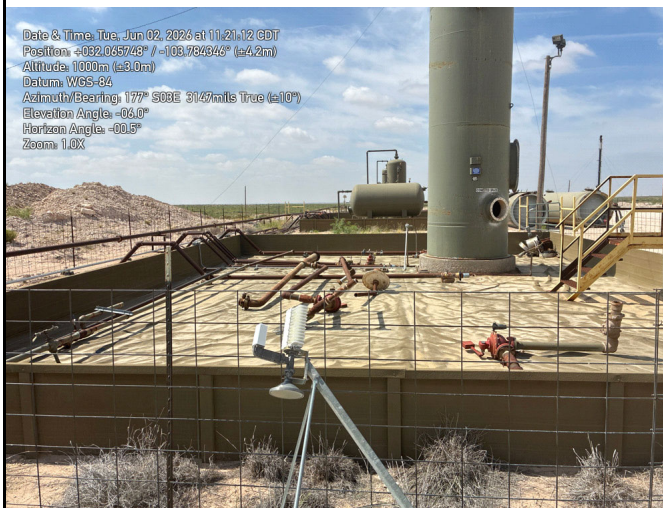
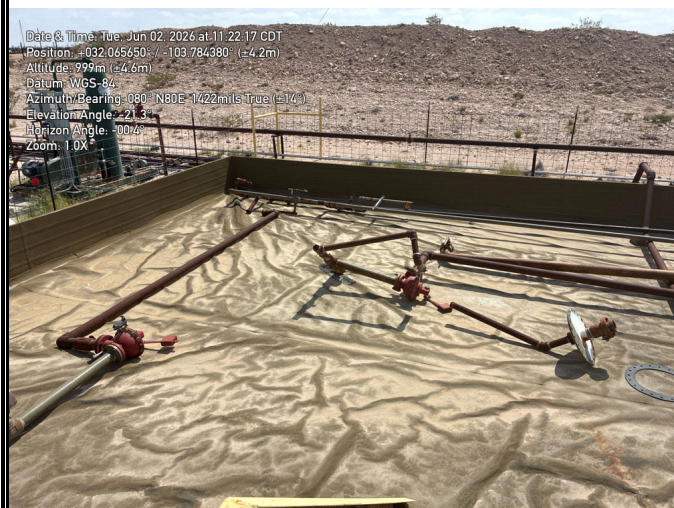
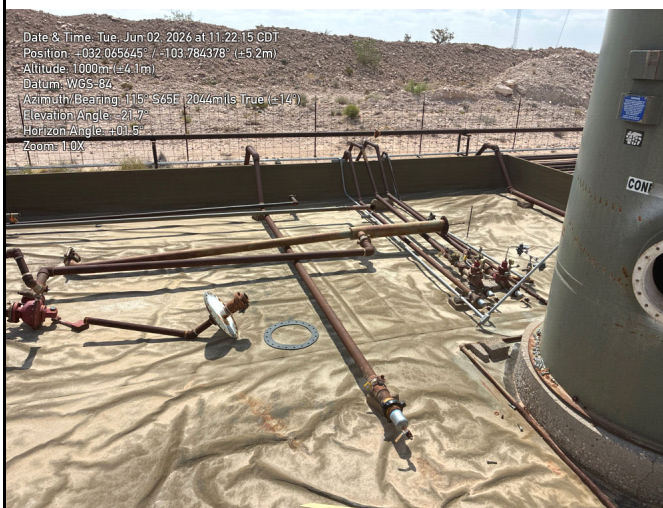
Photograph: 17 Date: 6/2/2026  
 Description: Liner deconstruction activities  
 View: Southeast

Photograph: 18 Date: 6/2/2026  
 Description: Liner deconstruction activities  
 View: South

Photograph: 19 Date: 6/2/2026  
 Description: Liner deconstruction activities  
 View: East

Photograph: 20 Date: 6/2/2026  
 Description: Liner deconstruction activities  
 View: East

- Excavation of impacted soil to a depth of 2 feet bgs. Excavation will proceed laterally until sidewall samples confirm all COC concentrations are compliant with the strictest Table I Closure Criteria.
- An estimated 90 cubic yards of impacted soil will be excavated. The excavated soil will be transferred a New Mexico approved landfill facility for disposal.
- Following excavation and a review of confirmation soil sampling results indicating all impacted soil has been removed, the excavation will be backfilled and recontoured to match pre-existing conditions.
