**Closure Report**  
**Lomas Rojas Water Line**  
**Incident ID: nAPP2532248697**  
**Lea County, New Mexico**  
**Unit O Sec 26 T25S R33E**  
**32.094734°, -103.541183°**

**Produced Water Release**  
**Point of Release: Equipment Failure on Flowline**  
**Release Date: 10/27/2025**  
**Volume Released: 19 Barrels of Produced Water**  
**Volume Recovered: 0 Barrels of Produced Water**

**Re: Closure Report**  
**Lomas Rojas Water Line (10.27.2025)**  
**EOG Resources Inc.**  
**NMOCD Incident ID: nAPP2532248697**  
**Site Location: Unit O, S26, T25S, R33E**  
**(Lat 32.094636°, Long -103.541045°)**  
**Lea County, New Mexico**

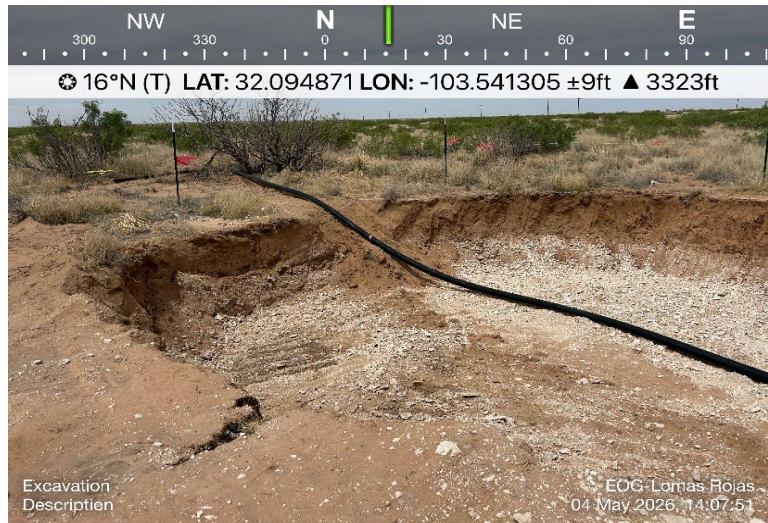
View North, area of CS-1

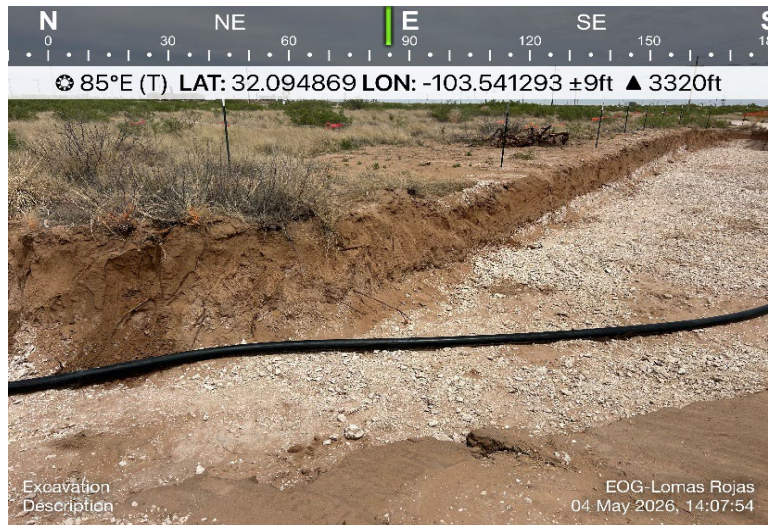
## Photograph No. 2

View East, area of CS-2 through CS-4

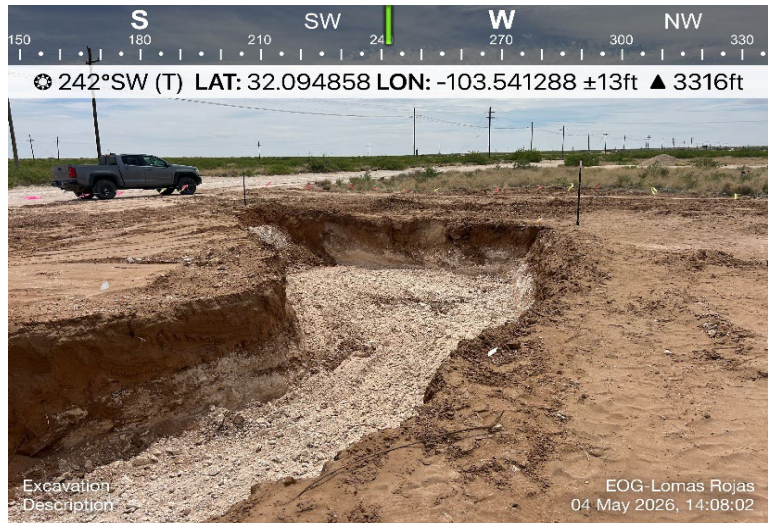
## Photograph No. 3

View Southwest, area of CS-5 through CS-8

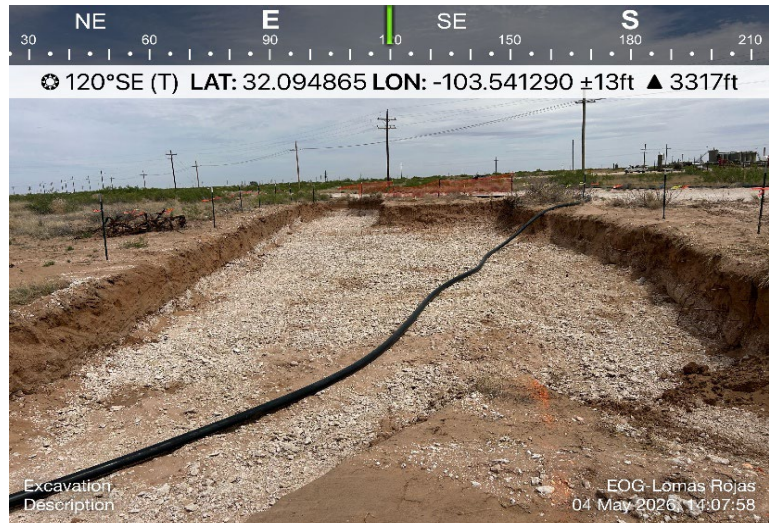
View Southeast, area of CS-9 through CS-14

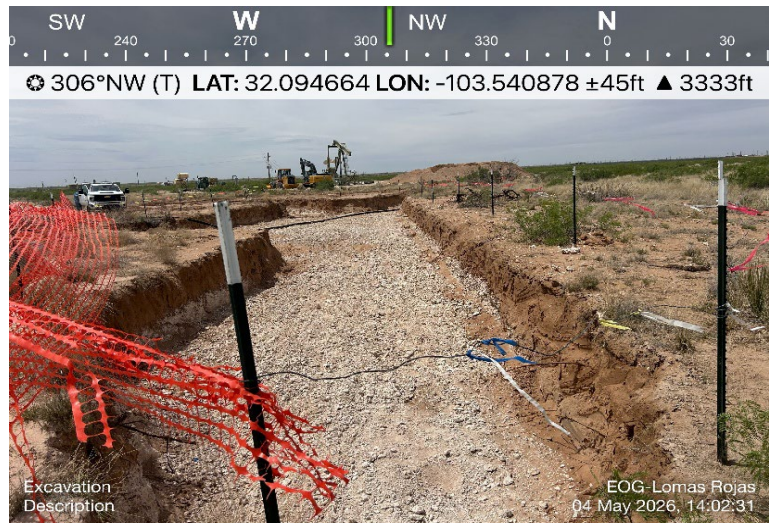
### Photograph No. 5

View Northwest, area of CS-15 through CS-19

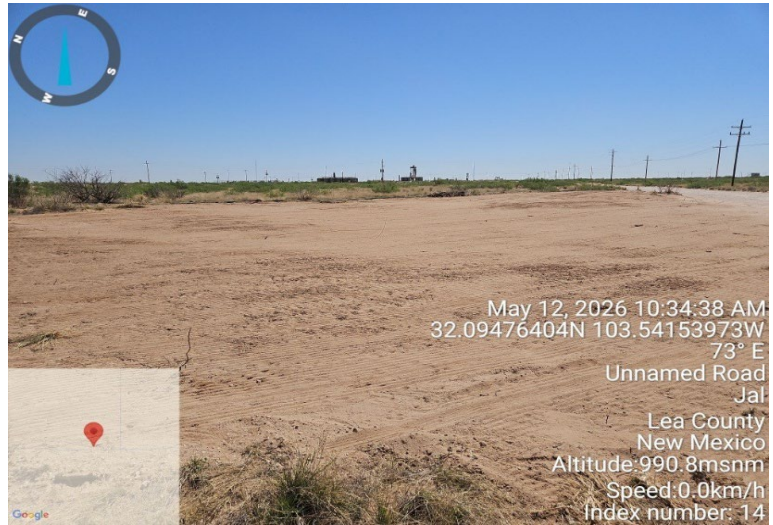
View East of backfilled and reclaimed area

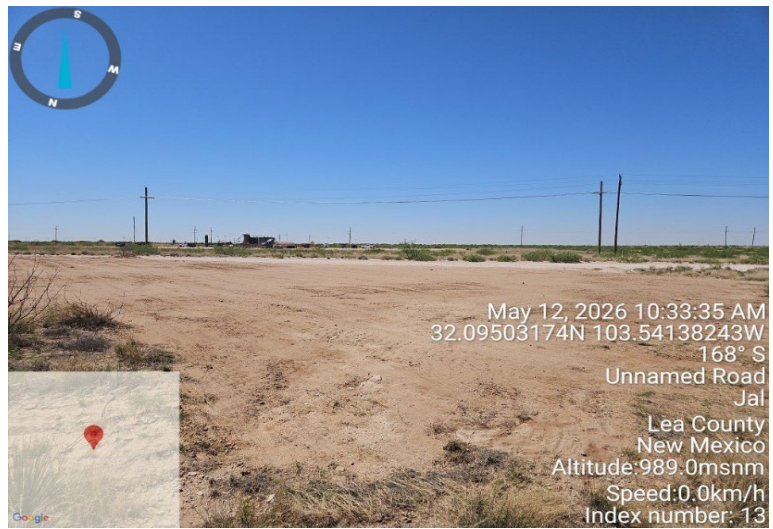
## Photograph No. 8

View South of backfilled and reclaimed area
