## Remediation Work Plan

**Roadhouse Federal Com #002H**

nAPP2612271122

**Remediation Work Plan**  
**Roadhouse Federal Com #002H**  
**nAPP2612271122**  
**API: 30-015-44279**  
**Section 06, Township 25, South, Range 29 East**  
**County: Eddy**

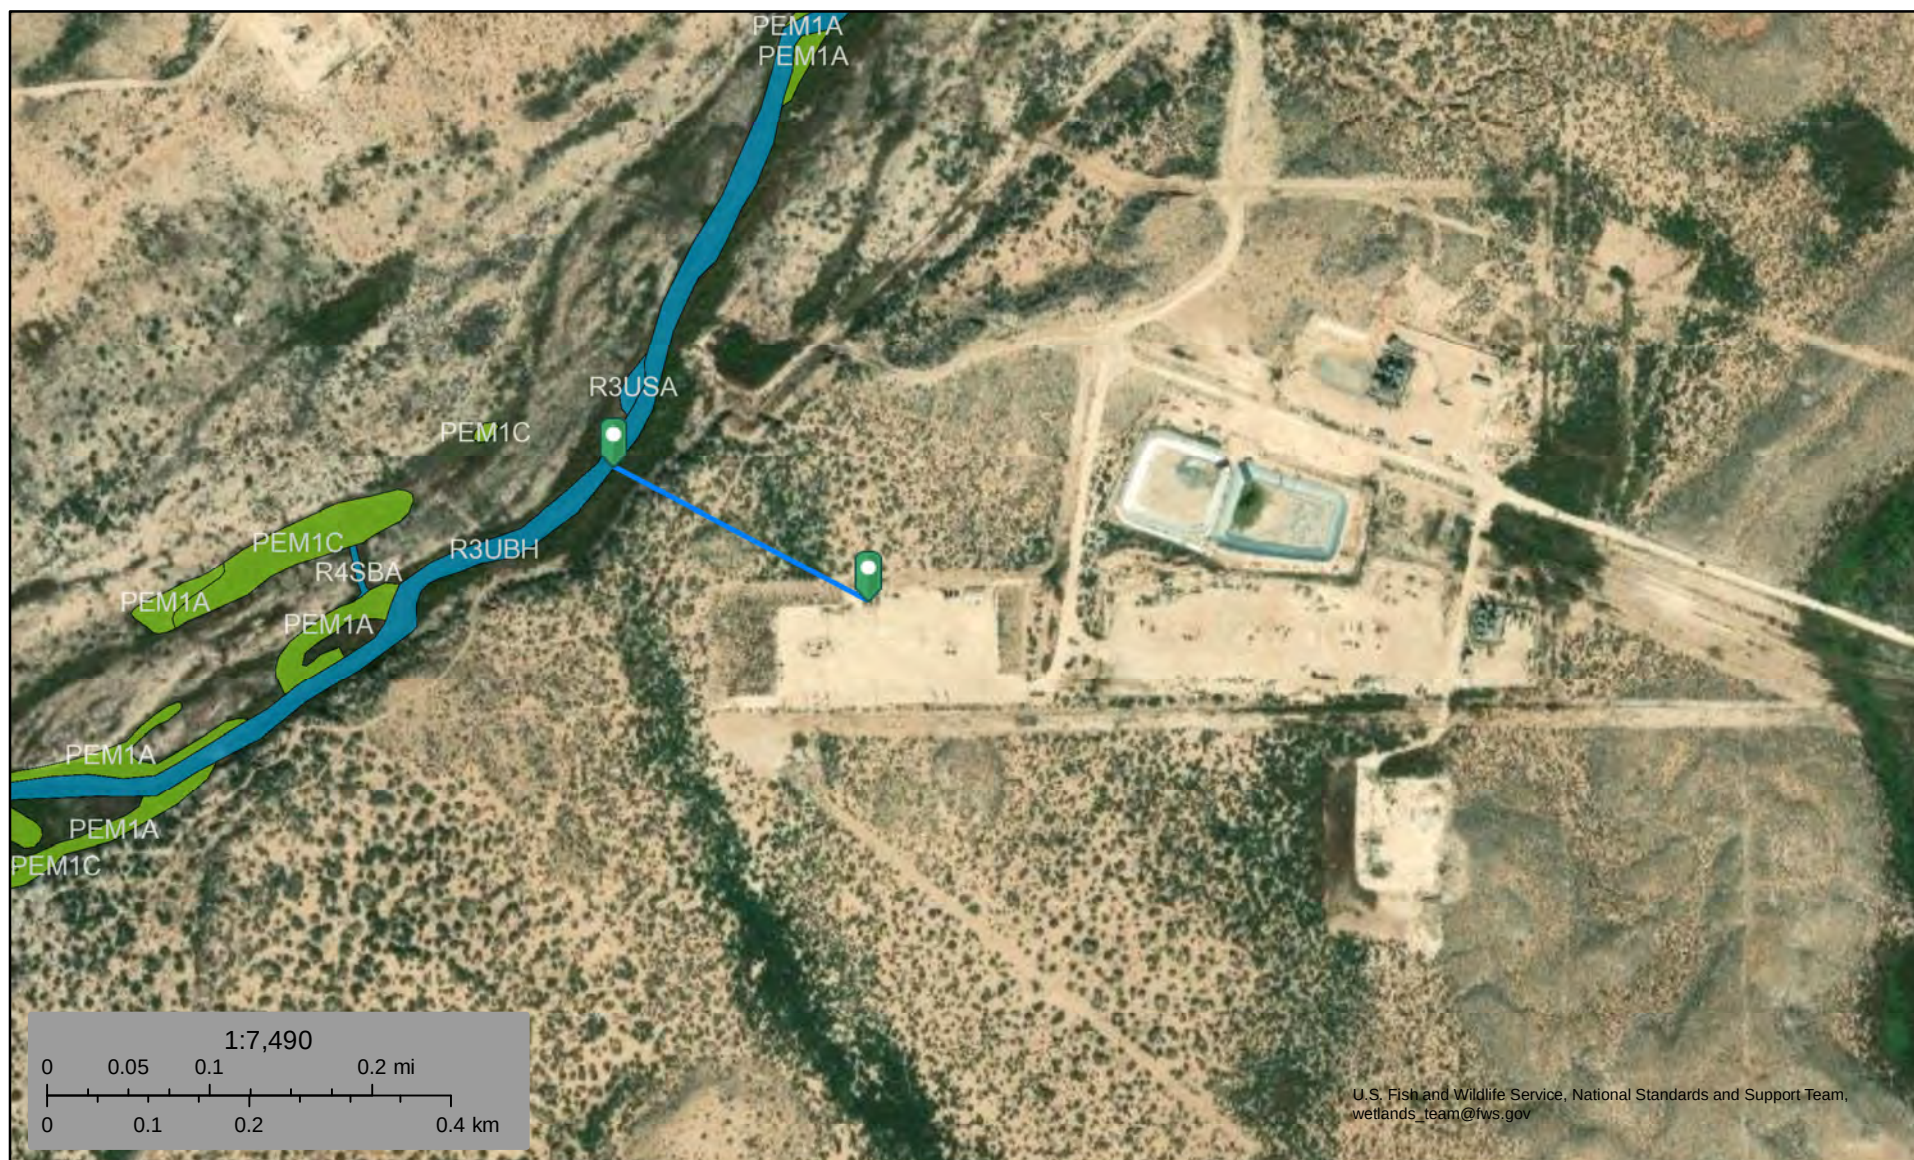
Watercourse 791 ft.

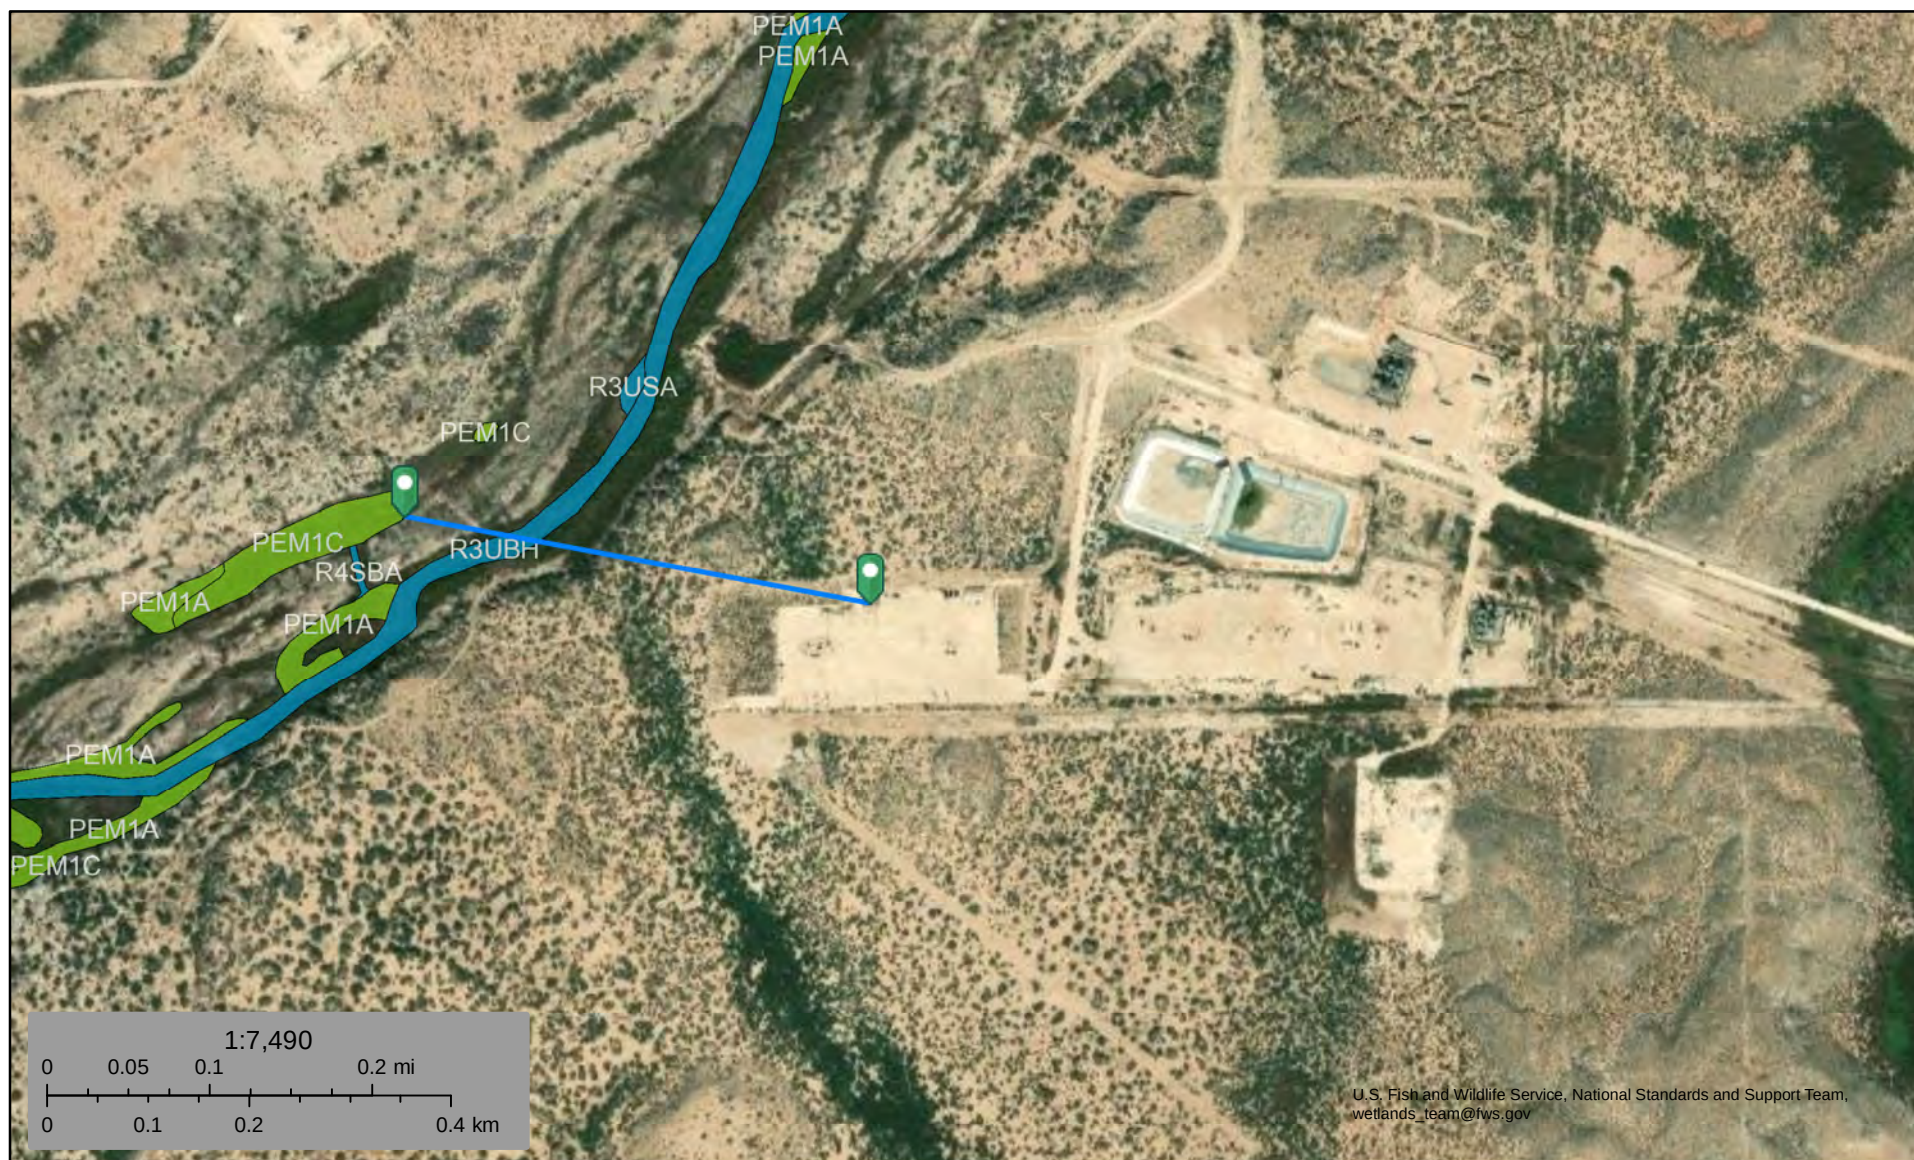
Playa 1,304 ft. W

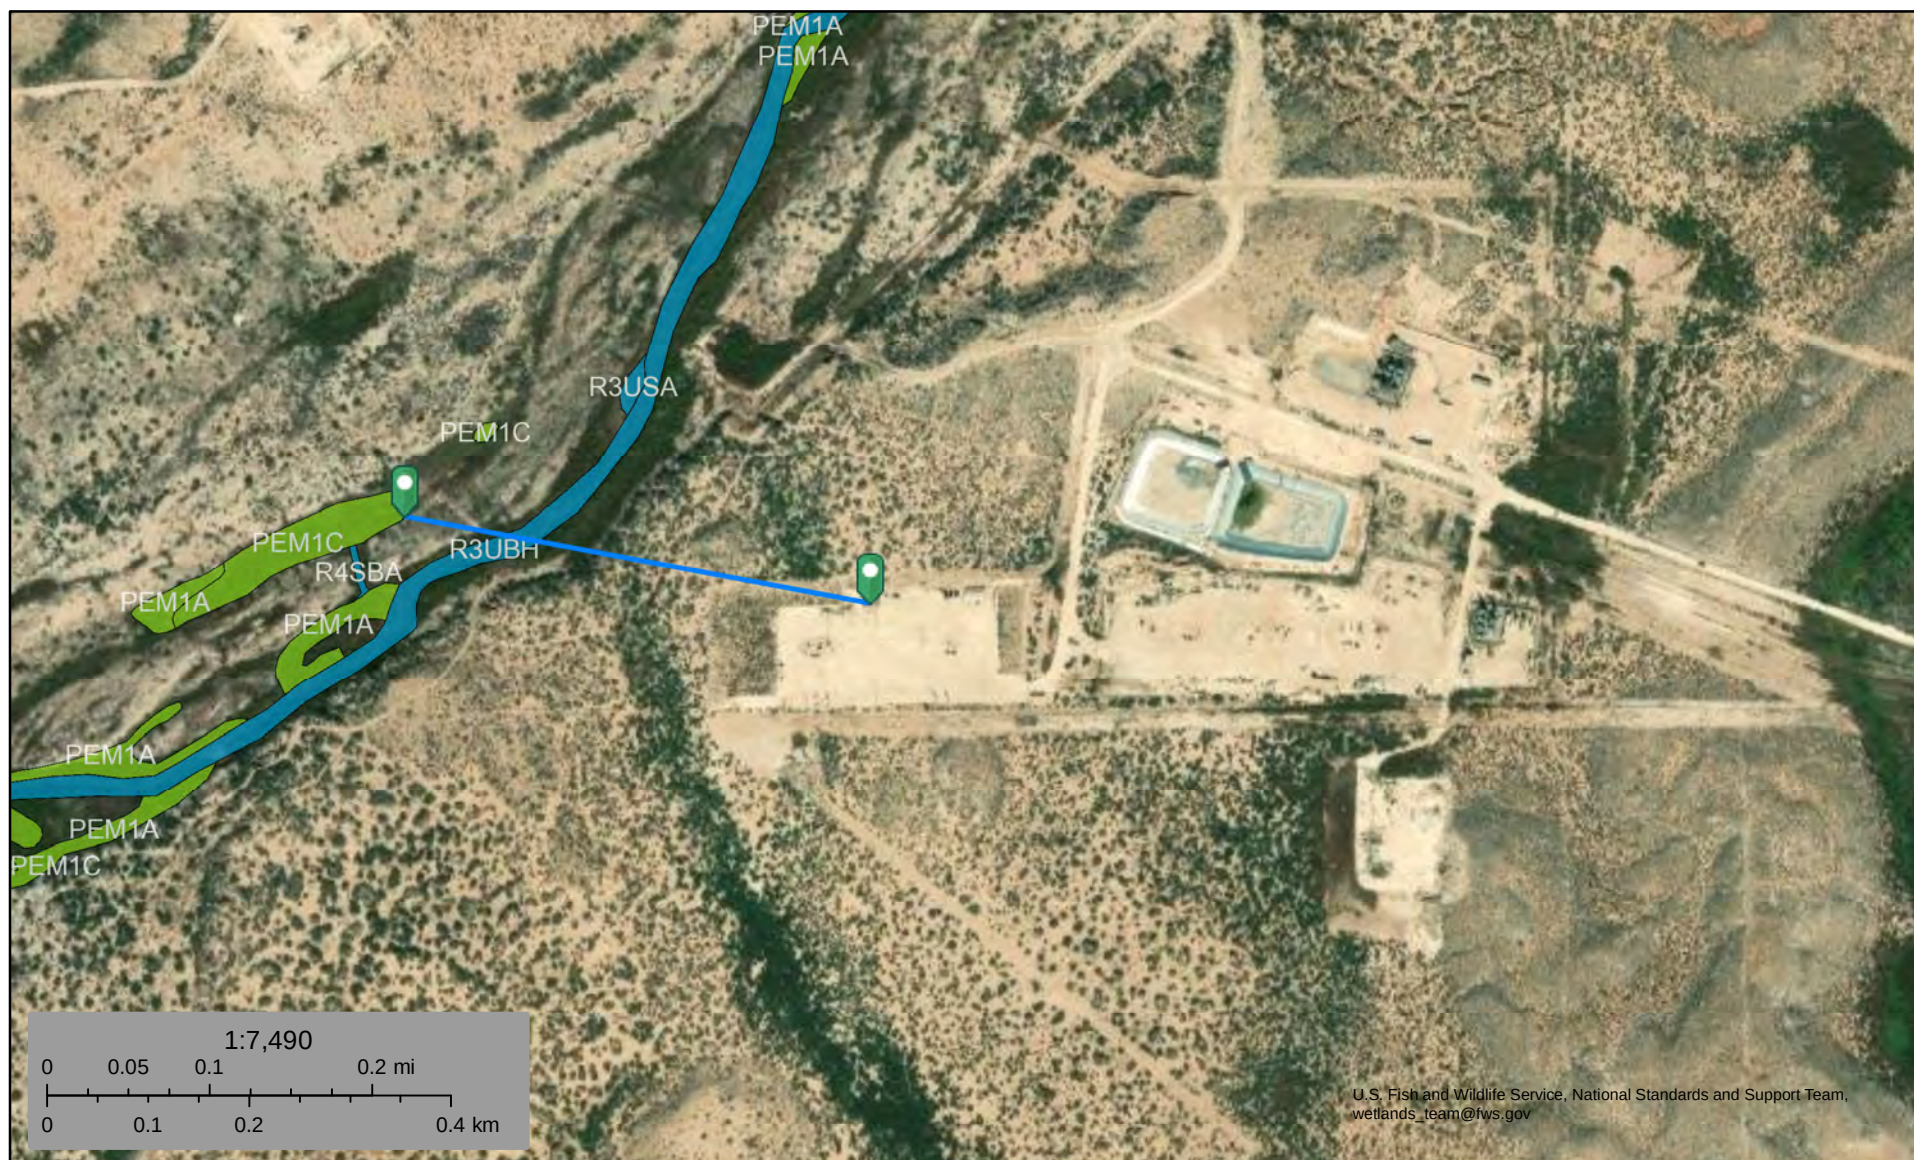
## Wetland 1304 ft. W

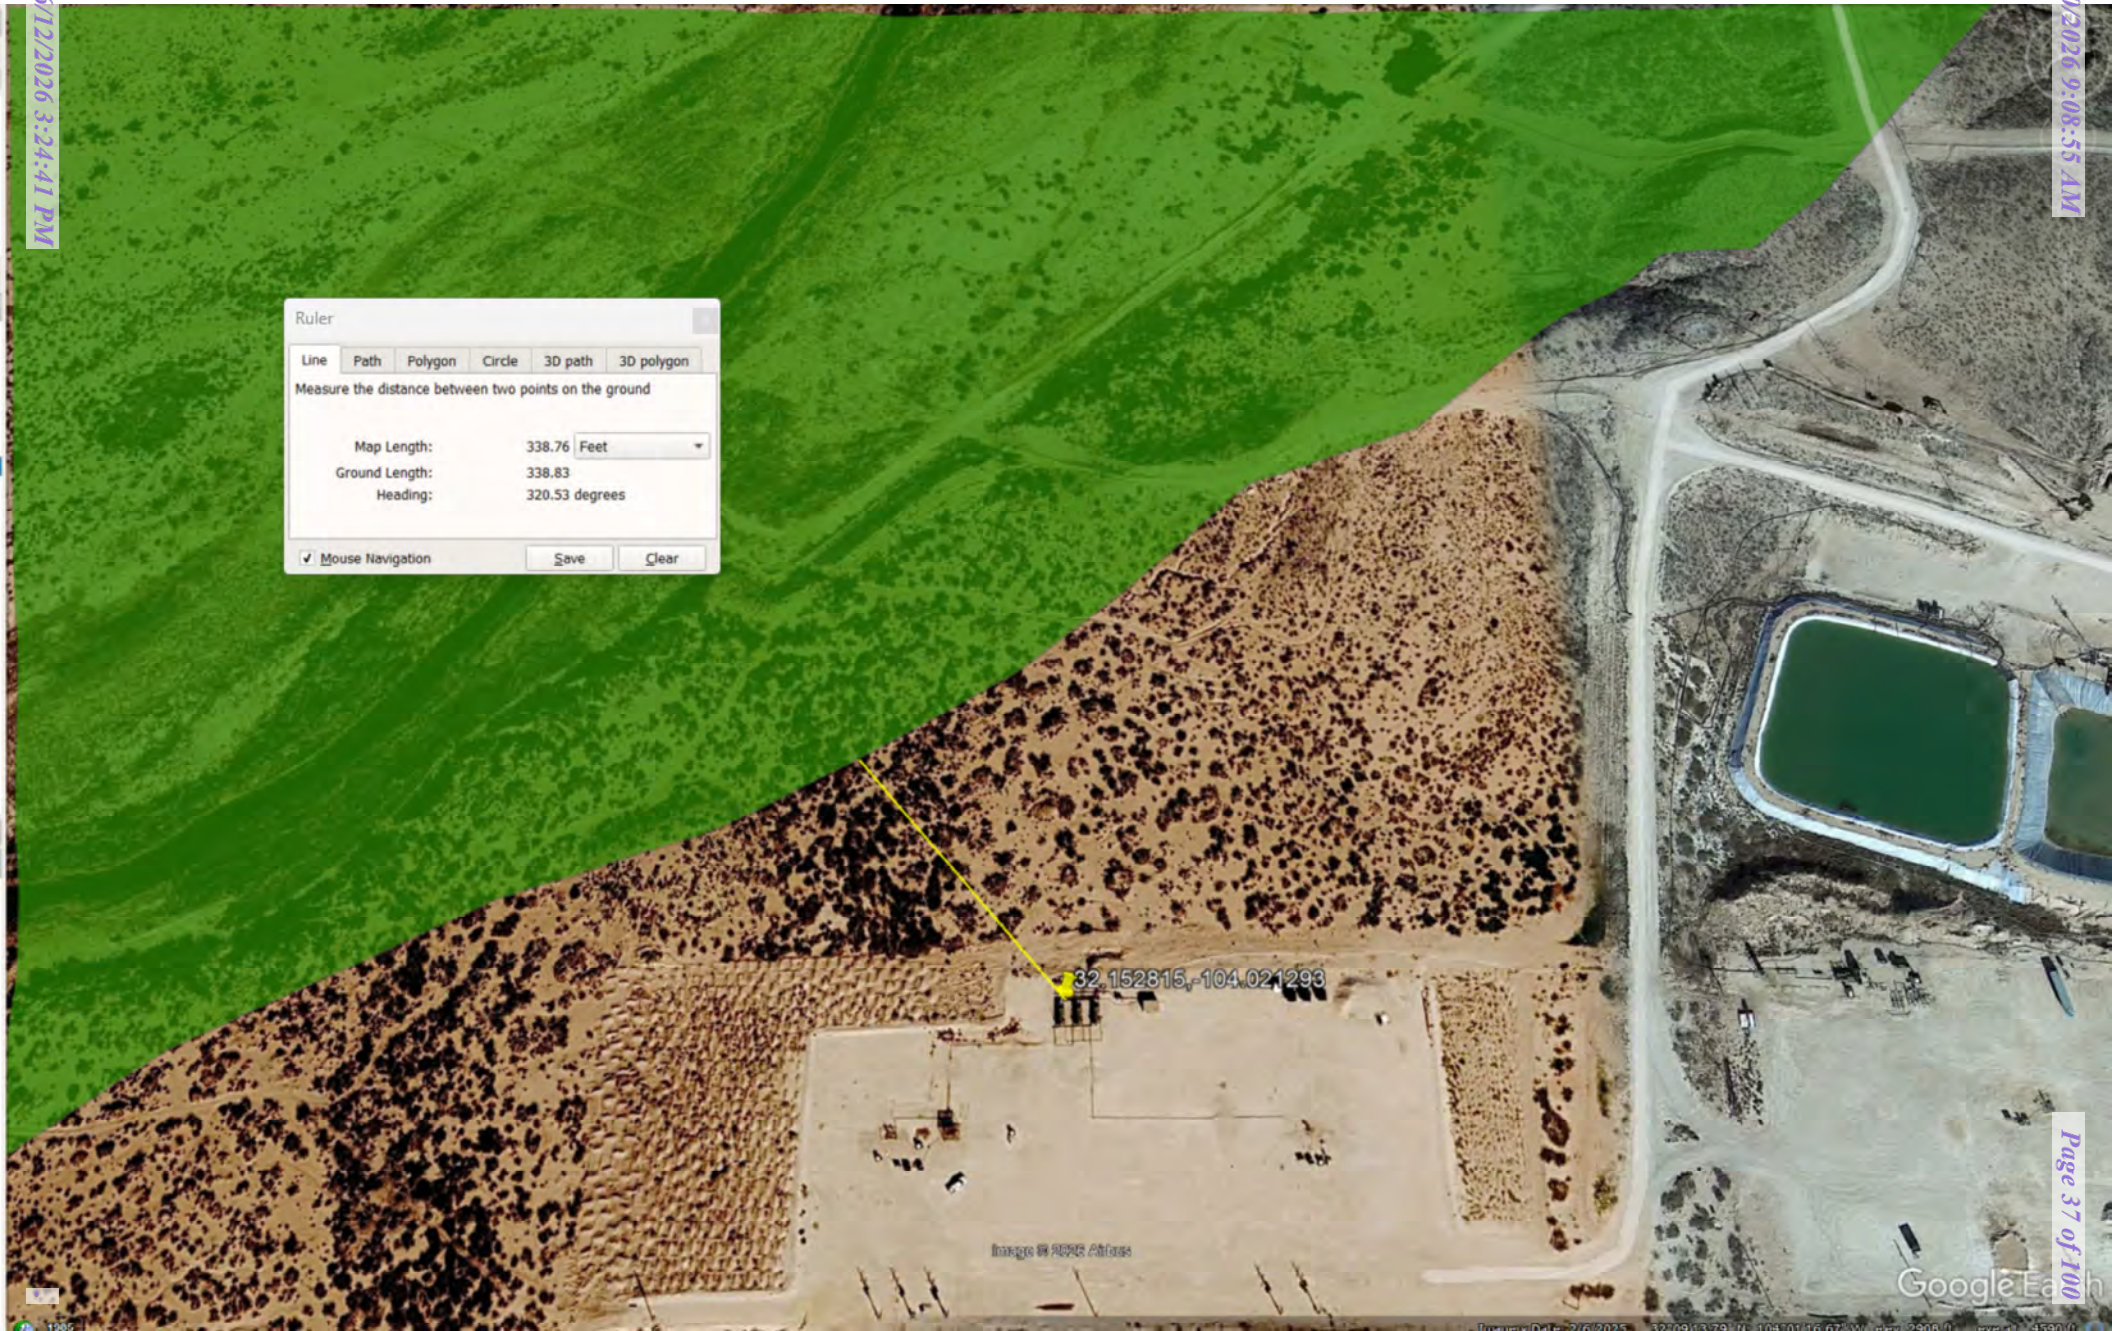
338 ft. to FEMA FloodZone A

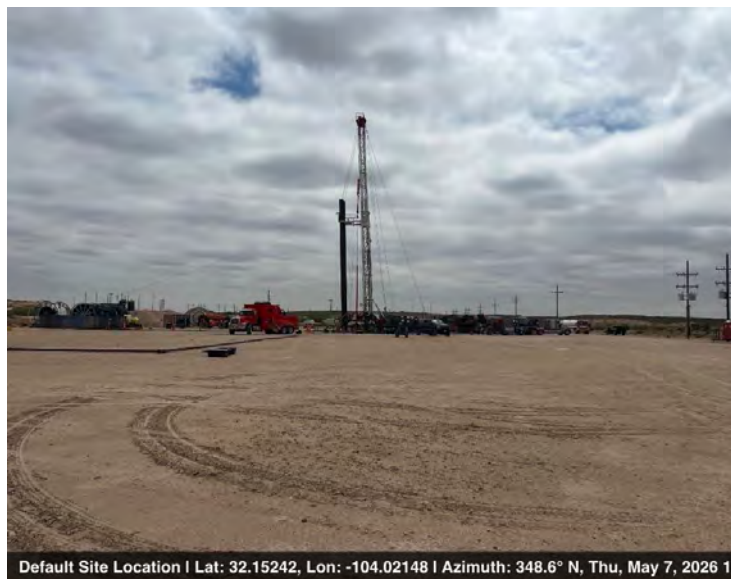
Date: 5/7/2026  
Time: 10:39  
Notes: Rig on location  
Latitude: 32.15241666666667  
Longitude: -104.02147777777778  
Direction: N

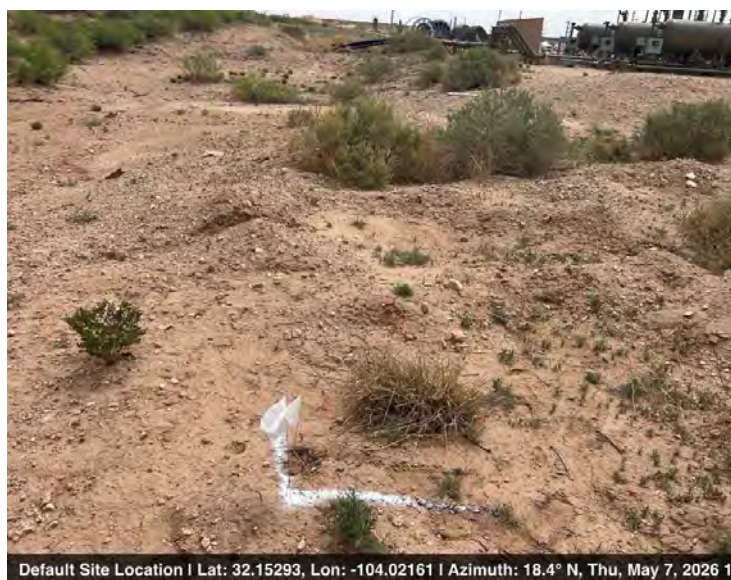
Date: 5/7/2026  
Time: 11:11  
Notes: 811 corners placed  
Latitude: 32.152927777777776  
Longitude: -104.02160555555555  
Direction: N

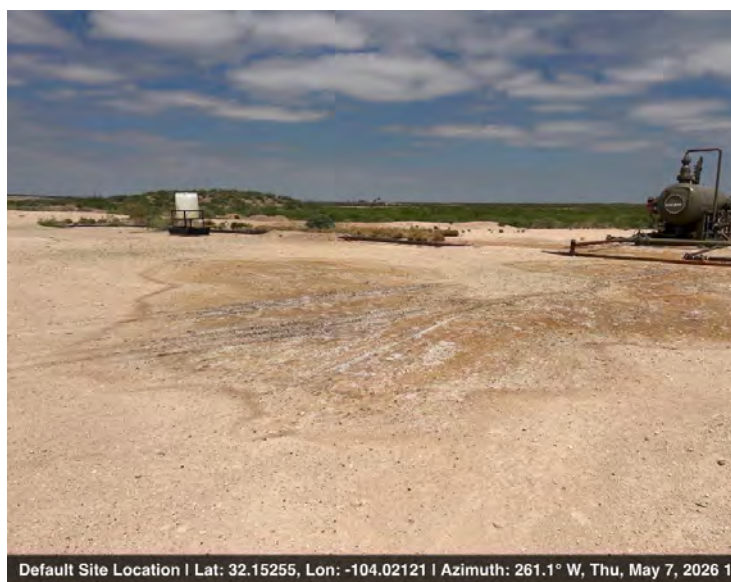
Date: 5/7/2026  
Time: 11:59  
Notes: Release and all surrounding production equipment mapped  
Latitude: 32.1525527777778  
Longitude: -104.02120833333333  
Direction: W

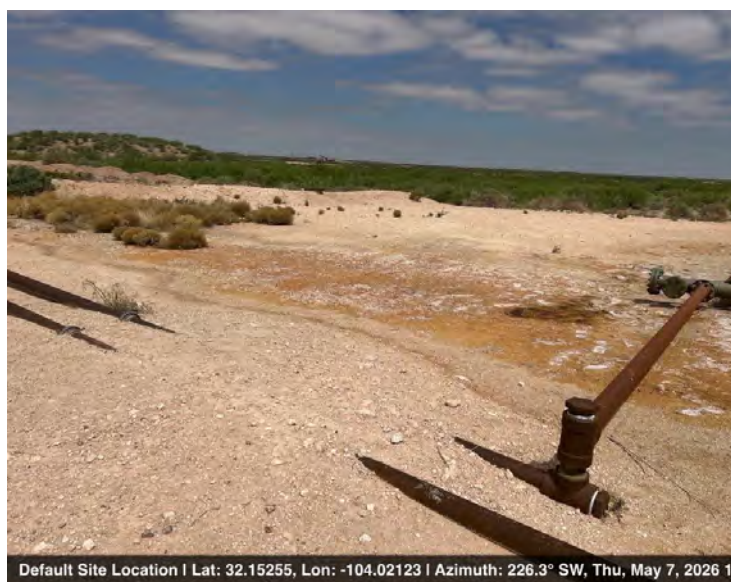
Date: 5/7/2026  
Time: 11:59  
Notes: Release and all surrounding production equipment mapped  
Latitude: 32.15255277777778  
Longitude: -104.02123333333333  
Direction: SW

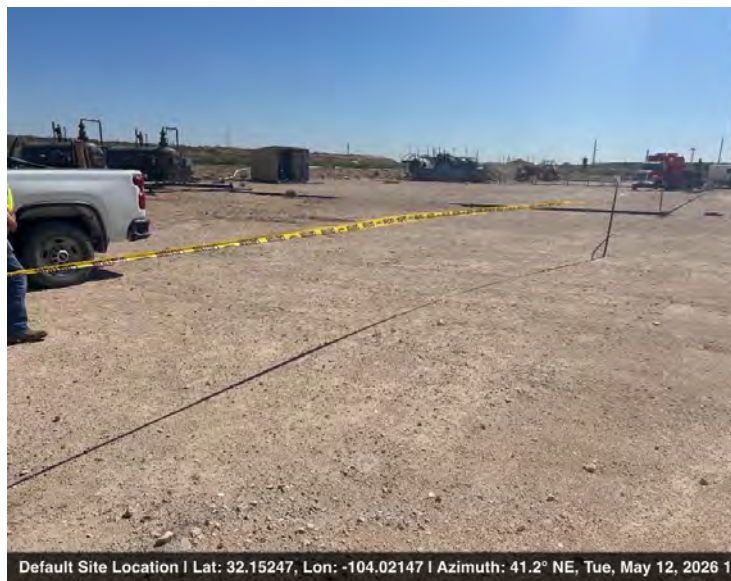
Date: 5/12/2026  
Time: 10:05  
Notes: Exclusion zone created  
Latitude: 32.1524722222222  
Longitude: -104.0214694444445  
Direction: NE

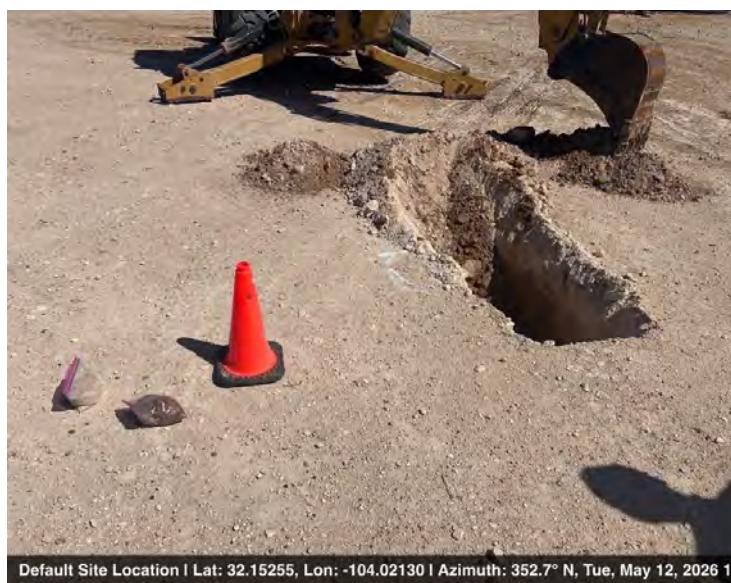
Date: 5/12/2026  
Time: 10:12  
Notes: BH26-01 @ 0'  
BH26-01 @ 2'  
Latitude: 32.1525527777778  
Longitude: -104.0213  
Direction: N

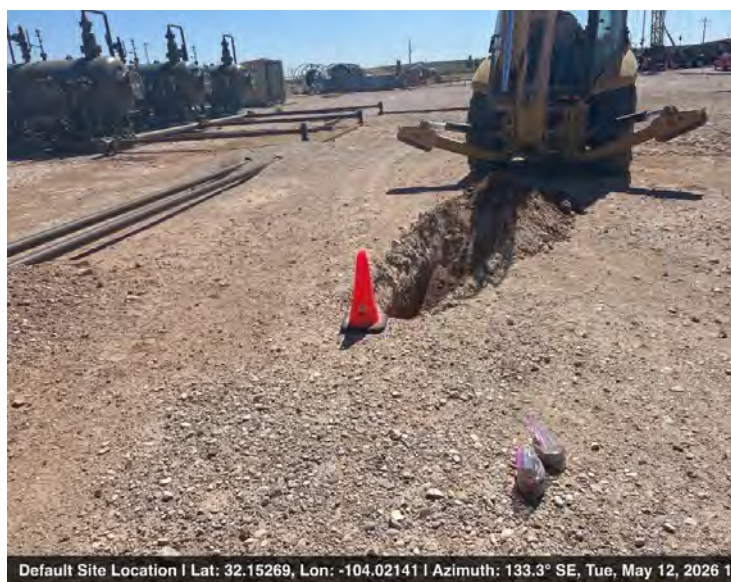
Date: 5/12/2026  
Time: 10:16  
Notes: BH26-02 @ 0'  
BH26-02 @ 2'  
Latitude: 32.15269166666666  
Longitude: -104.02140833333333  
Direction: SE

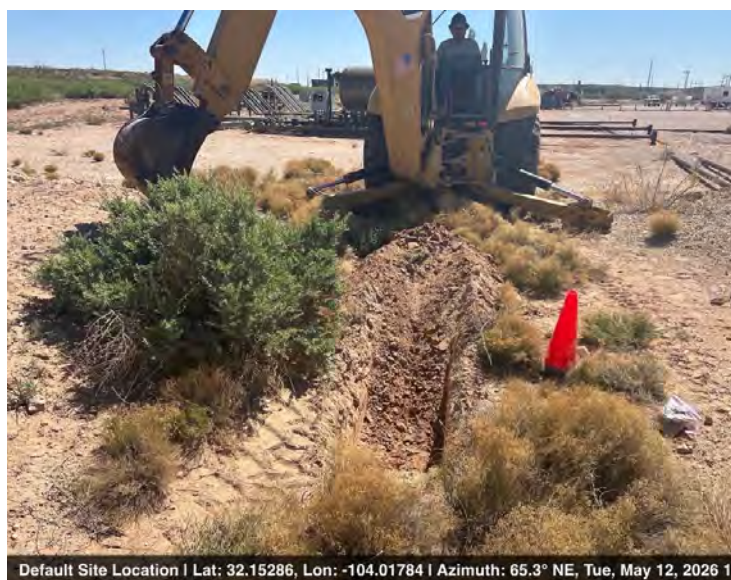
Date: 5/12/2026  
Time: 10:21  
Notes: BH26-03 @ 0'  
BH26-03 @ 2'  
Latitude: 32.15286111111111  
Longitude: -104.01784444444445  
Direction: E

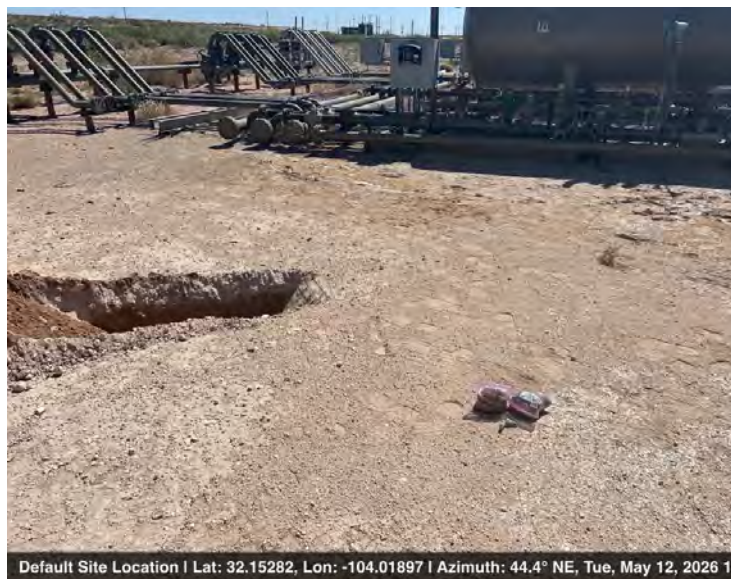
Date: 5/12/2026  
Time: 10:26  
Notes: BH26-04 @ 0'  
BH26-04 @ 2'  
Latitude: 32.15281944444444  
Longitude: -104.01896666666667  
Direction: NE

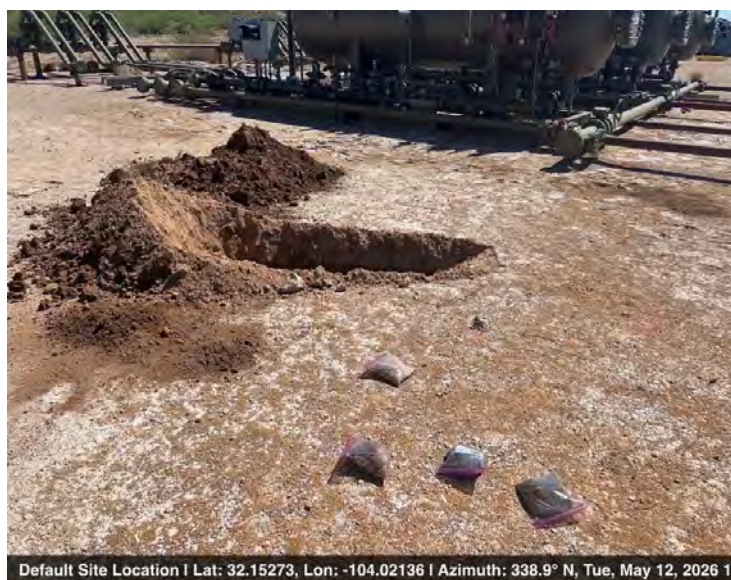
Date: 5/12/2026  
Time: 10:32  
Notes: BH26-09 @ 0'  
BH26-09 @ 1'  
BH26-09 @ 2'  
BH26-09 @ 3'  
Latitude: 32.15273333333333  
Longitude: -104.02135555555556  
Direction: N

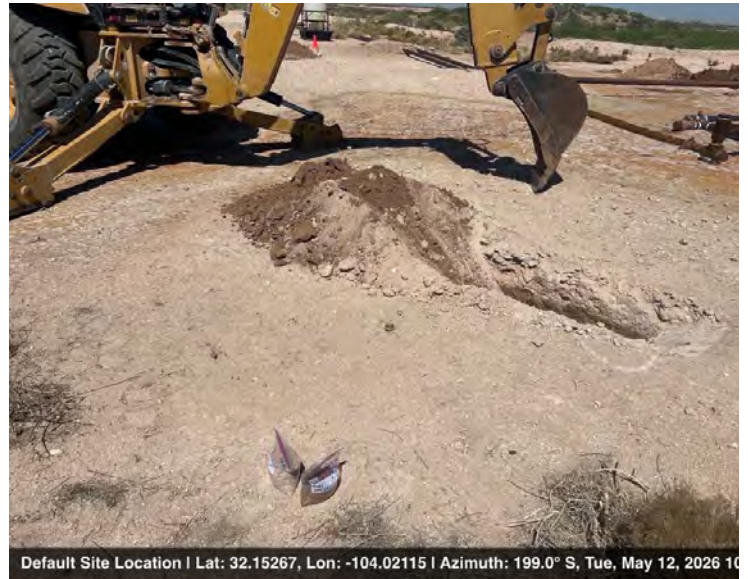
Date: 5/12/2026  
Time: 10:40  
Notes: BH26-06 @ 0'  
BH26-06 @ 2'  
Latitude: 32.15266666666667  
Longitude: -104.02115  
Direction: S

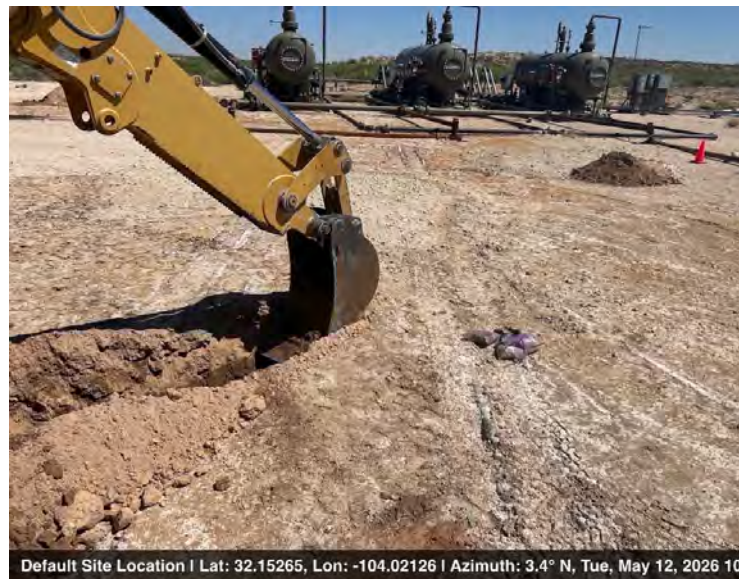
Date: 5/12/2026  
Time: 10:50  
Notes: BH26-07 @ 0'  
BH26-07 @ 2'  
BH26-07 @ 3'  
BH26-07 @ 4'  
Latitude: 32.15265  
Longitude: -104.02125555555556  
Direction: N

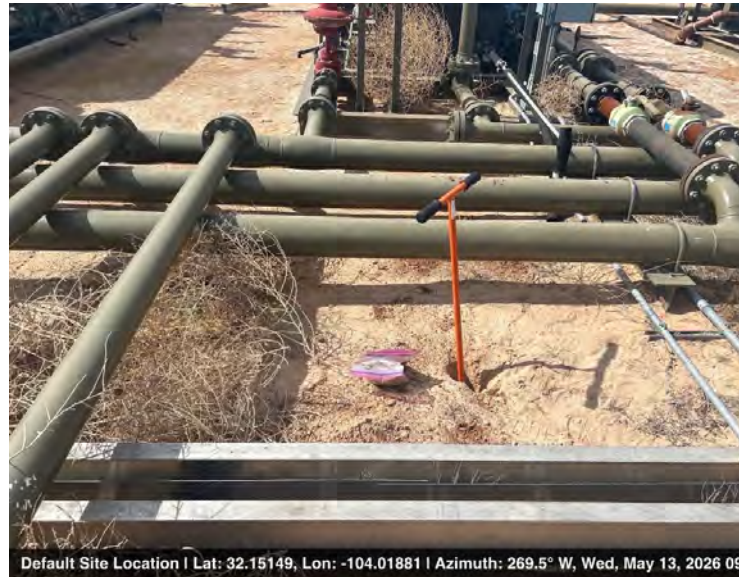
Date: 5/13/2026  
Time: 09:47  
Notes: BH26-05 @ 0'  
BH26-05 @ 2'  
Latitude: 32.15148888888885  
Longitude: -104.01880555555556  
Direction: W

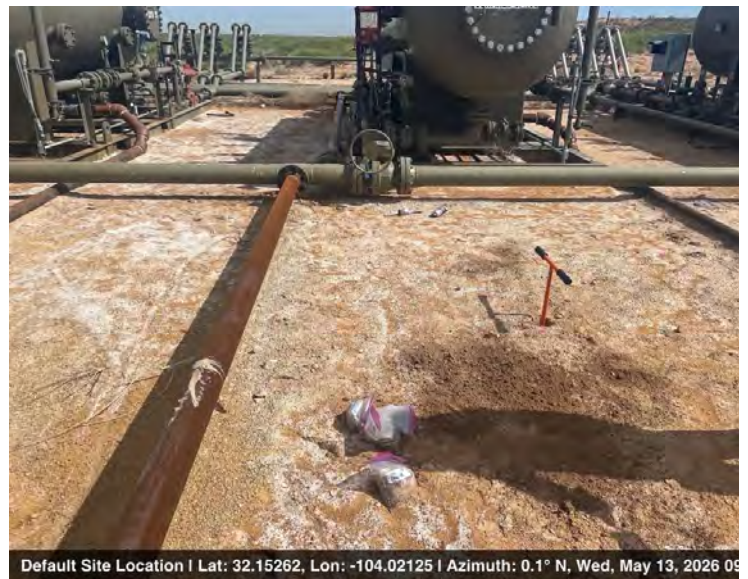
Date: 5/13/2026  
Time: 09:48  
Notes: BH26-08 @ 0'  
BH26-08 @ 2'  
BH26-08 @ 3'  
Latitude: 32.15262222222222  
Longitude: -104.02124722222221  
Direction: N

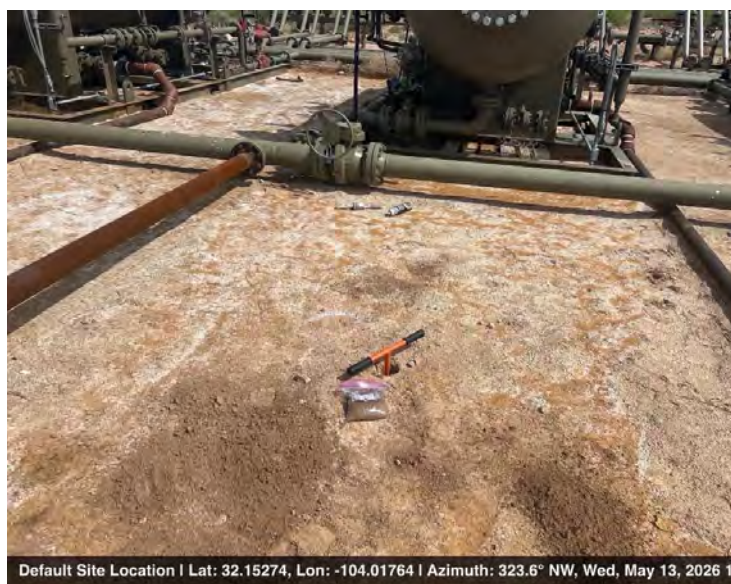
Date: 5/13/2026  
Time: 10:11  
Notes: BH26-08 @ 4'  
Latitude: 32.15274444444444  
Longitude: -104.01763888888888  
Direction: NW
