Site Characterization and Liner Inspection Report

SERPENTINE 2 FACILITY 1

nAPP2528329987, nAPP2528930966,
nAPP2529629057, & nAPP2600522423

Lea County, New Mexico

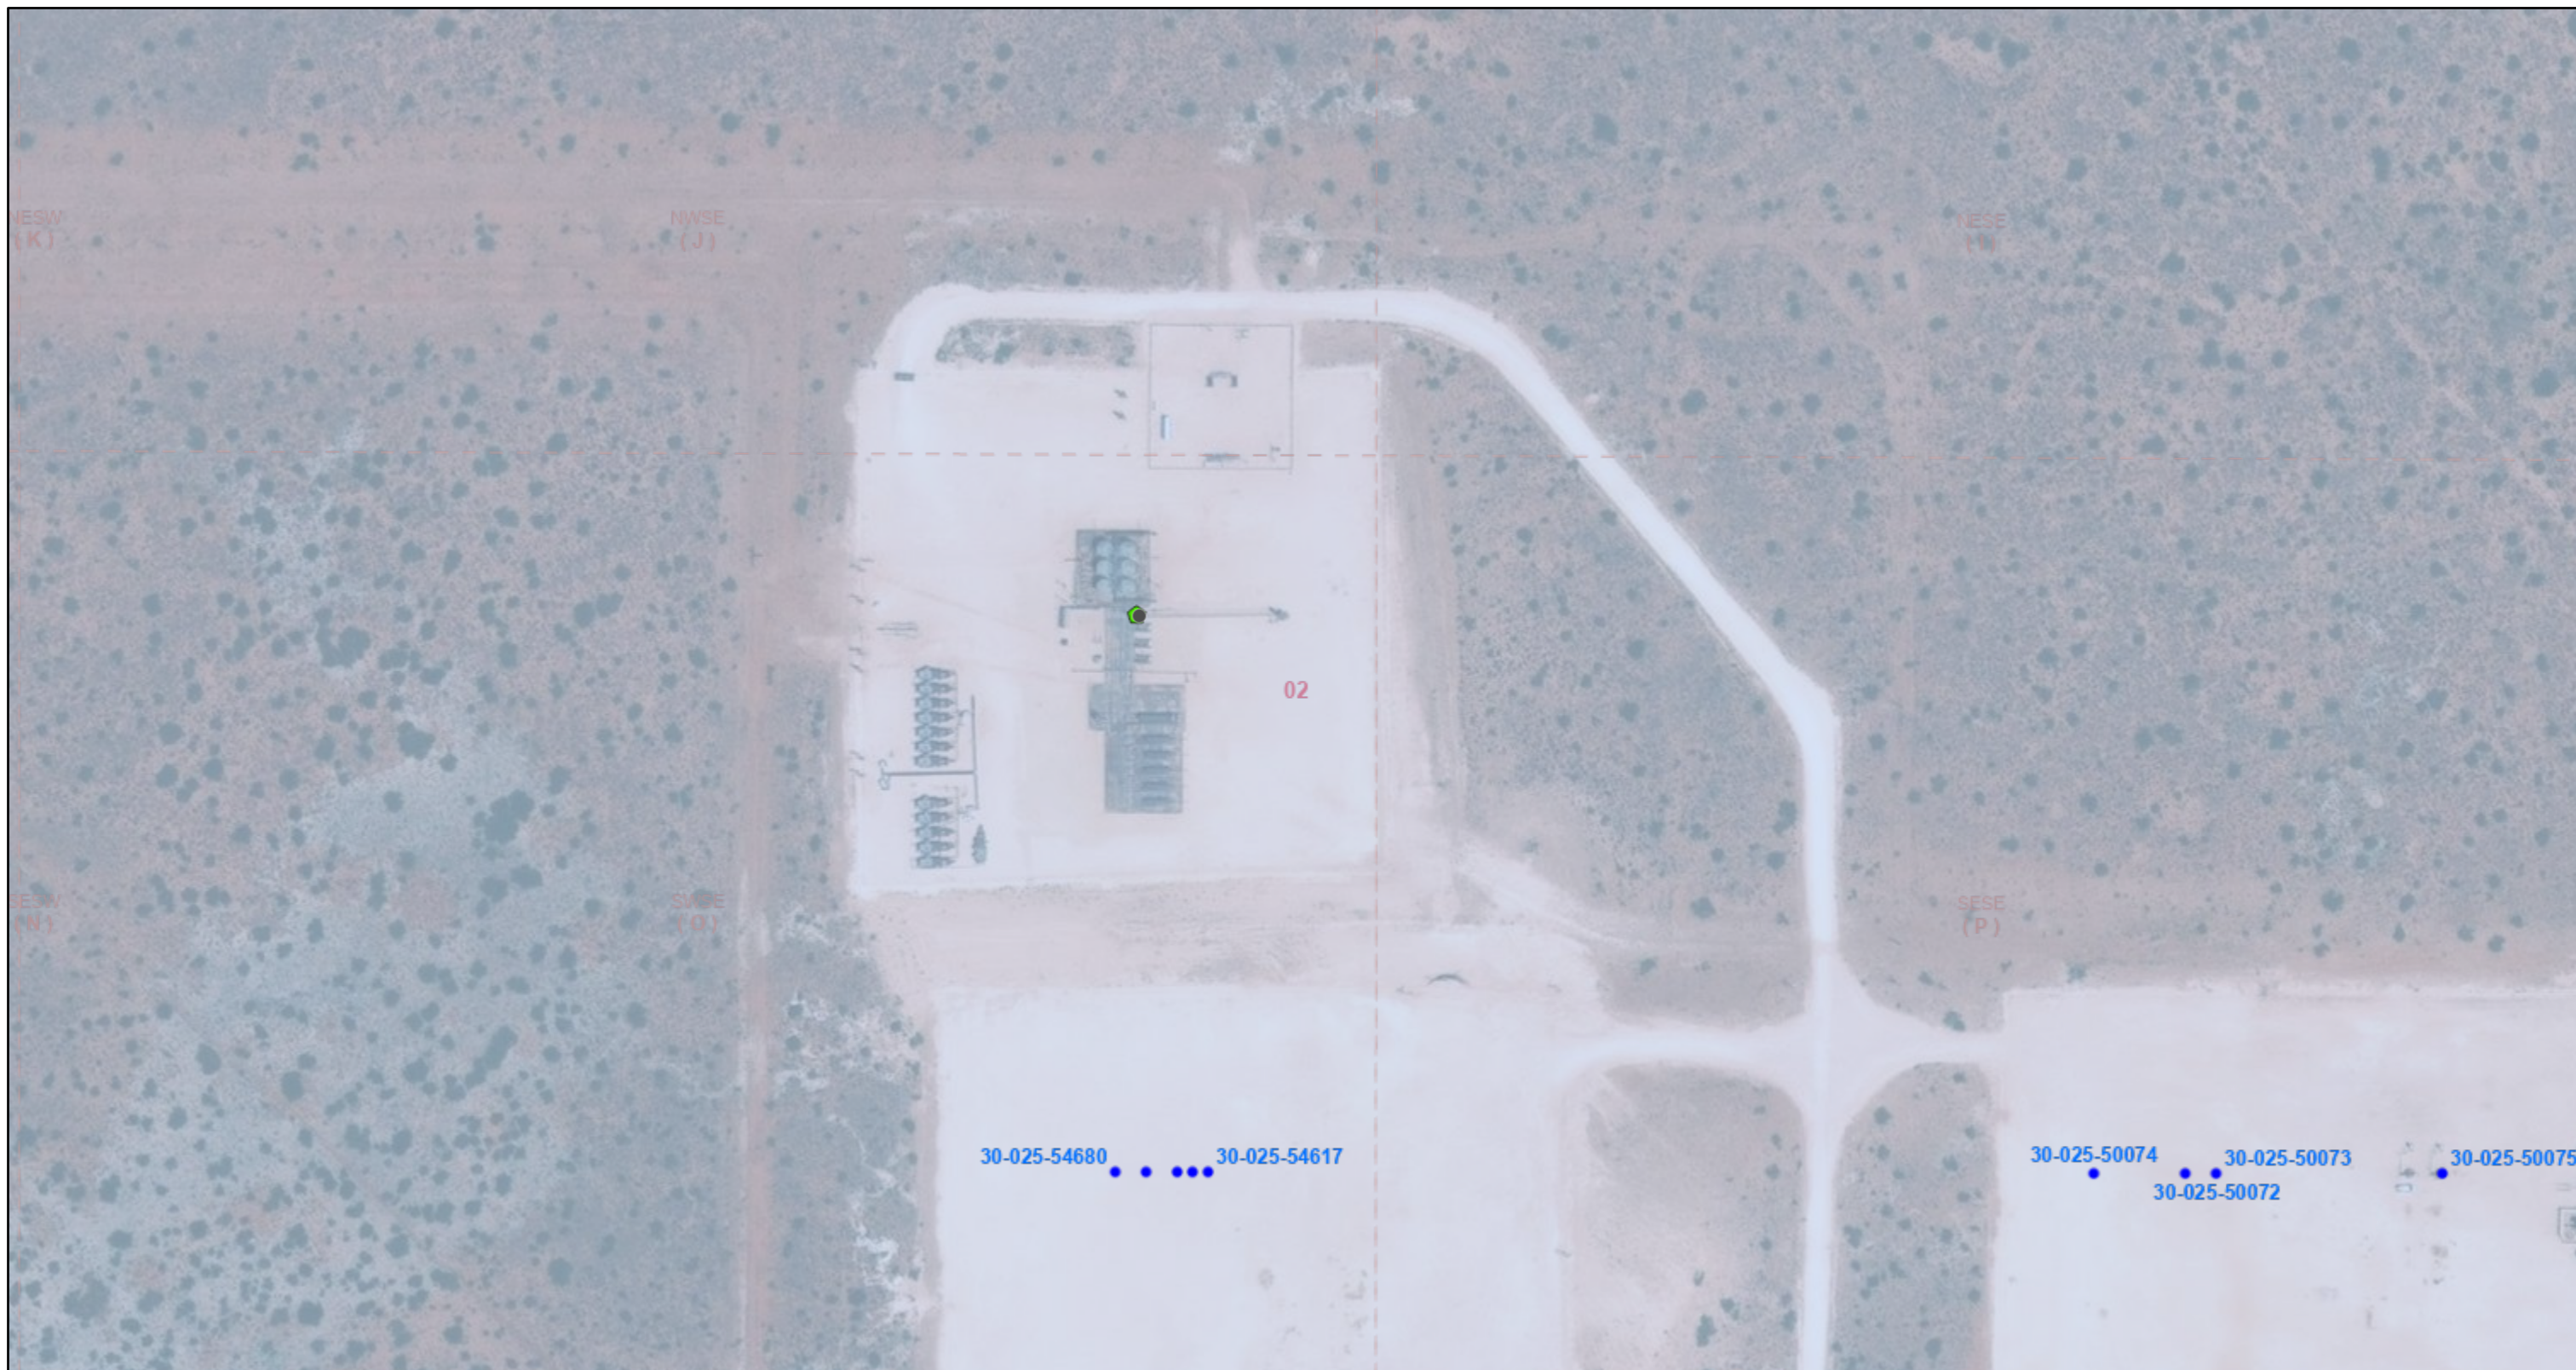
OCD Site Locations & Karst Potential

- Wells - Large Scale
 - Oil, New
 - ◆ Other
- Karst Occurrence Potential
 - Low
- Facility
 - ▭ PLSS First Division
 - - - PLSS Second Division

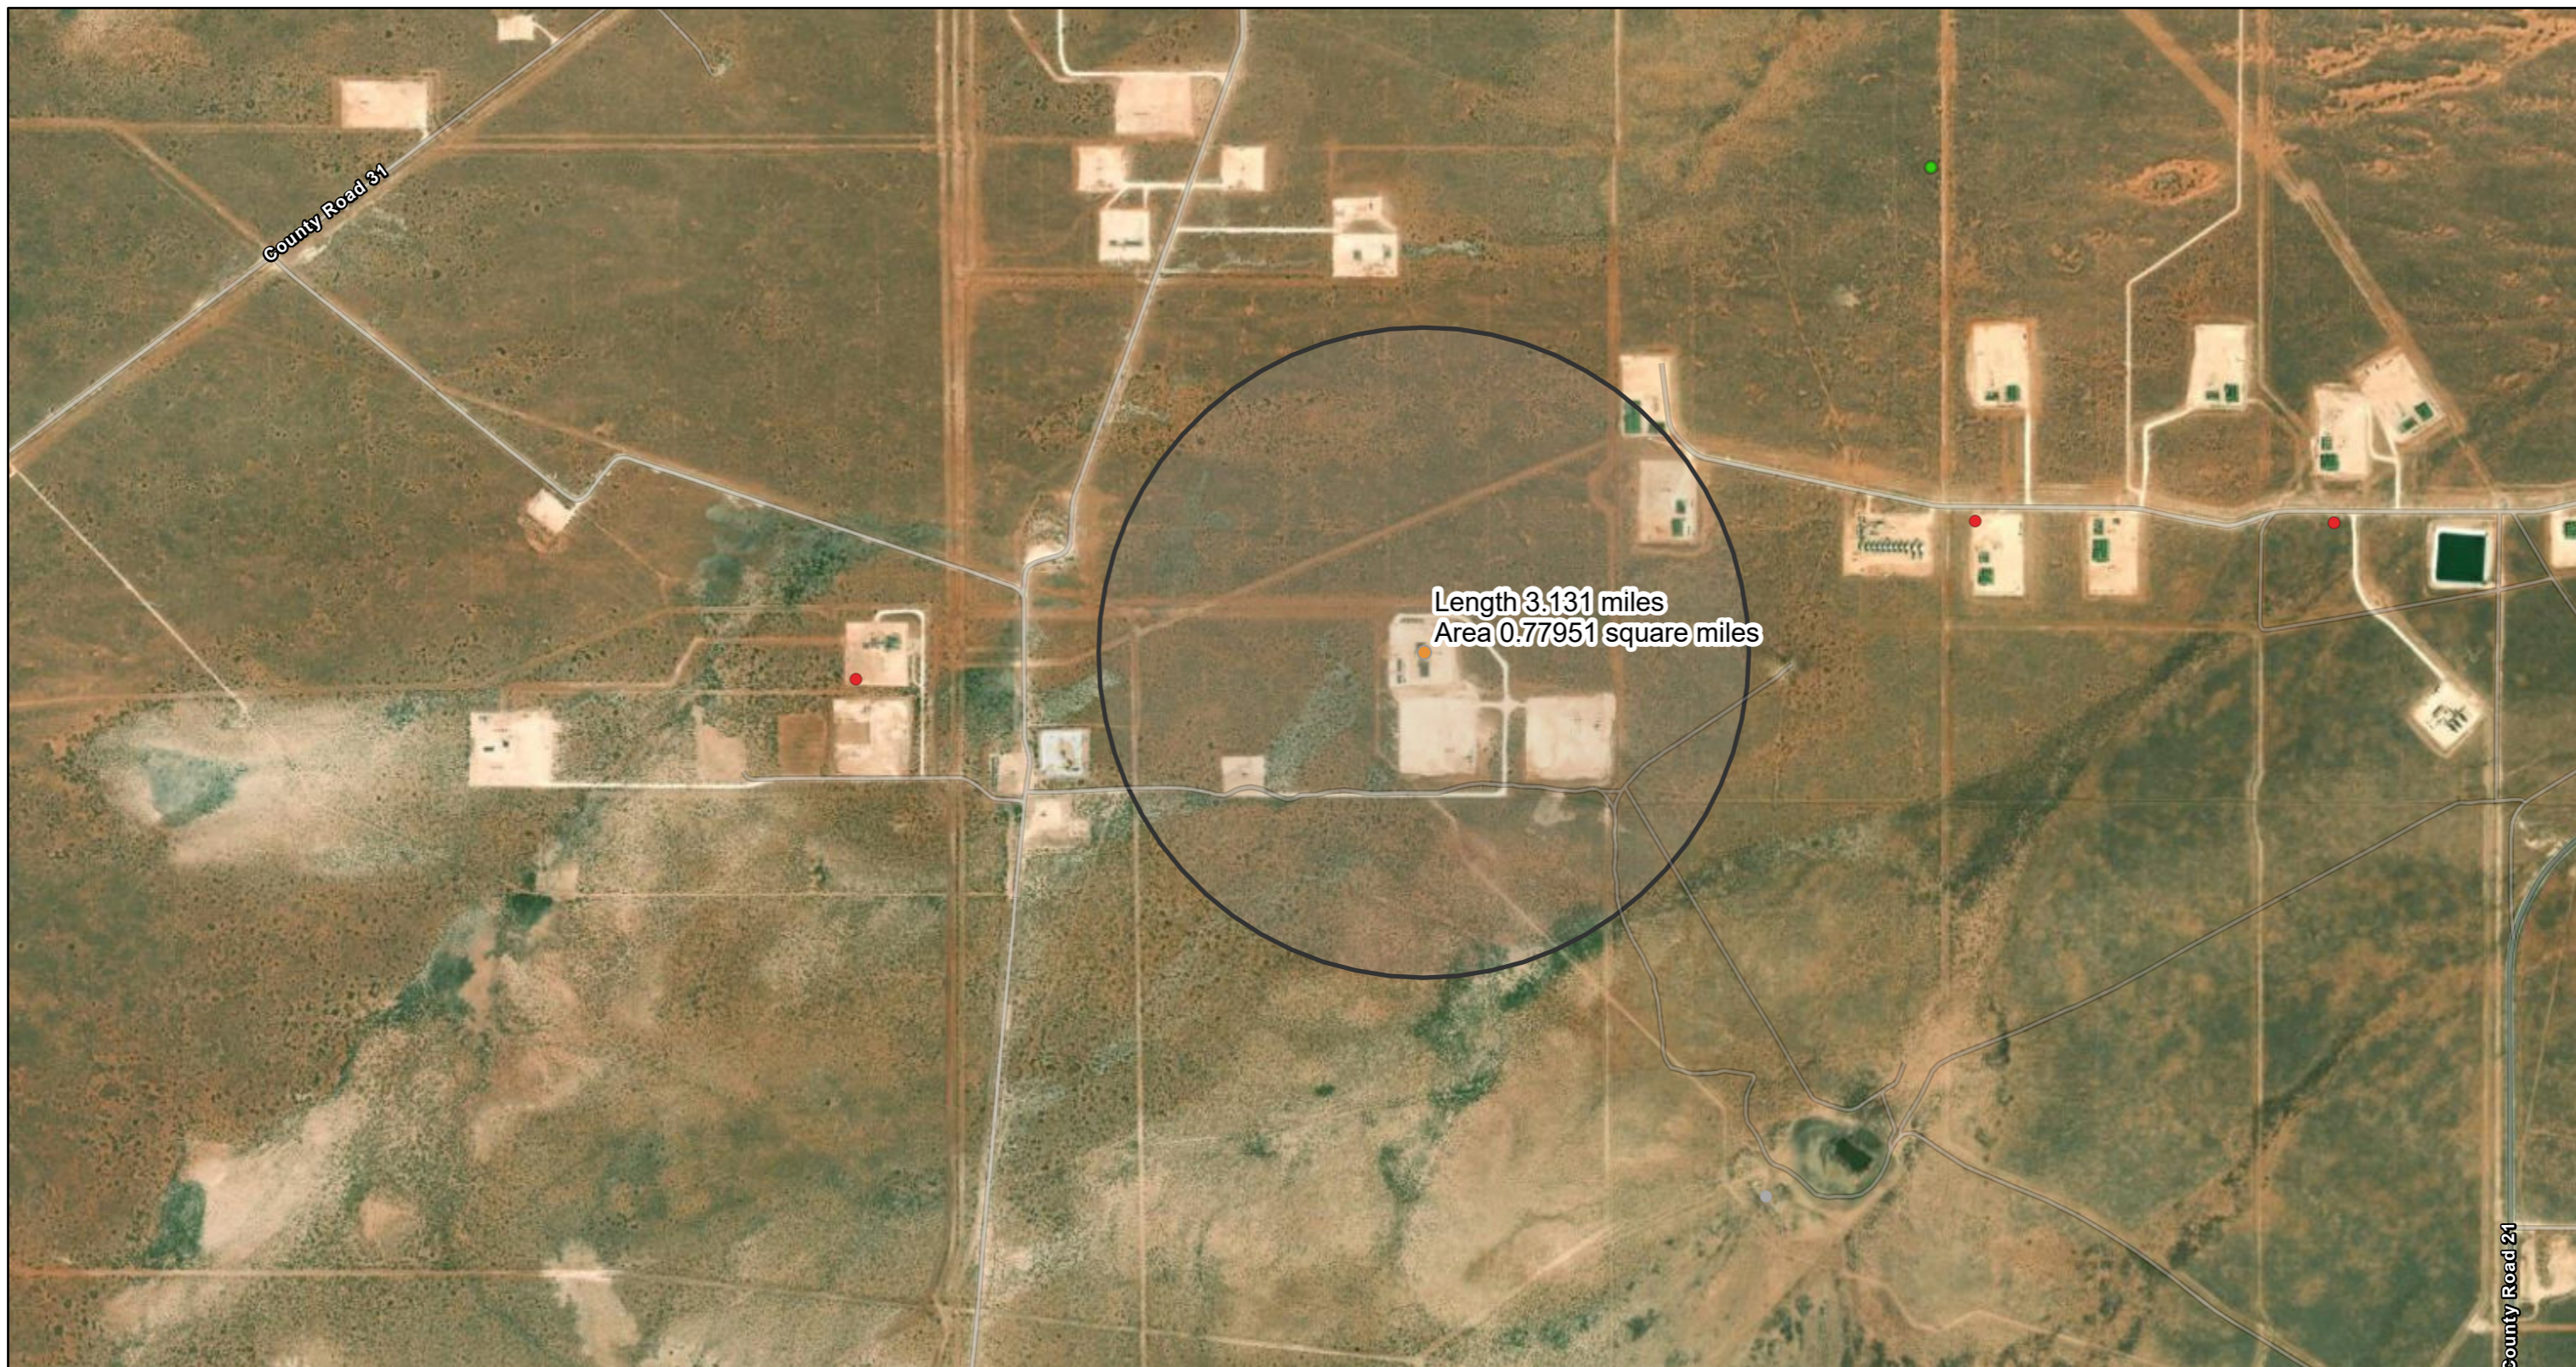
OSE POD Locations Map

GIS WATERS PODs

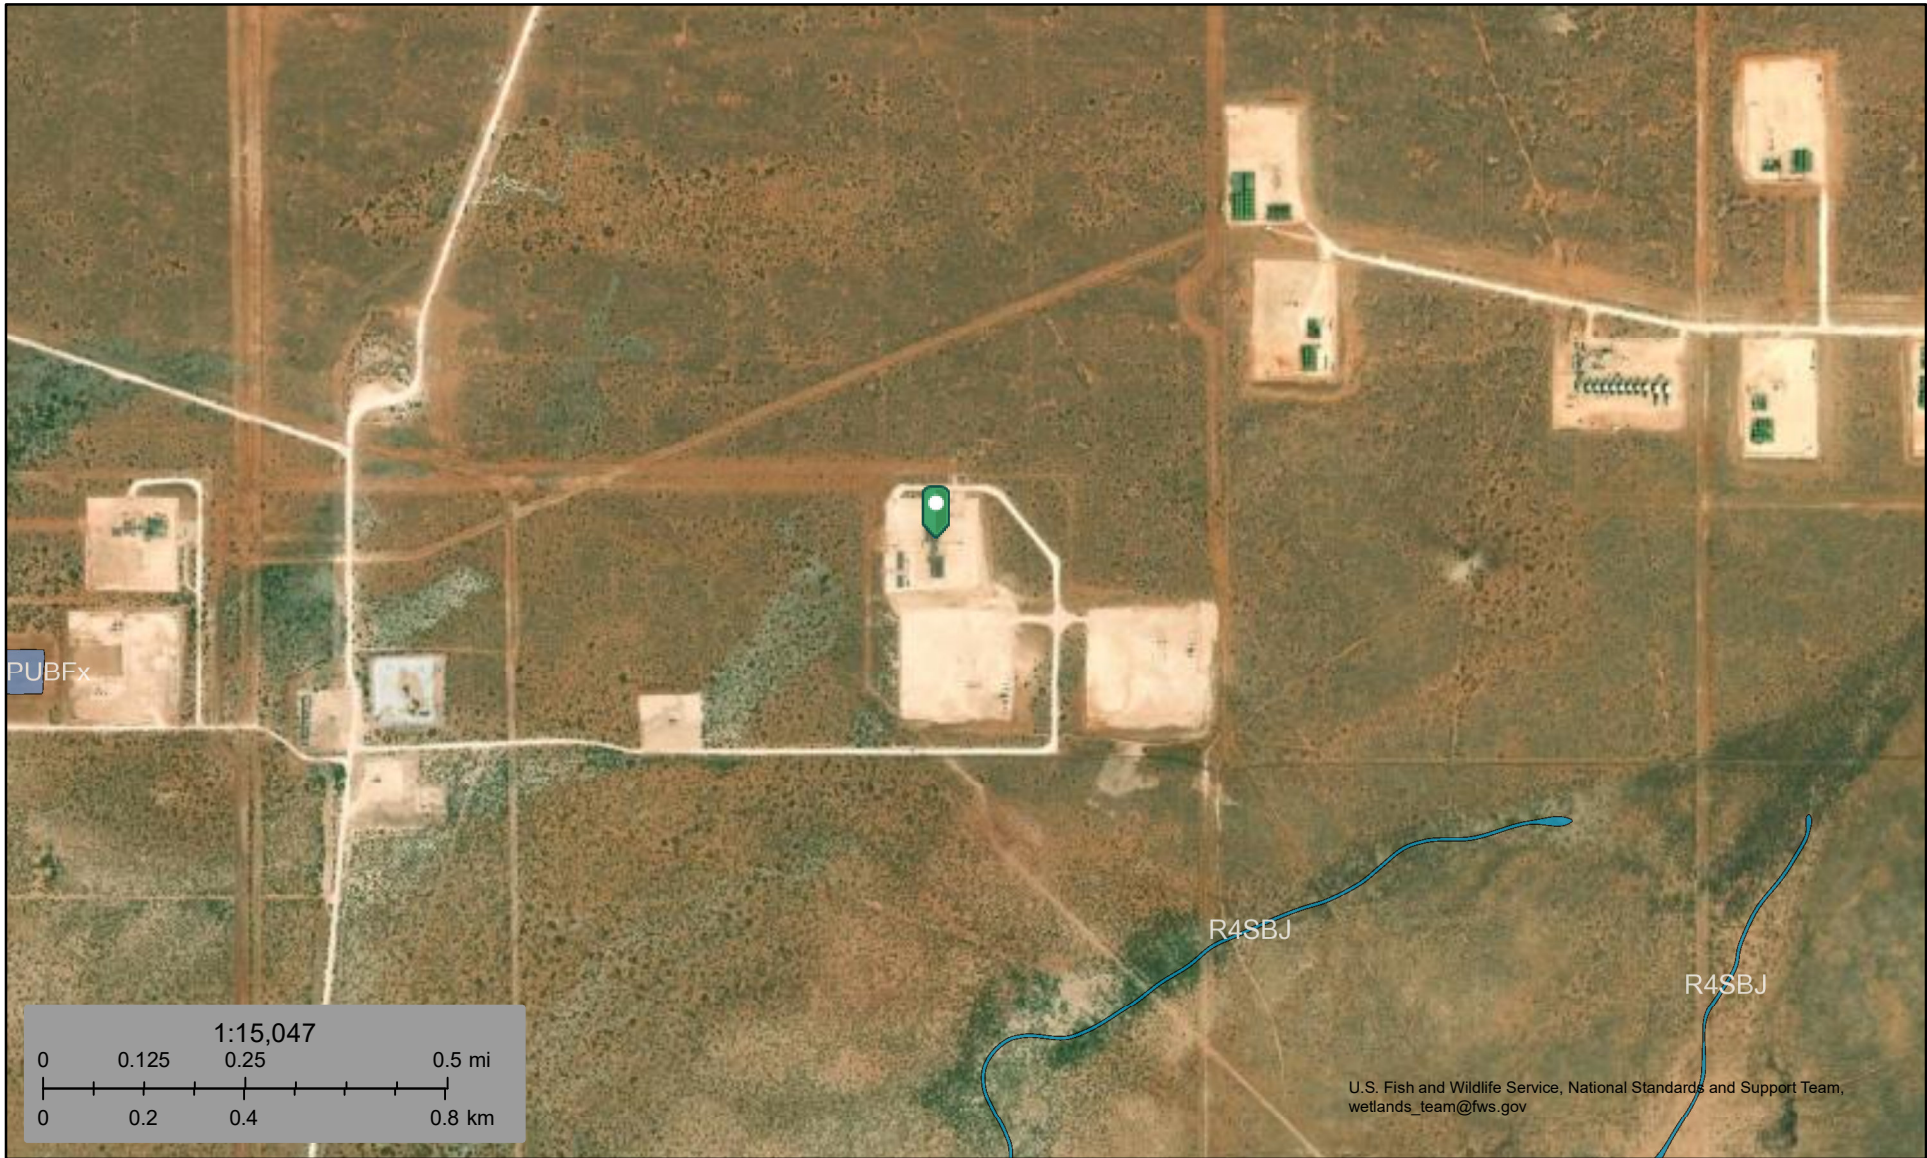
This map is for general reference only. The US Fish and Wildlife Service is not responsible for the accuracy or currentness of the base data shown on this map. All wetlands related data should be used in accordance with the layer metadata found on the Wetlands Mapper web site.

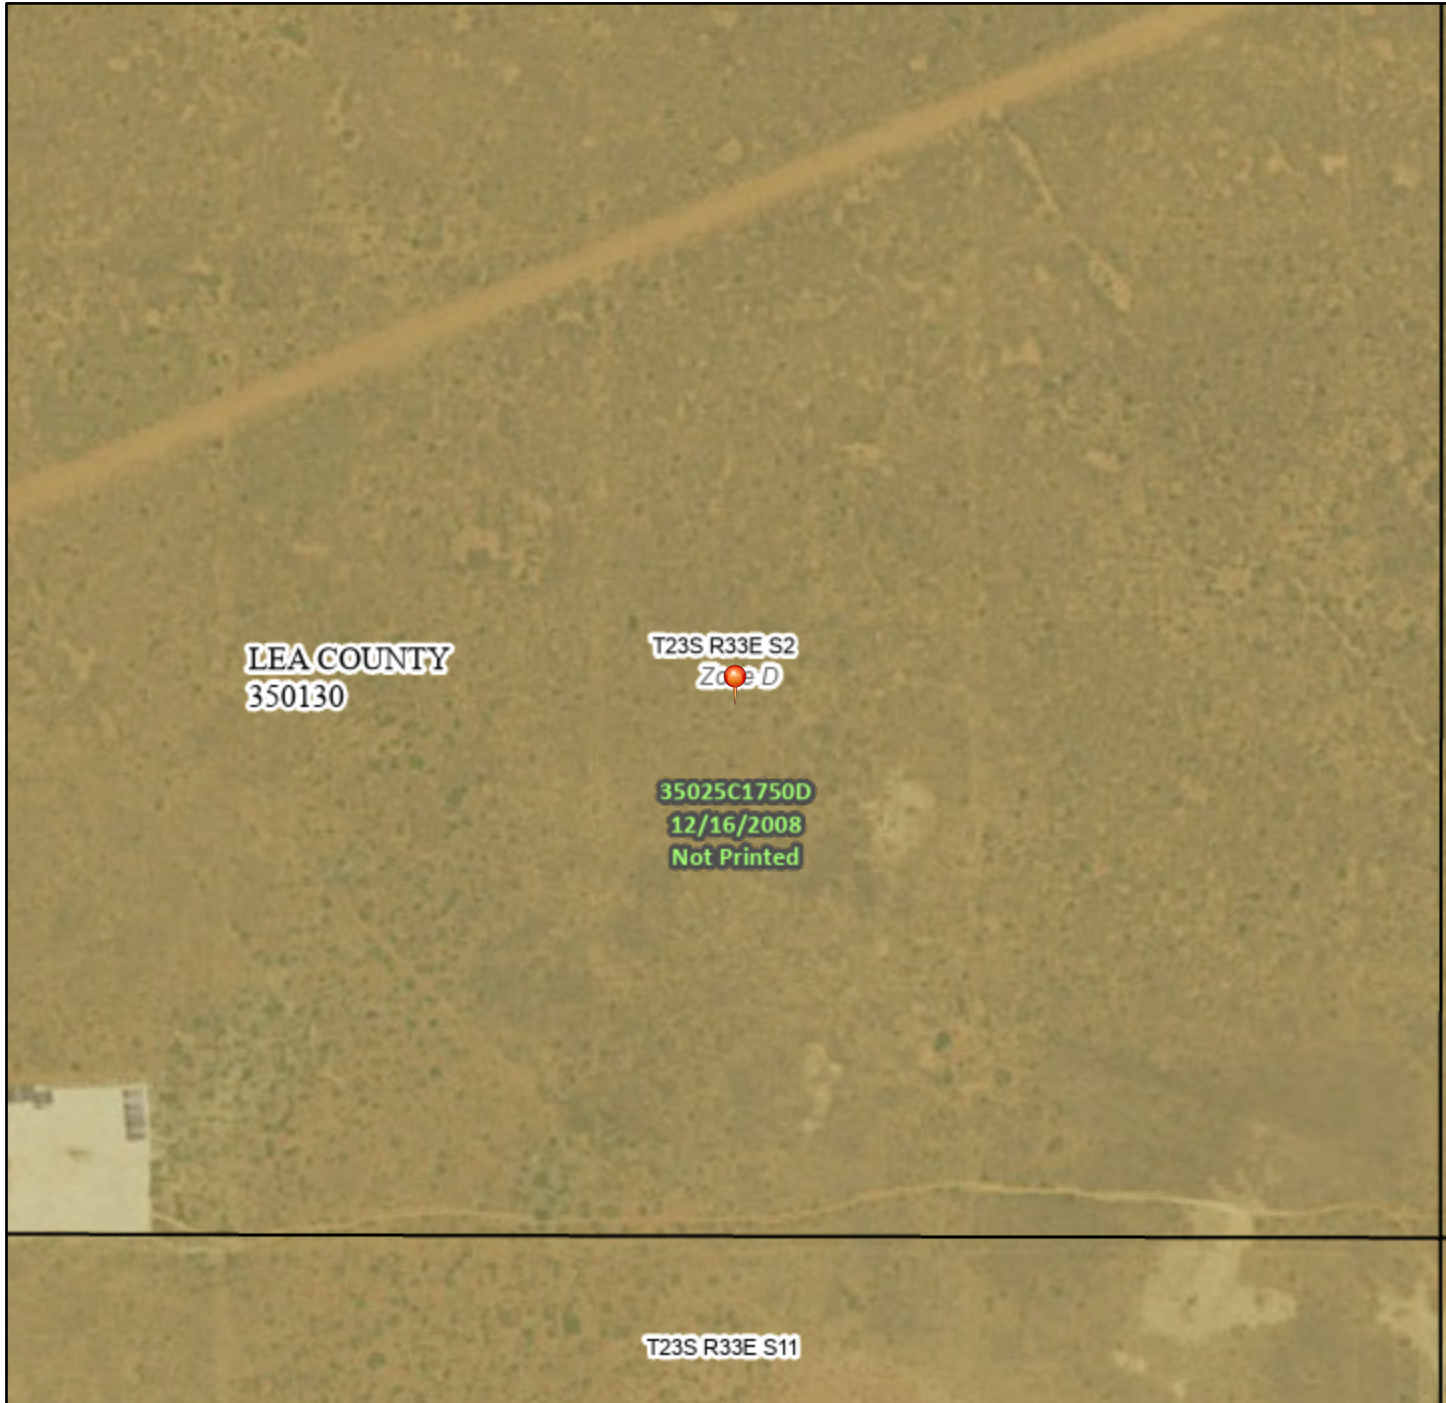
National Flood Hazard Layer FIRMMette

The flood hazard information is derived directly from the authoritative NFHL web services provided by FEMA. This map was exported on 5/14/2026 at 10:50 PM and does not reflect changes or amendments subsequent to this date and time. The NFHL and effective information may change or become superseded by new data over time.

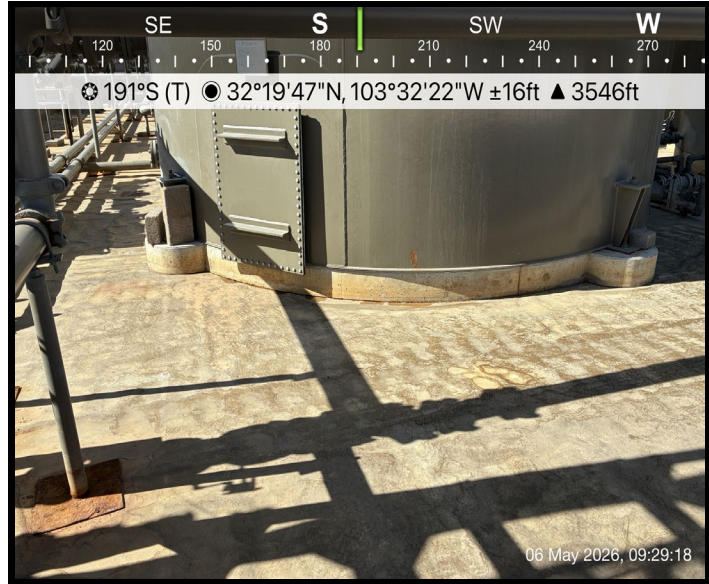
After the liner was cleaned, on May 6th, 2026, Standard performed a liner inspection. The liner was free of any standing fluid. The liner integrity was intact with no breaches or holes discovered during the inspection. Photographs taken during the liner inspection can be found under Attachment C: Photographic Log.

View of Liner
