**Re: Closure Request
Mr Potato Head 11 CTB 4
Incident Number nAPP2609624653
Eddy County, New Mexico**

Ensolum, LLC (Ensolum), on behalf of Devon Energy Production Company, LP (Devon), has prepared this *Closure Request* to document liner inspection activities performed at the Mr Potato Head 11 CTB 4 (Site) in Unit H, Section 11, Township 24 South, Range 29 East, in Eddy County, New Mexico (Figure 1). The purpose of the Site assessment was to assess for the presence or absence of impacts at the Site resulting from a release of produced water within a lined secondary containment at the Site. Based on field observations, Devon is submitting this *Closure Request* and requesting no further remedial activities for Incident Number nAPP2609624653.

Devon Energy Production Company, LP
Mr Potato Head 11 CTB 4
Incident Number: nAPP2609624653
Unit H, Section 11, T 24S, R 29E
Eddy County, New Mexico

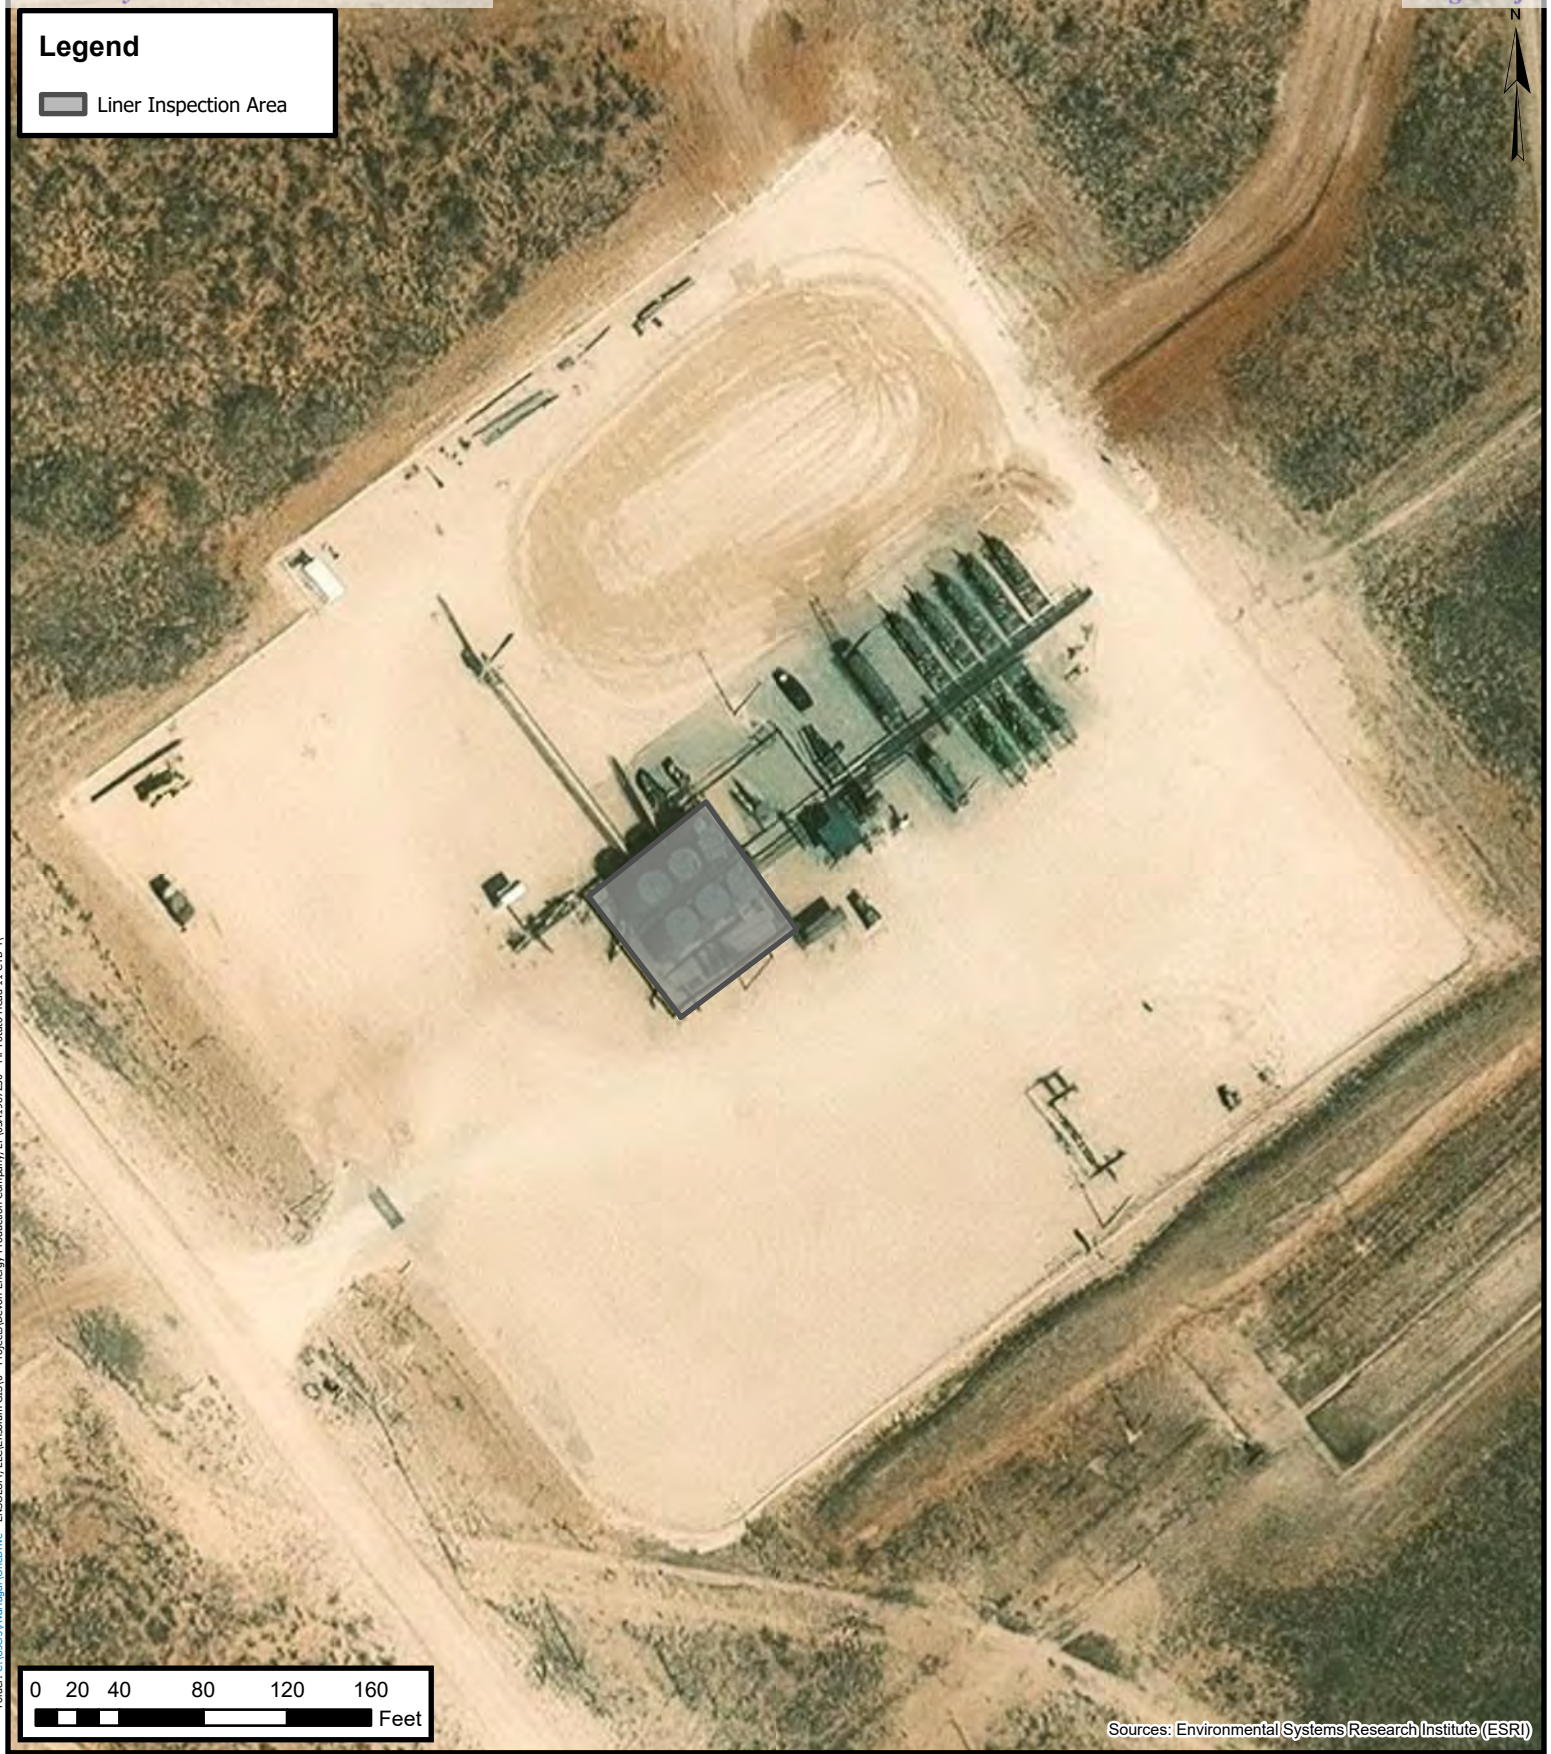
2

Liner Inspection Area

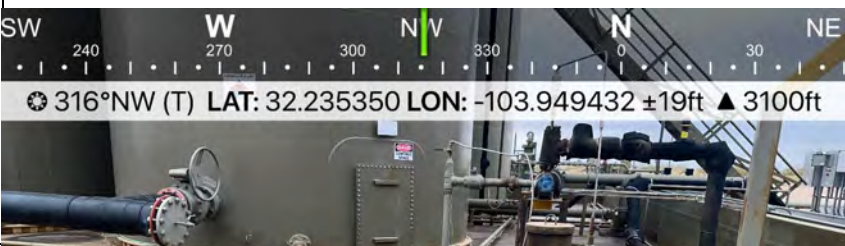
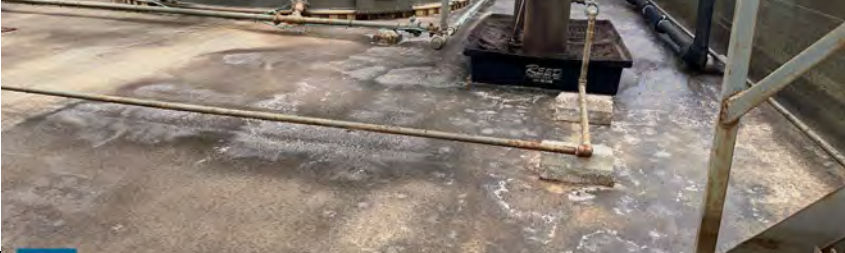
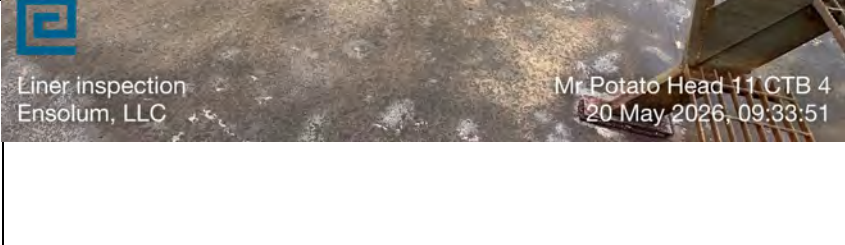
<p><u>Photograph</u> 7</p>	<p><u>Date</u> 4/20/2026</p>

<p><u>Description</u> Liner inspection</p>

<p><u>View</u> Northwest</p>

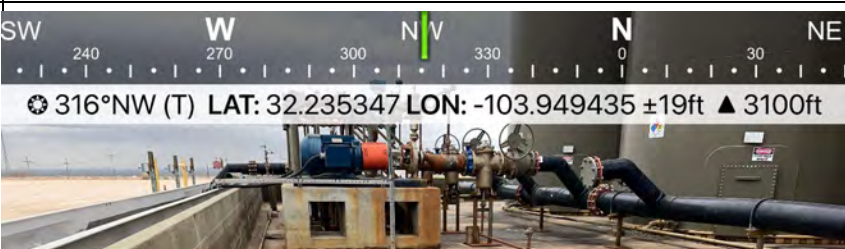
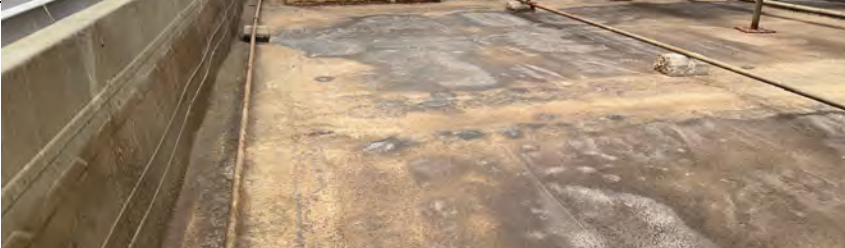
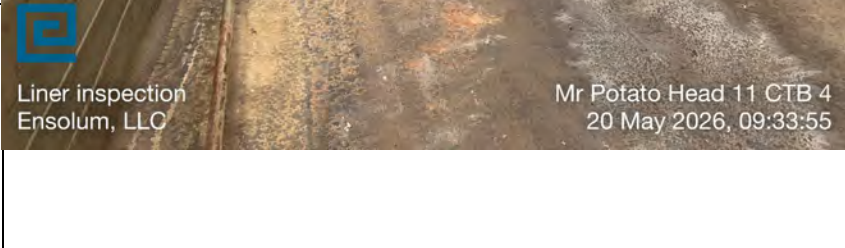
<p>Liner inspection Ensolum, LLC</p> <p>Mr Potato Head 11 CTB 4 20 May 2026, 09:33:51</p>
<p><u>Photograph</u> 8</p>	<p><u>Date</u> 4/20/2026</p>

<p><u>Description</u> Liner inspection</p>

<p><u>View</u> Northwest</p>
