## Release Notification

Re: **Reclamation Request**  
**NVA 260**  
**Tracking #: NAPP2300550705**

Trinity Oilfield Services (Trinity), on behalf of Cross Timbers Energy, LLC, hereby submits the following Reclamation Report in response to a release that occurred at the above-referenced location, and further described below.

## RELEASE BACKGROUND

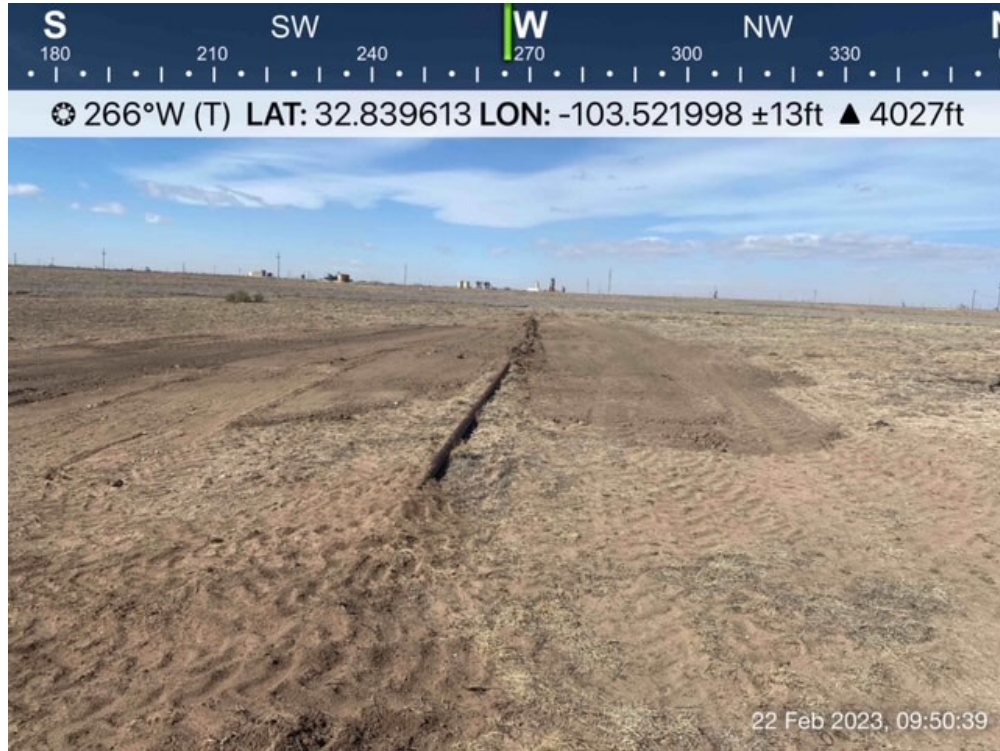
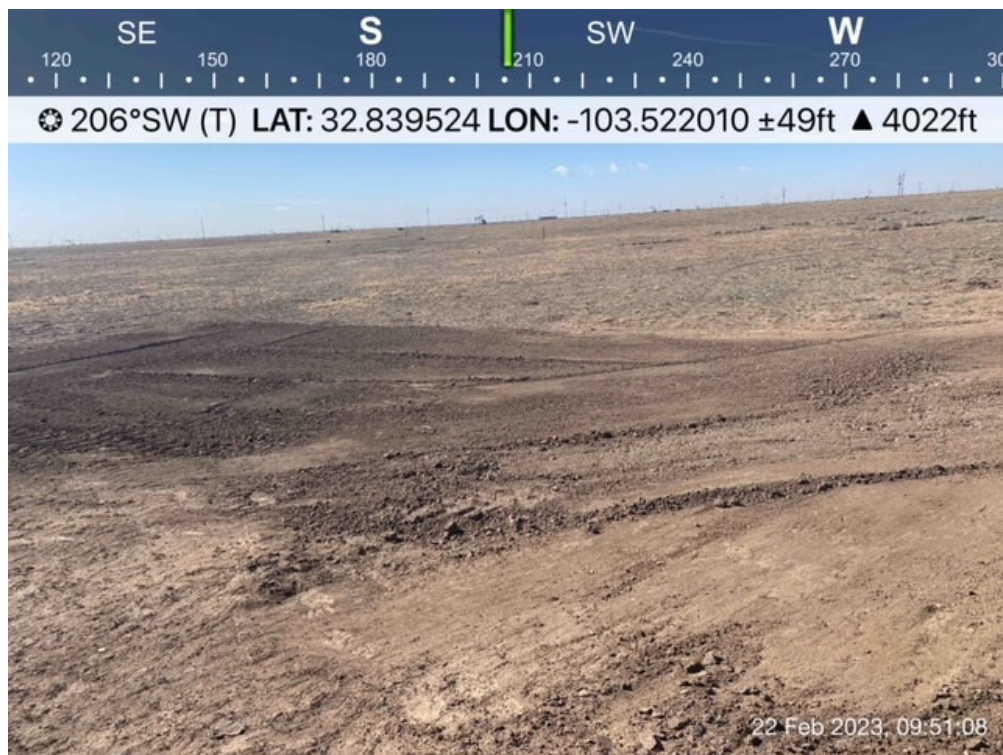
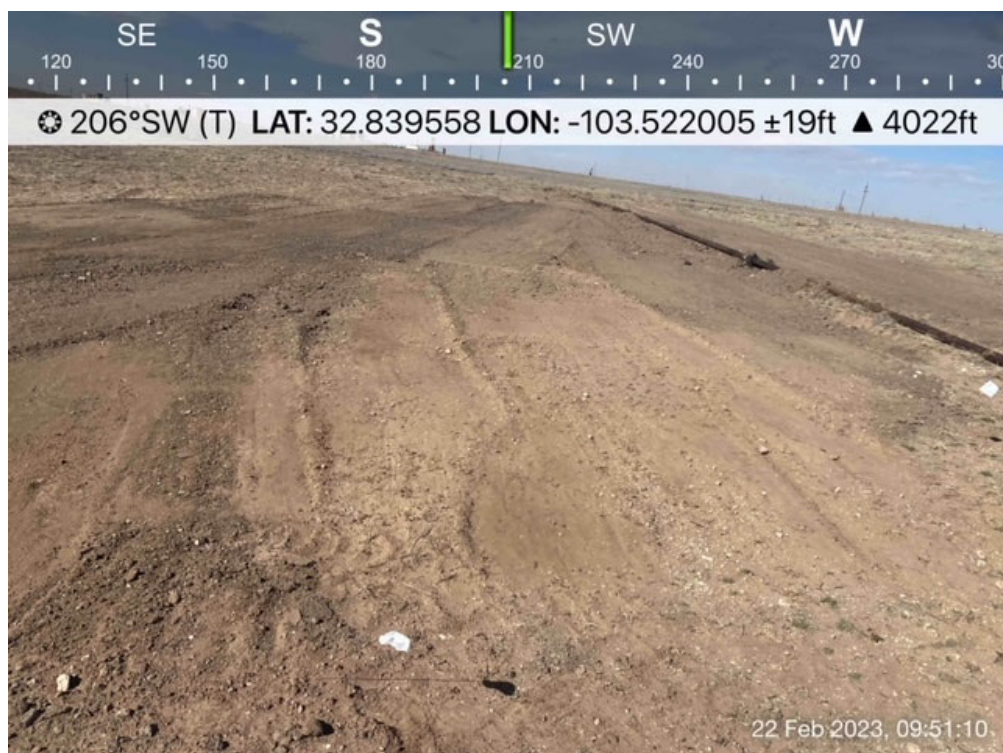
## Initial Release

On 01/05/2023, Cross Timbers Energy, LLC reported a release at the NVA 260. The release was caused when a 3" metal flowline froze and busted 3" coupling. Approximately 3,324 sqft. of the Pasture was found to be damp upon initial inspection.

| Release Information | |
|---|---|
| Affected Area – Damp Soil | Pasture - Approximately 3,324 sqft. |

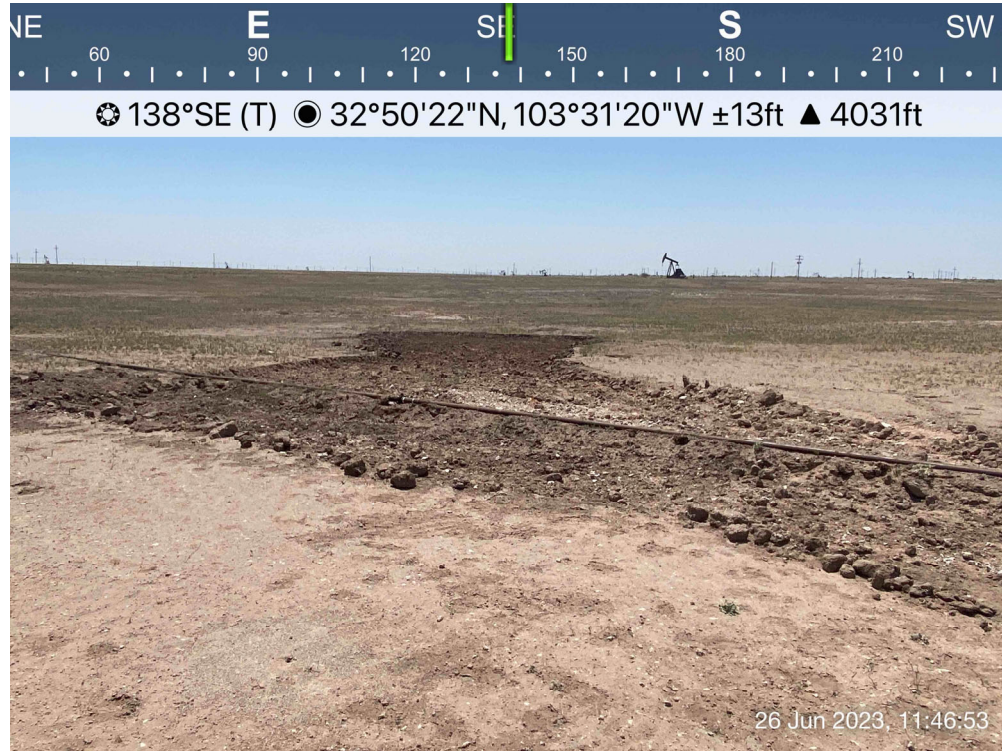
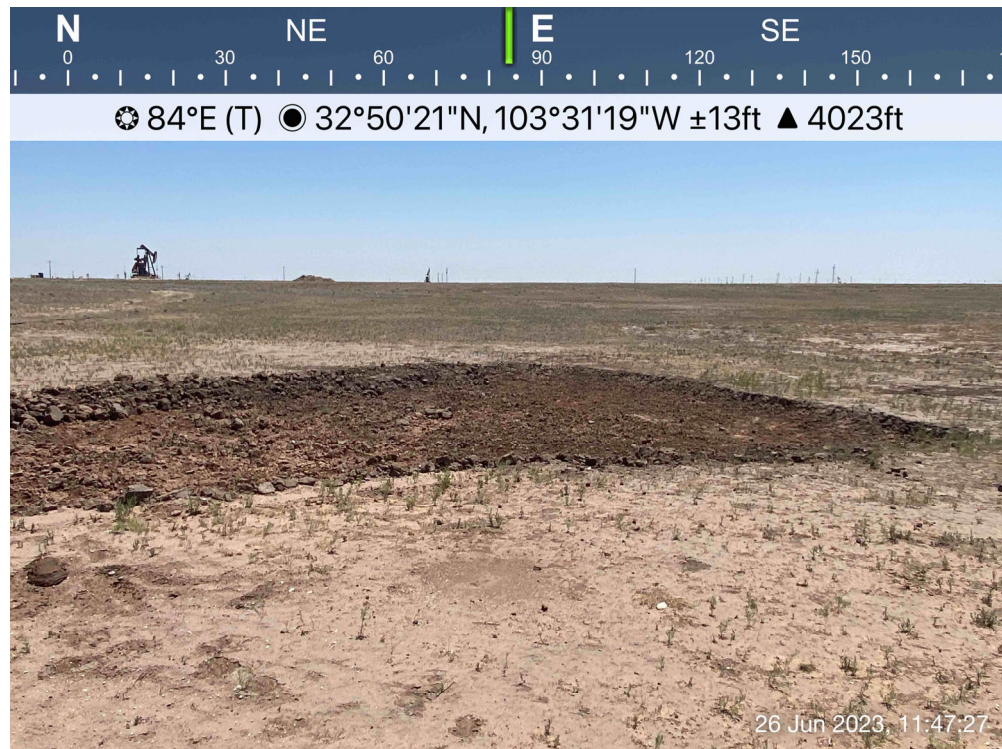
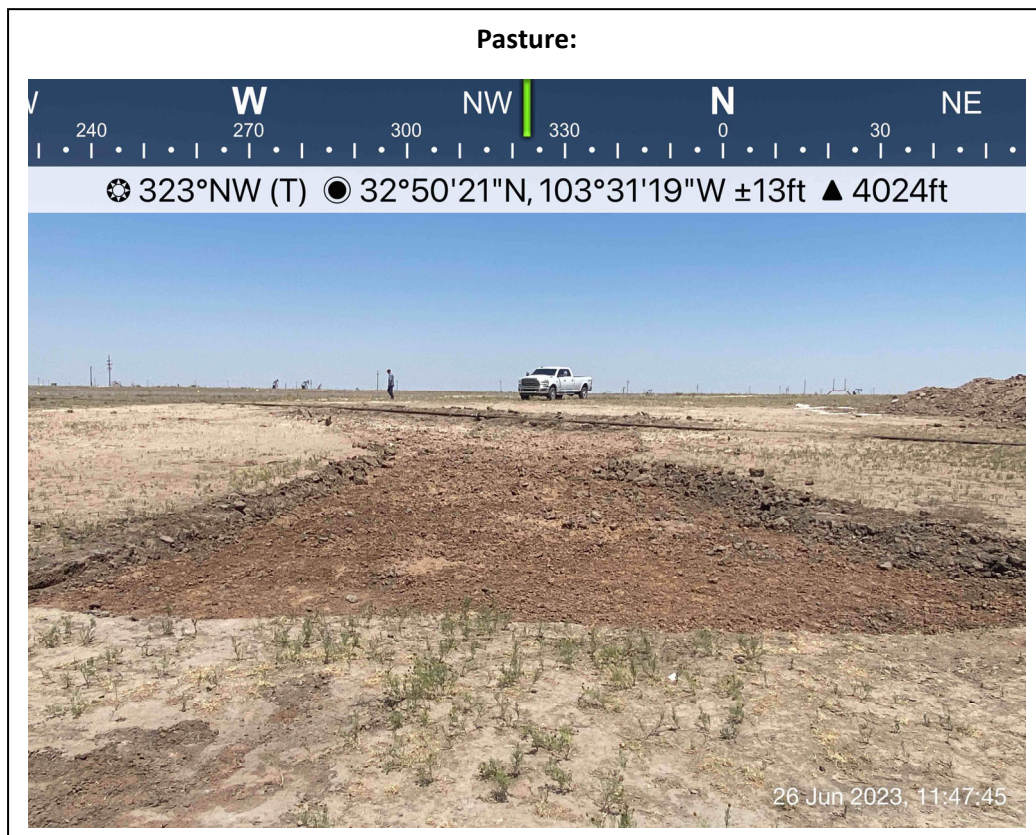
## Excavation

| Remediation Summary | |
|---|---|
| Depths Excavated | 1' |
| Total Volume of Excavated Soil | 123 yards |

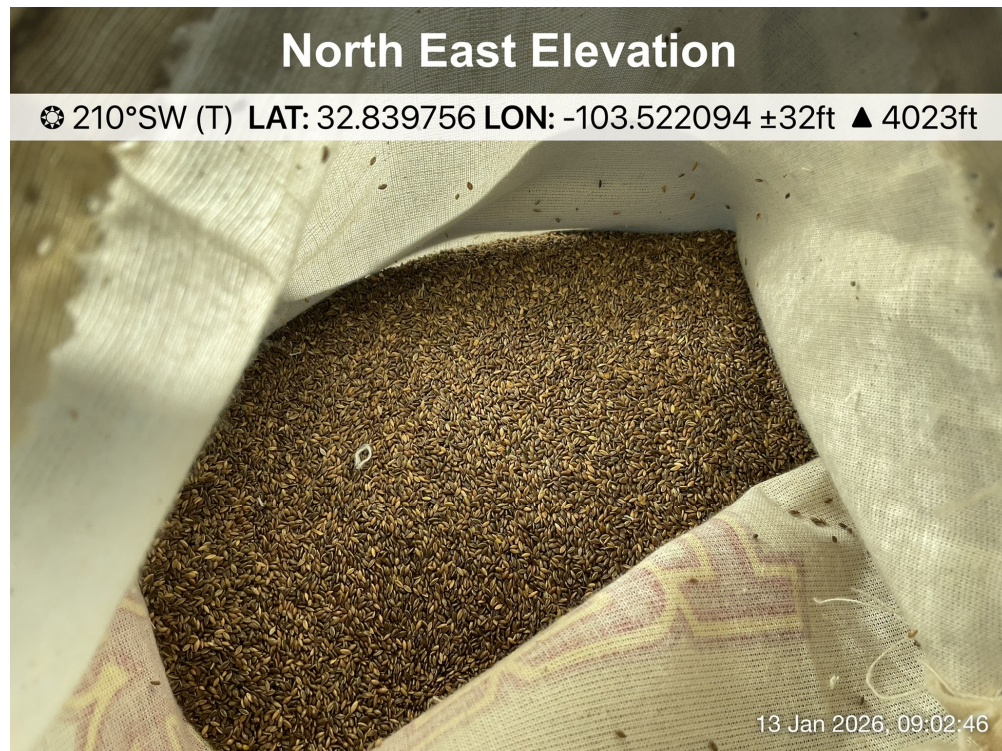
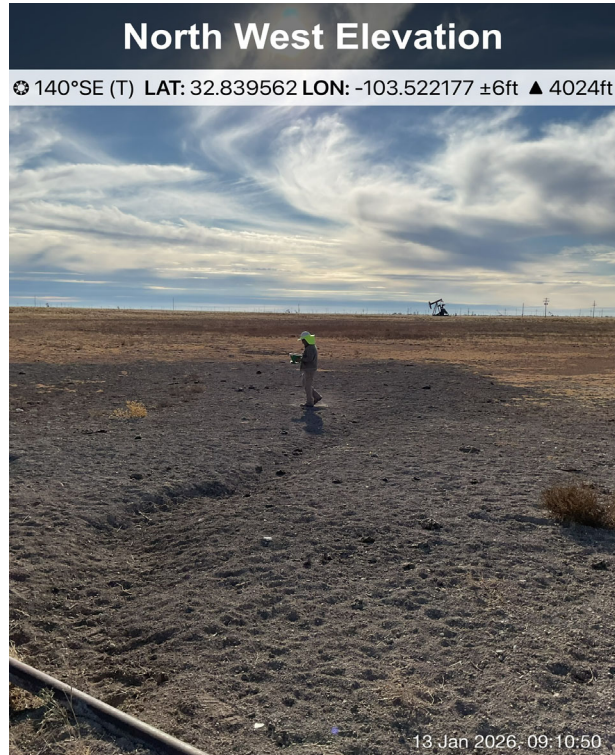
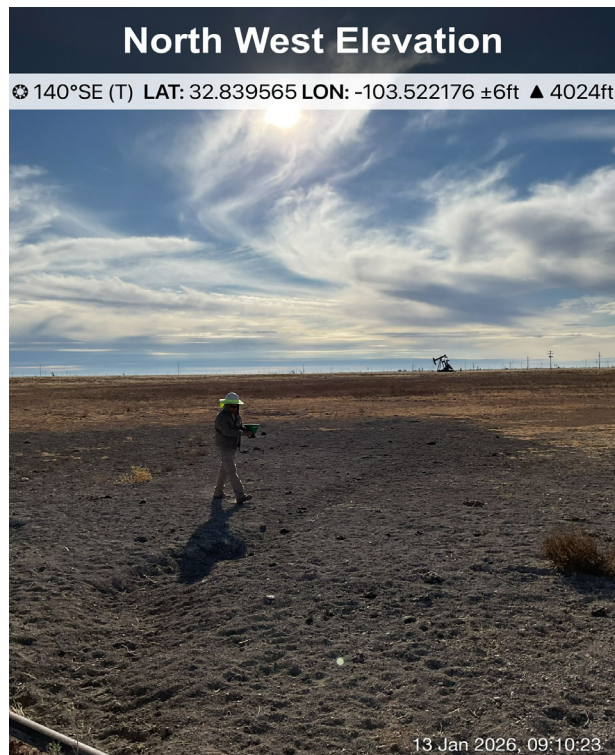
## Seeding Area

On 01/13/2026, the site was hand seeded with the landowner-preferred seed mixture (Kleingrass, “Selection 75”). Following distribution, the seed was incorporated into the soil surface by raking to promote proper seed-to-soil contact.

The site will be monitored and documented for successful vegetation growth and invasive/noxious weed populations. Annual inspections will occur until the vegetative cover established meets the life-form ratio of plus or minus fifty percent pre-disturbance levels and a total percent plant cover of at least seventy percent of pre-disturbance levels, excluding noxious weeds per 19.15.29.13 D.(3) NMAC.
