RE: **Boomslang 14 CTB 1 - Closure Request Report Addendum**  
Incident Number: nAPP2511542418  
GPS: 32.22419°, -103.54053°  
Lea County, New Mexico  
ESRR Project No. VP-342

Boomslang 14 CTB 1 - Closure Request Report Addendum  
Incident Number: nAPP2511542418  
GPS: 32.22419°, -103.54053°

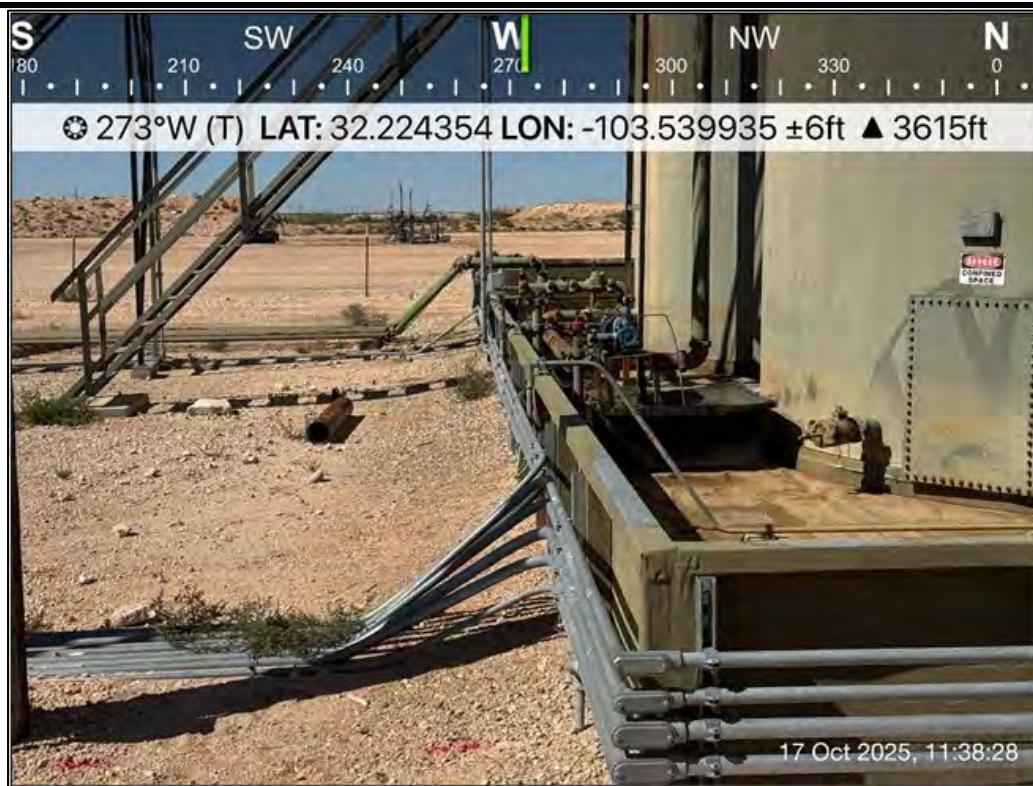
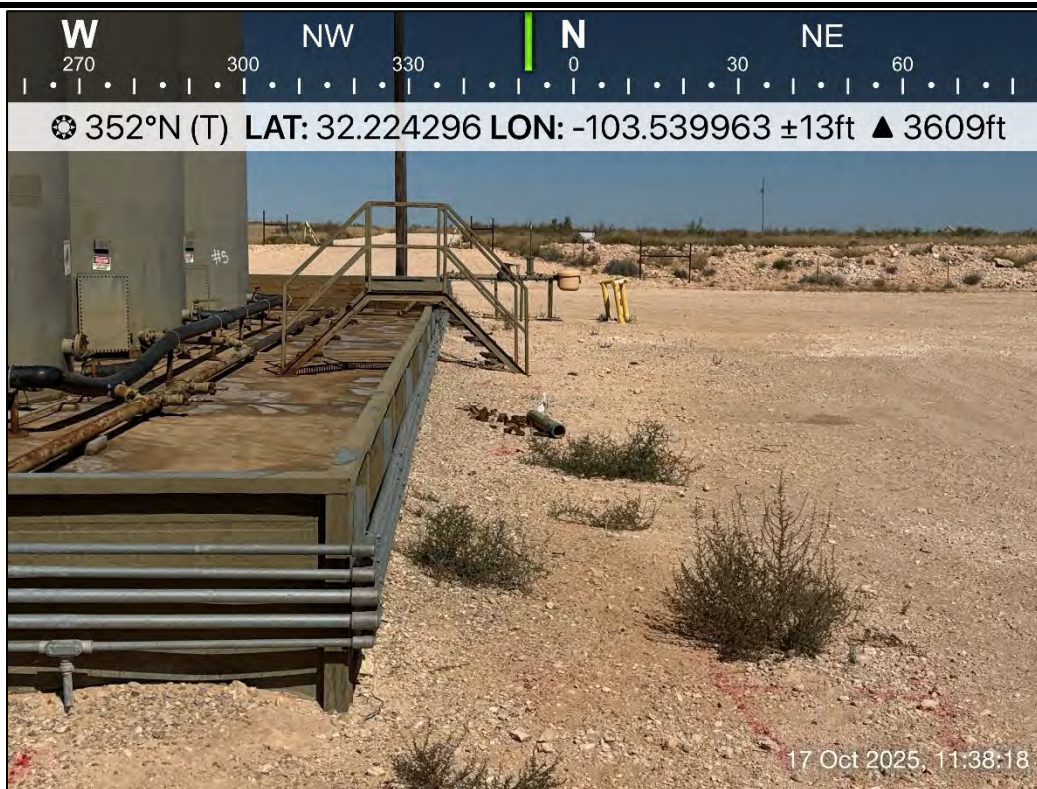
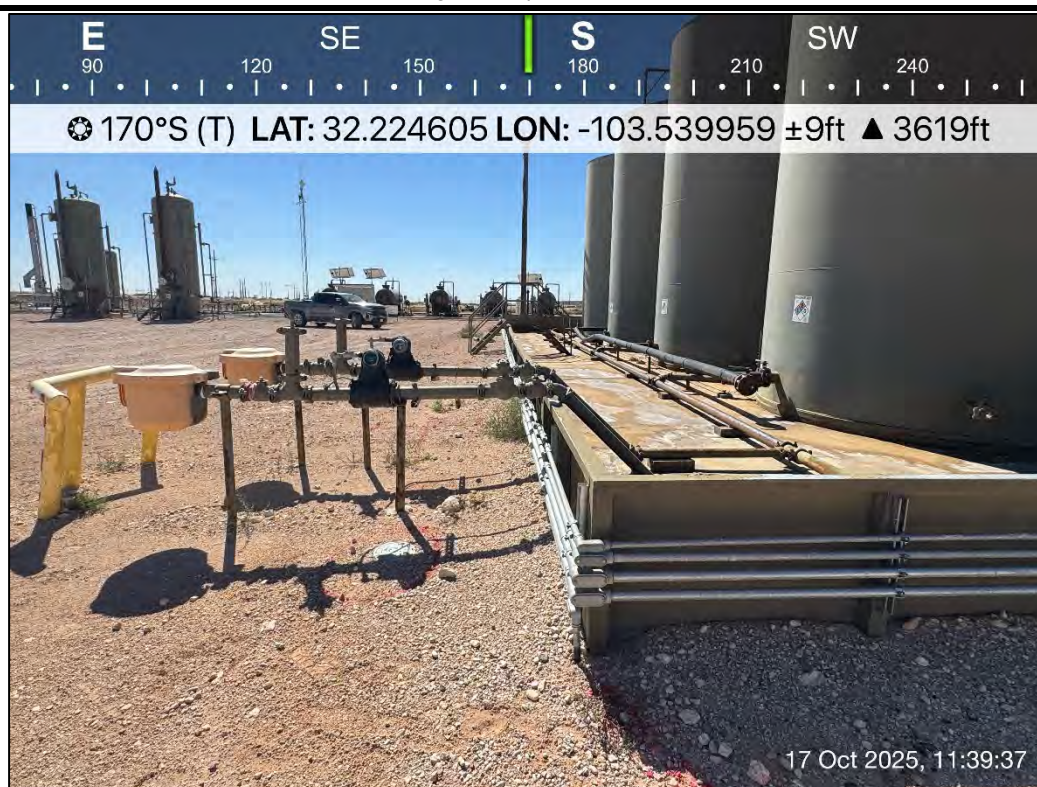
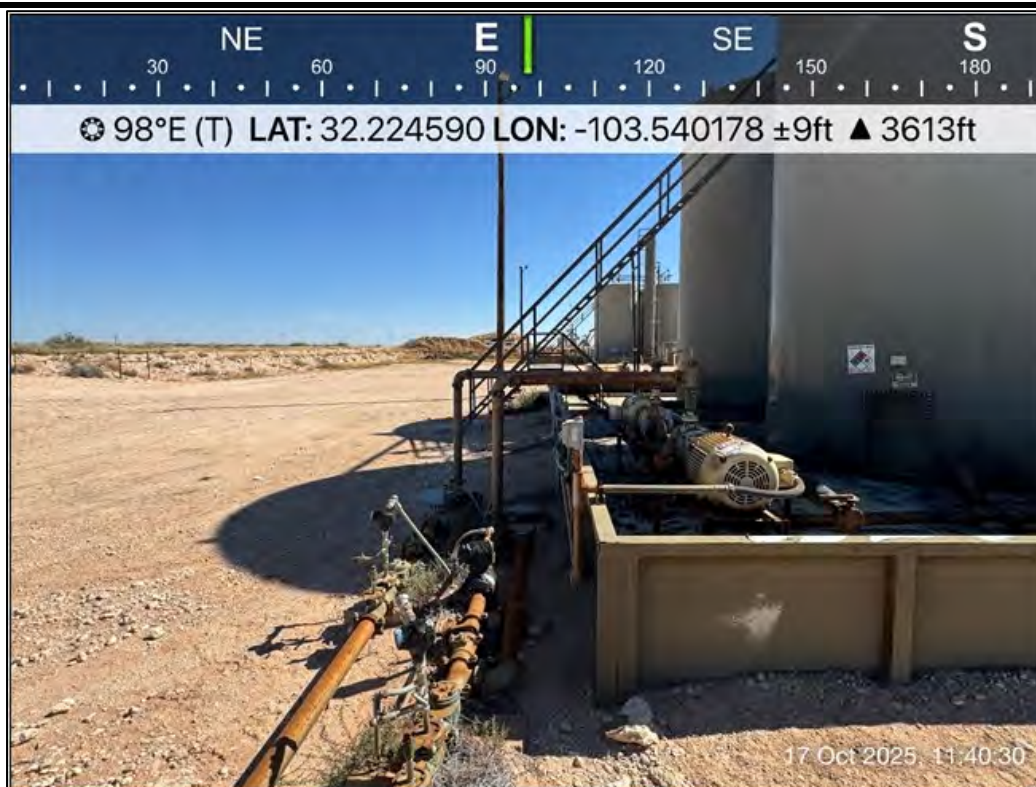
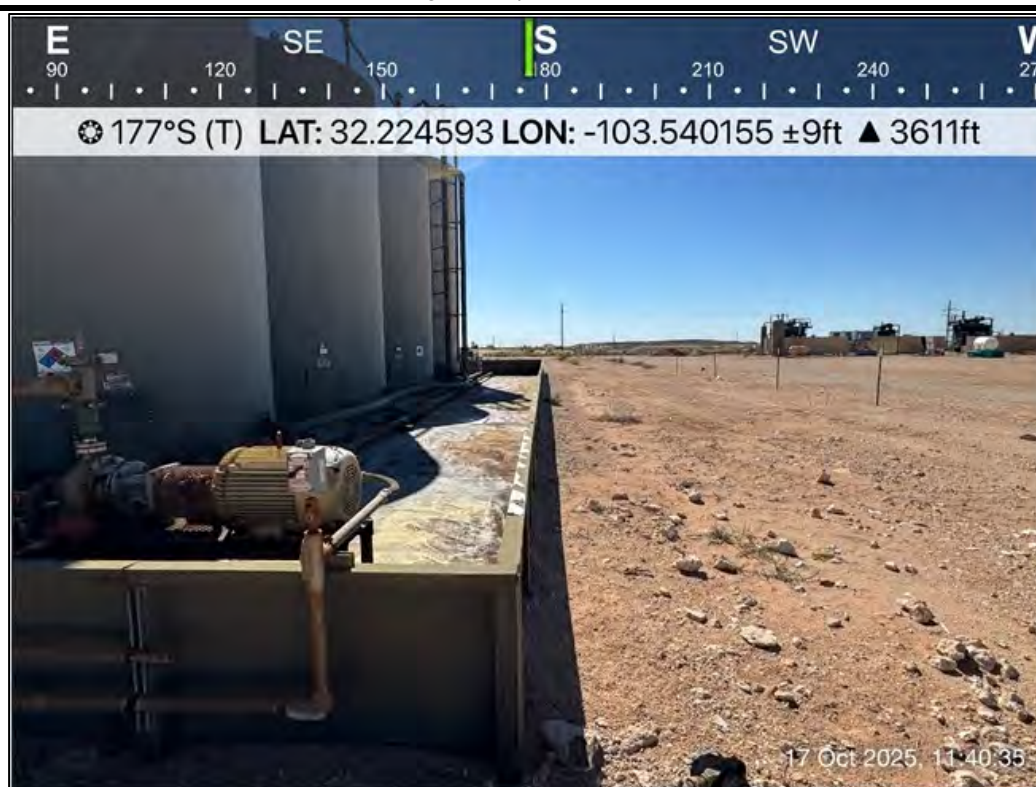
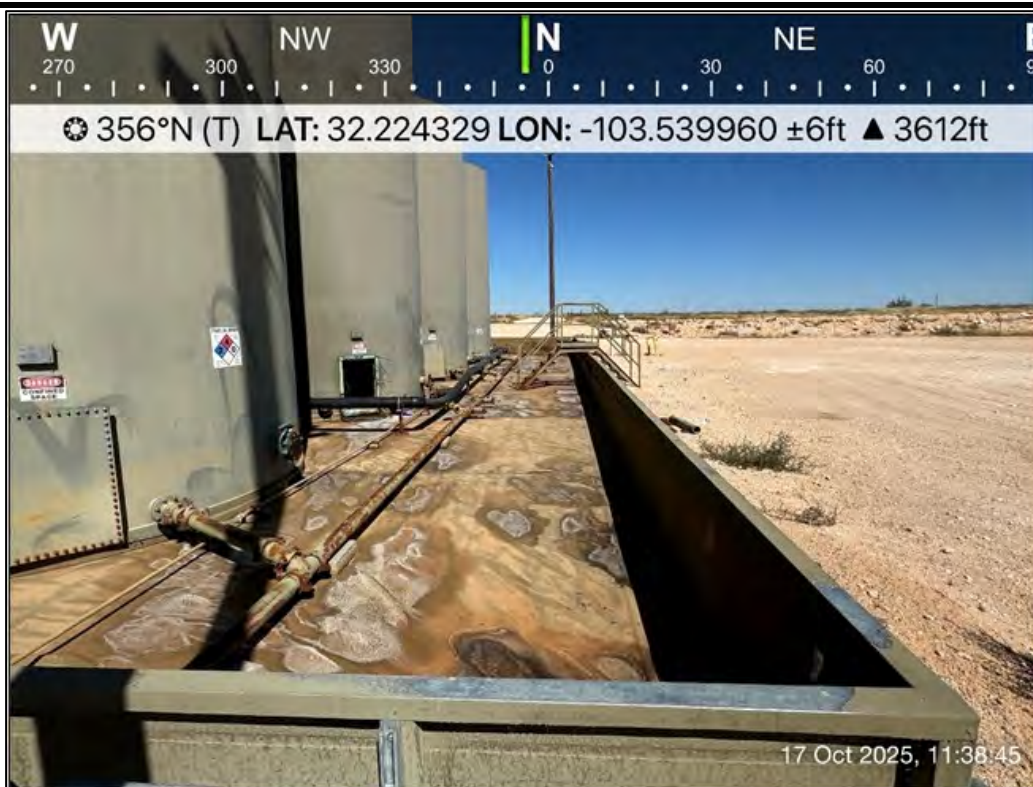
On October 17, 2025, ESRR conducted a thorough visual inspection of the LSC and found signs of damage, confirming evidence of a breach to the LSC. The LSC failed inspection and was considered to not be performing as designed due to cuts and/ or tears observed (**Figure 2**). **Photographic Documentation** of liner inspection activities is attached.
