**BASS 5 TANK BATTERY – NAPP2514349525**

**Remediation / Reclamation Closure Report**

**API No. 30-025-34550**

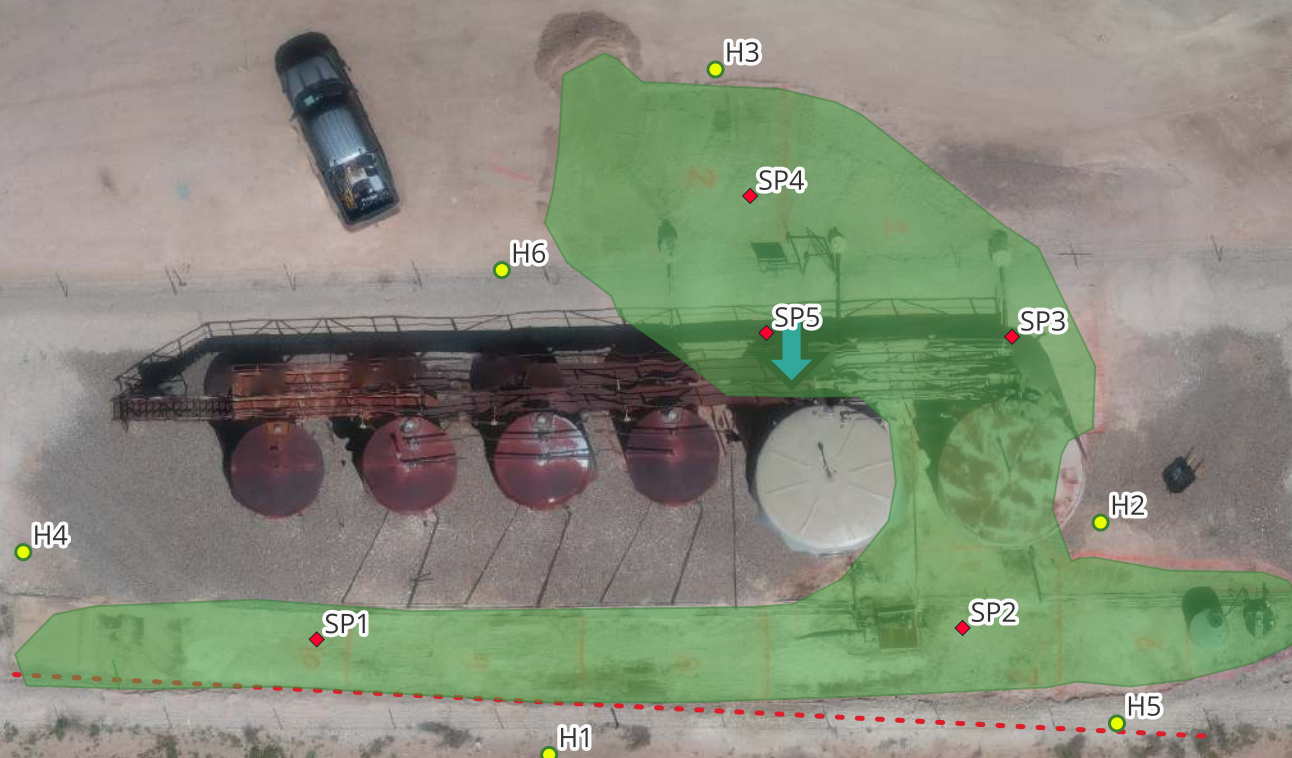
- ↓ Release Point
- ◆ Vertical Sample "SP"
- Horizontal Sample "H"
- Excavation Area

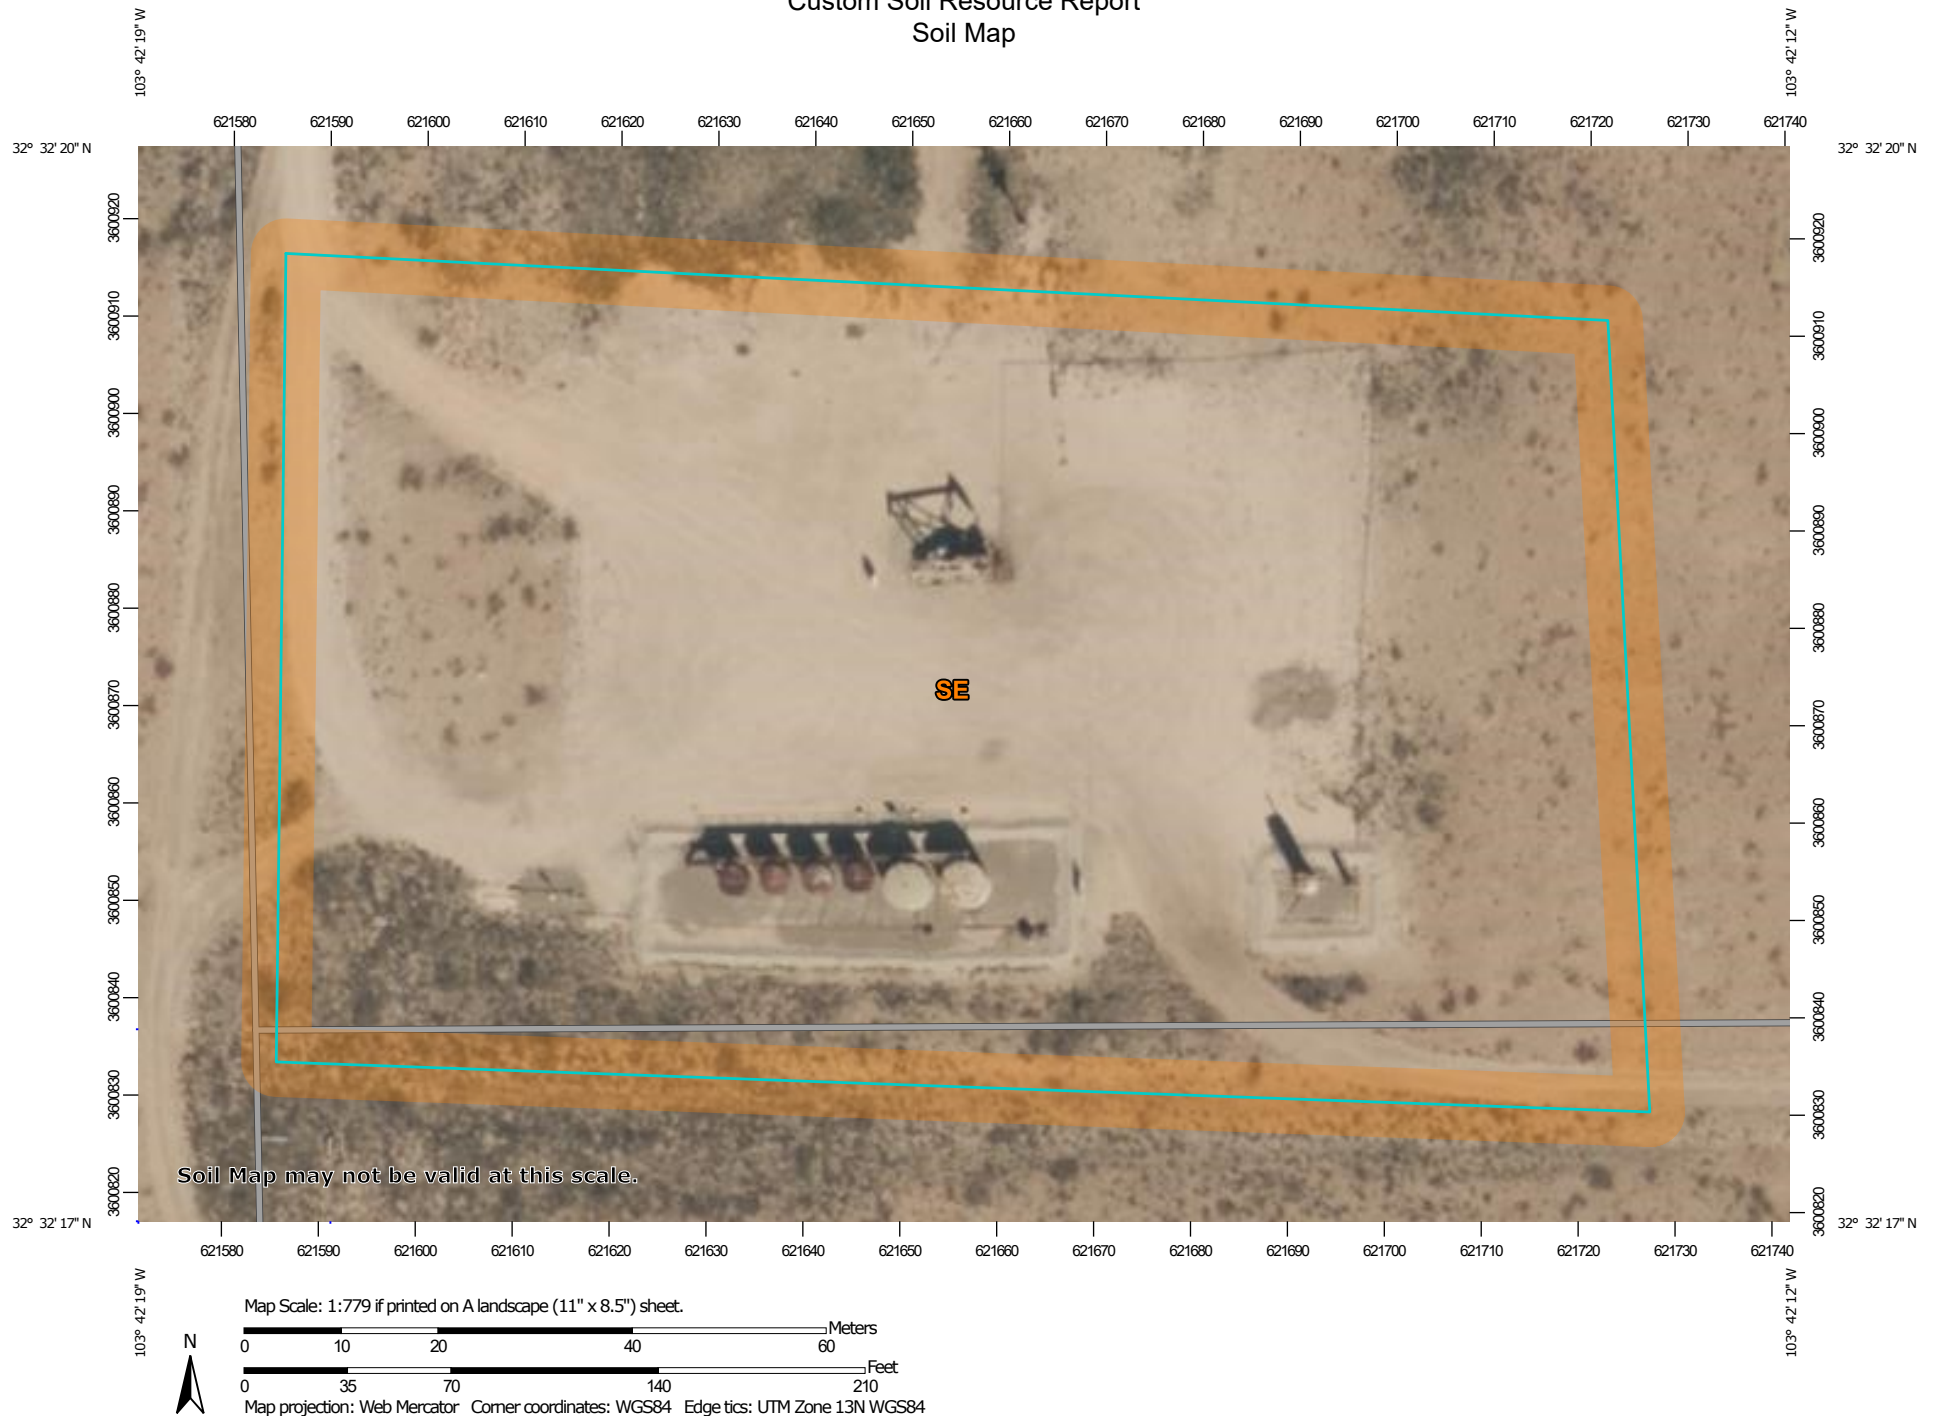
Custom Soil Resource Report  
Soil Map

The soil map section includes the soil map for the defined area of interest, a list of soil map units on the map and extent of each map unit, and cartographic symbols displayed on the map. Also presented are various metadata about data used to produce the map, and a description of each soil map unit.
