**Re: Remediation Report and Closure Request**

San Juan 30-5 #20M  
Hilcorp Energy Company  
NMOCD Incident No: nAPP2604754797

Ensolum, LLC (Ensolum), on behalf of Hilcorp Energy Company (Hilcorp), submits this *Remediation Report and Closure Request* for a release at the San Juan 30-5 #20M natural gas production well (Site). The Site is located on private surface in Unit G, Section 8, Township 30 North, Range 5 West, Rio Arriba County, New Mexico (Figure 1). This report summarizes soil delineation and confirmation sampling activities conducted at the Site. Analytical results indicated concentrations of constituents of concern (COCs) were not detected above applicable Closure Criteria, demonstrating impacts associated with the release have been adequately delineated and no longer remain at concentrations exceeding Closure Criteria.

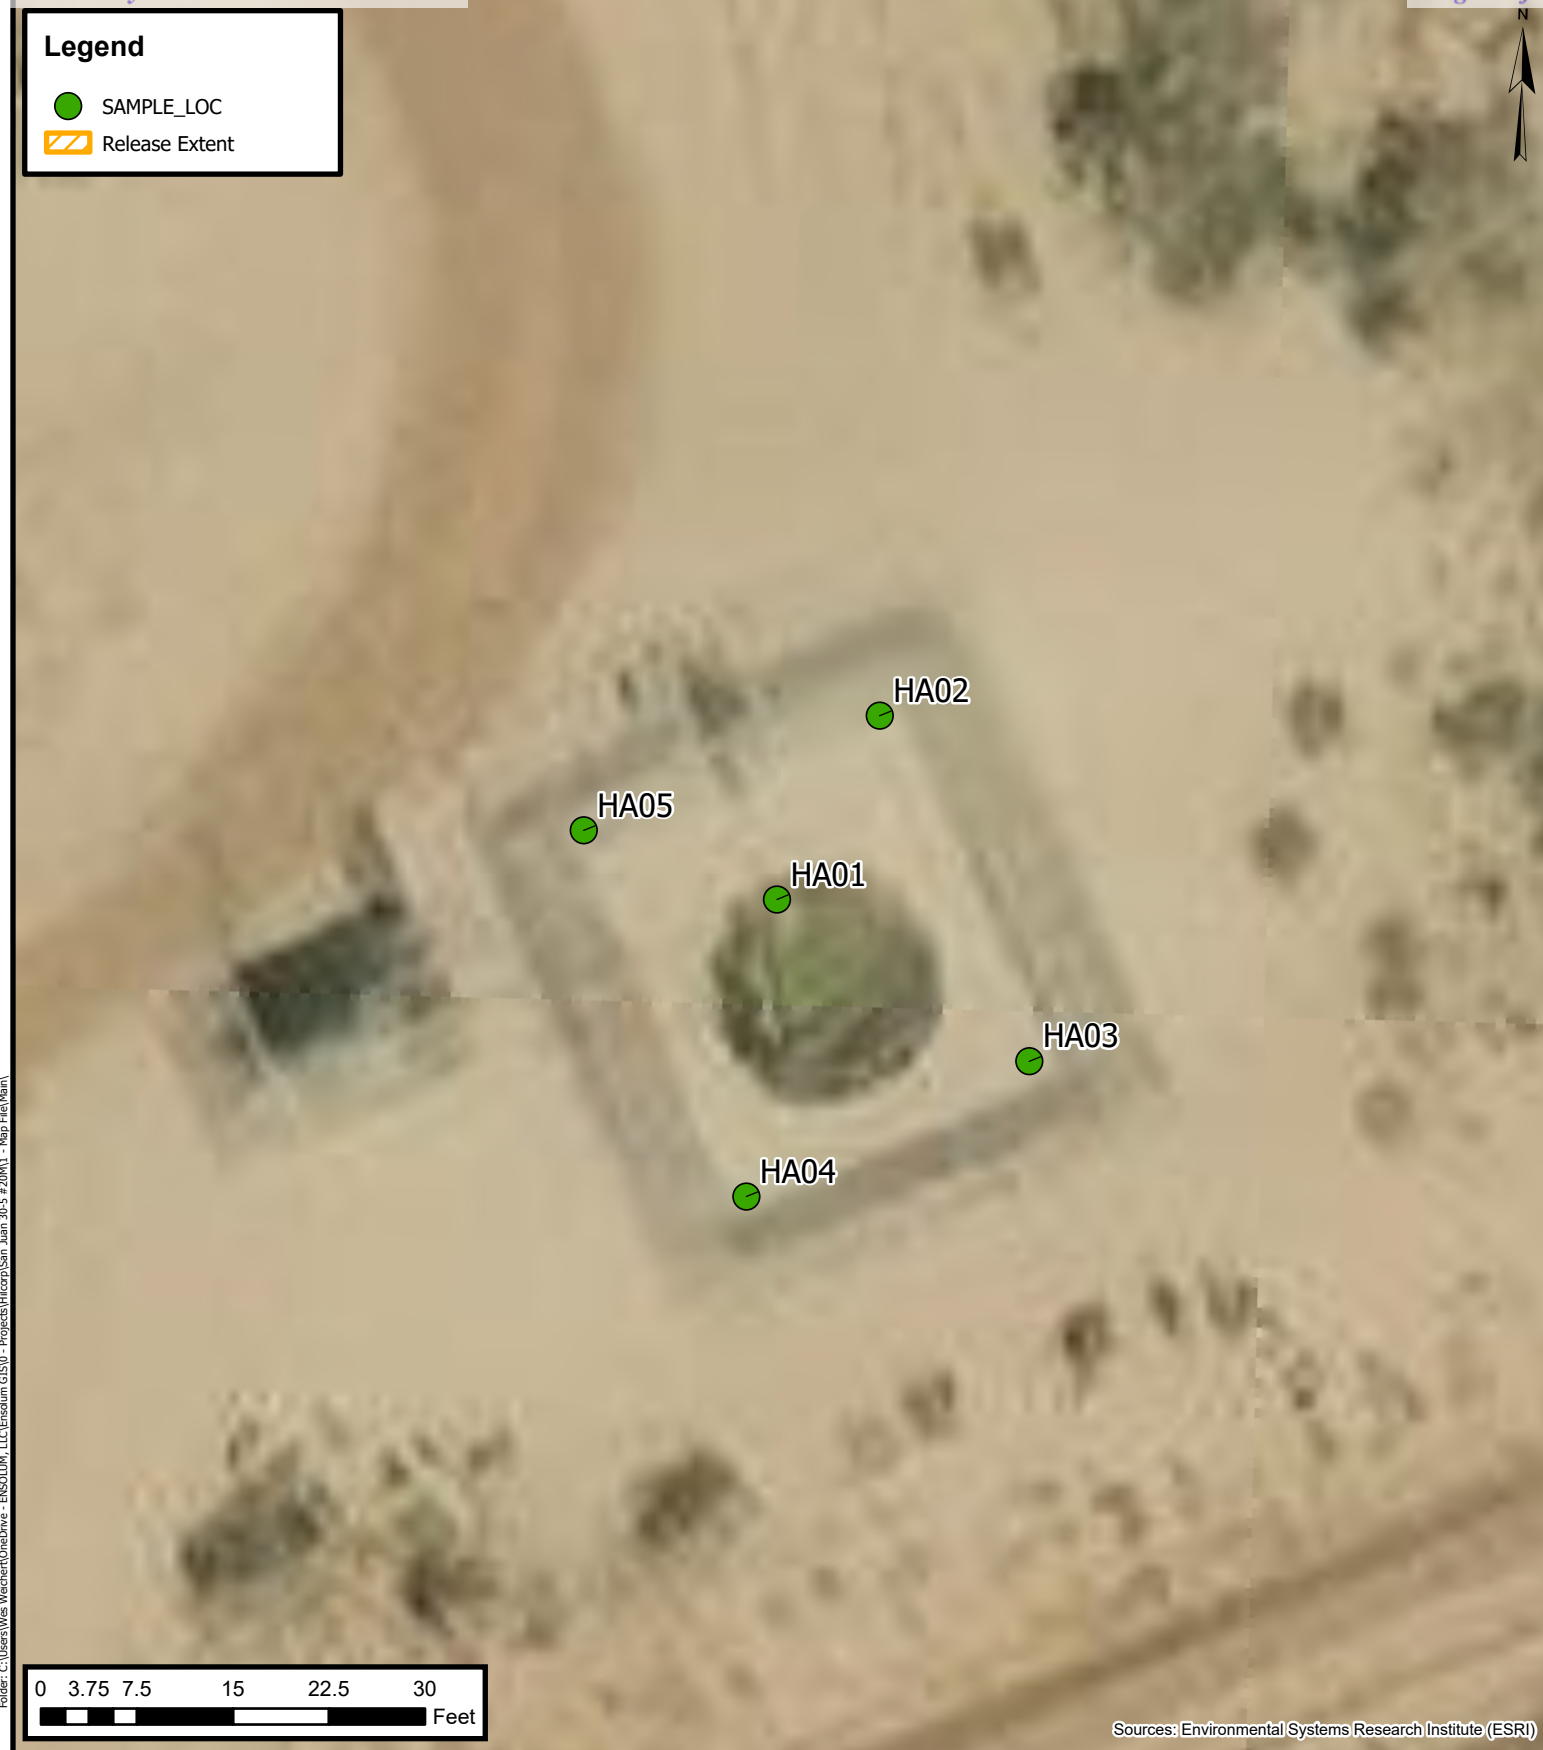
**FIGURE**  
**2**

## Delineation Soil Sample Locations

Hilcorp Energy Company  
San Juan 30-5 #20M  
Incident Number: nAPP2604754797  
36.8280983,-107.380043  
Rio Arriba County, New Mexico

Upon discovery of the release, Hilcorp retained Ensolum to conduct hand auger delineation activities on February 25, 2026. Notification of sampling activities was provided to the NMOCD prior to the delineation work (Appendix B). A total of five hand auger boreholes (HA01 through HA05) were advanced at the Site to depths up to 7.5 feet bgs (Figure 2).

Hand auger borehole HA01 was advanced within the BGT pit cribbing and immediately adjacent to the BGT (source area) to evaluate the vertical extent of impacts at the location of greatest potential impact. Step-out boreholes HA02 through HA05 were advanced radially from the source area to delineate the lateral extent of impacts.

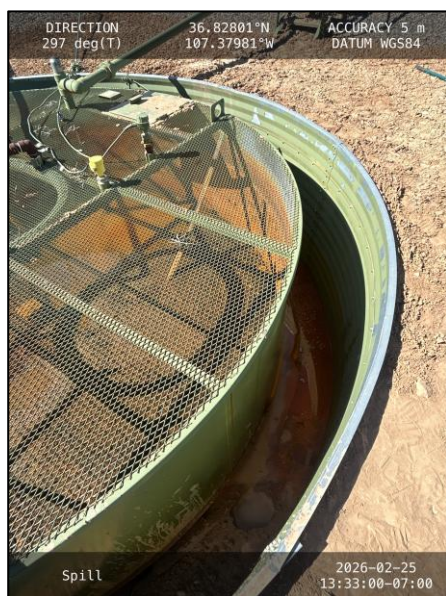
Photograph: 1 Date: 02/25/2026  
Description: The source of the release and standing fluid within the BGT containment pit.  
View: West

The release was confined to the interior of the berm and pit cribbing, impacting an area approximately 20 feet by 20 feet to a depth of approximately 6 feet below ground surface (bgs). Standing water was observed within the cribbing at the time of discovery. Immediate response actions included removal of standing water and recovery of fluids within the BGT, which was subsequently pumped dry and taken out of service. Corrective actions included repairing and re-coating of the BGT to prevent recurrence.

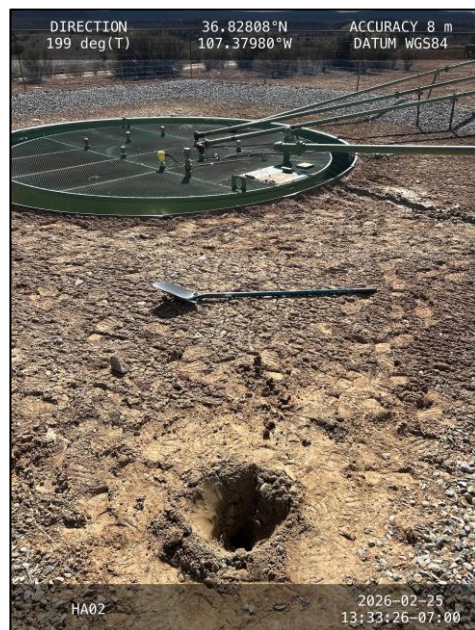
Photograph: 3 Date: 02/25/2026  
Description: Hand auger boring HA02, advanced to the north of the source of the release.  
View: South

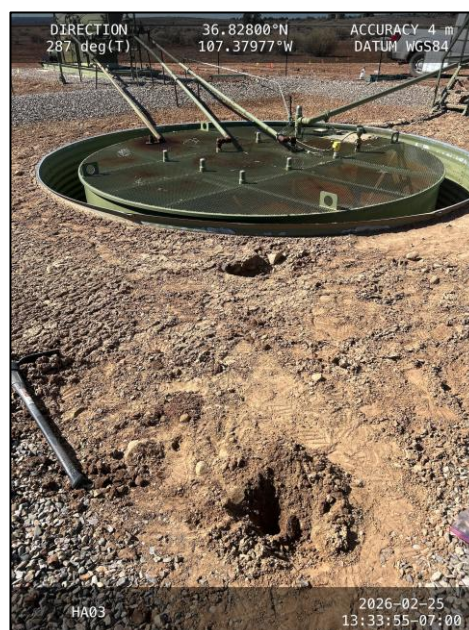
Photograph: 4 Date: 02/25/2026  
Description: Hand auger boring HA03, advanced to the east of the source of the release.  
View: West

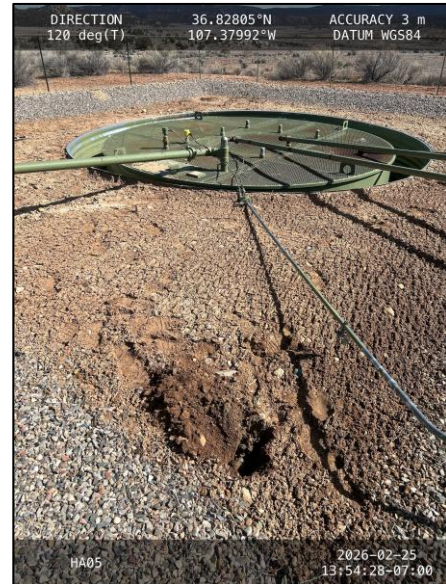
Photograph: 6 Date: 02/25/2026  
Description: Hand auger boring HA05, advanced to the west of the source of the release.  
View: Southeast
