SUBJECT: Liner Inspection and Closure Report for RDX Federal 17 #016H Tank Battery– June 30, 2026  
Site Visit

Incident ID: nAPP2614229487

API Number (Name): 30-015-41089 (RDX FEDERAL 17 #016H TANK BATTERY)

# Environmental Liner Inspection Field Notes & Photolog Report

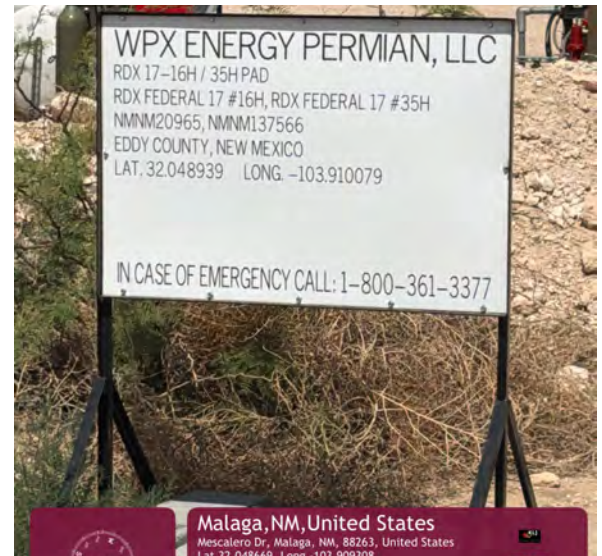
~~1~~ Liner inspection

- Arrive on site, check for hazards
- Begin inspection
- Inspect liner and look for any areas that look brittle, ripped, or torn.
- Take photos of containment from different angles around the tanks and equipment
- Photos at each cardinal direction
- Liner has been pressure washed and cleaned
- No signs of perforations, weathering or spots potential of a breach.
- Liner integrity confirmed & passed inspection

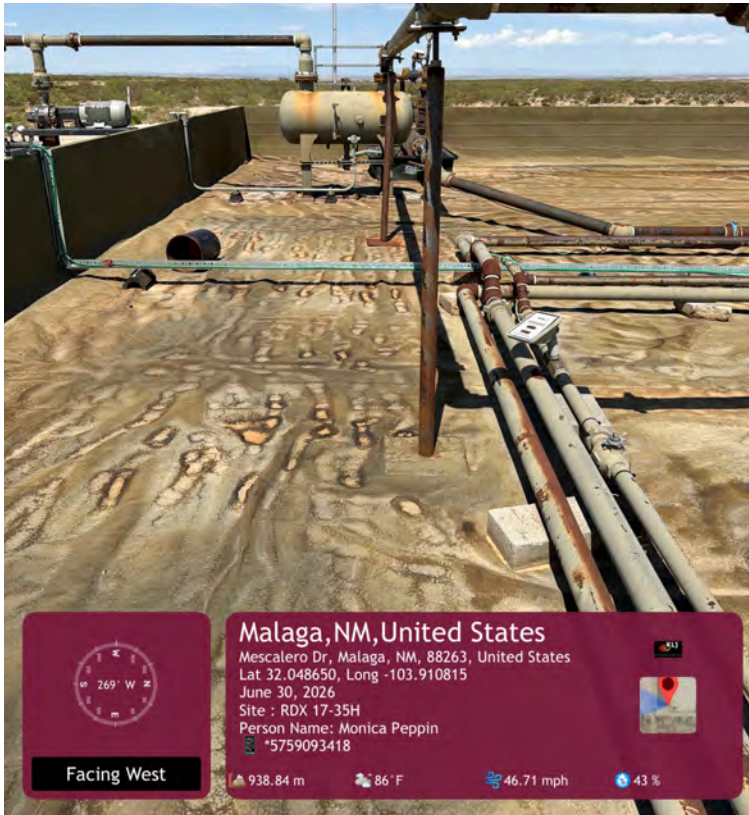
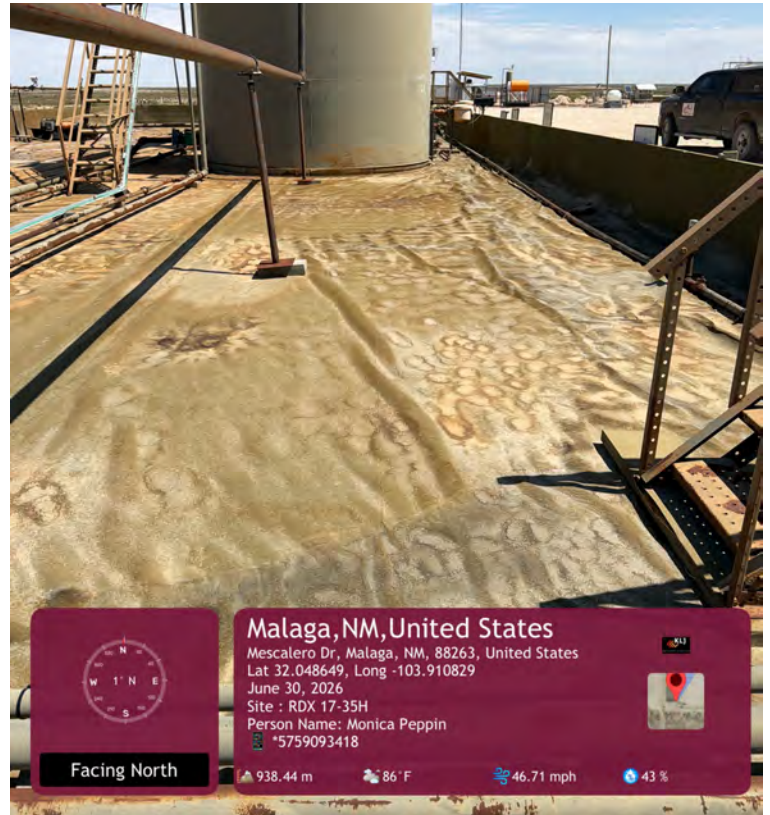
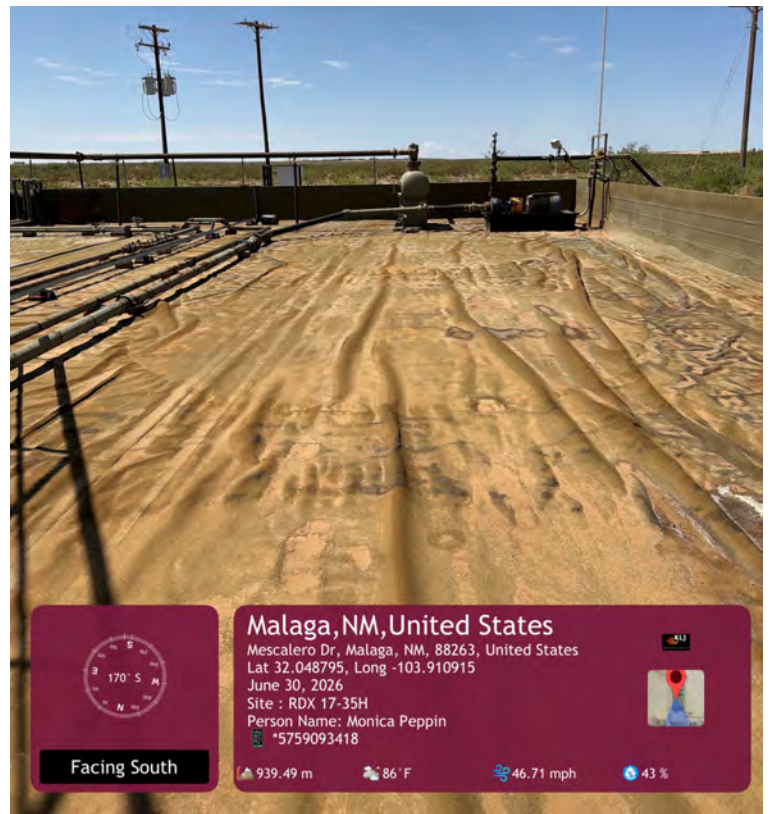
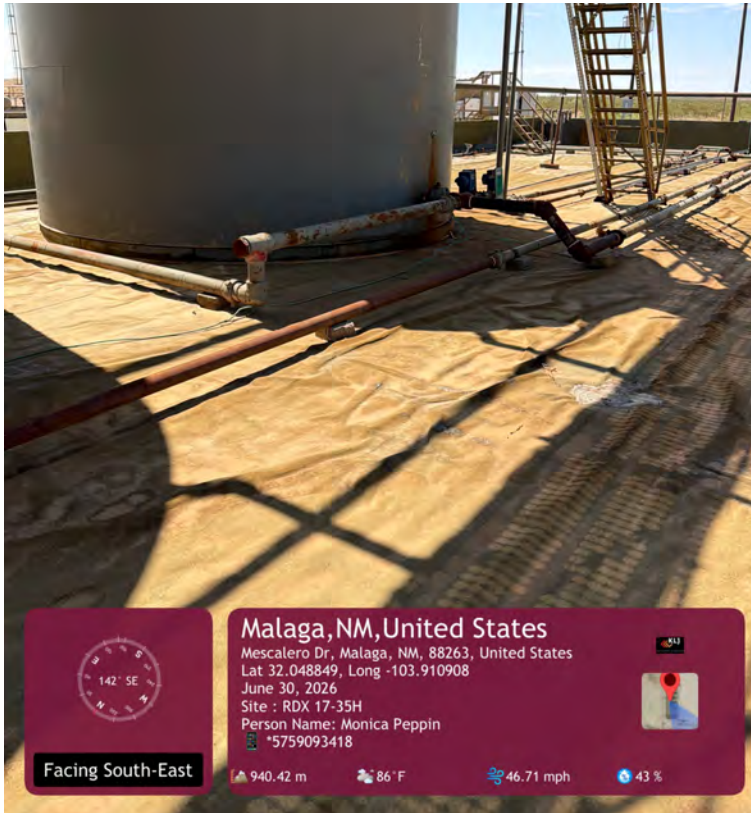
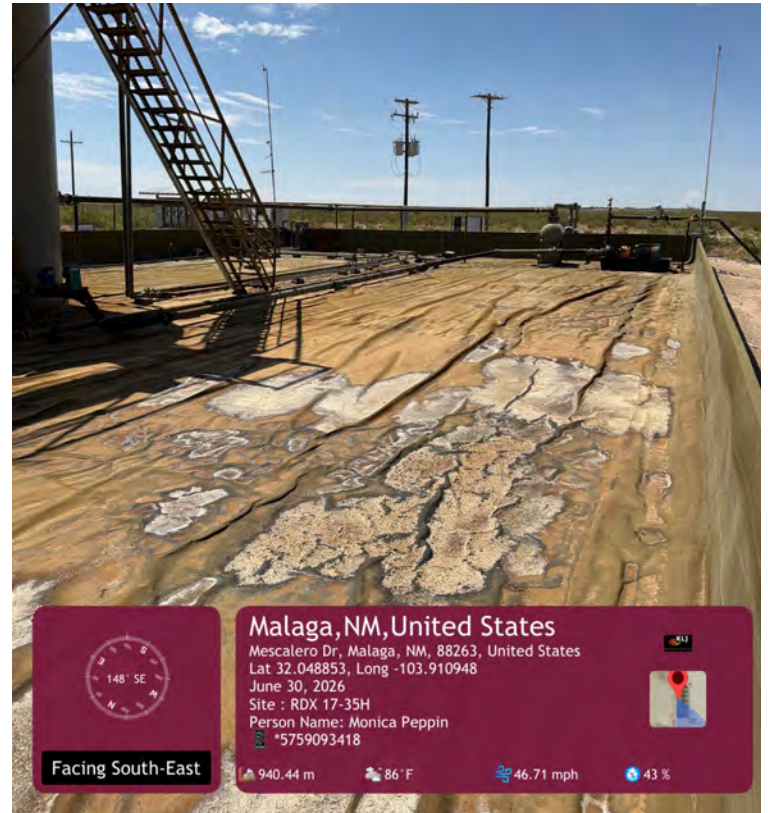
# Photolog

During the visit on June 30, 2026, KLJ personnel conducted a visual inspection of the secondary containment to verify liner integrity. Observations included checks for perforations, tears, cuts, or weathering that could compromise containment performance. The liner was confirmed to be intact, with no observed integrity issues or conditions requiring repair or replacement. Photographic documentation is included in the Liner Inspection Field Notes & Photolog Report (**Appendix A**).

- Visual observation of liner is complete.
- Liner integrity confirmed and passes inspection.
- Upload field notes and photos for field report for supporting documentation.
- No additional recommendations or further actions required.
