# **Liner Inspection and Closure Report**

**Solaris Water Midstream LLC**

Pintail Reuse Facility

Incident ID: nAPP2618250645

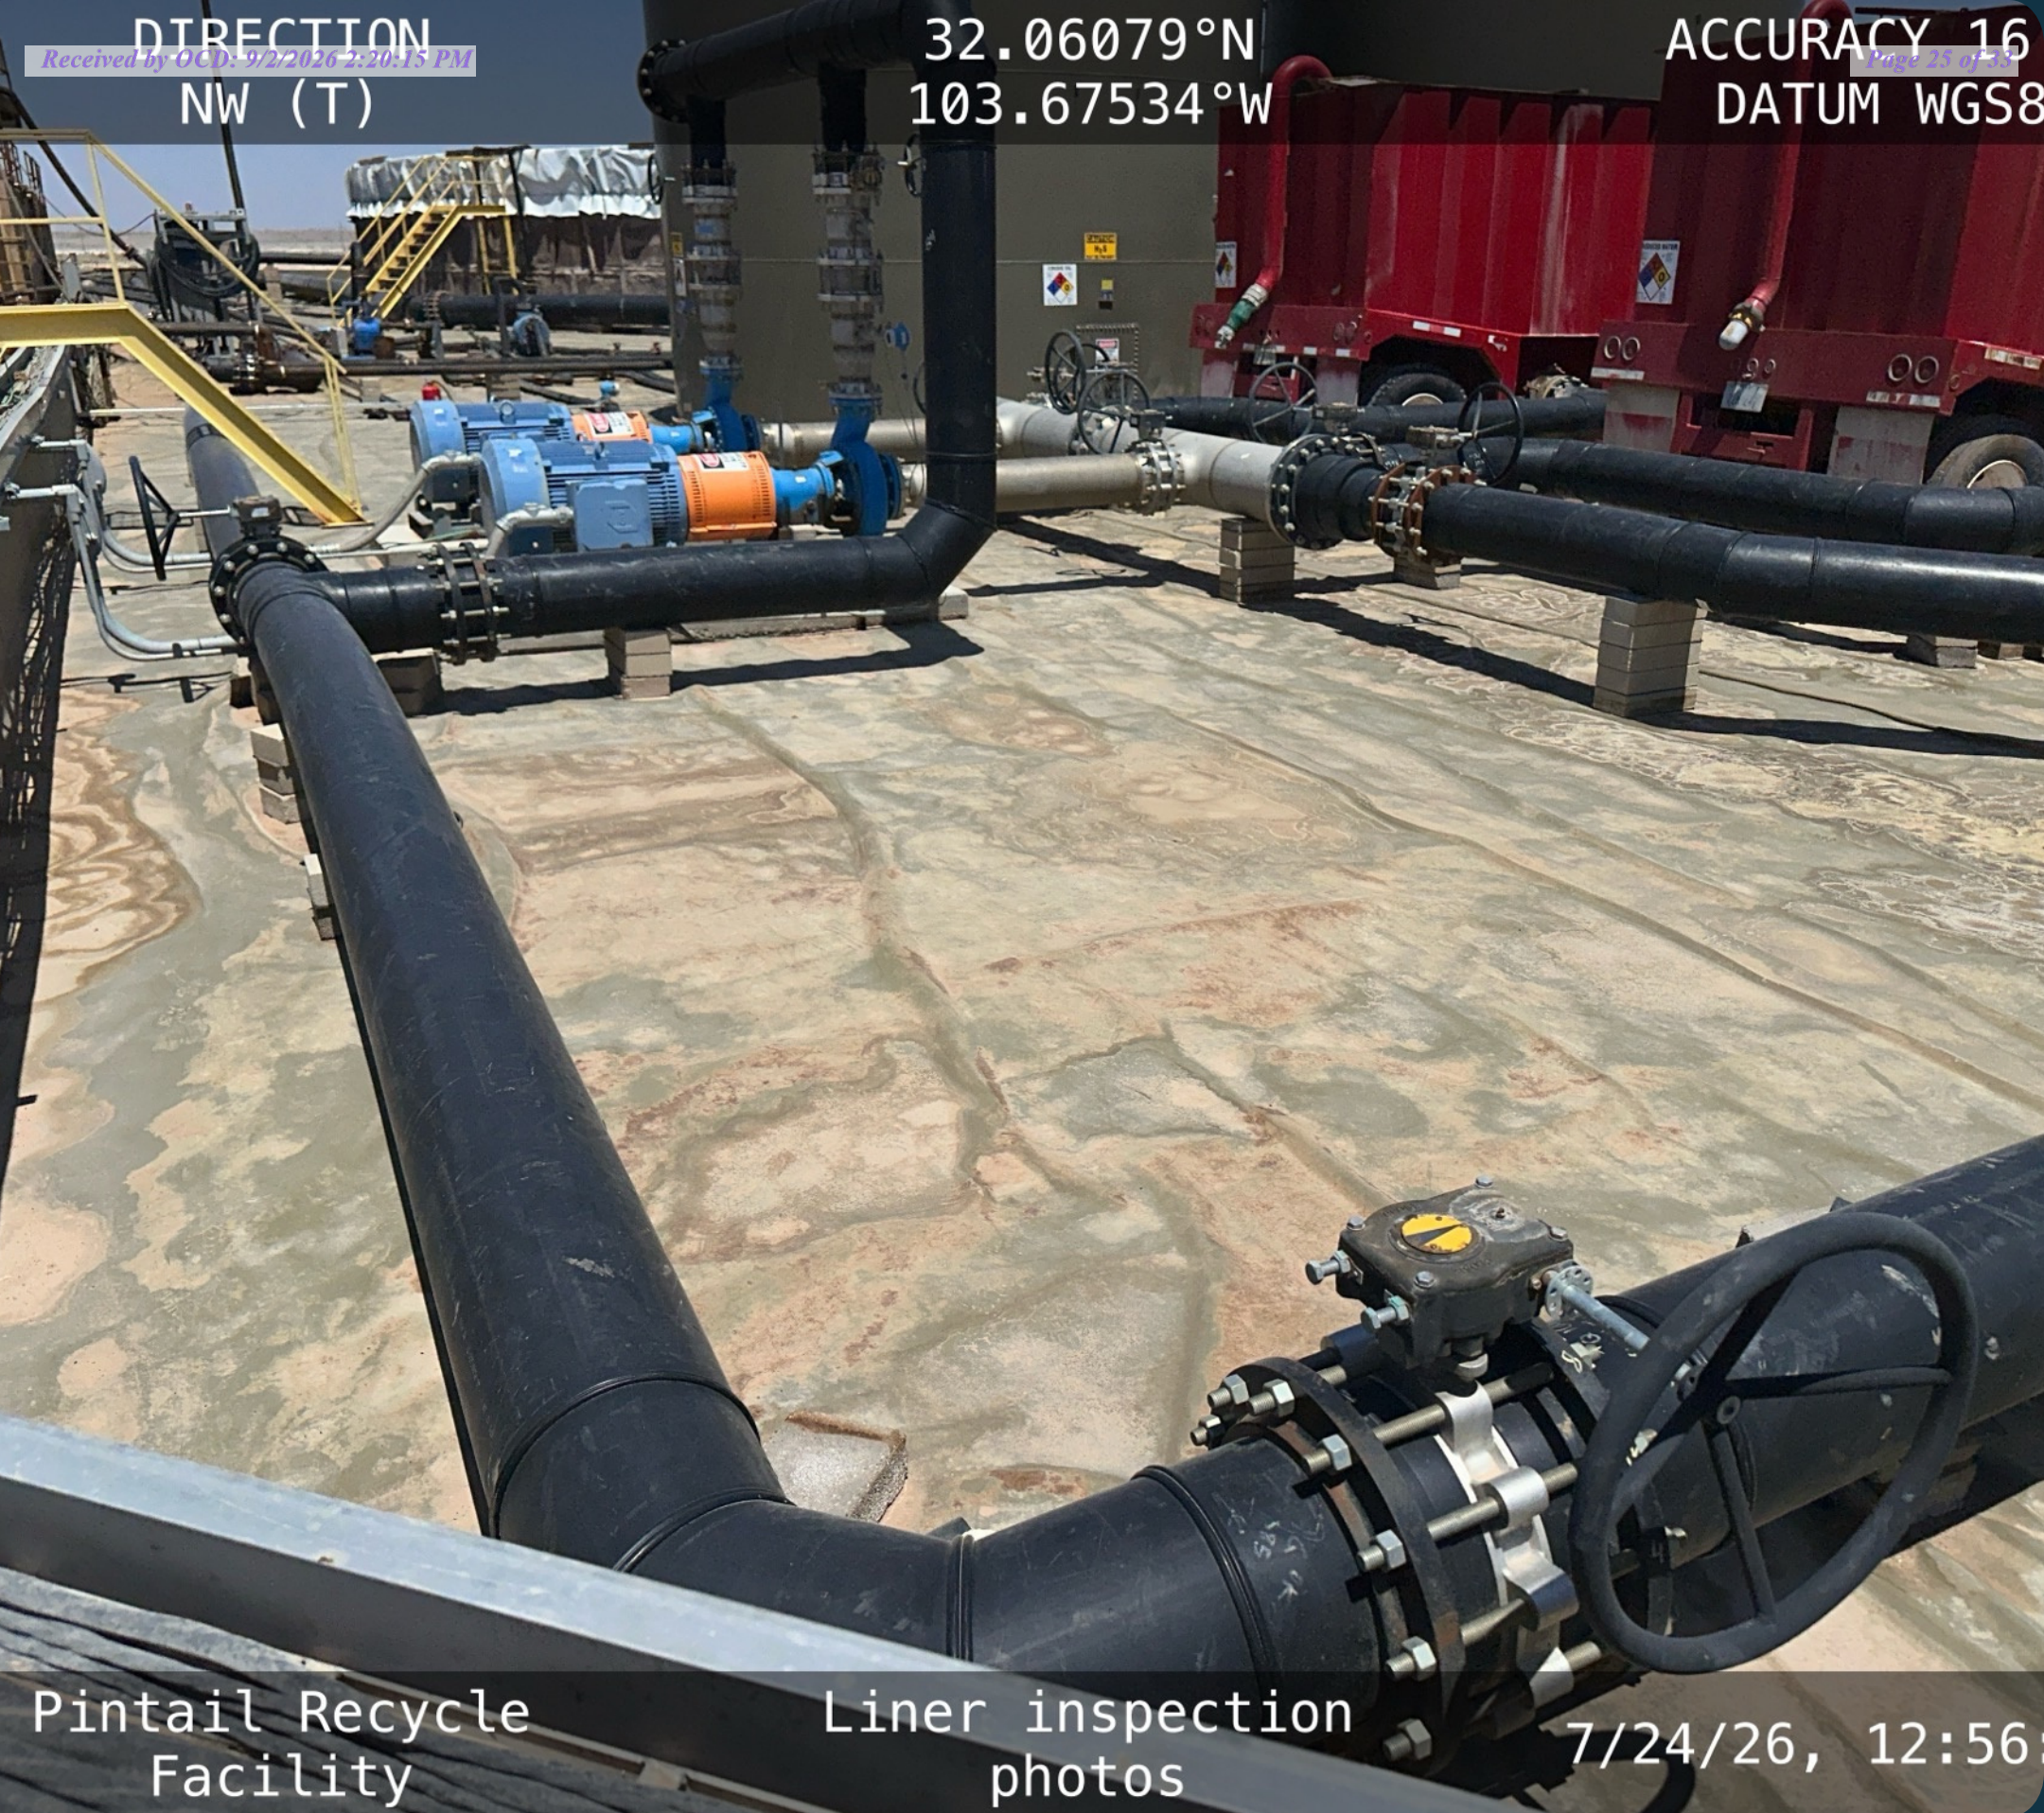
DIRECTION  
NW (T)

| Inspection Question | Yes | No | Comments |
|---|---|---|---|
| Is the liner retaining any fluids? | | X | |
| Does the liner have integrity to contain a leak? | X | | |
