Justis SWD

C-144s

**(North & South
BGTs)**

Closure Reports

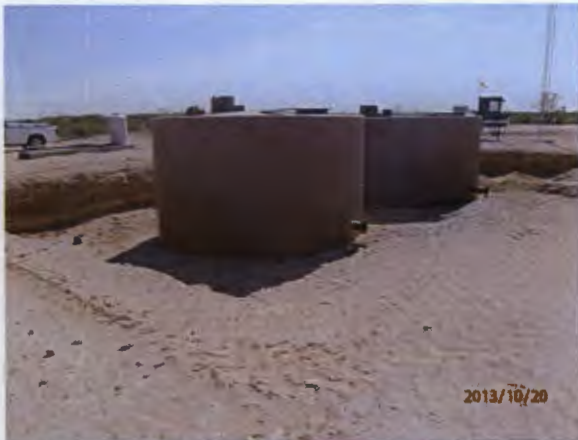
former below grade tanks 10/22/2013

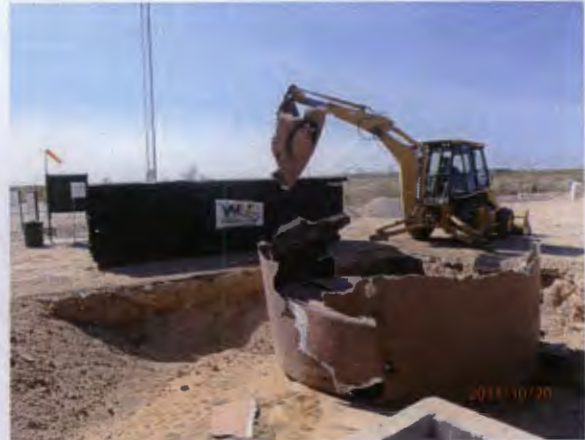
removing the below grade tanks 10/22/2013

Based on the October 7, 2013, Finalization of Below Grade Tank Closure Plan, the north and south below grade tanks were removed from the site on October 22, 2013 and were properly disposed. On November 4, 2013, a composite sample was collected from the area beneath the former north tank. Laboratory analysis of the North Tank 5 Pt. Comp resulted in chloride, TPH, and BTEX concentrations below detectable limits.

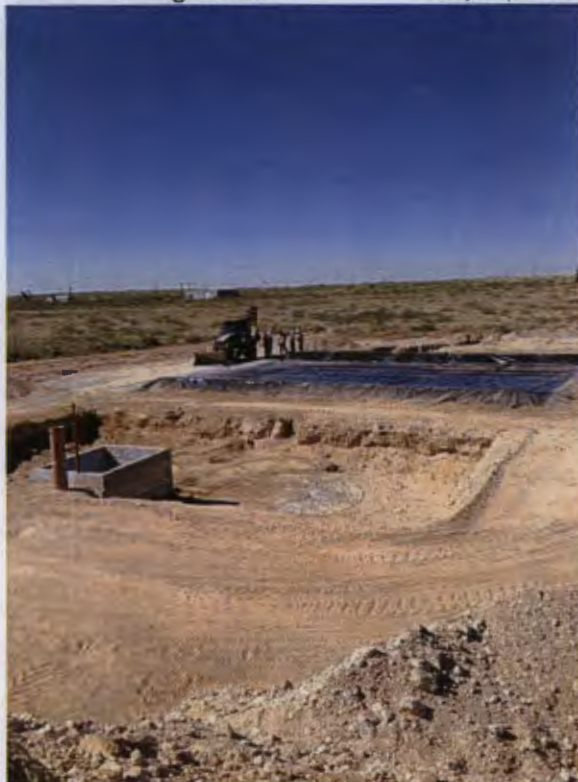
below grade tanks removed with new facility
being built in the background, facing southwest
10/22/2013

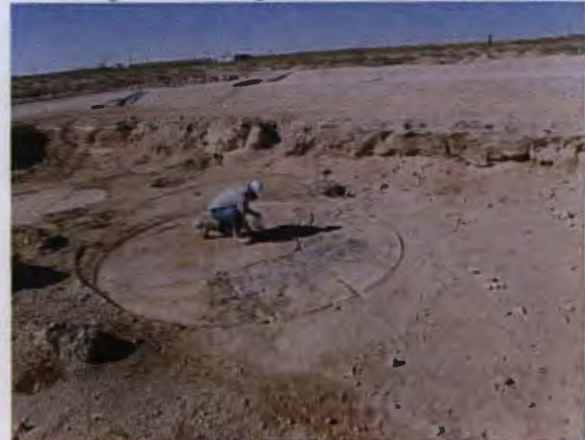
sampling beneath the former north BGT,
facing southwest 11/4/2013

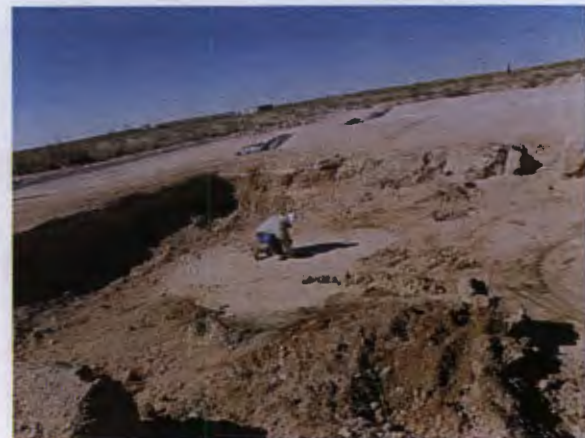
sampling beneath the former south BGT,
facing southwest 11/4/2013

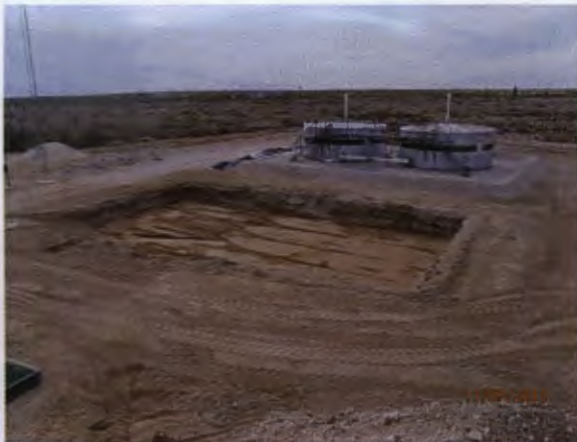
excavation padded with 6 inches of blow sand,
facing southwest 11/7/2013

To further protect groundwater, a 56x30-ft, 20-mil reinforced liner was installed at approximately 4 ft below ground surface (bgs). The top and the bottom of the liner was then padded with 6 inches of imported soil. Laboratory analysis of the imported soil resulted in a chloride concentration below detectable limit and a PID (field) reading of 0.0. The remaining excavation was backfilled with the remaining caliche previously

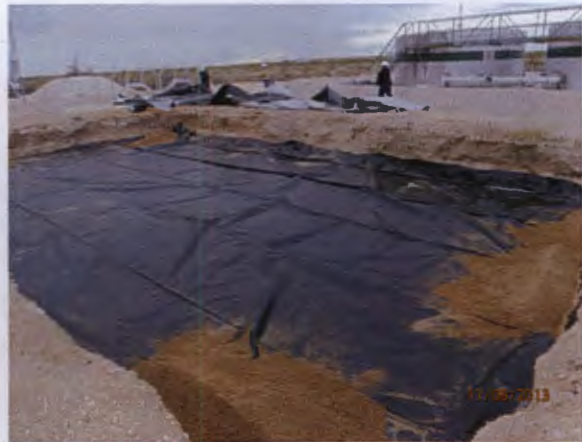
20-mil reinforced liner installed at 4 ft bgs,
facing southwest 11/8/2013

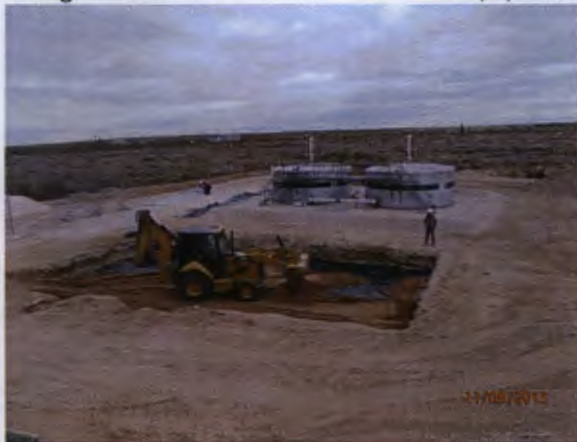
padding the liner with 6 inches of blow sand,
facing southwest 11/8/2013

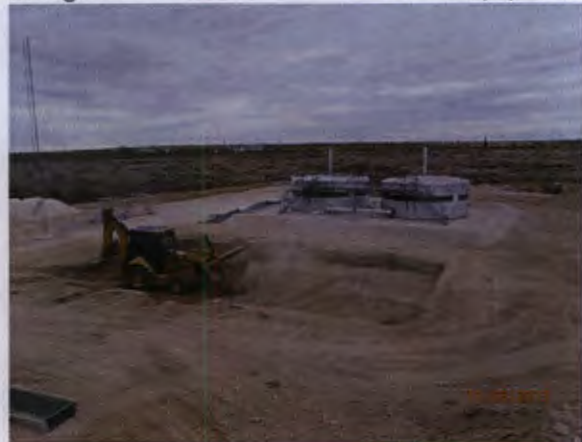
backfilling the excavation with caliche,
facing southwest 11/8/2013

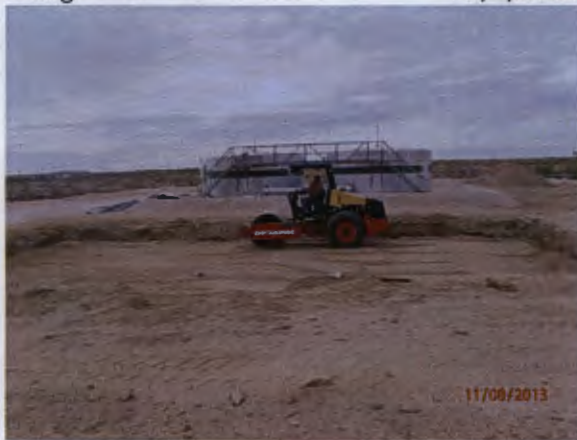
compacting the caliche, facing west 11/8/2013

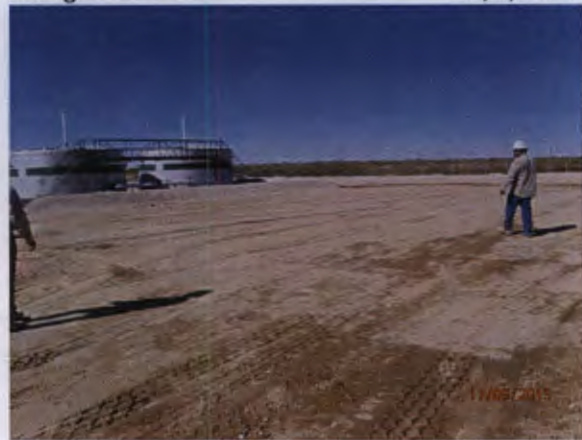
site complete, facing northwest 11/9/2013

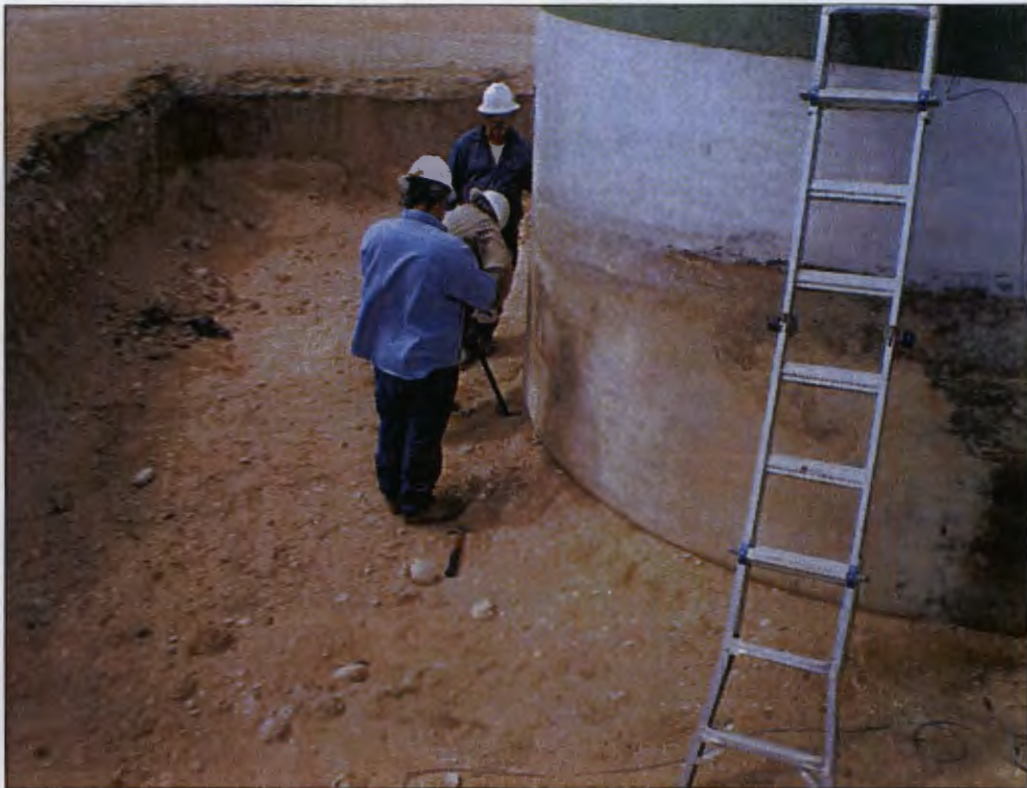
Photograph C– View of soil augering under south tank.

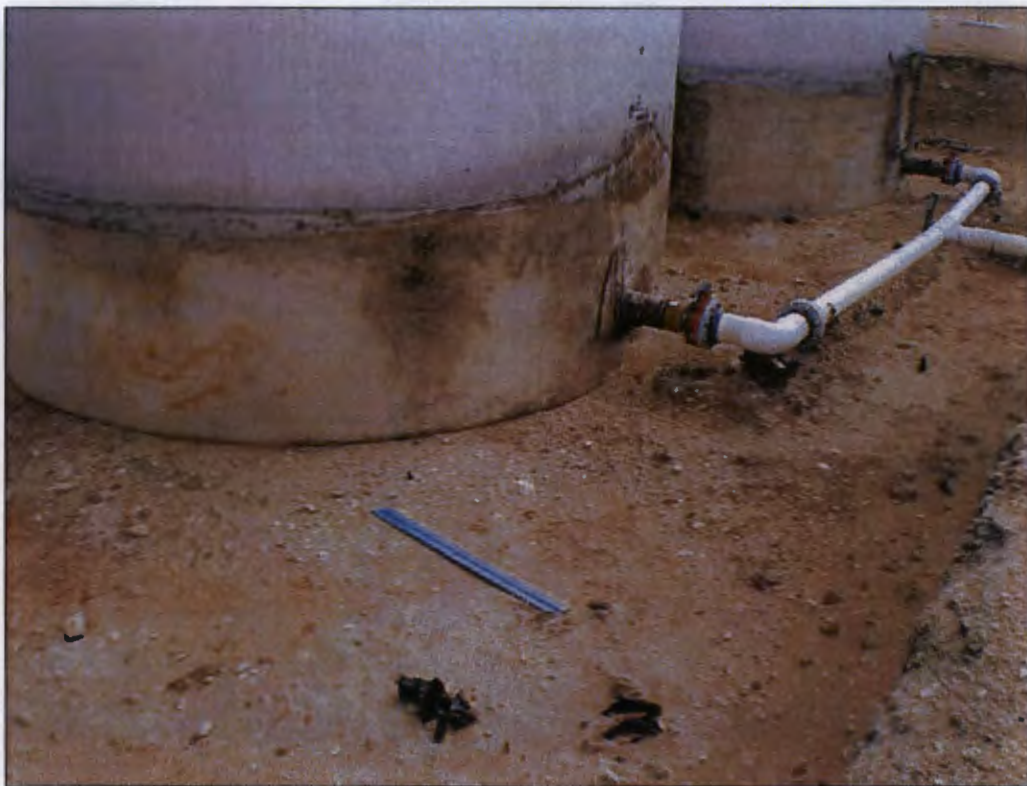
Photograph D – View of north (left) and south (right) below-grade tanks and appurtenances.

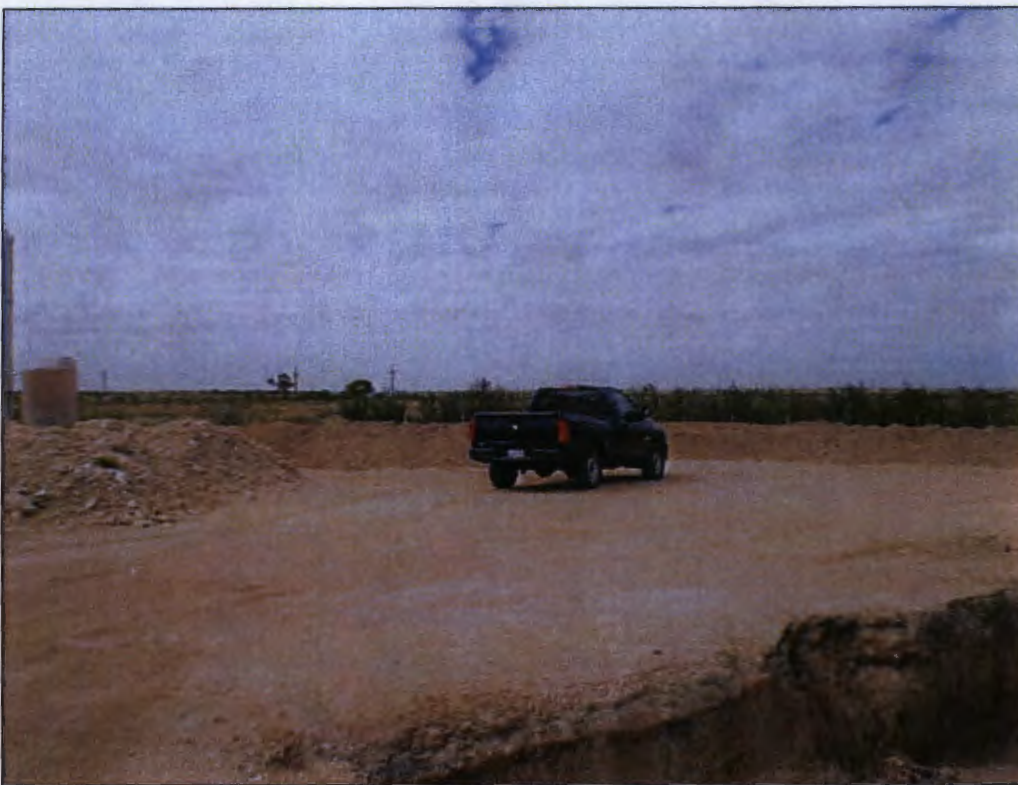
Photograph F – View of excavated soil (beyond truck) from edge of tank area.

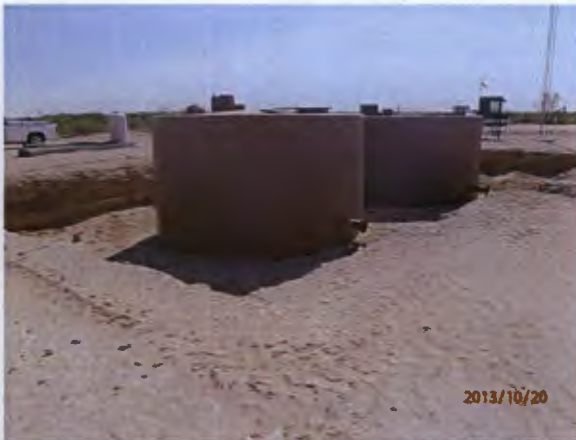
former below grade tanks 10/22/2013

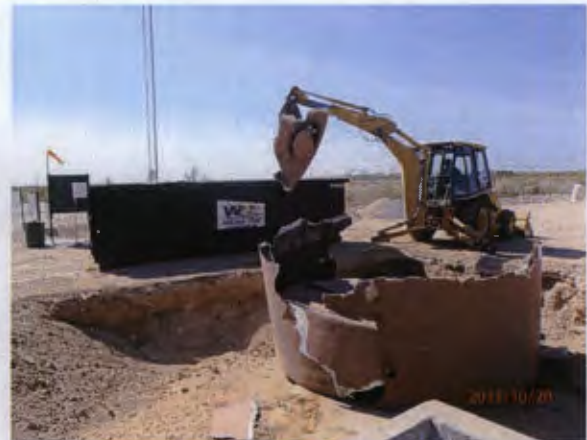
removing the below grade tanks 10/22/2013

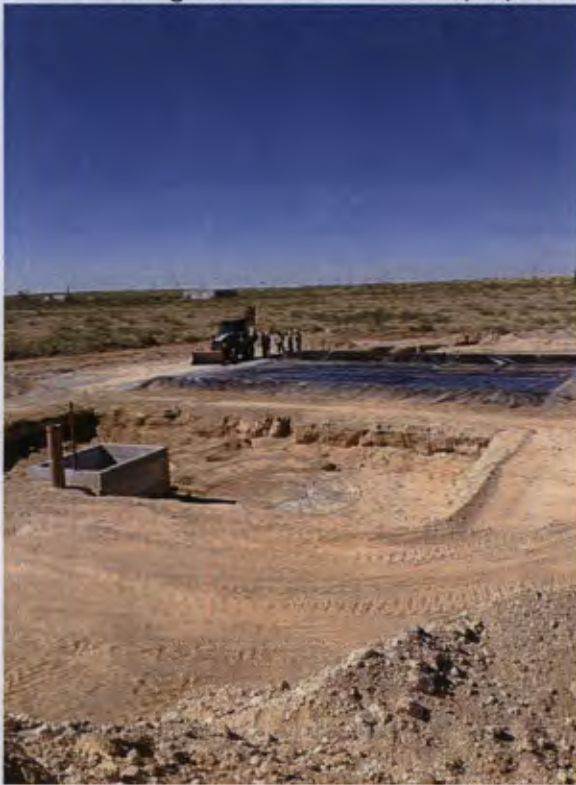
below grade tanks removed with new facility
being built in the background, facing southwest
10/22/2013

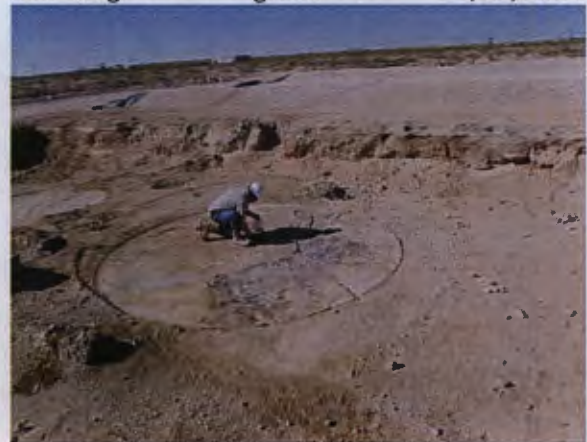
sampling beneath the former north BGT,
facing southwest 11/4/2013

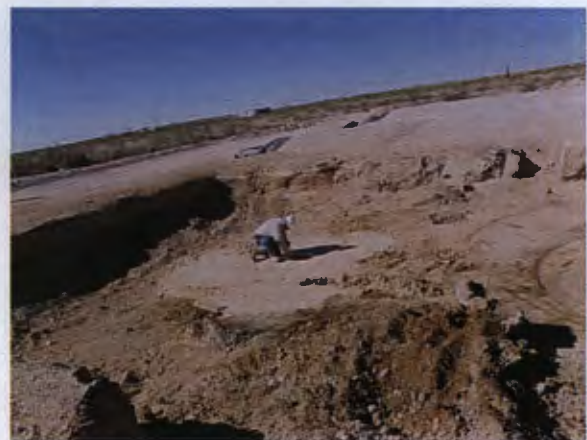
sampling beneath the former south BGT,
facing southwest 11/4/2013

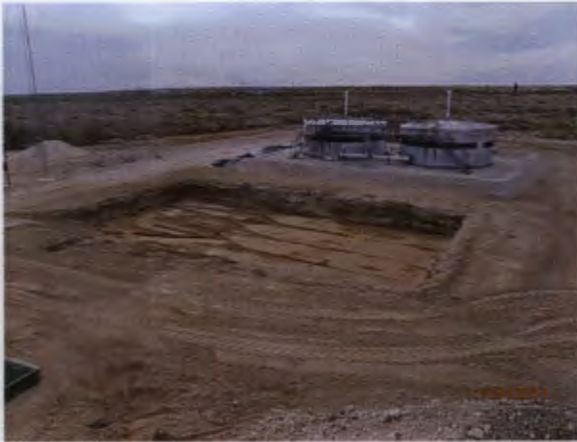
excavation padded with 6 inches of blow sand,
facing southwest 11/7/2013

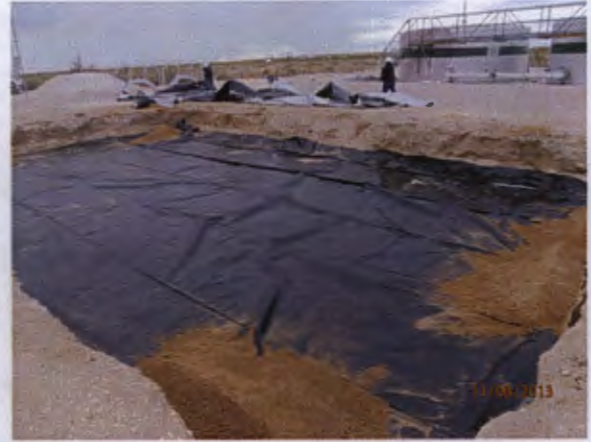
20-mil reinforced liner installed at 4 ft bgs,
facing southwest 11/8/2013

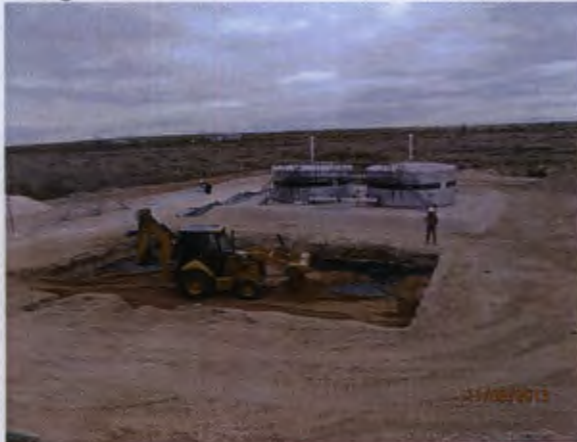
padding the liner with 6 inches of blow sand,
facing southwest 11/8/2013

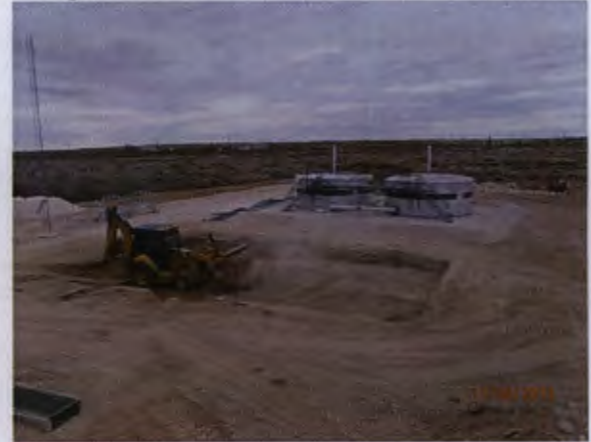
backfilling the excavation with caliche,
facing southwest 11/8/2013

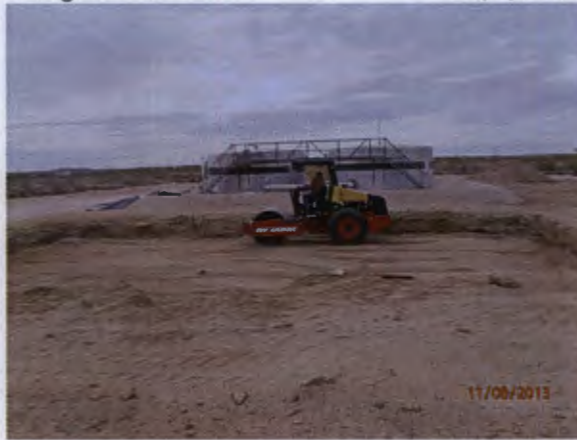
compacting the caliche, facing west 11/8/2013

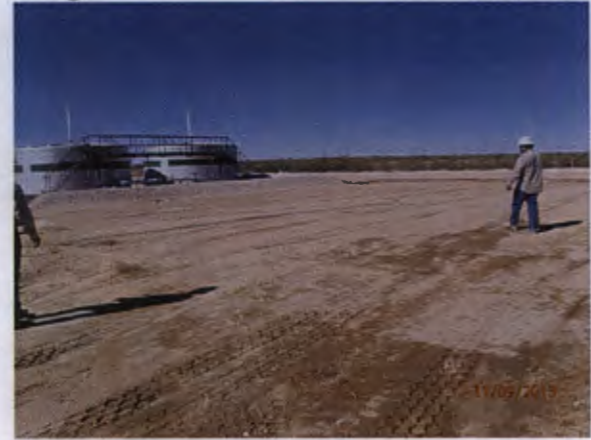
site complete, facing northwest 11/9/2013

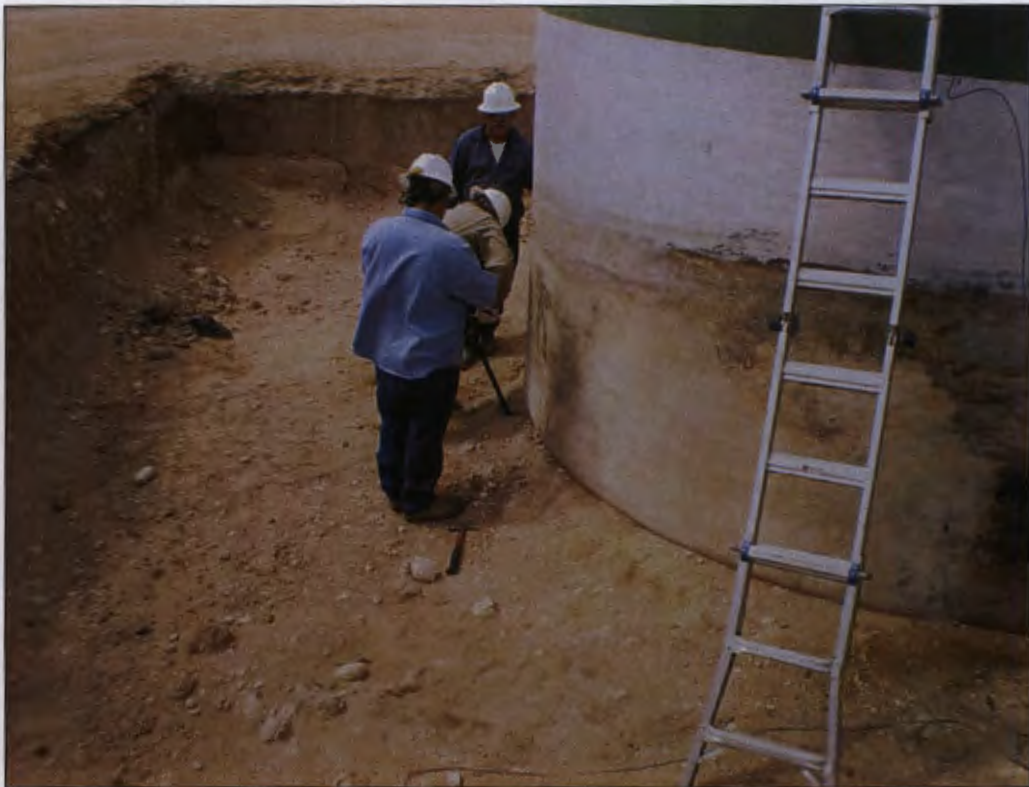
Photograph C– View of soil augering under south tank.

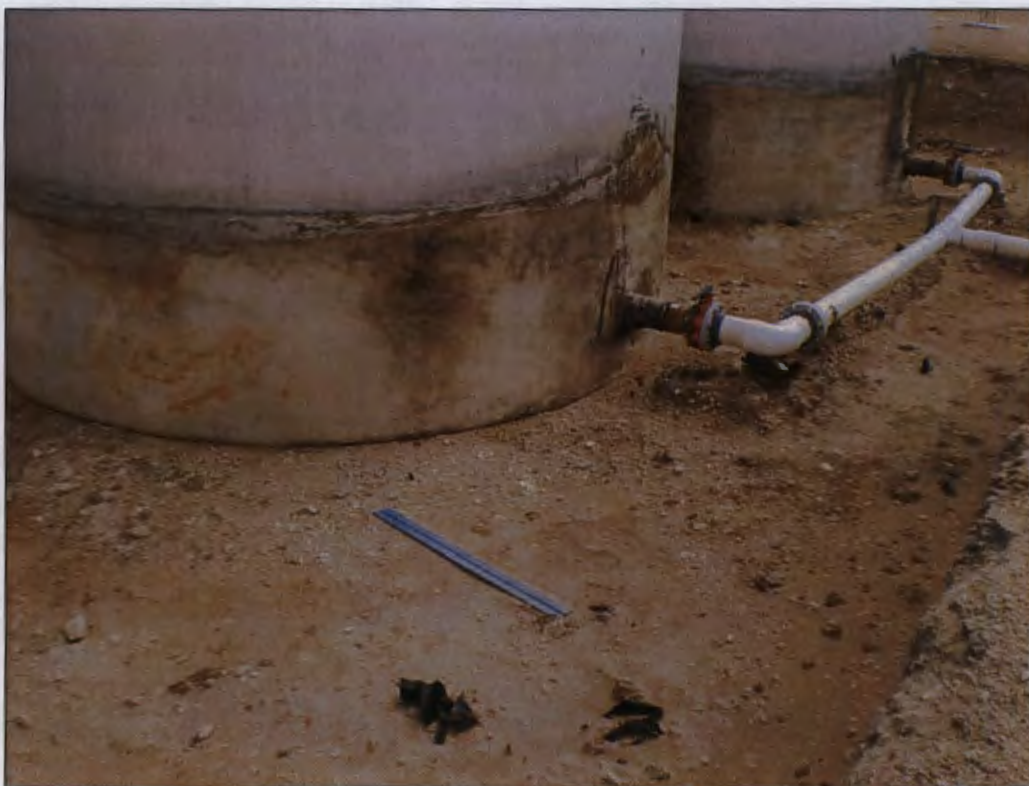
Photograph D – View of north (left) and south (right) below-grade tanks and appurtenances.

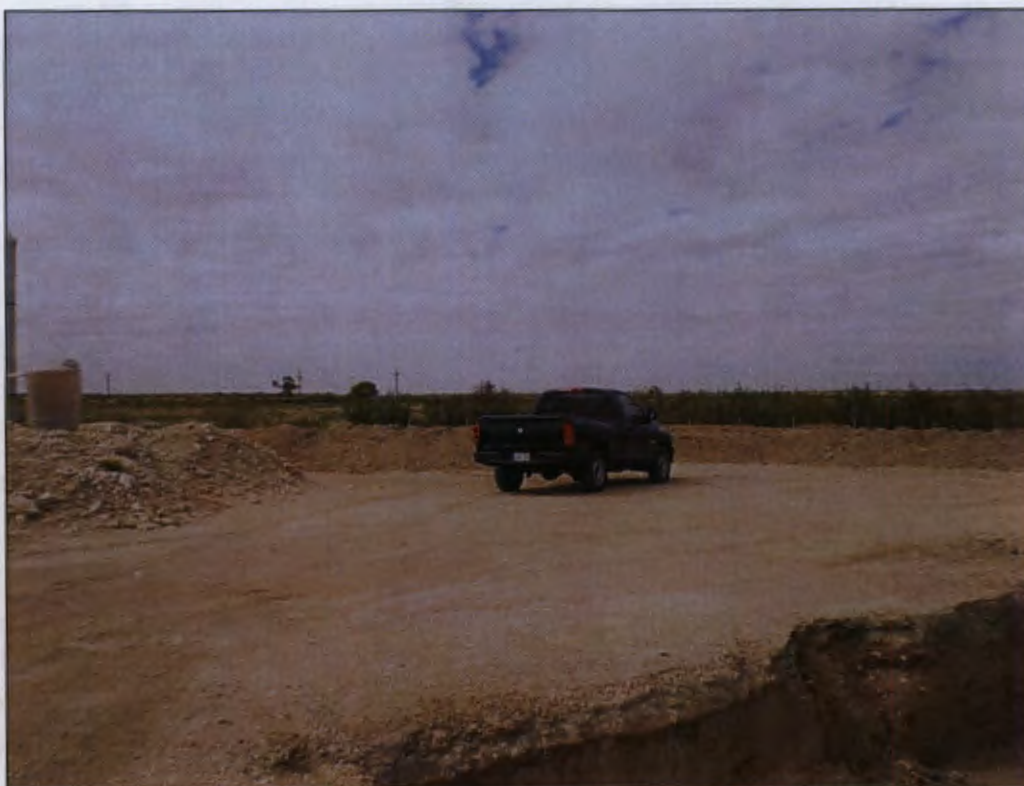
Photograph F – View of excavated soil (beyond truck) from edge of tank area.
